Final Report

Pavement Condition Report

Glenwood Municipal Airport (GHW)

December 2014

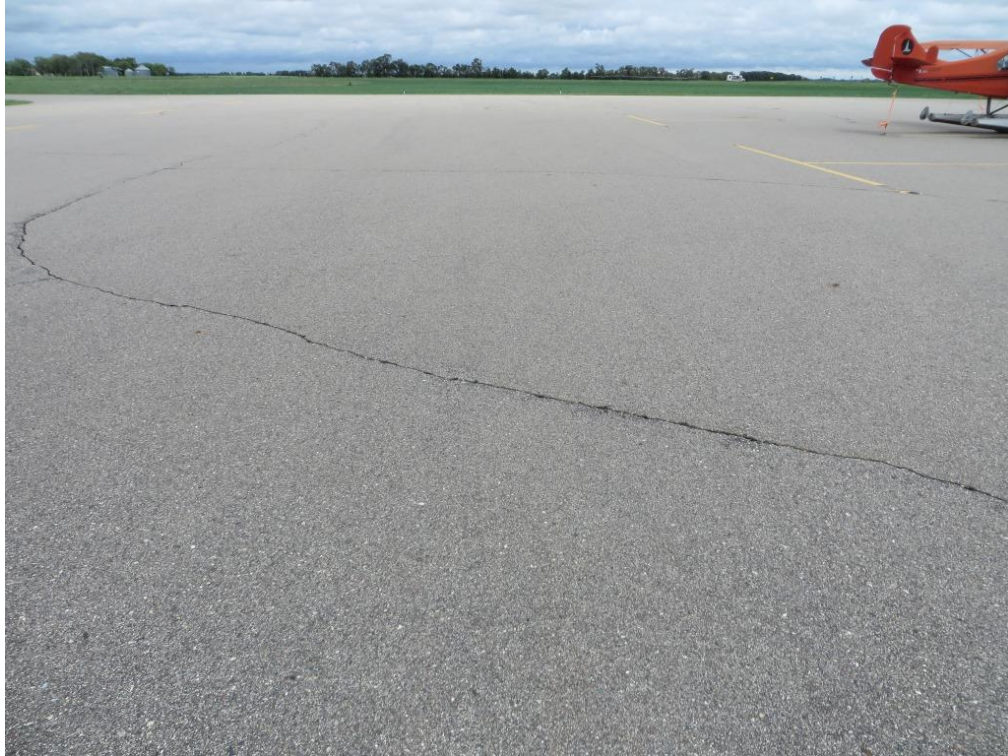
GHW APA 001 (PCI = 71)

| Branch ID | Section ID | Surface type ¹ | Section area (SF) | LCD ² | 2011 PCI | 2014 PCI | Drop in PCI/Yr ³ | % Deduct due to | | Distress types |
|---|---|---|---|---|---|---|---|---|---|---|
| APA | 1 | AC | 65,300 | 2008 | 83 | 71 | 4.8 | 21 | 79 | L&T cracking, rutting |

Conditions: PCI: 71

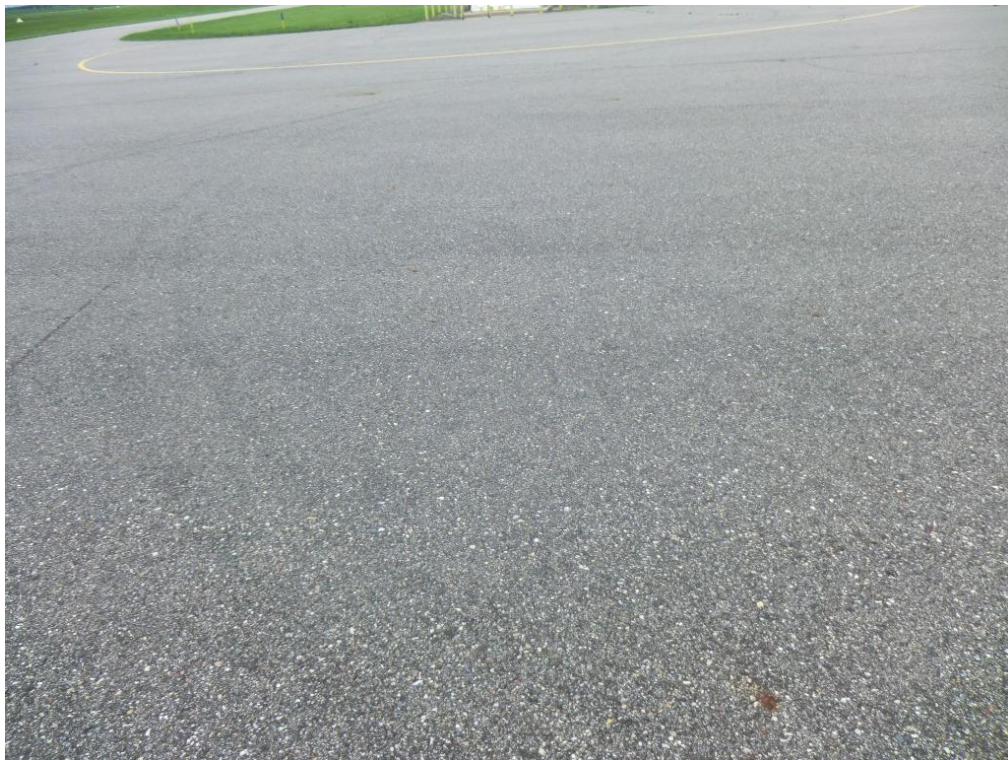
GHW APB 001 (PCI = 70)

| Branch ID | Section ID | Surface type ¹ | Section area (SF) | LCD ² | 2011 PCI | 2014 PCI | Drop in PCI/Yr ³ | % Deduct due to | | Distress types |
|---|---|---|---|---|---|---|---|---|---|---|
| APB | 1 | AC | 52,500 | 2008 | 89 | 70 | 5.0 | 0 | 100 | L&T cracking |

Conditions: PCI: 70

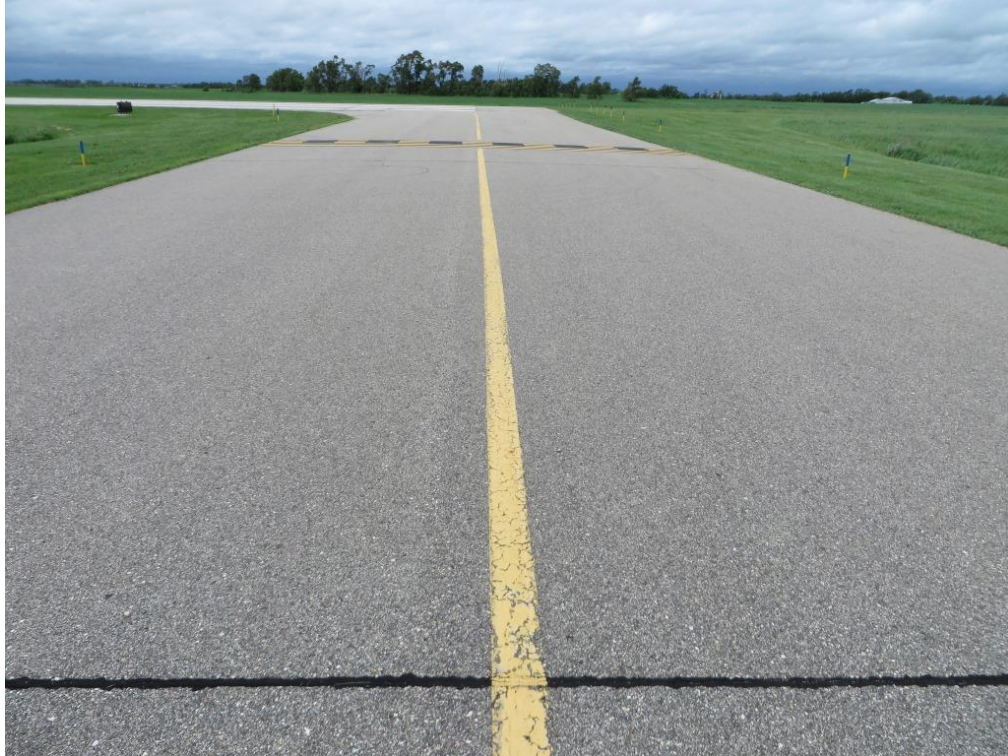
GHW CTA 001 (PCI=83)

| Branch ID | Section ID | Surface type ¹ | Section area (SF) | LCD ² | 2011 PCI | 2014 PCI | Drop in PCI/Yr ³ | % Deduct due to | | Distress types |
|---|---|---|---|---|---|---|---|---|---|---|
| CTA | 1 | AC | 29,250 | 2008 | 96 | 83 | 2.8 | 0 | 100 | L&T cracking |

Conditions: PCI : 83

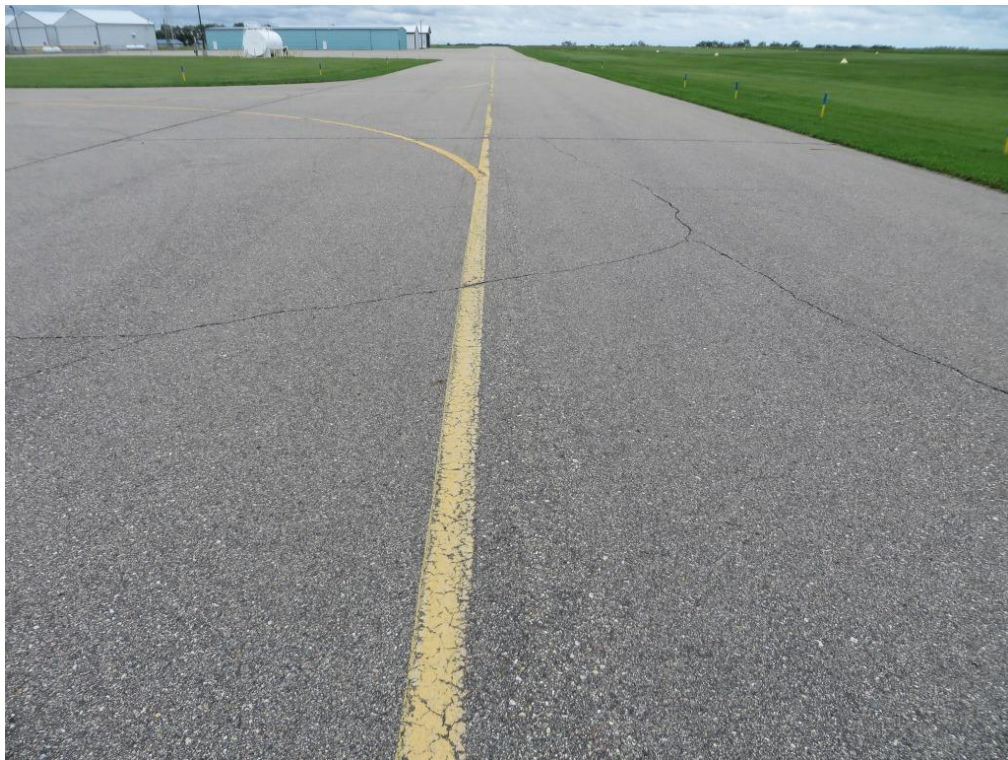
GHW CTB 001 (PCI = 87)

| Branch ID | Section ID | Surface type ¹ | Section area (SF) | LCD ² | 2011 PCI | 2014 PCI | Drop in PCI/Yr ³ | % Deduct due to | | Distress types |
|---|---|---|---|---|---|---|---|---|---|---|
| CTB | 1 | AC | 64,615 | 2008 | 97 | 87 | 2.2 | 0 | 100 | L&T cracking, weathering |

Conditions: PCI : 87

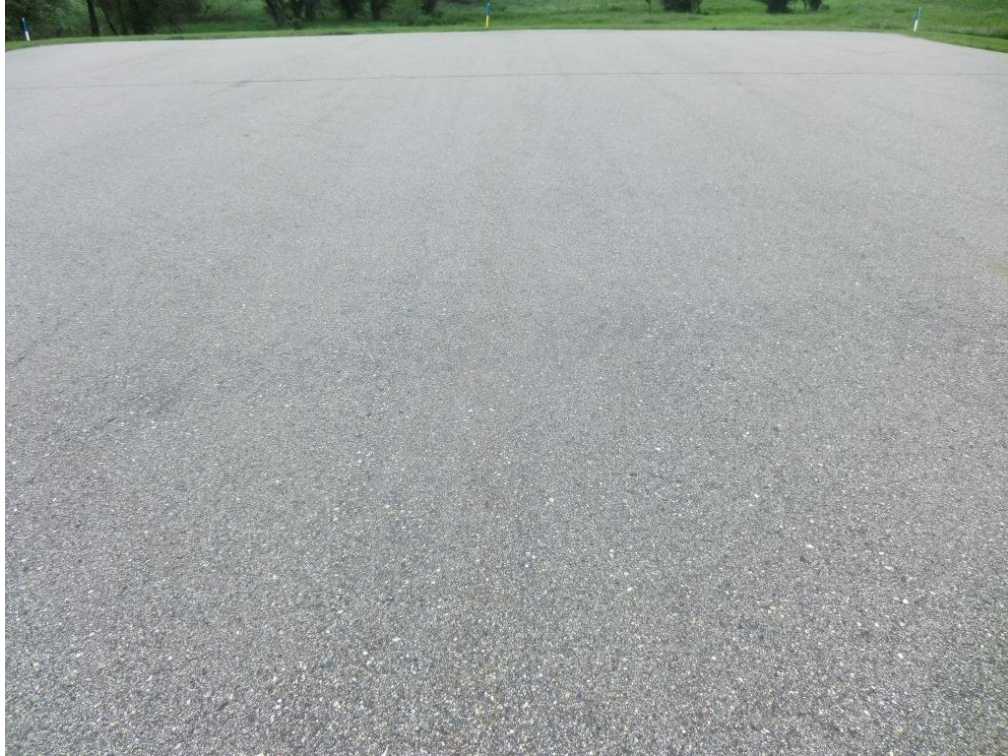
GHW RTA 001 (PCI = 99)

Conditions: PCI : 99

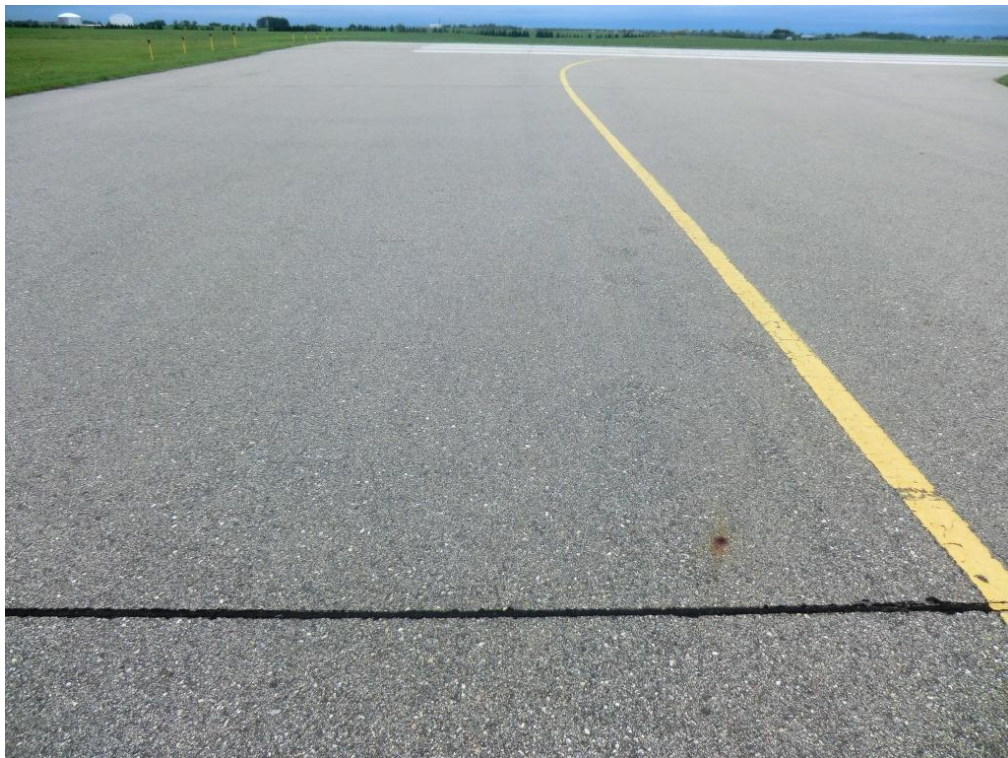
GHW RTA 002 (PCI = 97)

| Branch ID | Section ID | Surface type ¹ | Section area (SF) | LCD ² | 2011 PCI | 2014 PCI | Drop in PCI/Yr ³ | % Deduct due to | | Distress types |
|---|---|---|---|---|---|---|---|---|---|---|
| RTA | 2 | AC | 14,075 | 2008 | 100 | 97 | 0.5 | 0 | 65 | L&T cracking, oil spillage |

Conditions: PCI: 97

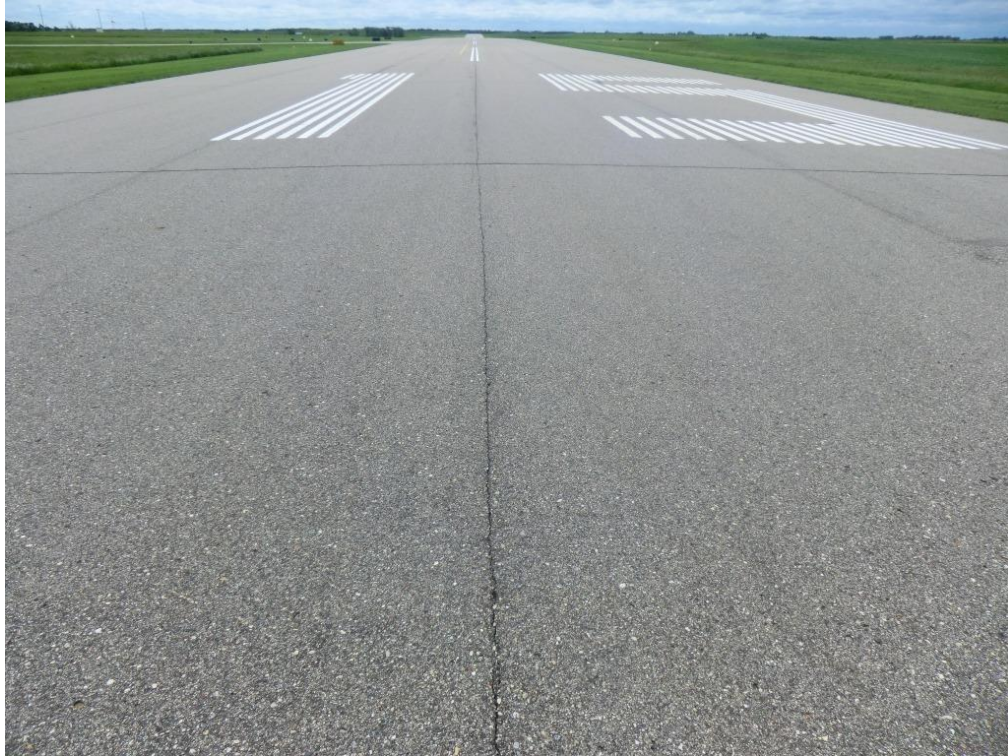
GHW RY1533 001 (PCI = 90)

| Branch ID | Section ID | Surface type ¹ | Section area (SF) | LCD ² | 2011 PCI | 2014 PCI | Drop in PCI/Yr ³ | % Deduct due to | | Distress types |
|---|---|---|---|---|---|---|---|---|---|---|
| RY1533 | 1 | AC | 262,500 | 2008 | 100 | 90 | 1.7 | 0 | 100 | L&T cracking |

Conditions: PCI : 90

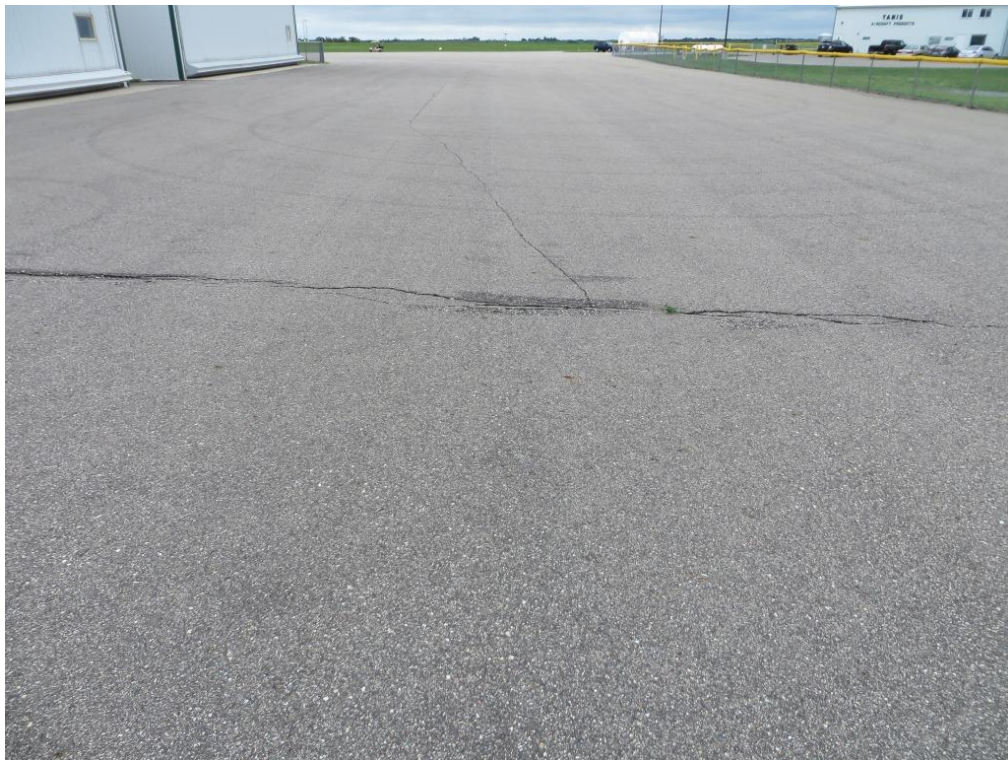
GHW TLA 001 (PCI = 82)

| Branch ID | Section ID | Surface type ¹ | Section area (SF) | LCD ² | 2011 PCI | 2014 PCI | Drop in PCI/Yr ³ | % Deduct due to | | Distress types |
|---|---|---|---|---|---|---|---|---|---|---|
| TLA | 1 | AC | 35,250 | 2008 | 97 | 82 | 3.0 | 0 | 100 | L&T cracking |

Conditions: PCI : 82

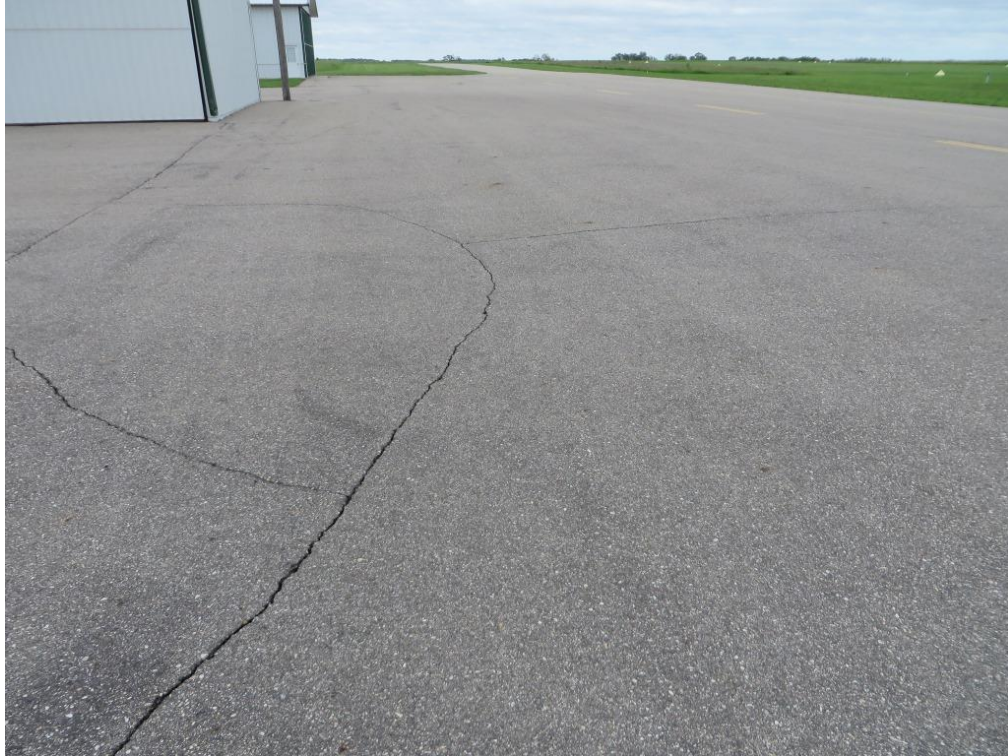
GHW TLB 001 (PCI = 89)

| Branch ID | Section ID | Surface type ¹ | Section area (SF) | LCD ² | 2011 PCI | 2014 PCI | Drop in PCI/Yr ³ | % Deduct due to | | Distress types |
|---|---|---|---|---|---|---|---|---|---|---|
| TLB | 1 | AC | 33,595 | 2008 | 96 | 89 | 1.8 | 0 | 100 | L&T cracking |

Conditions: PCI: 89
