Pavement Condition Report

Alexandria Municipal Airport (AXN)

December 2016

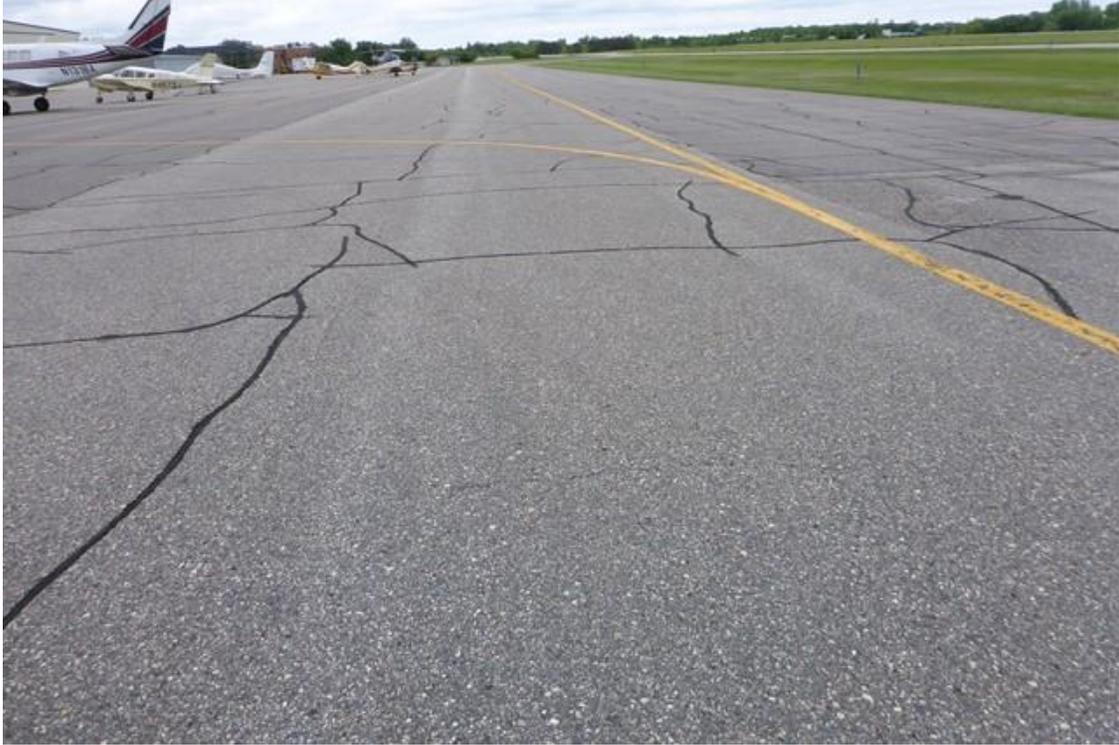
AXN APA 001 (PCI = 53)

Network:	AXN	Name:	ALEXANDRIA						
Branch:	APA	Name:	APRON A	Use:	APRON	Area:	223,737 SqFt		
Section:	001	of 2	From:	200	To:	508	Last Const.:	9/30/1995	
Surface:	AAC	Family:	MN2013 Asphalt Aprons	Zone:	W	Category:	3	Rank:	S
Area:	183,400 SqFt	Length:	869 Ft	Width:	200 Ft				
Slabs:	Slab Length:	Ft	Slab Width:	Ft	Joint Length:	Ft			
Shoulder:	Street Type:		Grade:	0	Lanes:	0			
Section Comments:	maint. (R&E) CS								
Last Insp. Date:	6/1/2016	TotalSamples:	38	Surveyed:	7				
Conditions:	PCI: 53								
Inspection Comments:									
Sample Number:	202	Type:	R	Area:	5000.00 SqFt	PCI:	40		
Sample Comments:									
43	BLOCK CR	M	720.00	SqFt					
43	BLOCK CR	L	4200.00	SqFt					
57	WEATHERING	M	150.00	SqFt					
41	ALLIGATOR CR	M	10.00	SqFt					
52	RAVELING	H	30.00	SqFt					
43	BLOCK CR	H	70.00	SqFt					
Sample Number:	206	Type:	R	Area:	5000.00 SqFt	PCI:	50		
Sample Comments:									
43	BLOCK CR	M	200.00	SqFt

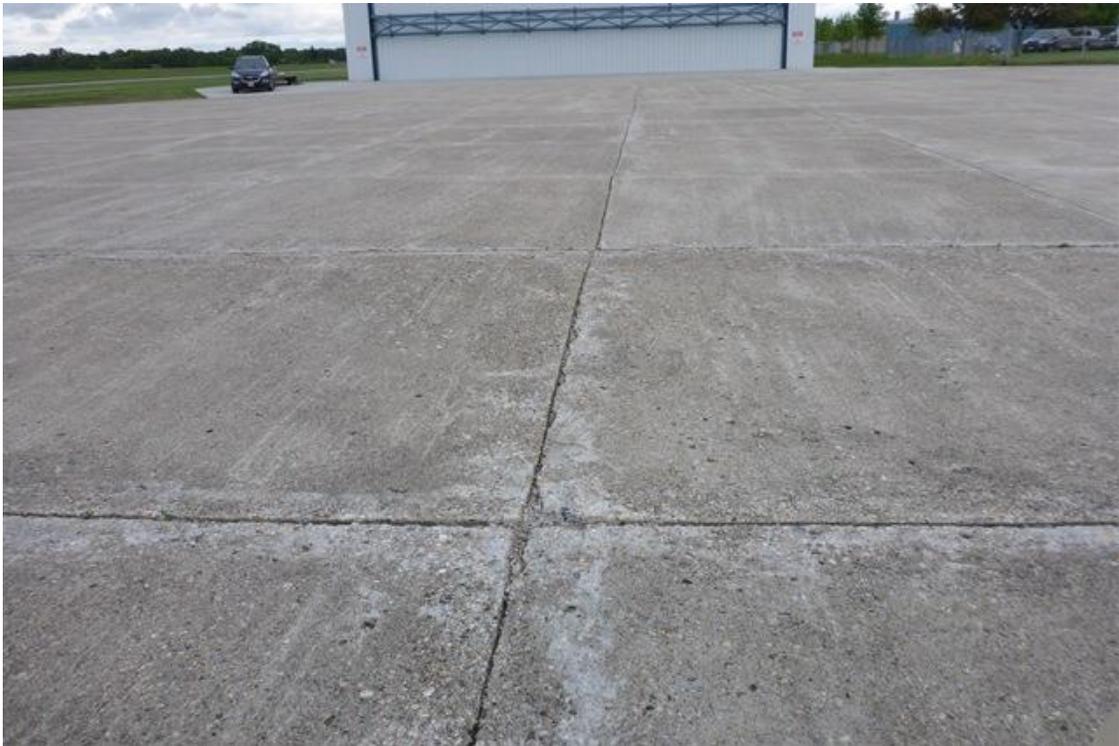
AXN APA 002 (PCI = 44)

Network:	AXN	Name:	ALEXANDRIA						
Branch:	APA	Name:	APRON A	Use:	APRON	Area:	223,737 SqFt		
Section:	002	of 2	From:	100	To:	207	Last Const.:	9/30/1982	
Surface:	PCC	Family:	MN2013 PCC	Zone:	W	Category:	3	Rank:	S
Area:	40,337 SqFt	Length:	209 Ft	Width:	193 Ft				
Slabs:	305	Slab Length:	12 Ft	Slab Width:	12 Ft	Joint Length:	6,613 Ft		
Shoulder:		Street Type:		Grade:	0	Lanes:	0		
Section Comments:	historical images date this pavement to WWII era								
Last Insp. Date:	6/1/2016	TotalSamples:	16	Surveyed:	6				
Conditions:	PCI: 44								
Inspection Comments:									
Sample Number:	101	Type:	R	Area:	17.00 Slabs	PCI:	30		
Sample Comments:									
75	CORNER SPALL	H	3.00	Slabs					
62	CORNER BREAK	H	1.00	Slabs					
64	DURABIL. CR	M	2.00	Slabs					
75	CORNER SPALL	M	3.00	Slabs					
71	FAULTING	L	1.00	Slabs					
63	LINEAR CR	L	1.00	Slabs					
63	LINEAR CR	M	2.00	Slabs					
65	JT SEAL DMG	H	17.00	Slabs					
75	CORNER SPALL	L	1.00	Slabs

66	SMALL PATCH	H	2.00	Slabs					
Sample Number:	103	Type:	R	Area:	18.00 Slabs	PCI:	39		
Sample Comments:									
65	JT SEAL DMG	H	18.00	Slabs					
75	CORNER SPALL	H	1.00	Slabs					
66	SMALL PATCH	H	1.00	Slabs					
74	JOINT SPALL	M	1.00	Slabs					
64	DURABIL. CR	M	5.00	Slabs					
66	SMALL PATCH	H	3.00	Slabs					
64	DURABIL. CR	H	1.00	Slabs					
Sample Number:	105	Type:	R	Area:	18.00 Slabs	PCI:	67		
Sample Comments:									
75	CORNER SPALL	H	1.00	Slabs					
66	SMALL PATCH	H	1.00	Slabs					
64	DURABIL. CR	M	2.00	Slabs					
65	JT SEAL DMG	H	18.00	Slabs					
Sample Number:	201	Type:	R	Area:	18.00 Slabs	PCI:	28		
Sample Comments:									
66	SMALL PATCH	H	4.00	Slabs					
64	DURABIL. CR	M	5.00	Slabs					
65	JT SEAL DMG	H	18.00	Slabs					
75	CORNER SPALL	H	2.00	Slabs					
63	LINEAR CR	M	1.00	Slabs					
62	CORNER BREAK	L	3.00	Slabs					
71	FAULTING	M	3.00	Slabs					
75	CORNER SPALL	M	1.00	Slabs					
Sample Number:	202	Type:	R	Area:	16.00 Slabs	PCI:	34

Sample Comments:									
75	CORNER SPALL	M	3.00	Slabs					
75	CORNER SPALL	H	2.00	Slabs					
64	DURABIL. CR	M	3.00	Slabs					
65	JT SEAL DMG	H	16.00	Slabs					
64	DURABIL. CR	L	1.00	Slabs					
74	JOINT SPALL	M	3.00	Slabs					
74	JOINT SPALL	H	3.00	Slabs

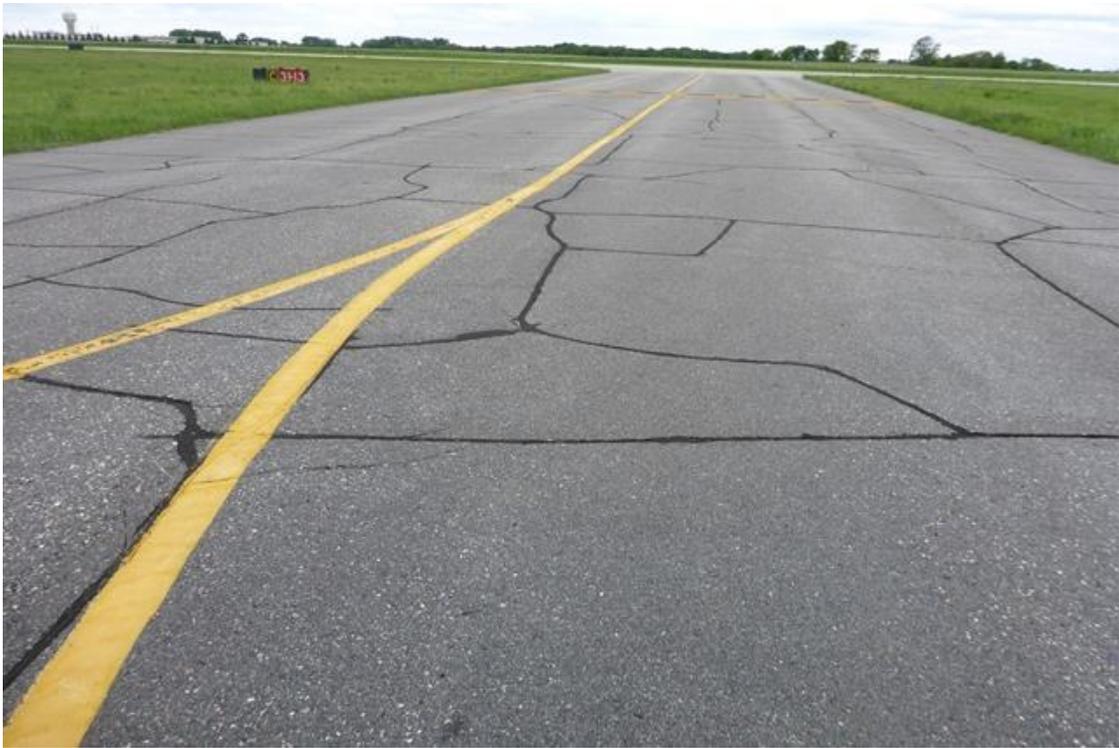
AXN CTC 001 (PCI = 60)

Network:	AXN	Name:	ALEXANDRIA						
Branch:	CTC	Name:	CONNECTING TAXIWAY C	Use:	TAXIWAY	Area:	14,425 SqFt		
Section:	001	of 1	From:	200	To:	202	Last Const.:	9/30/1995	
Surface:	AAC	Family:	MN2013 Asphalt Taxiways	Zone:	W	Category:	3	Rank:	S
Area:	14,425 SqFt	Length:	275 Ft	Width:	50 Ft				
Slabs:		Slab Length:	Ft	Slab Width:	Ft	Joint Length:	Ft		
Shoulder:		Street Type:		Grade:	0	Lanes:	0		
Section Comments:	maint. (R&E) CS								
Last Insp. Date:	6/1/2016	TotalSamples:	3	Surveyed:	1				
Conditions:	PCI: 60								
Inspection Comments:									
Sample Number:	201	Type:	R	Area:	5000.00 SqFt	PCI:	60		
Sample Comments:									
43	BLOCK CR	M	100.00	SqFt					
43	BLOCK CR	L	4900.00	SqFt

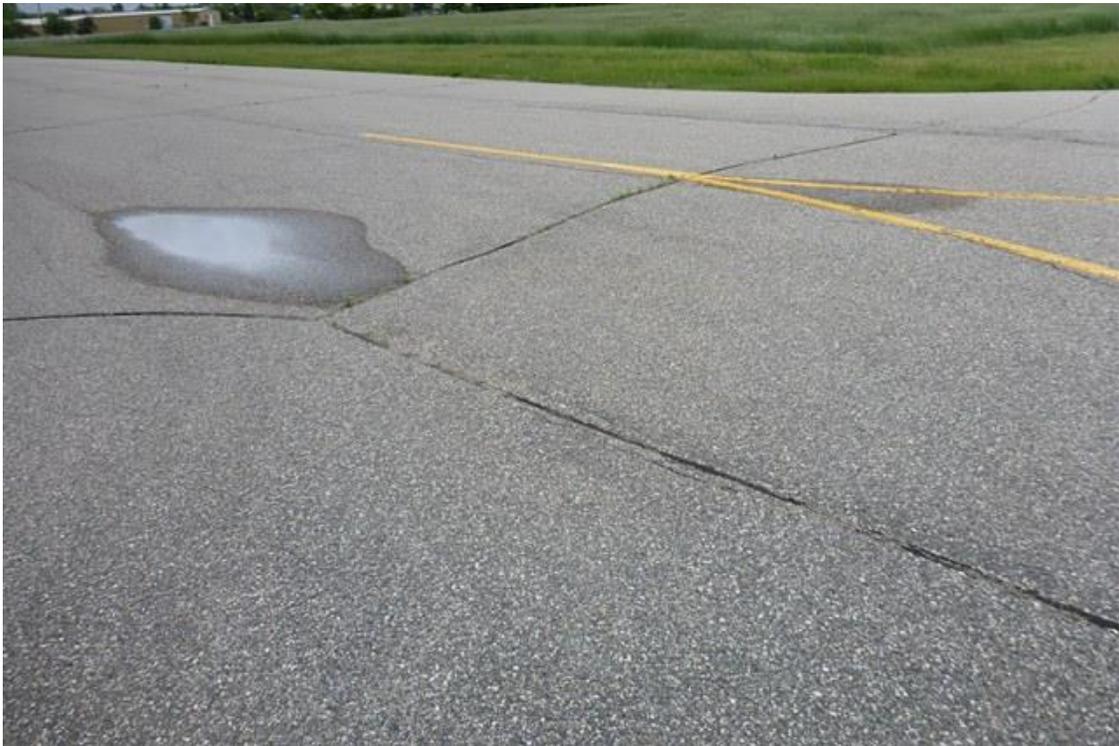
AXN CTG 001 (PCI = 67)

Network:	AXN	Name:	ALEXANDRIA						
Branch:	CTG	Name:	Connecting Taxiway G	Use:	TAXIWAY	Area:	5,160 SqFt		
Section:	001	of 1	From:	100	To:	100	Last Const.:	6/15/2007	
Surface:	AC	Family:	MN2013 Asphalt Taxiways	Zone:	W	Category:	3	Rank:	S
Area:	5,160 SqFt	Length:	80 Ft	Width:	50 Ft				
Slabs:		Slab Length:	Ft	Slab Width:	Ft	Joint Length:	Ft		
Shoulder:		Street Type:		Grade:	0	Lanes:	0		
Section Comments:									
Last Insp. Date:	6/1/2016	TotalSamples:	1	Surveyed:	1				
Conditions:	PCI: 67								
Inspection Comments:									
Sample Number:	100	Type:	R	Area:	4000.00 SqFt	PCI:	67		
Sample Comments:									
57	WEATHERING	M	320.00	SqFt					
48	L & T CR	L	255.00	Ft					
48	L & T CR	M	170.00	Ft

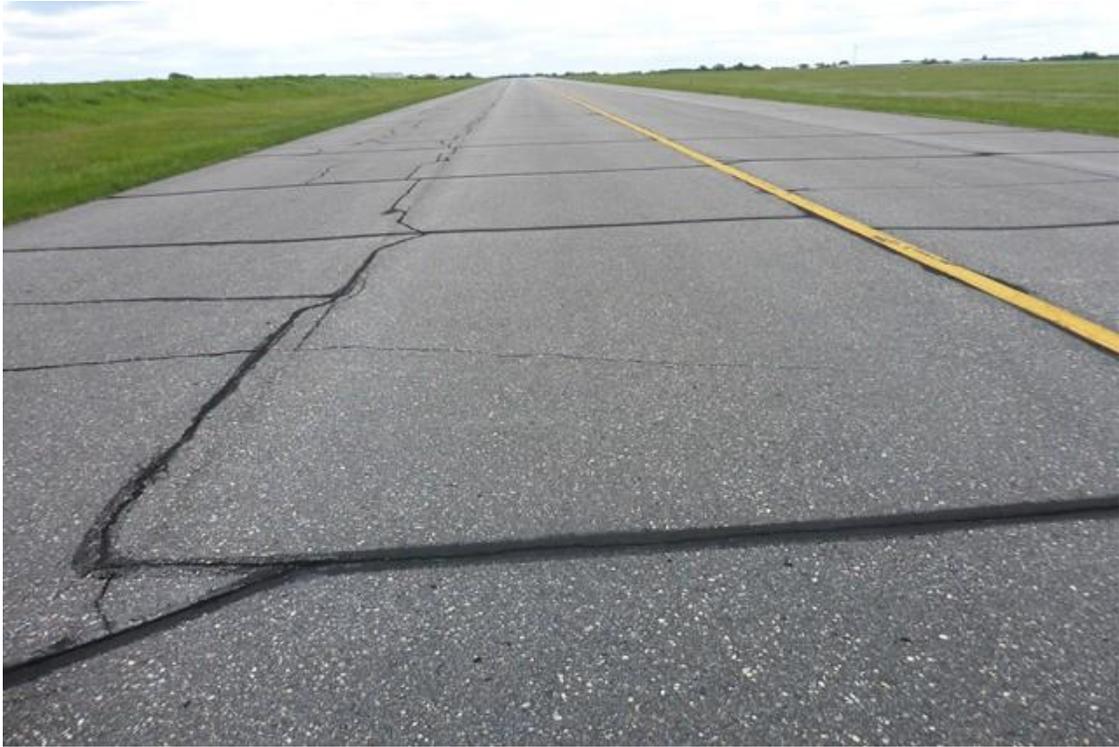
AXN PTA 001 (PCI = 60)

Network:	AXN	Name:	ALEXANDRIA						
Branch:	PTA	Name:	PARALLEL TAXIWAY A	Use:	TAXIWAY	Area:	275,665 SqFt		
Section:	001	of 1	From:	100	To:	155	Last Const.:	9/30/1995	
Surface:	AAC	Family:	MN2013 Asphalt Taxiways	Zone:	W	Category:	3	Rank:	P
Area:	275,665 SqFt	Length:	5,600 Ft	Width:	50 Ft				
Slabs:		Slab Length:	Ft	Slab Width:	Ft	Joint Length:	Ft		
Shoulder:		Street Type:		Grade:	0	Lanes:	0		
Section Comments:	maint. (R&E) CS								
Last Insp. Date:	6/1/2016	TotalSamples:	56	Surveyed:	6				
Conditions:	PCI: 60								
Inspection Comments:									
Sample Number:	104	Type:	R	Area:	5000.00 SqFt	PCI:	62		
Sample Comments:									
43	BLOCK CR	L	2250.00	SqFt					
48	L & T CR	L	349.00	Ft					
48	L & T CR	M	77.00	Ft					
Sample Number:	113	Type:	R	Area:	5000.00 SqFt	PCI:	62		
Sample Comments:									
48	L & T CR	L	8.00	Ft					
43	BLOCK CR	L	4100.00	SqFt					
48	L & T CR	L	91.00	Ft					
Sample Number:	122	Type:	R	Area:	5000.00 SqFt	PCI:	57

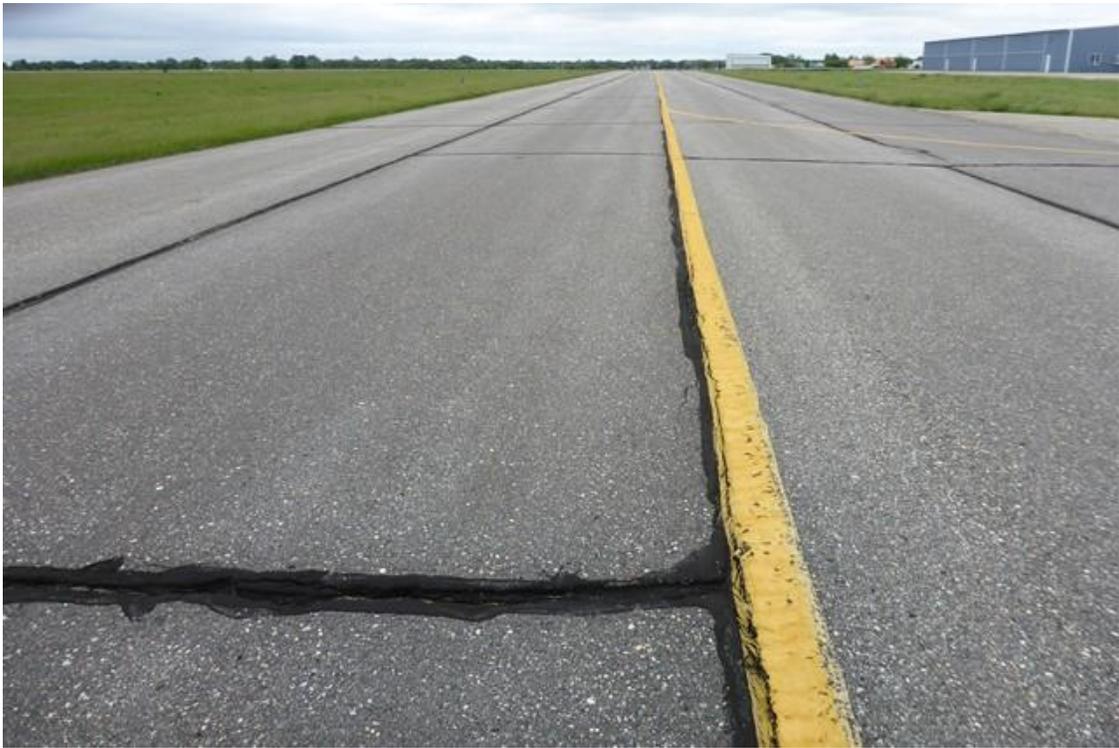
AXN PTB 001 (PCI = 61)

Network:	AXN	Name:	ALEXANDRIA						
Branch:	PTB	Name:	PARALLEL TAXIWAY B	Use:	TAXIWAY	Area:	232,410 SqFt		
Section:	001	of 2	From:	100	To:	123	Last Const.:	9/30/1995	
Surface:	AC	Family:	MN2013 Asphalt Taxiways	Zone:	W	Category:	3	Rank:	S
Area:	110,580 SqFt	Length:	2,275 Ft	Width:	50 Ft				
Slabs:		Slab Length:	Ft	Slab Width:	Ft	Joint Length:	Ft		
Shoulder:		Street Type:		Grade:	0	Lanes:	0		
Section Comments:	maint. (R&E) CS								
Last Insp. Date:	6/1/2016	TotalSamples:	23	Surveyed:	4				
Conditions:	PCI: 61								
Inspection Comments:									
Sample Number:	102	Type:	R	Area:	5000.00 SqFt	PCI:	70		
Sample Comments:									
48	L & T CR	M	232.00	Ft					
48	L & T CR	L	305.00	Ft					
Sample Number:	108	Type:	R	Area:	5000.00 SqFt	PCI:	57		
Sample Comments:									
41	ALLIGATOR CR	M	4.00	SqFt					
48	L & T CR	L	204.00	Ft					
48	L & T CR	H	4.00	Ft					
48	L & T CR	M	302.00	Ft					
Sample Number:	114	Type:	R	Area:	5000.00 SqFt	PCI:	60

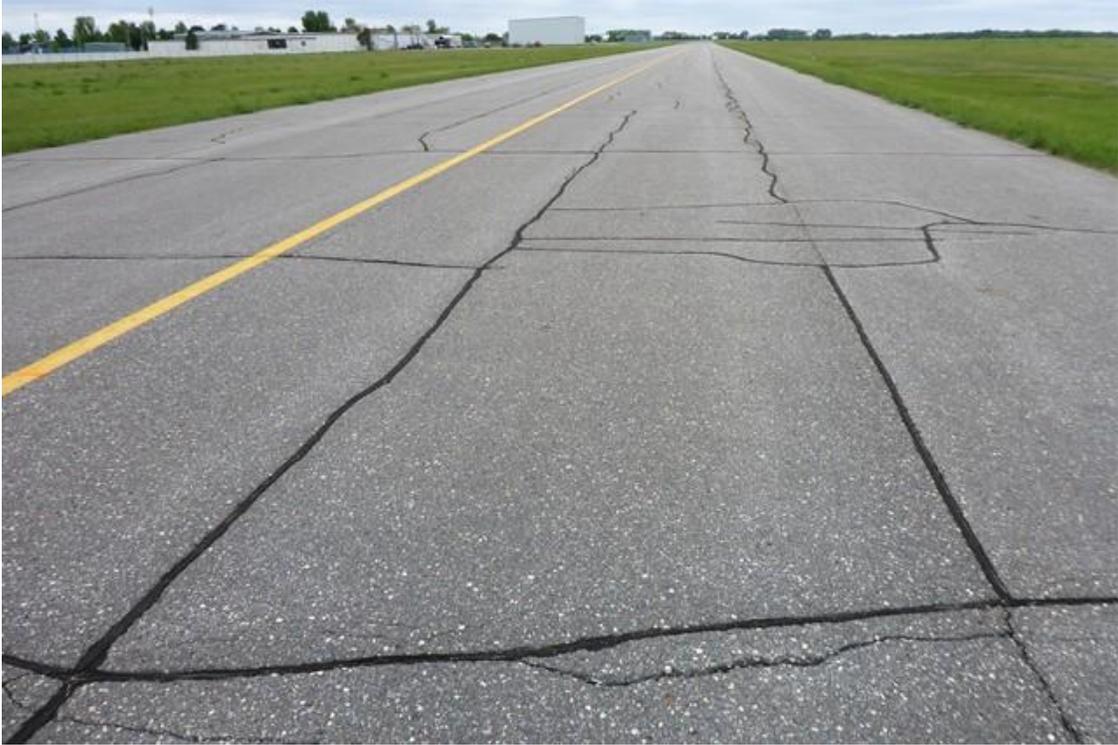
AXN PTB 002 (PCI = 54)

Network:	AXN	Name:	ALEXANDRIA						
Branch:	PTB	Name:	PARALLEL TAXIWAY B	Use:	TAXIWAY	Area:	232,410 SqFt		
Section:	002	of 2	From:	124	To:	148	Last Const.:	9/30/1995	
Surface:	AC	Family:	MN2013 Asphalt Taxiways	Zone:	W	Category:	3	Rank:	S
Area:	121,830 SqFt	Length:	2,500 Ft	Width:	50 Ft				
Slabs:		Slab Length:	Ft	Slab Width:	Ft	Joint Length:	Ft		
Shoulder:		Street Type:		Grade:	0	Lanes:	0		
Section Comments:									
Last Insp. Date:	6/1/2016	TotalSamples:	25	Surveyed:	5				
Conditions:	PCI: 54								
Inspection Comments:									
Sample Number:	126	Type:	R	Area:	5000.00 SqFt	PCI:	51		
Sample Comments:									
43	BLOCK CR	L	2875.00	SqFt					
48	L & T CR	M	31.00	Ft					
48	L & T CR	L	194.00	Ft					
43	BLOCK CR	M	100.00	SqFt					
57	WEATHERING	M	300.00	SqFt					
Sample Number:	131	Type:	R	Area:	5000.00 SqFt	PCI:	59		
Sample Comments:									
48	L & T CR	M	93.00	Ft					
57	WEATHERING	M	350.00	SqFt					
52	RAVELING	M	3.00	SqFt
