# Pavement Condition Report

## Lac Qui Parle County (Madison) Airport (DXX)

**December 2016**

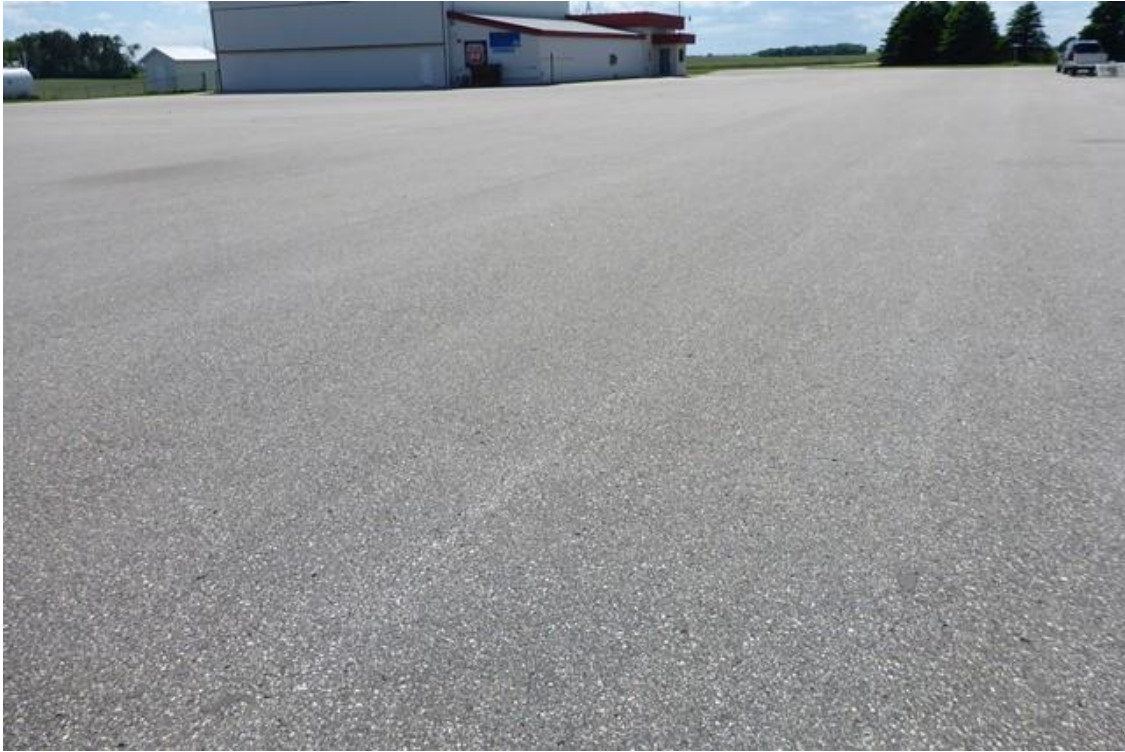
DXX APA 001 prior to slurry seal (PCI = 84, 6/2/2016)

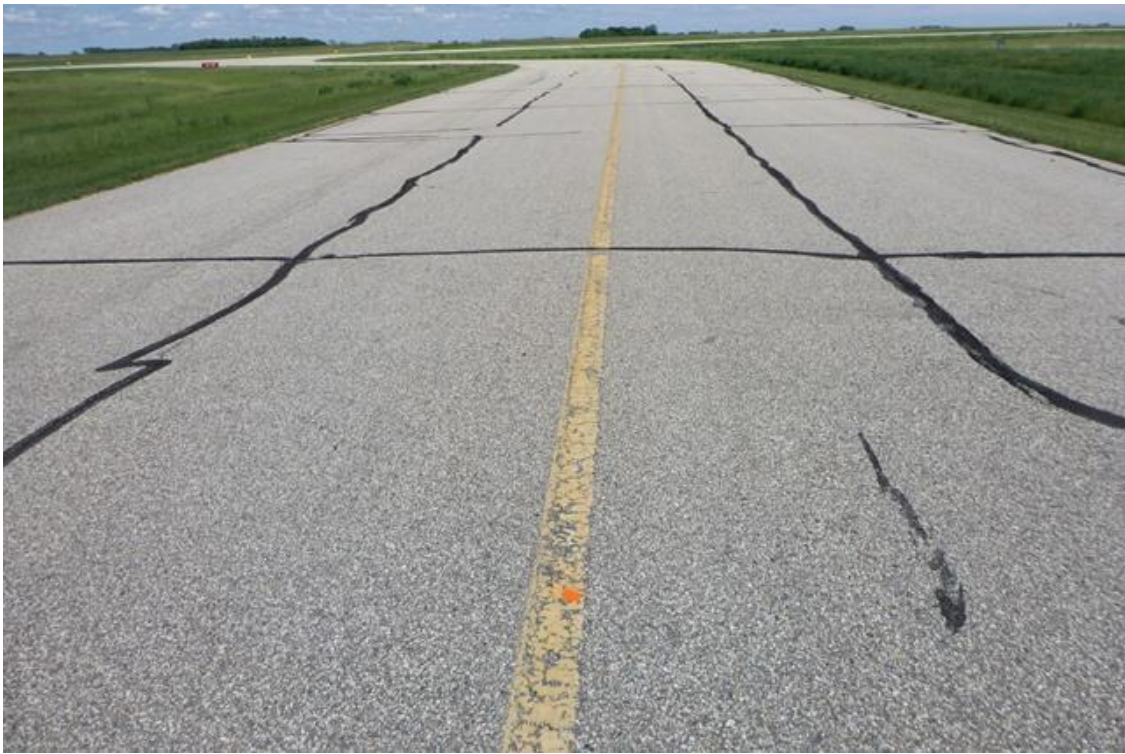
DXX CTA 001 prior to slurry seal (PCI = 63, 6/2/2016)

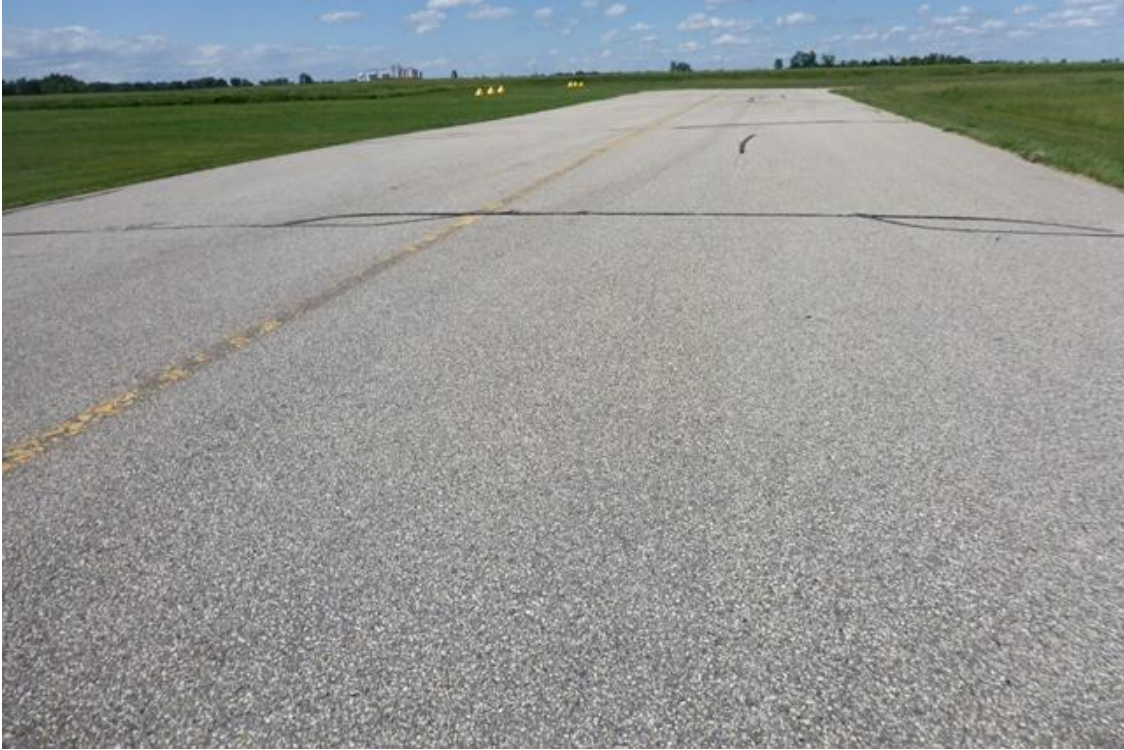
DXX CTB 001 prior to slurry seal (PCI = 60, 6/2/2016)

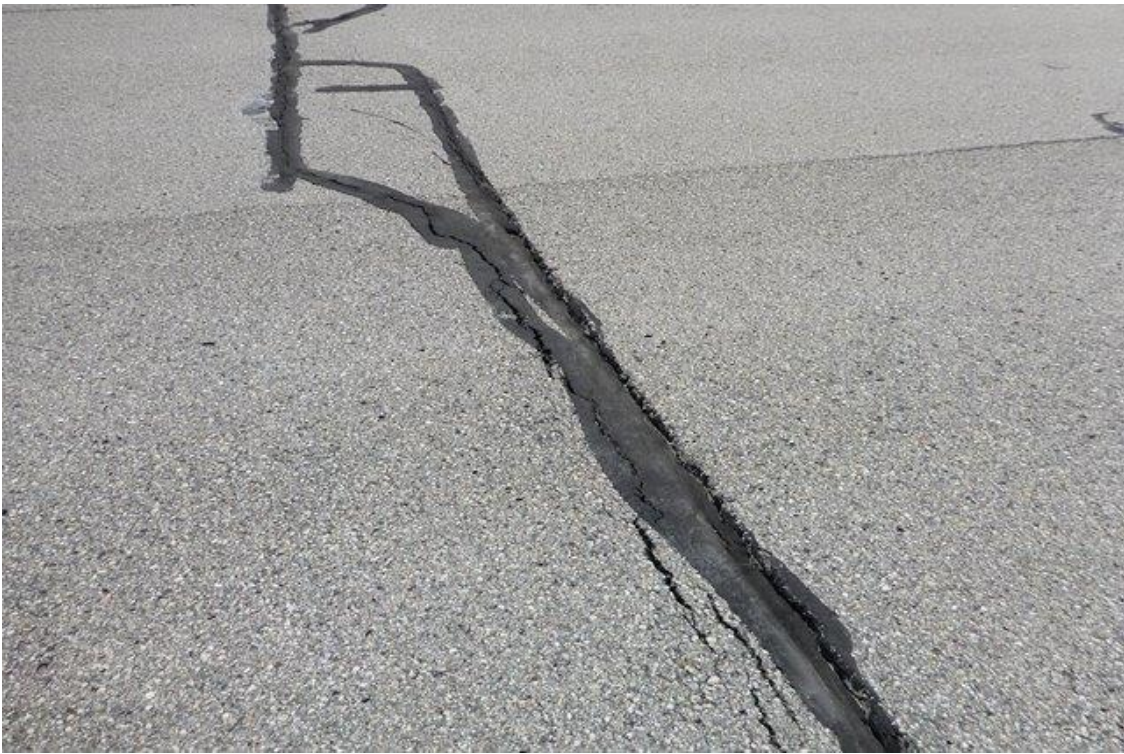
DXX RY1432 001 prior to slurry seal (PCI = 63, 6/2/2016)

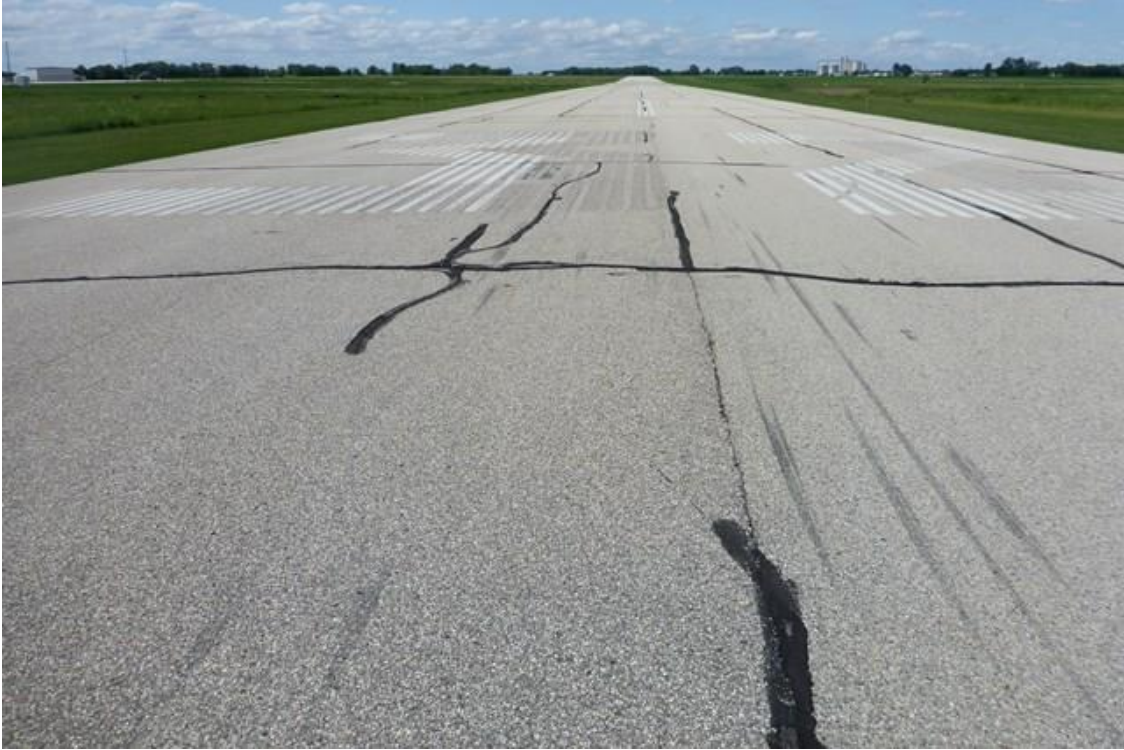
DXX RY1432 001 prior to slurry seal (PCI = 63, 6/2/2016)

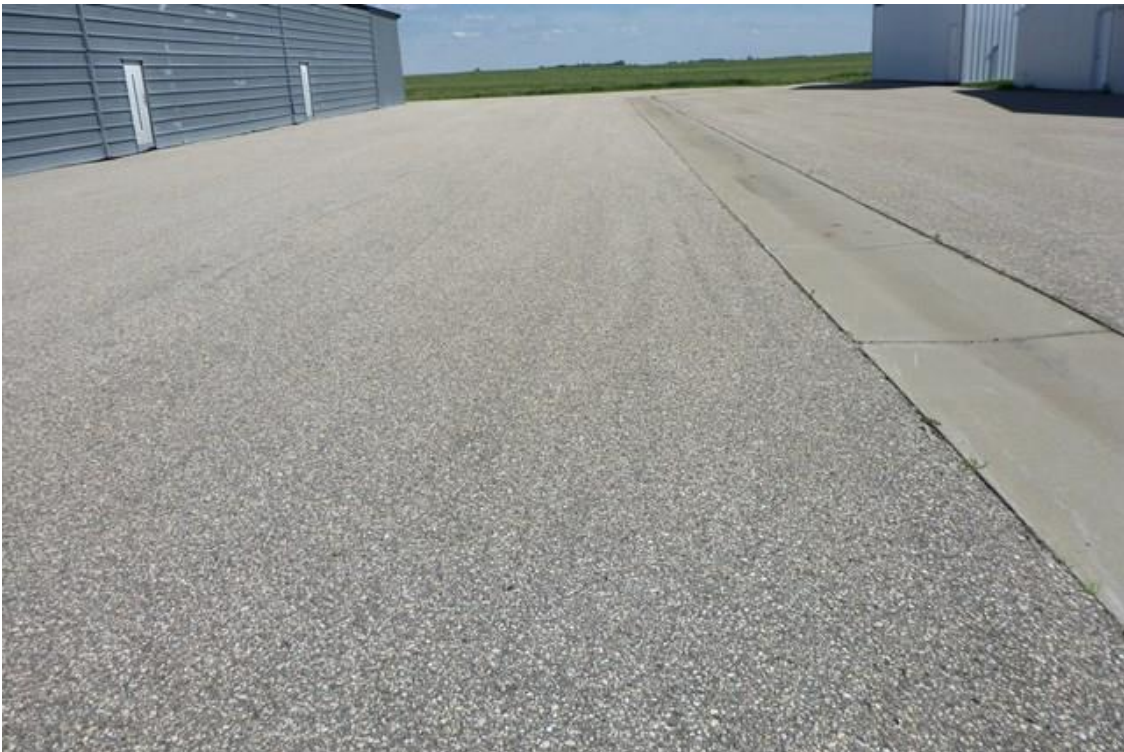
DXX TLA 001 prior to slurry seal (PCI = 73, 6/2/2016)

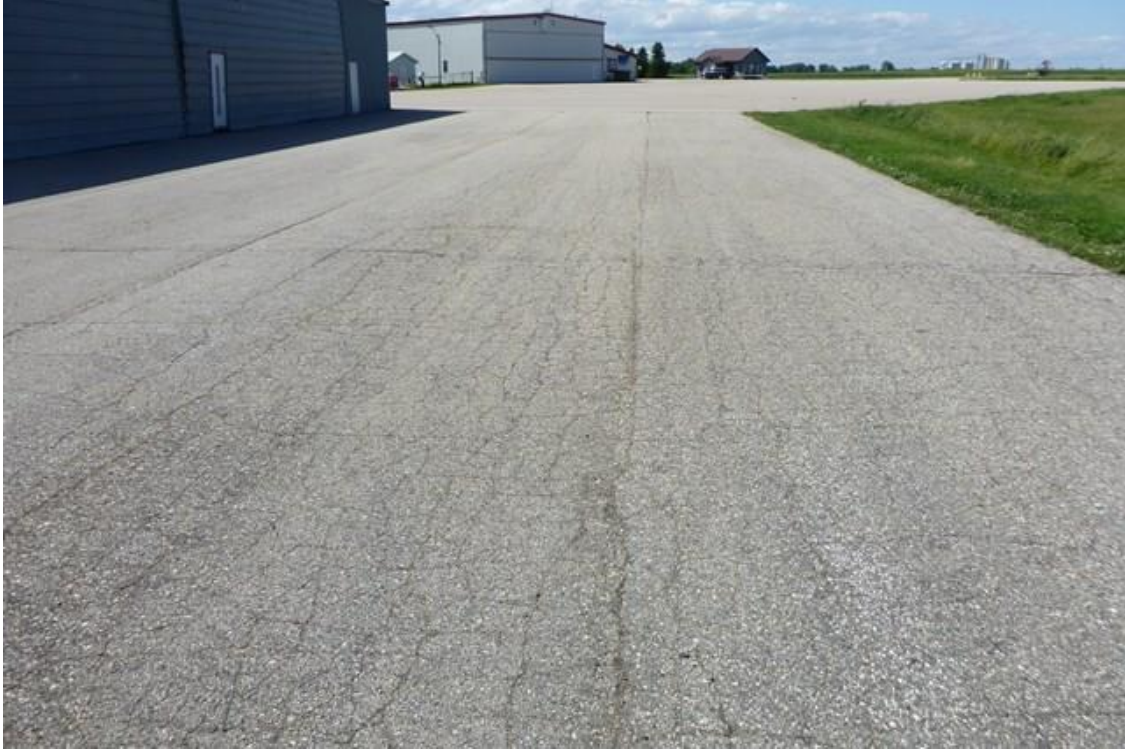
DXX TLA 002 prior to slurry seal (PCI = 17, 6/2/2016)
