Pavement Condition Report

Little Falls - Morrison County Airport (LXL)

December 2016

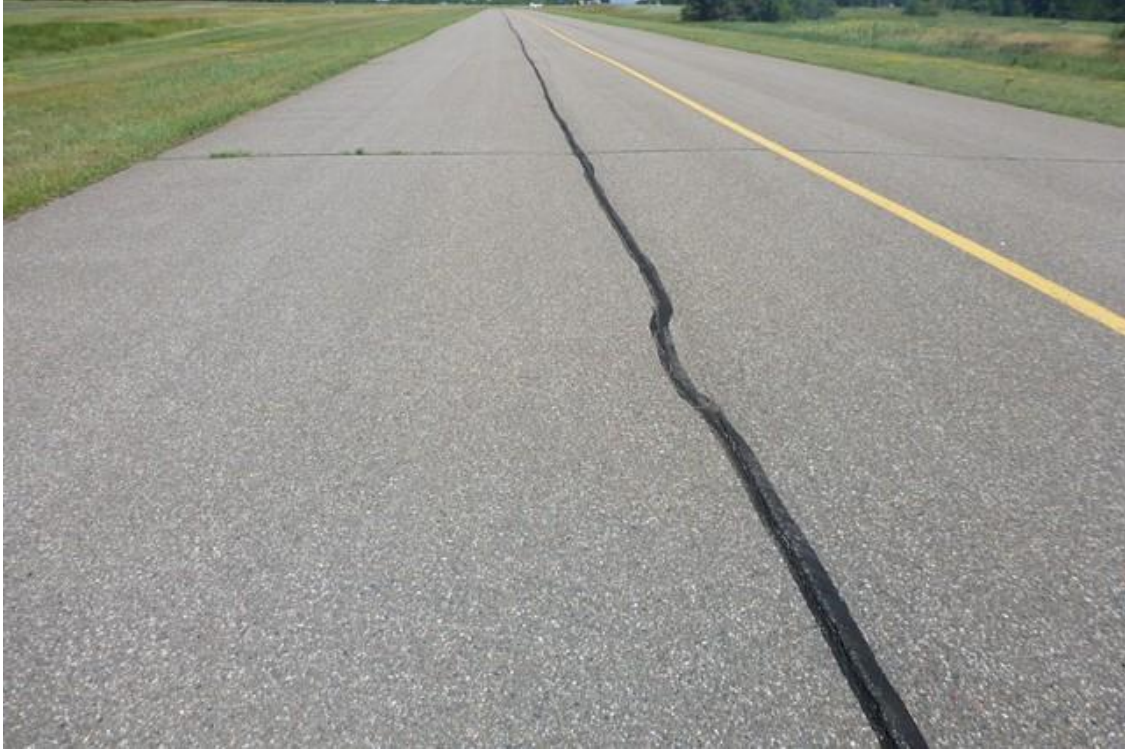
LXL PTA 001 (PCI = 70)

Network:	LXL	Name:	LITTLE FALLS						
Branch:	PTA	Name:	PARALLEL TAXIWAY A	Use:	TAXIWAY	Area:	181,700 SqFt		
Section:	001	of 1	From:	101	To:	140	Last Const.: 9/30/1998		
Surface:	AC	Family:	MN2013 Asphalt Taxiways	Zone:	E	Category:	3	Rank:	P
Area:	181,700 SqFt	Length:	4,490 Ft	Width:	40 Ft				
Slabs:		Slab Length:	Ft	Slab Width:	Ft	Joint Length:	Ft		
Shoulder:		Street Type:		Grade:	0	Lanes:	0		
Section Comments:									
Last Insp. Date:	7/12/2016	TotalSamples:	44	Surveyed:	6				
Conditions:	PCI: 70								
Inspection Comments:									
Sample Number:	101	Type:	A	Area:	4000.00 SqFt	PCI:	58		
Sample Comments:									
48	L & T CR	M	40.00	Ft					
48	L & T CR	H	3.00	Ft					
48	L & T CR	L	117.00	Ft					
57	WEATHERING	M	4000.00	SqFt					
45	DEPRESSION	L	250.00	SqFt					
Sample Number:	103	Type:	R	Area:	4000.00 SqFt	PCI:	65		
Sample Comments:									
57	WEATHERING	L	2000.00	SqFt					
56	SWELLING	M	15.00	SqFt					
48	L & T CR	L	158.00	Ft

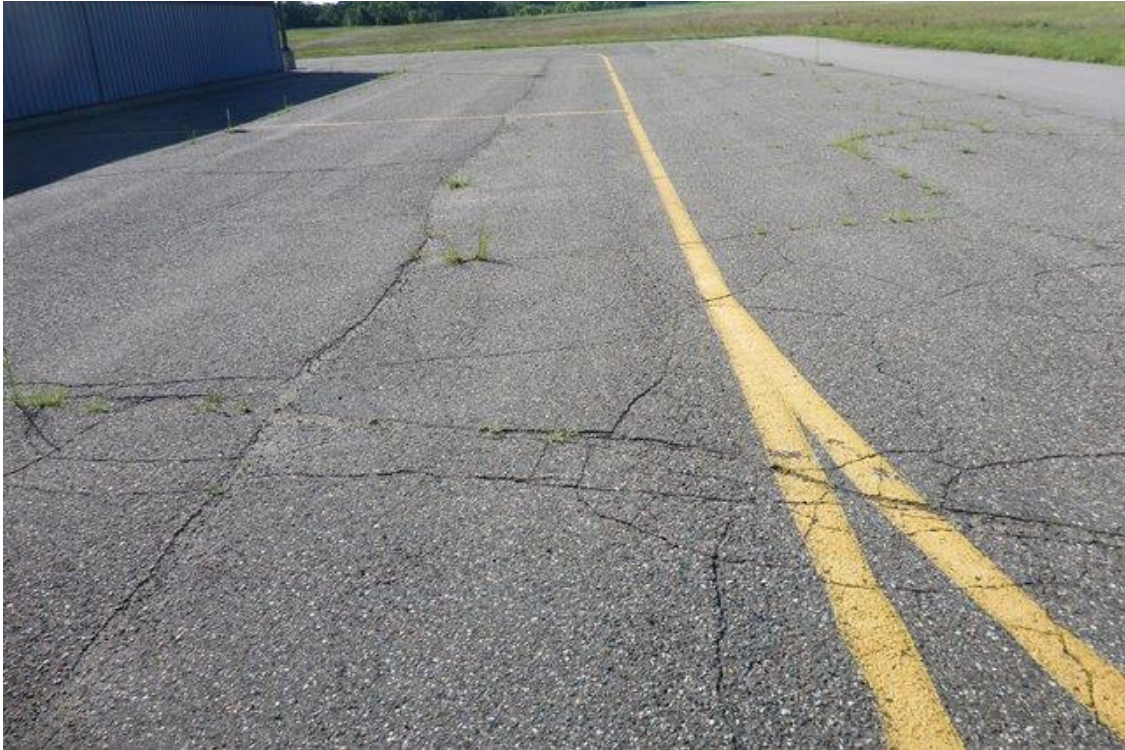
LXL TLD 001 (PCI = 24)

TLD	001	AC	30,150	1990	44	24	3	12	88	Alligator Cr, Block cracking, L&T CR, Raveling, Weathering
TLD	002	AC	2,850	2008	97	96	1	0	100	L&T cracking
TLE	001	AAC	10,000	2008	94	94	1	0	100	L&T cracking
