Pavement Condition Report

Park Rapids Municipal Airport (PKD)

December 2016

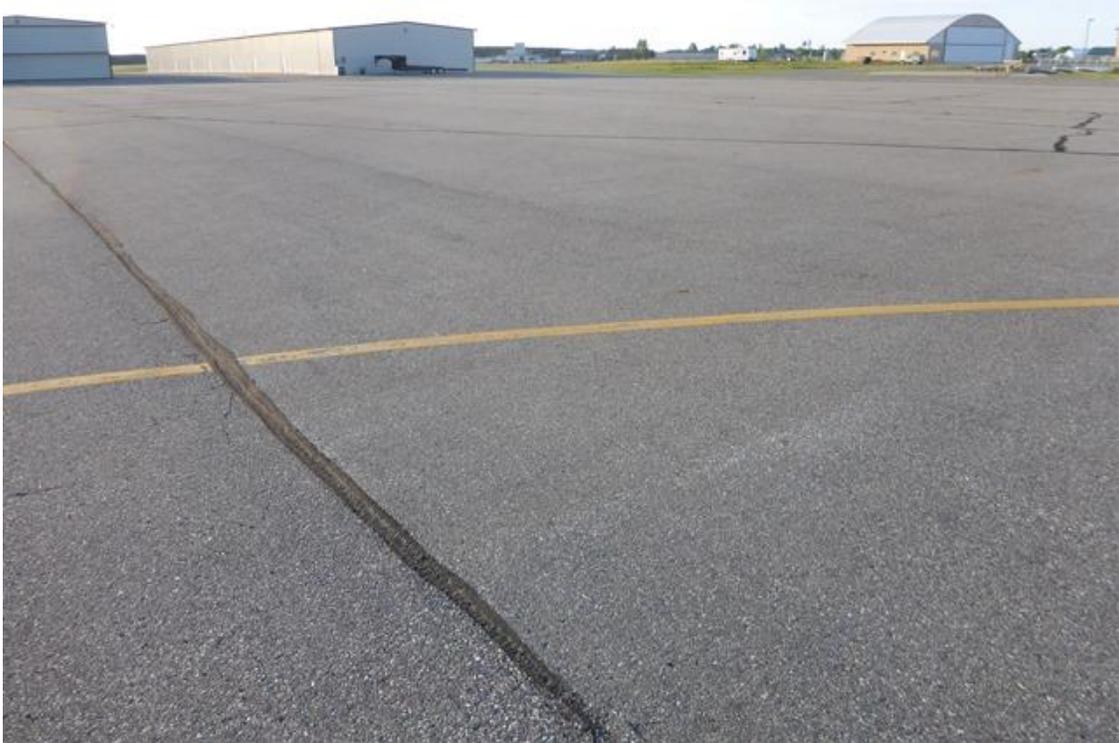
PKD APA 003 (PCI = 86)

Network:	PKD	Name:	PARK RAPIDS						
Branch:	APA	Name:	APRON A	Use:	APRON	Area:	333,375 SqFt		
Section:	003	of 2	From:	100	To:	403	Last Const.:	6/1/2007	
Surface:	AC	Family:	MN2013 Asphalt Aprons	Zone:	N	Category:	3	Rank:	S
Area:	82,645 SqFt	Length:	315 Ft	Width:	223 Ft				
Slabs:	Slab Length:	Ft	Slab Width:	Ft	Joint Length:	Ft			
Shoulder:	Street Type:	Grade:	0	Lanes:	0				
Section Comments:	maint. (R&E) CS								
Last Insp. Date:	6/2/2016	TotalSamples:	15	Surveyed:	3				
Conditions:	PCI: 86								
Inspection Comments:									
Sample Number:	101	Type:	R	Area:	5000.00 SqFt	PCI:	85		
Sample Comments:									
48	L & T CR	L	251.00	Ft					
Sample Number:	202	Type:	R	Area:	5000.00 SqFt	PCI:	88		
Sample Comments:									
48	L & T CR	L	193.00	Ft					
Sample Number:	301	Type:	R	Area:	5000.00 SqFt	PCI:	84		
Sample Comments:									
48	L & T CR	L	282.00	Ft

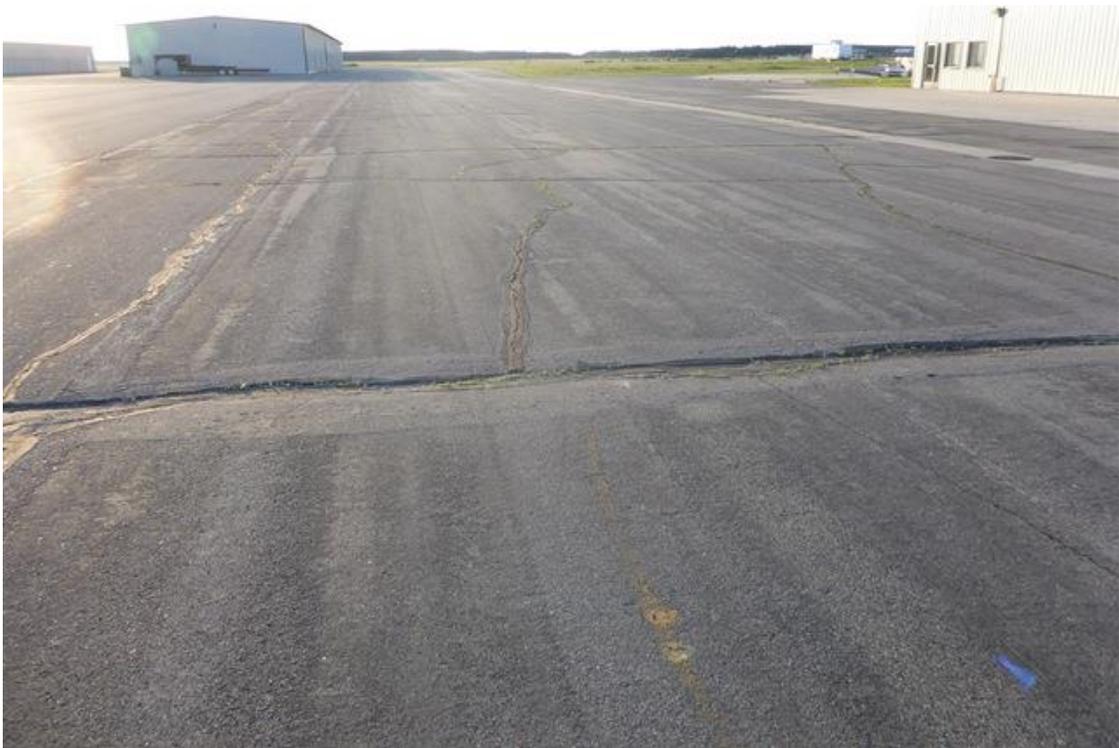
PKD APB 001 (PCI = 63)

Network:	PKD	Name:	PARK RAPIDS						
Branch:	APB	Name:	APRON B	Use:	APRON	Area:	45,666 SqFt		
Section:	001	of 1	From:	100	To:	206	Last Const.:	9/30/1998	
Surface:	AC	Family:	MN2013 Asphalt Aprons	Zone:	N	Category:	3	Rank:	S
Area:	45,666 SqFt	Length:	531 Ft	Width:	86 Ft				
Slabs:	Slab Length:	Ft	Slab Width:	Ft	Joint Length:	Ft			
Shoulder:	Street Type:	Grade:	0	Lanes:	0				
Section Comments:	drainage improvement project since 2010								
Last Insp. Date:	6/2/2016	TotalSamples:	10	Surveyed:	2				
Conditions:	PCI: 63								
Inspection Comments:									
Sample Number:	103	Type:	R	Area:	5000.00 SqFt	PCI:	69		
Sample Comments:									
48	L & T CR	M	79.00	Ft					
48	L & T CR	L	598.00	Ft					
Sample Number:	205	Type:	R	Area:	3600.00 SqFt	PCI:	55		
Sample Comments:									
48	L & T CR	M	57.00	Ft					
50	PATCHING	L	400.00	SqFt					
45	DEPRESSION	L	108.00	SqFt					
48	L & T CR	L	579.00	Ft

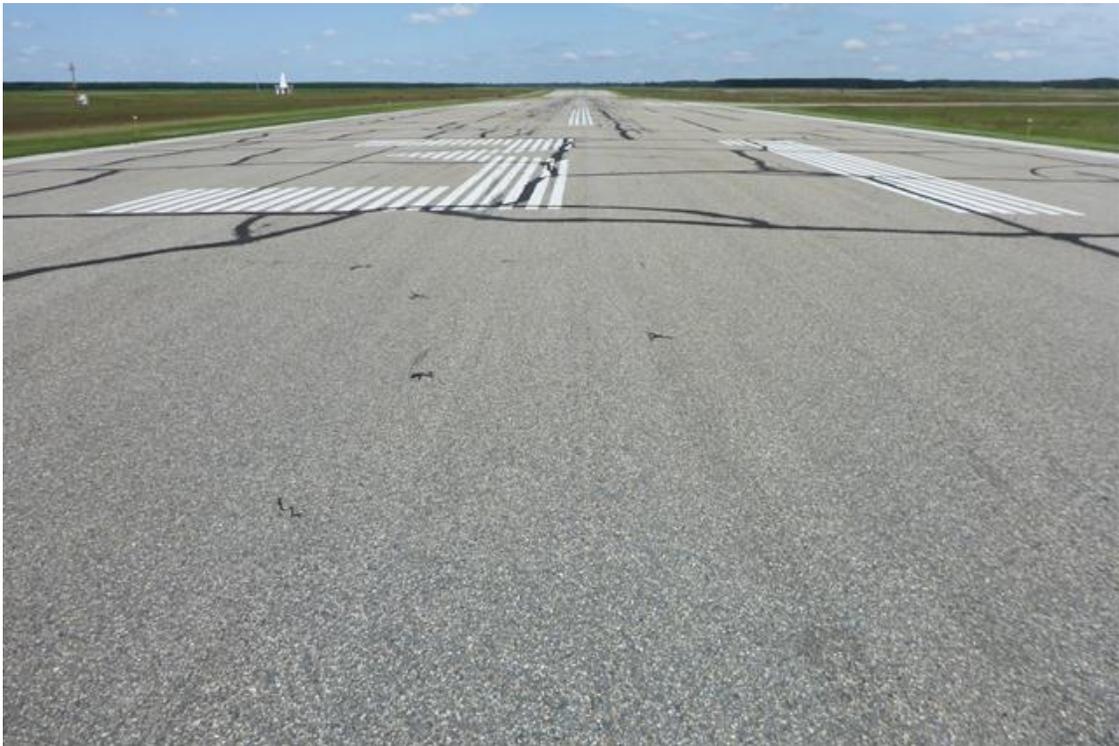
PKD RY1331 001 (PCI = 68)

Network:	PKD	Name:	PARK RAPIDS						
Branch:	RY1331	Name:	RUNWAY 13-31	Use:	RUNWAY	Area:	550,000 SqFt		
Section:	001	of 4	From:	100	To:	142	Last Const.:	9/30/1998	
Surface:	AAC	Family:	MN2013 Asphalt Runways	Zone:	N	Category:	3	Rank:	P
Area:	161,250 SqFt	Length:	2,150 Ft	Width:	75 Ft				
Slabs:		Slab Length:	Ft	Slab Width:	Ft	Joint Length:	Ft		
Shoulder:		Street Type:		Grade:	0	Lanes:	0		
Section Comments:	maint. (R&E) CS								
Last Insp. Date:	6/2/2016	TotalSamples:	43	Surveyed:	5				
Conditions:	PCI: 68								
Inspection Comments:									
Sample Number:	103	Type:	R	Area:	3750.00 SqFt	PCI:	75		
Sample Comments:									
48	L & T CR	M	27.00	Ft					
48	L & T CR	L	282.00	Ft					
Sample Number:	112	Type:	R	Area:	3750.00 SqFt	PCI:	67		
Sample Comments:									
48	L & T CR	M	7.00	Ft					
48	L & T CR	L	366.00	Ft					
57	WEATHERING	M	300.00	SqFt					
Sample Number:	121	Type:	R	Area:	3750.00 SqFt	PCI:	65		
Sample Comments:

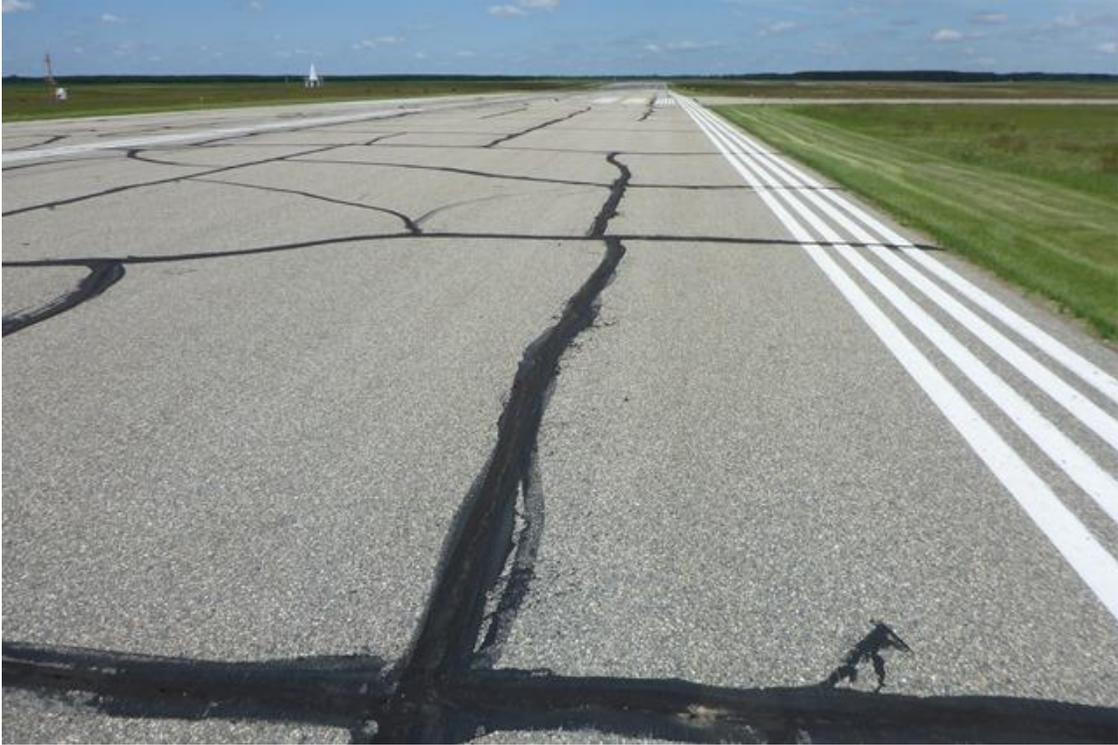
PKD RY1331 002 (PCI = 70)

Network:	PKD	Name:	PARK RAPIDS						
Branch:	RY1331	Name:	RUNWAY 13-31	Use:	RUNWAY	Area:	550,000 SqFt		
Section:	002	of 4	From:	200	To:	229	Last Const.:	9/30/1998	
Surface:	AAC	Family:	MN2013 Asphalt Runways	Zone:	N	Category:	3	Rank:	P
Area:	53,750 SqFt	Length:	2,150 Ft	Width:	25 Ft				
Slabs:		Slab Length:	Ft	Slab Width:	Ft	Joint Length:	Ft		
Shoulder:		Street Type:		Grade:	0	Lanes:	0		
Section Comments:	maint. (R&E) CS								
Last Insp. Date:	6/2/2016	TotalSamples:	22	Surveyed:	6				
Conditions:	PCI: 70								
Inspection Comments:									
Sample Number:	210	Type:	R	Area:	2500.00 SqFt	PCI:	71		
Sample Comments:									
48	L & T CR	L	255.00	Ft					
48	L & T CR	M	5.00	Ft					
Sample Number:	211	Type:	R	Area:	2500.00 SqFt	PCI:	69		
Sample Comments:									
48	L & T CR	M	20.00	Ft					
48	L & T CR	L	315.00	Ft					
Sample Number:	218	Type:	R	Area:	2500.00 SqFt	PCI:	75		
Sample Comments:									
48	L & T CR	L	204.00	Ft

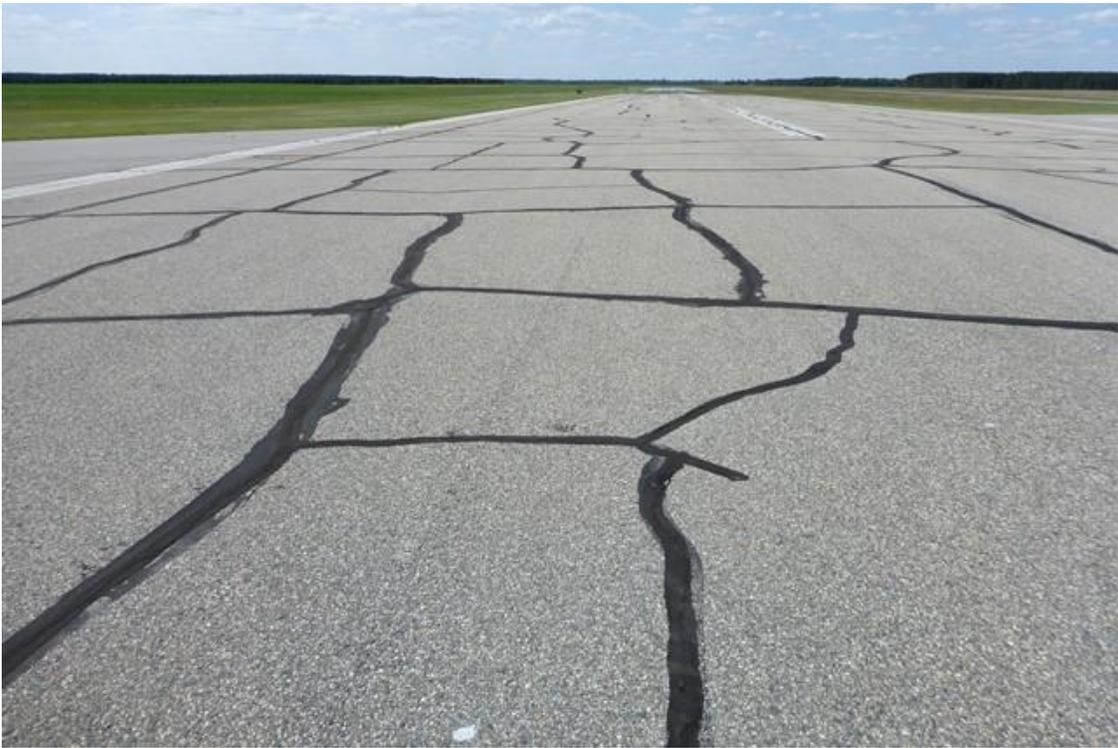
PKD RY1331 003 (PCI = 67)

Network:	PKD	Name:	PARK RAPIDS						
Branch:	RY1331	Name:	RUNWAY 13-31	Use:	RUNWAY	Area:	550,000 SqFt		
Section:	003	of 4	From:	143	To:	174	Last Const.:	9/30/1998	
Surface:	AAC	Family:	MN2013 Asphalt Runways	Zone:	N	Category:	3	Rank:	P
Area:	160,000 SqFt	Length:	1,600 Ft	Width:	100 Ft				
Slabs:		Slab Length:	Ft	Slab Width:	Ft	Joint Length:	Ft		
Shoulder:		Street Type:		Grade:	0	Lanes:	0		
Section Comments:	maint. (R&E) CS								
Last Insp. Date:	6/2/2016	TotalSamples:	32	Surveyed:	4				
Conditions:	PCI: 67								
Inspection Comments:									
Sample Number:	147	Type:	R	Area:	5000.00 SqFt	PCI:	69		
Sample Comments:									
57	WEATHERING	L	250.00	SqFt					
48	L & T CR	M	26.00	Ft					
48	L & T CR	L	566.00	Ft					
Sample Number:	155	Type:	R	Area:	5000.00 SqFt	PCI:	67		
Sample Comments:									
48	L & T CR	M	25.00	Ft					
48	L & T CR	L	632.00	Ft					
57	WEATHERING	L	250.00	SqFt					
Sample Number:	163	Type:	R	Area:	5000.00 SqFt	PCI:	65

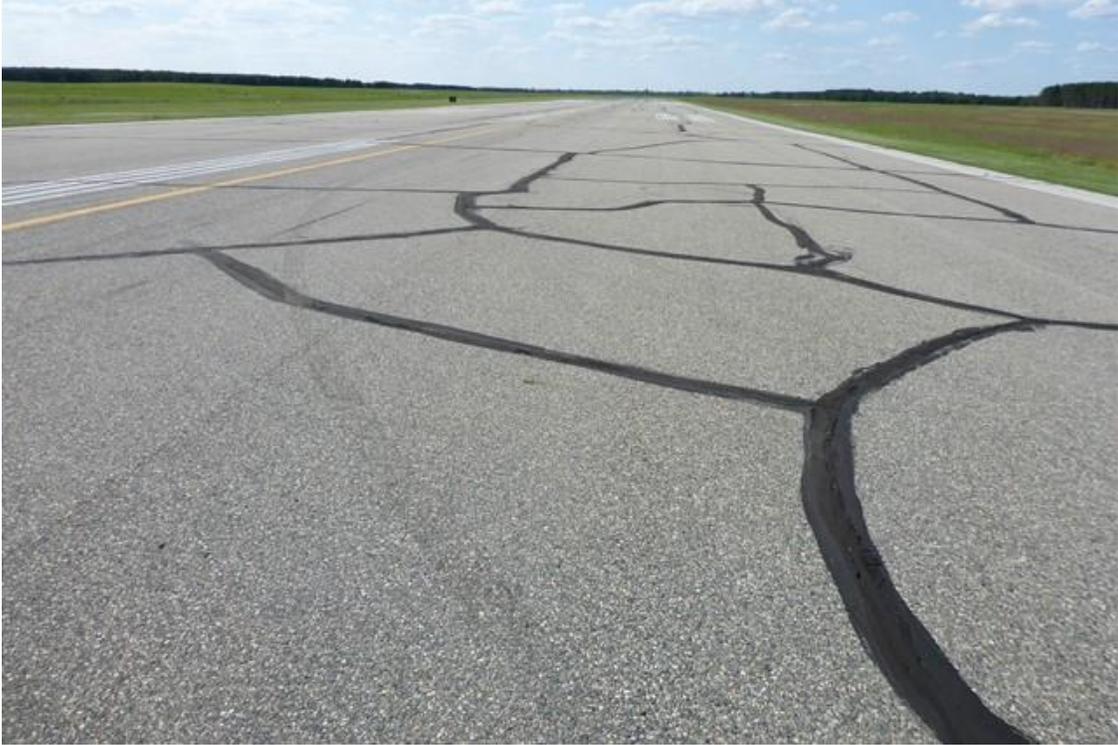
PKD RY1331 004 (PCI = 66)

Network:	PKD	Name:	PARK RAPIDS						
Branch:	RY1331	Name:	RUNWAY 13-31	Use:	RUNWAY	Area:	550,000 SqFt		
Section:	004	of 4	From:	175	To:	209	Last Const.:	9/30/1998	
Surface:	AAC	Family:	MN2013 Asphalt Runways	Zone:	N	Category:	3	Rank:	P
Area:	175,000 SqFt	Length:	1,750 Ft	Width:	100 Ft				
Slabs:		Slab Length:	Ft	Slab Width:	Ft	Joint Length:	Ft		
Shoulder:		Street Type:		Grade:	0	Lanes:	0		
Section Comments:	maint. (R&E) CS								
Last Insp. Date:	6/2/2016	TotalSamples:	35	Surveyed:	4				
Conditions:	PCI: 66								
Inspection Comments:									
Sample Number:	179	Type:	R	Area:	5000.00 SqFt	PCI:	68		
Sample Comments:									
57	WEATHERING	M	400.00	SqFt					
41	ALLIGATOR CR	L	30.00	SqFt					
48	L & T CR	L	324.00	Ft					
48	L & T CR	M	70.00	Ft					
Sample Number:	188	Type:	R	Area:	5000.00 SqFt	PCI:	60		
Sample Comments:									
57	WEATHERING	M	350.00	SqFt					
48	L & T CR	L	607.00	Ft					
41	ALLIGATOR CR	L	40.00	SqFt

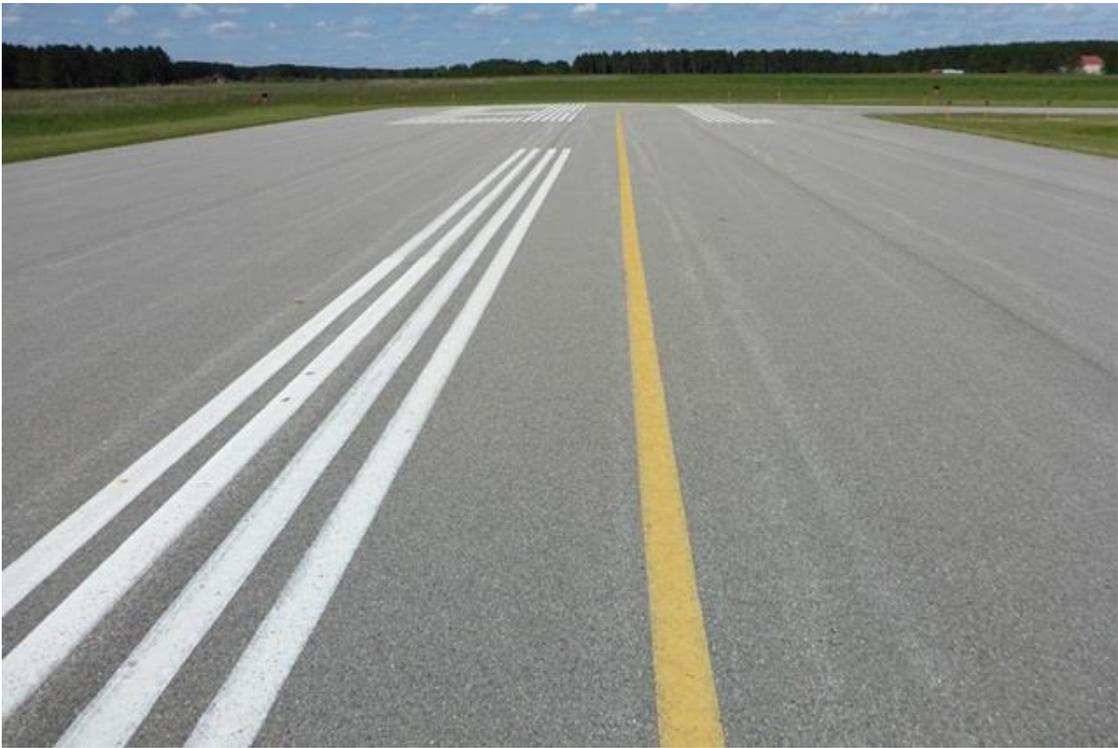
PKD RY1836 001 (PCI = 100)

Network:	PKD	Name:	PARK RAPIDS						
Branch:	RY1836	Name:	RUNWAY 18-36	Use:	RUNWAY	Area:	265,190 SqFt		
Section:	001	of 1	From:	A	To:	B	Last Const.:	10/1/2014	
Surface:	AC	Family:	MN2013 Asphalt Runways	Zone:		Category:		Rank:	P
Area:	265,190 SqFt	Length:	3,500 Ft	Width:	75 Ft				
Slabs:		Slab Length:	Ft	Slab Width:	Ft	Joint Length:		Ft	
Shoulder:		Street Type:		Grade:	0	Lanes:	0		
Section Comments:									
Last Insp. Date:	6/2/2016	TotalSamples:	69	Surveyed:	8				
Conditions:	PCI: 100								
Inspection Comments:									
Sample Number:	107	Type:	R	Area:	3750.00 SqFt	PCI:	100		
Sample Comments:									
<No Distress>									
Sample Number:	117	Type:	R	Area:	3750.00 SqFt	PCI:	100		
Sample Comments:									
<No Distress>									
Sample Number:	127	Type:	R	Area:	3750.00 SqFt	PCI:	100		
Sample Comments:									
<No Distress>									
Sample Number:	137	Type:	R	Area:	3750.00 SqFt	PCI:	100		
Sample Comments:

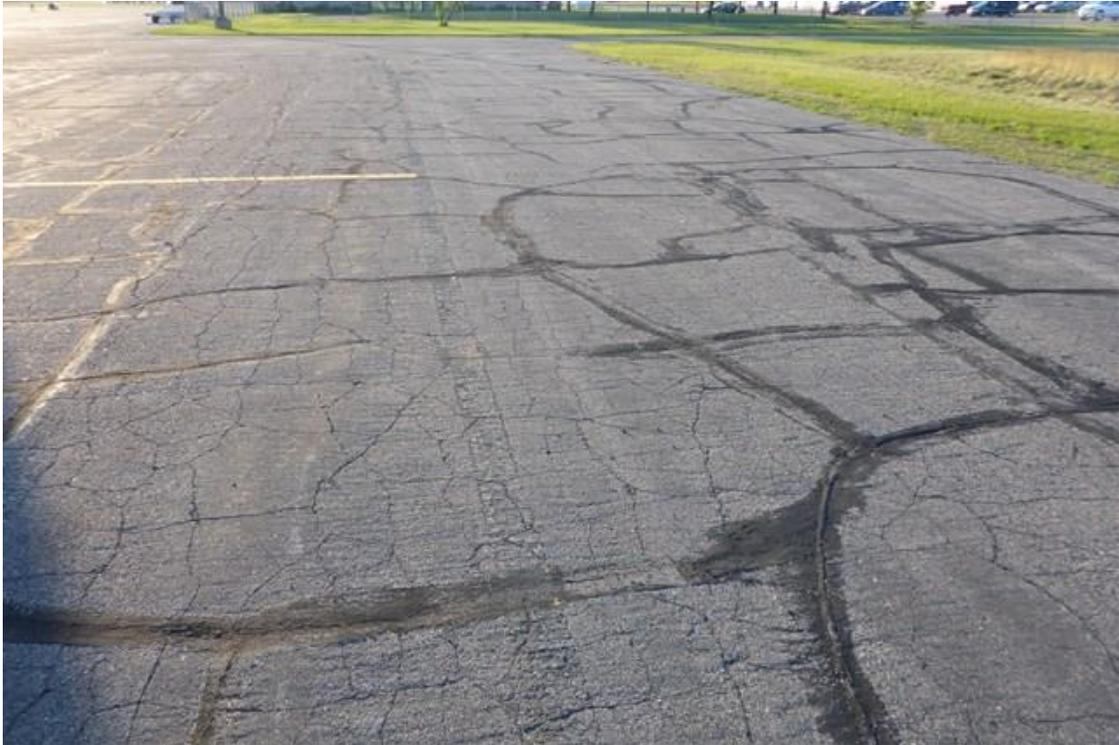
PKD TLA 001 (PCI = 14)

Network:	PKD	Name:	PARK RAPIDS						
Branch:	TLA	Name:	TAXILANE A	Use:	TAXILANE	Area:	66,460 SqFt		
Section:	001	of 1	From:	509	To:	712	Last Const.: 9/30/1998		
Surface:	AC	Family:	MN2013 Asphalt Taxilanes	Zone:	N	Category:	3	Rank:	T
Area:	66,460 SqFt	Length:	419 Ft	Width:	200 Ft				
Slabs:		Slab Length:	Ft	Slab Width:	Ft	Joint Length:	Ft		
Shoulder:		Street Type:		Grade:	0	Lanes:	0		
Section Comments:									
Last Insp. Date:	6/2/2016	TotalSamples:	15	Surveyed:	3				
Conditions:	PCI: 14								
Inspection Comments:									
Sample Number:	510	Type:	R	Area:	5000.00 SqFt	PCI:	13		
Sample Comments:									
43	BLOCK CR	L	3000.00	SqFt					
41	ALLIGATOR CR	M	1600.00	SqFt					
53	RUTTING	L	25.00	SqFt					
43	BLOCK CR	M	400.00	SqFt					
53	RUTTING	M	100.00	SqFt					
Sample Number:	611	Type:	R	Area:	5000.00 SqFt	PCI:	19		
Sample Comments:									
53	RUTTING	M	40.00	SqFt					
53	RUTTING	L	100.00	SqFt					
43	BLOCK CR	L	3500.00	SqFt

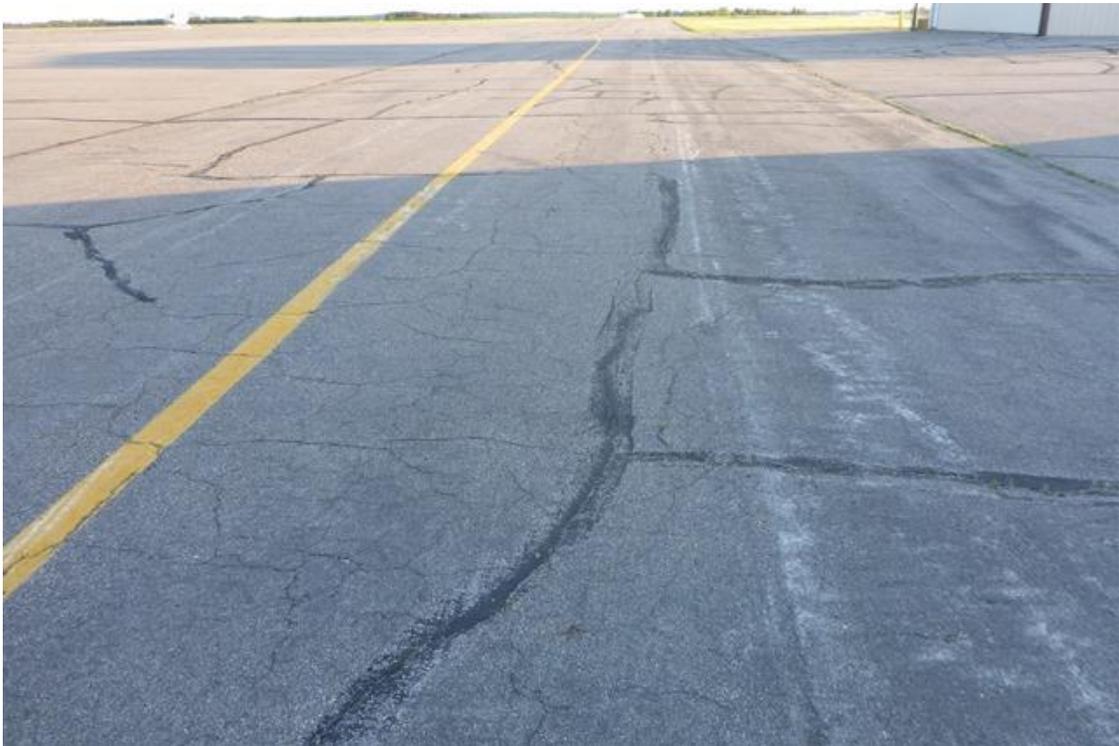
PKD TLB 001 (PCI = 41)

Conditions: PCI: 41

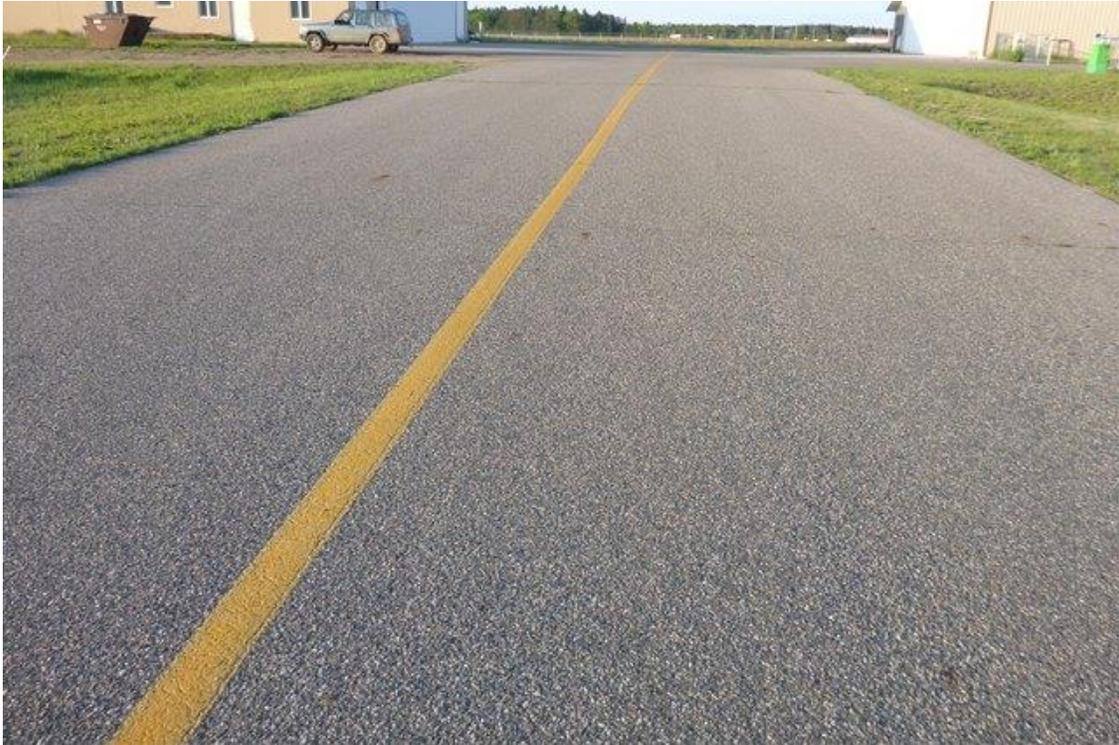
PKD TLB 002 (PCI = 73)

Conditions: PCI: 73

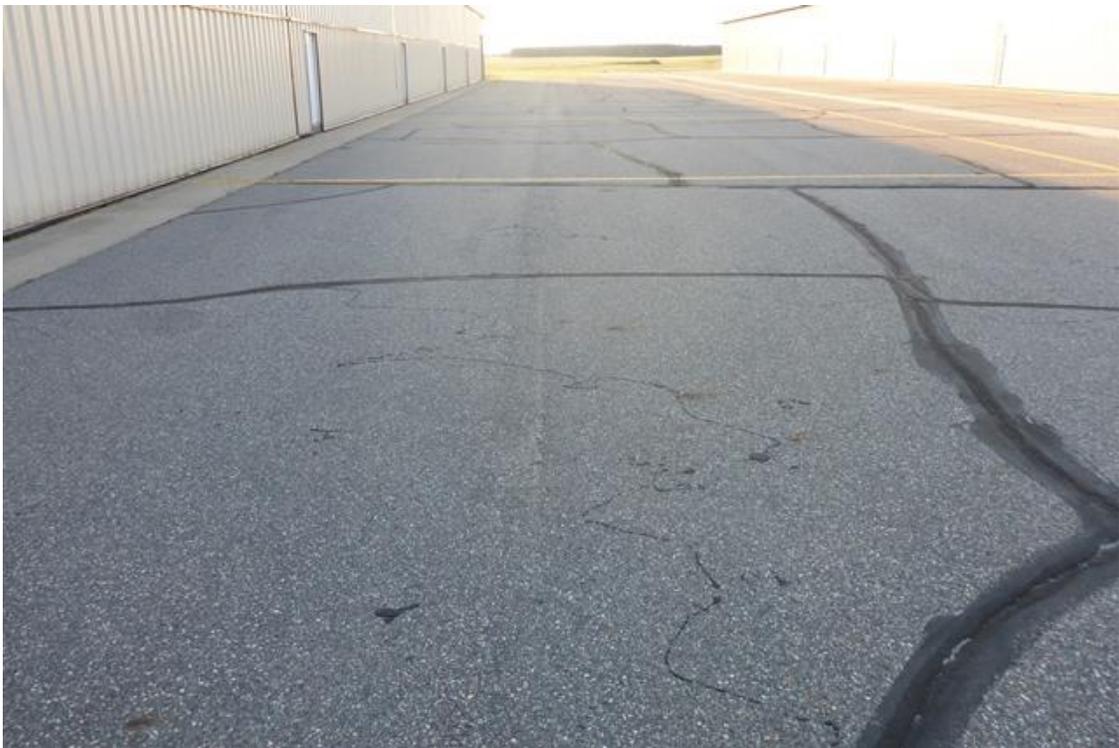
PKD TLC 001 (PCI = 70)

Conditions: PCI: 70

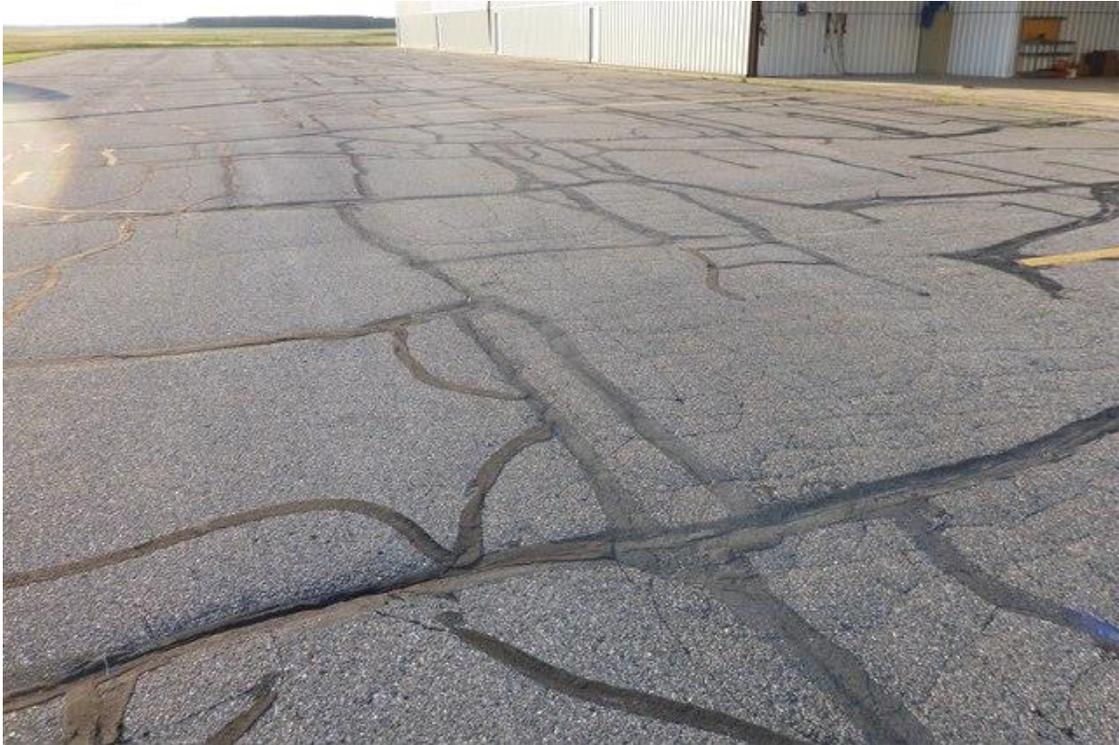
PKD TLC 002 (PCI = 18)

Conditions: PCI: 18

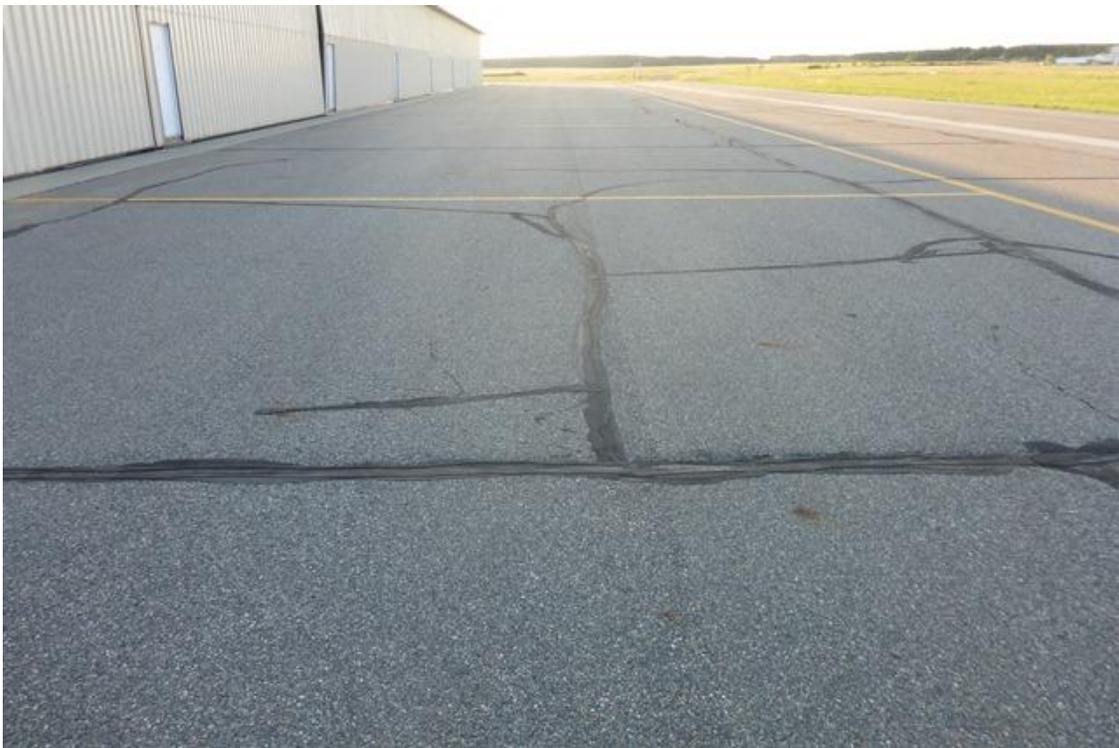
PKD TLC 003 (PCI = 74)

Conditions: PCI: 74
