Pavement Condition Report

New Ulm Municipal Airport (ULM)

December 2016

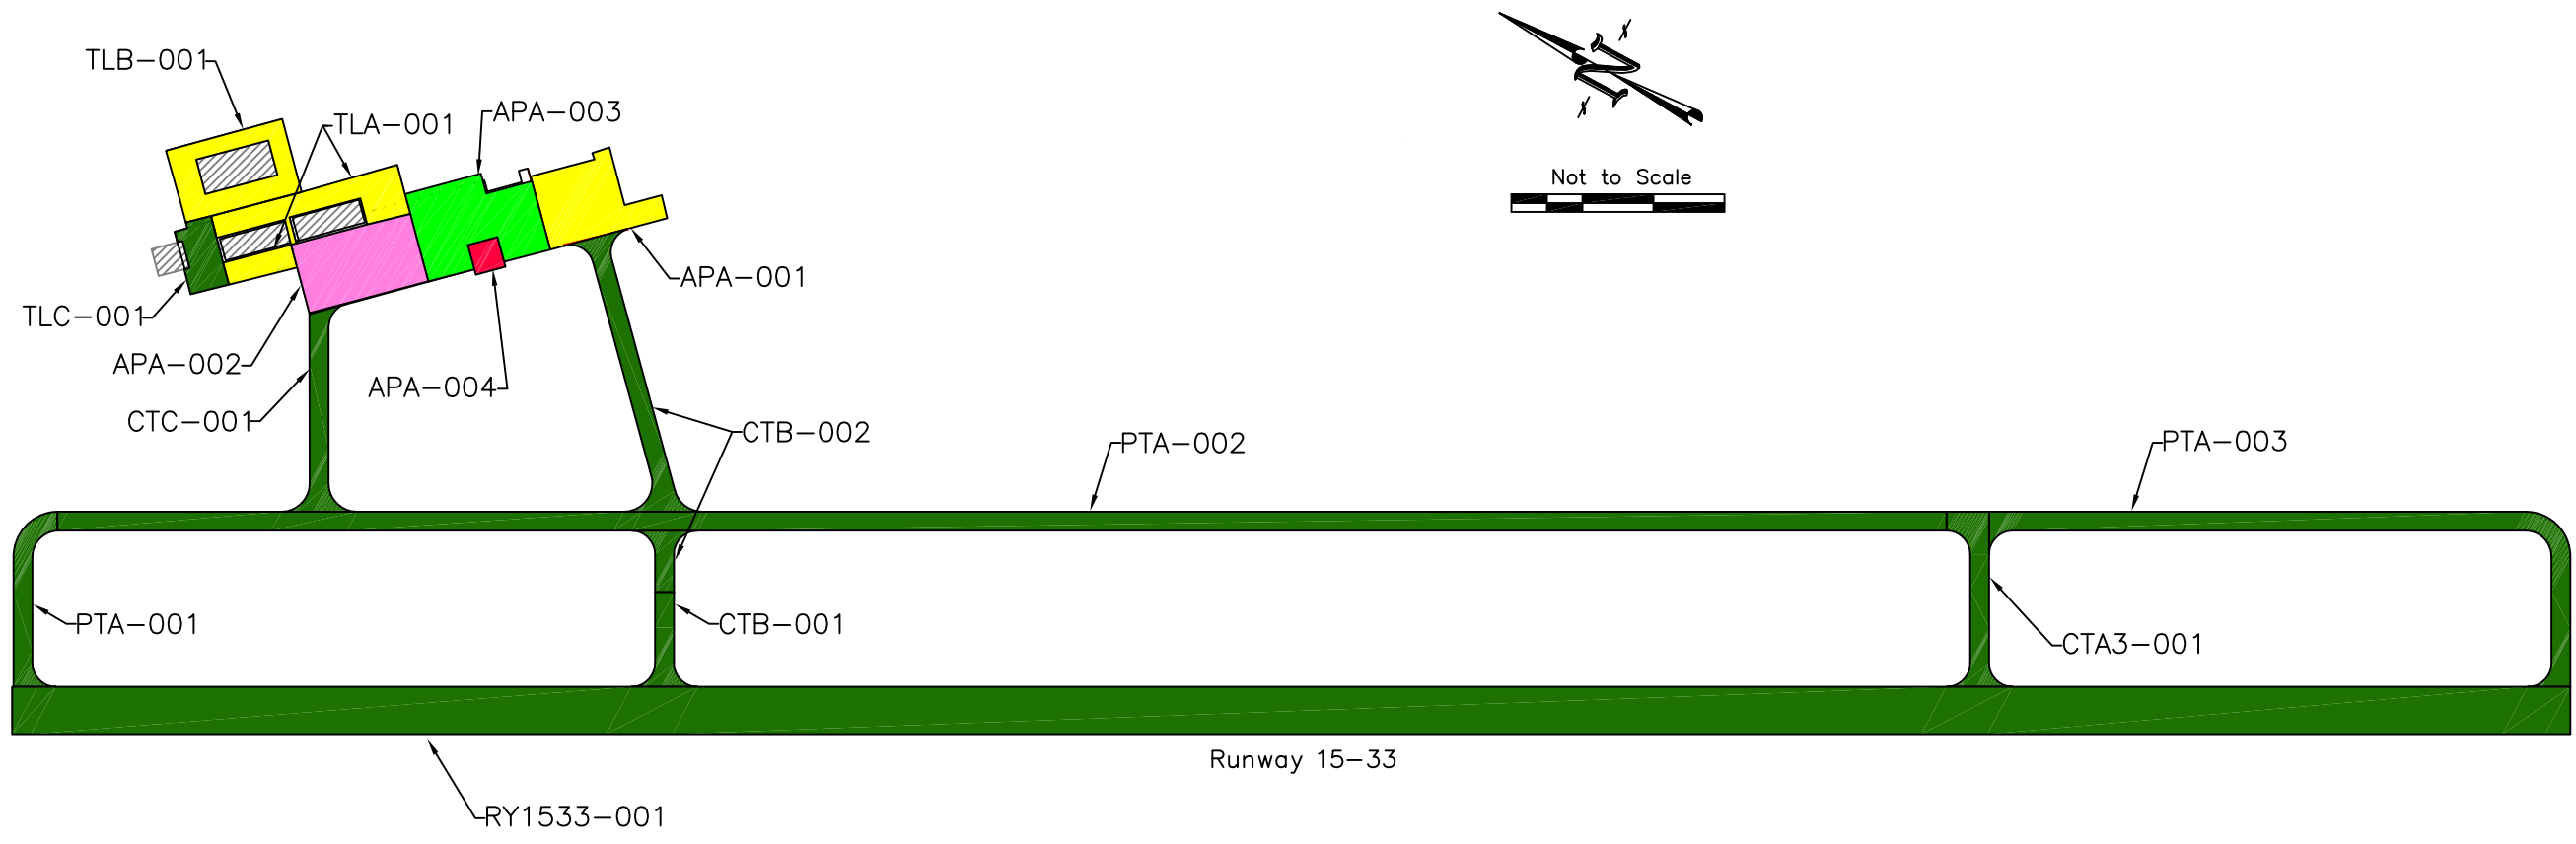
Figure 4. 2016 Pavement Condition Index Rating at New Ulm Municipal Airport (ULM).

Localized maintenance has been performed at the airport since the last inspection resulting in higher PCI values for some sections.

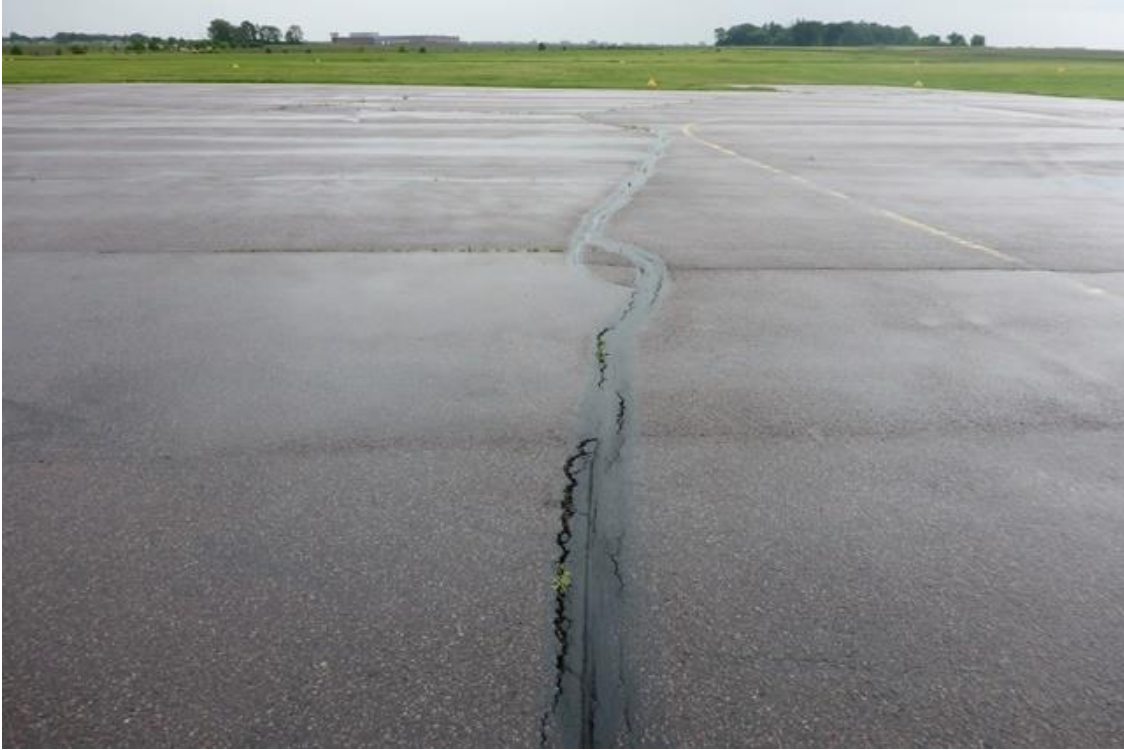
ULM APA 001 (PCI = 60)

Last Insp. Date: 5/27/2016 **TotalSamples:** 7 **Surveyed:** 2
Conditions: PCI: 60
Inspection Comments:

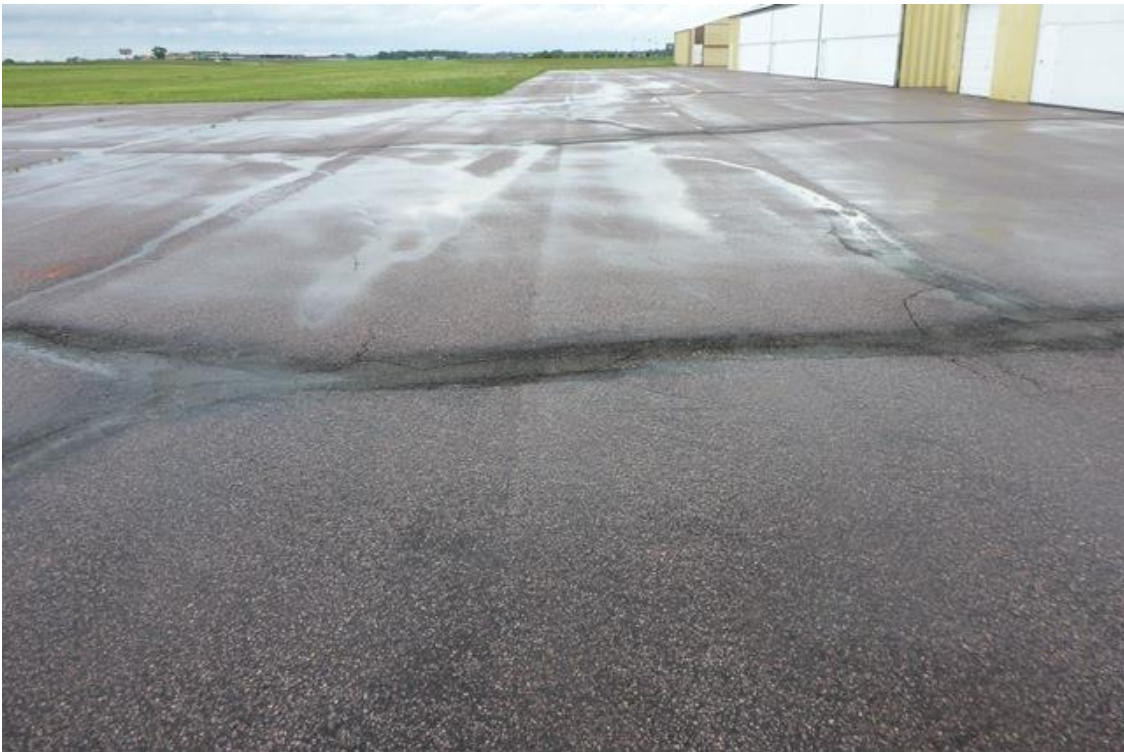
ULM APA 002 (PCI = 55)

Conditions: PCI: 55

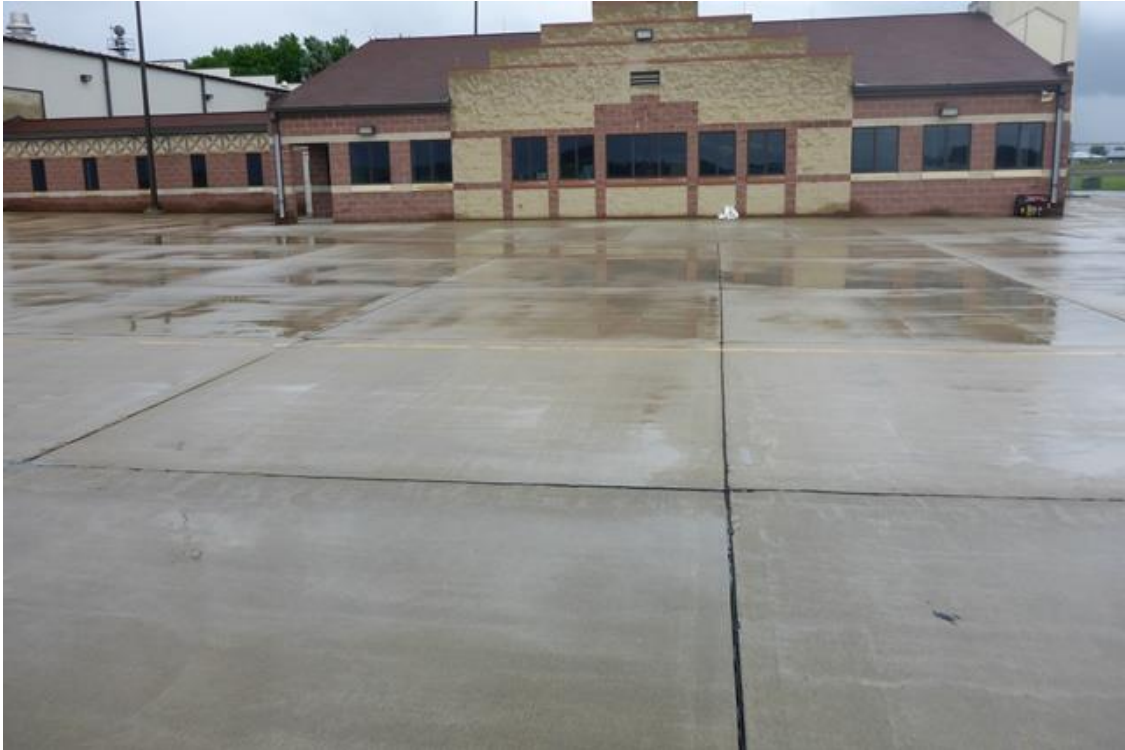
ULM APA 003 (PCI = 78)

Conditions: PCI: 78

Inspection Comments: replacement slabs

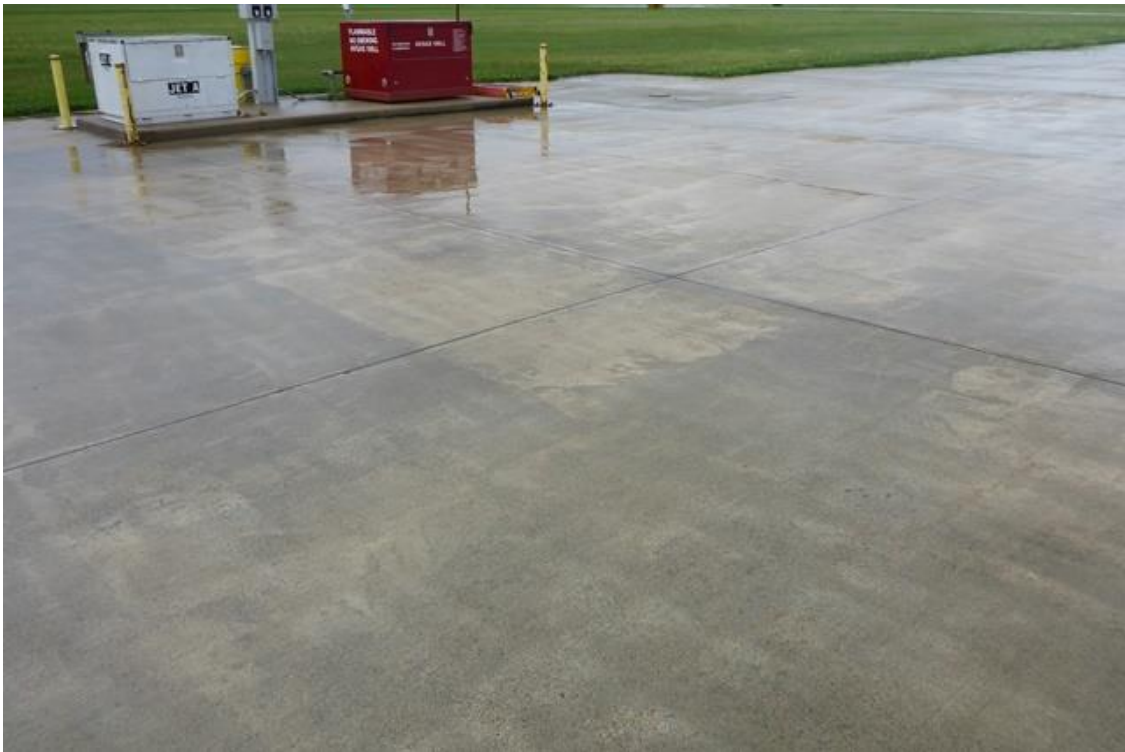
ULM APA 004 (PCI = 29)

Conditions: PCI: 29

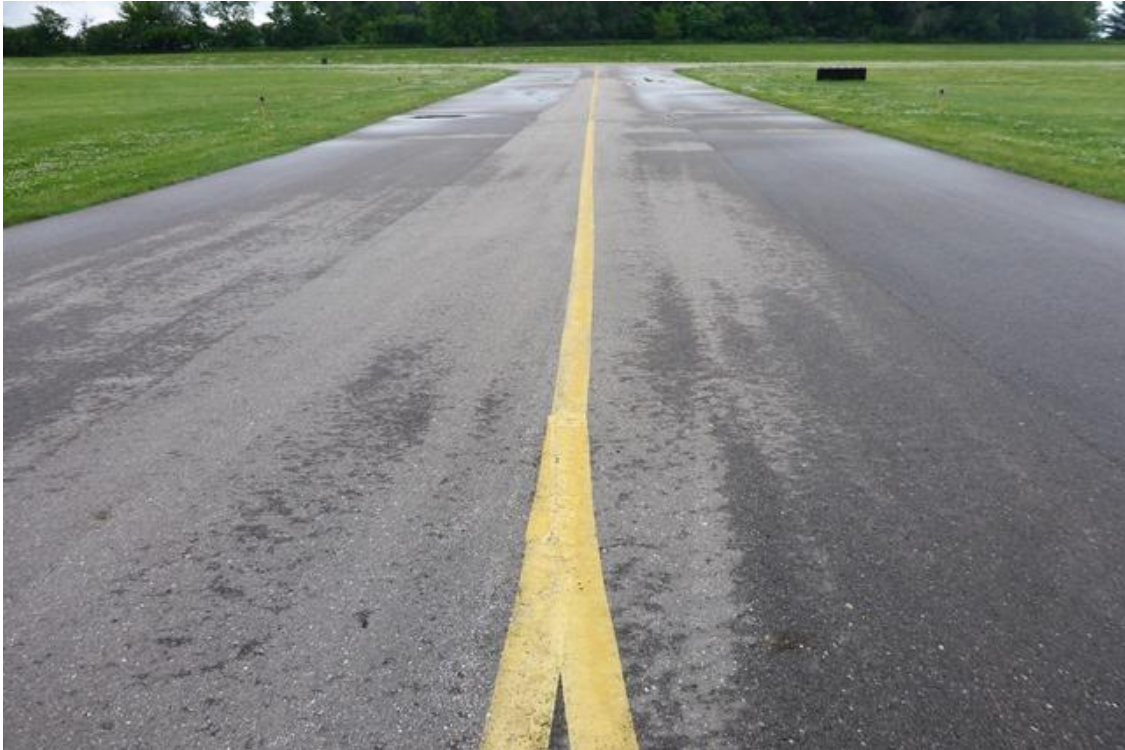
ULM CTA3 001 (PCI = 96)

Network:	ULM	Name:	NEW ULM				
Branch:	CTA3	Name:	CONNECTING TAXIWAY A3	Use:	TAXIWAY	Area:	15,500 SqFt
Section:	001	of 1	From:	100	To:	103	Last Const.: 7/30/2013
Surface:	AC	Family:	MN2013 Asphalt Taxiways	Zone:		Category:	Rank: S
Area:	15,500 SqFt	Length:	345 Ft	Width:	40 Ft		
Slabs:		Slab Length:	Ft	Slab Width:	Ft	Joint Length:	Ft
Shoulder:		Street Type:		Grade:	0	Lanes:	0
Section Comments:							
Last Insp. Date:	5/27/2016	TotalSamples:	3	Surveyed:	1		
Conditions:	PCI: 96						
Inspection Comments:							
Sample Number:	101	Type:	R	Area:	4000.00 SqFt	PCI:	96
Sample Comments:							
48	L & T CR	L	13.00	Ft

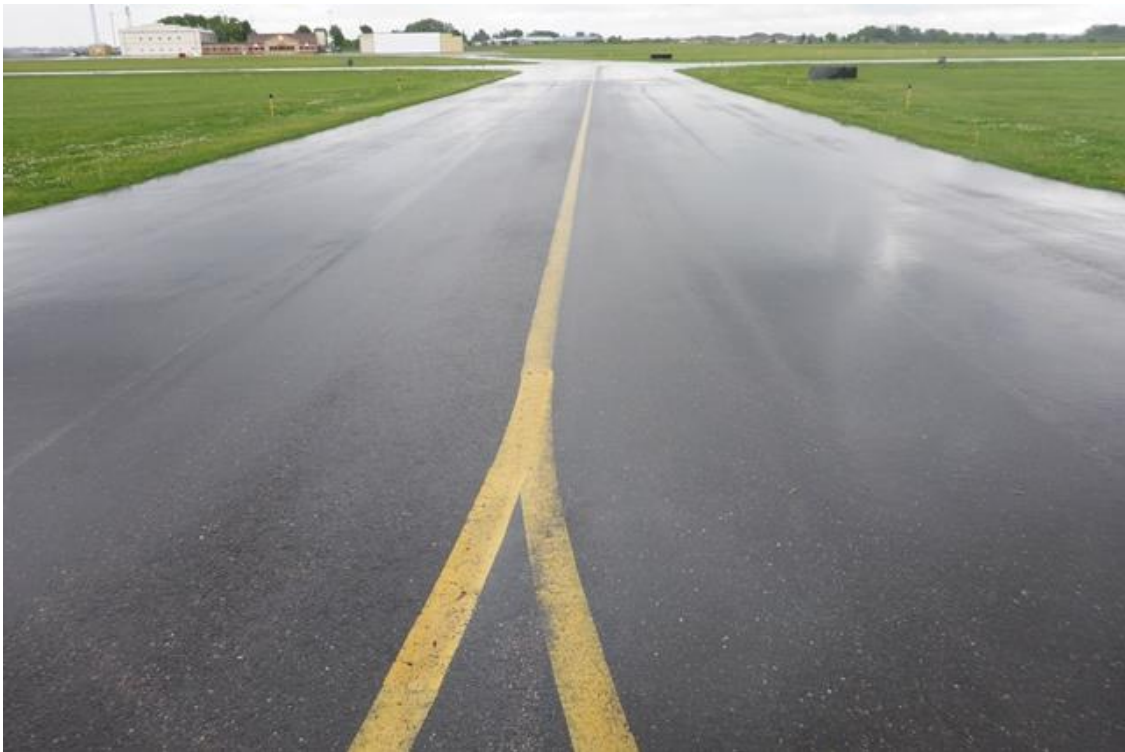
ULM CTB 001 (PCI = 89)

Network:	ULM	Name:	NEW ULM						
Branch:	CTB	Name:	CONNECTING TAXIWAY B	Use:	TAXIWAY	Area:	42,310 SqFt		
Section:	001	of 2	From:	300	To:	303	Last Const.:	7/30/2013	
Surface:	AC	Family:	MN2013 Asphalt Taxiways	Zone:	S	Category:	3	Rank:	P
Area:	9,080 SqFt	Length:	357 Ft	Width:	40 Ft				
Slabs:		Slab Length:	Ft	Slab Width:	Ft	Joint Length:	Ft		
Shoulder:		Street Type:		Grade:	0	Lanes:	0		
Section Comments:									
Last Insp. Date:	5/27/2016	TotalSamples:	2	Surveyed:	1				
Conditions:	PCI: 89								
Inspection Comments:									
Sample Number:	301	Type:	R	Area:	4000.00 SqFt	PCI:	89		
Sample Comments:	Med Crack at Feature Line								
48	L & T CR	M	40.00	Ft

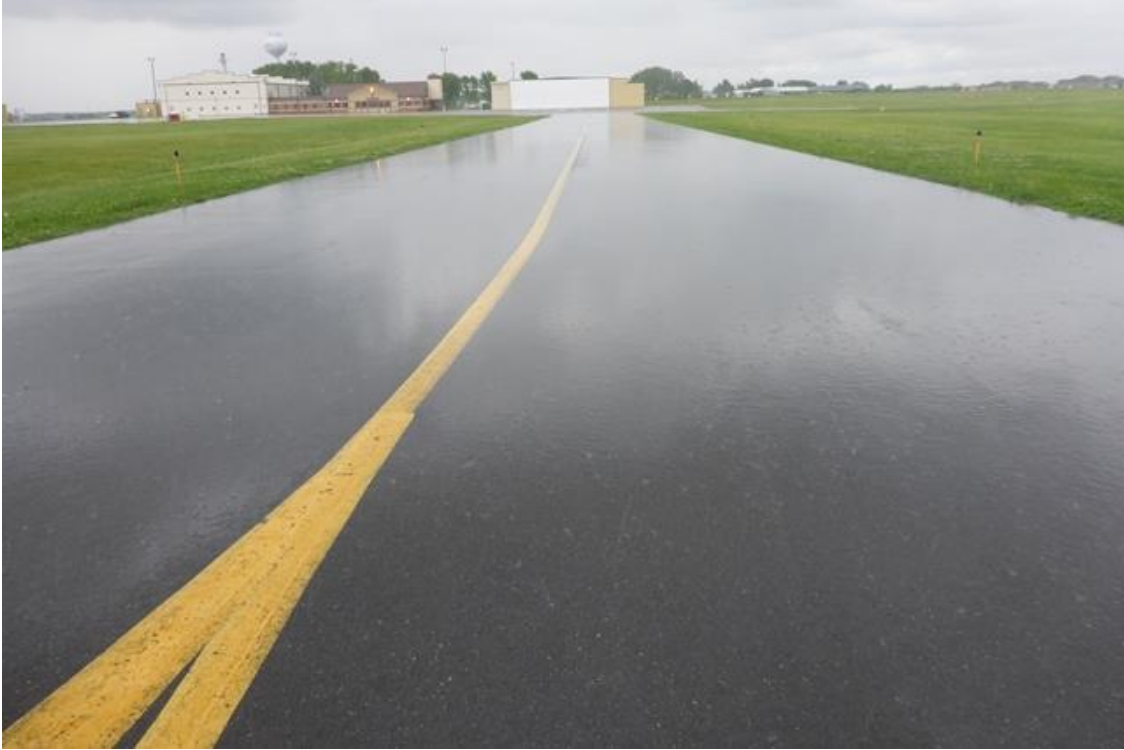
ULM CTB 002 (PCI = 100)

Network:	ULM	Name:	NEW ULM						
Branch:	CTB	Name:	CONNECTING TAXIWAY B	Use:	TAXIWAY	Area:	42,310 SqFt		
Section:	002	of 2	From:	304	To:	309	Last Const.:	10/1/2013	
Surface:	AC	Family:	MN2013 Asphalt Taxiways	Zone:	S	Category:	3	Rank:	P
Area:	33,230 SqFt	Length:	592 Ft	Width:	40 Ft				
Slabs:		Slab Length:	Ft	Slab Width:	Ft	Joint Length:	Ft		
Shoulder:		Street Type:		Grade:	0	Lanes:	0		
Section Comments:	slated for recon in Fall 2013								
Last Insp. Date:	5/27/2016	TotalSamples:	7	Surveyed:	3				
Conditions:	PCI: 100								
Inspection Comments:									
Sample Number:	304	Type:	R	Area:	4500.00 SqFt	PCI:	100		
Sample Comments:	<No Distress>								
Sample Number:	306	Type:	R	Area:	4000.00 SqFt	PCI:	100		
Sample Comments:	<No Distress>								
Sample Number:	308	Type:	R	Area:	4000.00 SqFt	PCI:	100		
Sample Comments:	<No Distress>

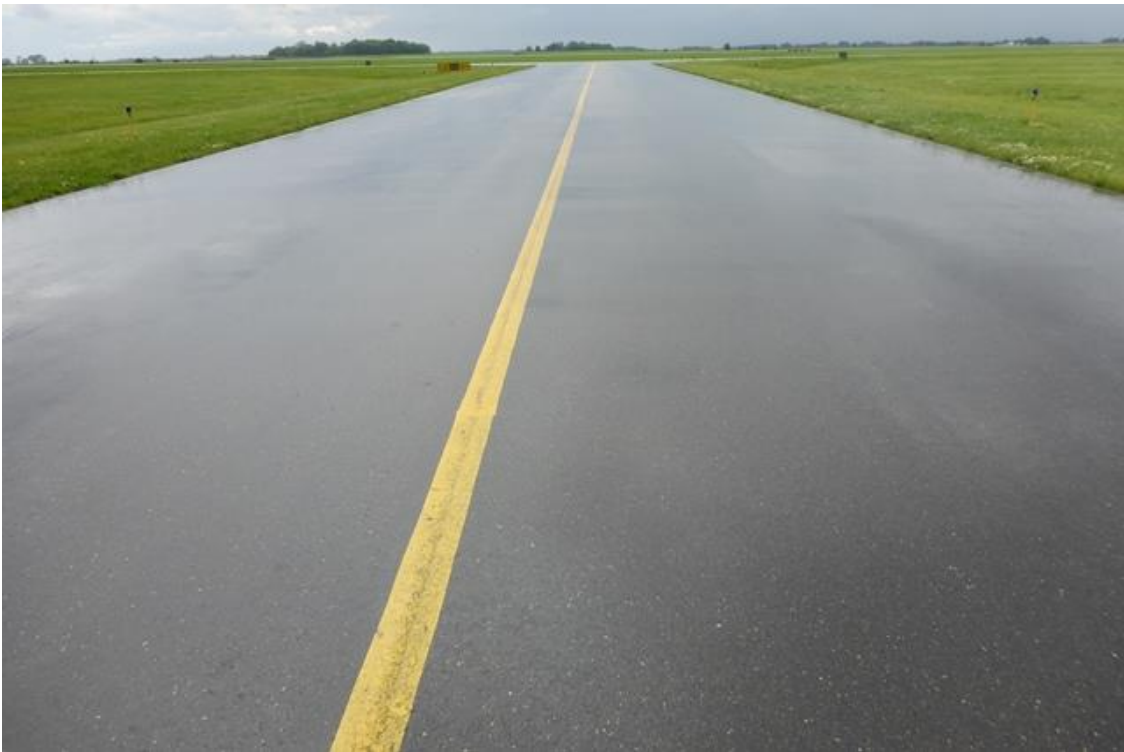
ULM CTC 001 (PCI = 100)

Network:	ULM	Name:	NEW ULM						
Branch:	CTC	Name:	CONNECTING TAXIWAY C	Use:	TAXIWAY	Area:	18,980 SqFt		
Section:	001	of 1	From:	200	To:	203	Last Const.:	10/1/2003	
Surface:	AC	Family:	MN2013 Asphalt Taxiways	Zone:	S	Category:	3	Rank:	S
Area:	18,980 SqFt	Length:	400 Ft	Width:	40 Ft				
Slabs:		Slab Length:	Ft	Slab Width:	Ft	Joint Length:	Ft		
Shoulder:		Street Type:		Grade:	0	Lanes:	0		
Section Comments:	slated for recon in Fall 2013								
Last Insp. Date:	5/27/2016	TotalSamples:	4	Surveyed:	2				
Conditions:	PCI: 100								
Inspection Comments:									
Sample Number:	201	Type:	R	Area:	4000.00 SqFt	PCI:	100		
Sample Comments:									
<No Distress>									
Sample Number:	202	Type:	R	Area:	4000.00 SqFt	PCI:	100		
Sample Comments:									
<No Distress>

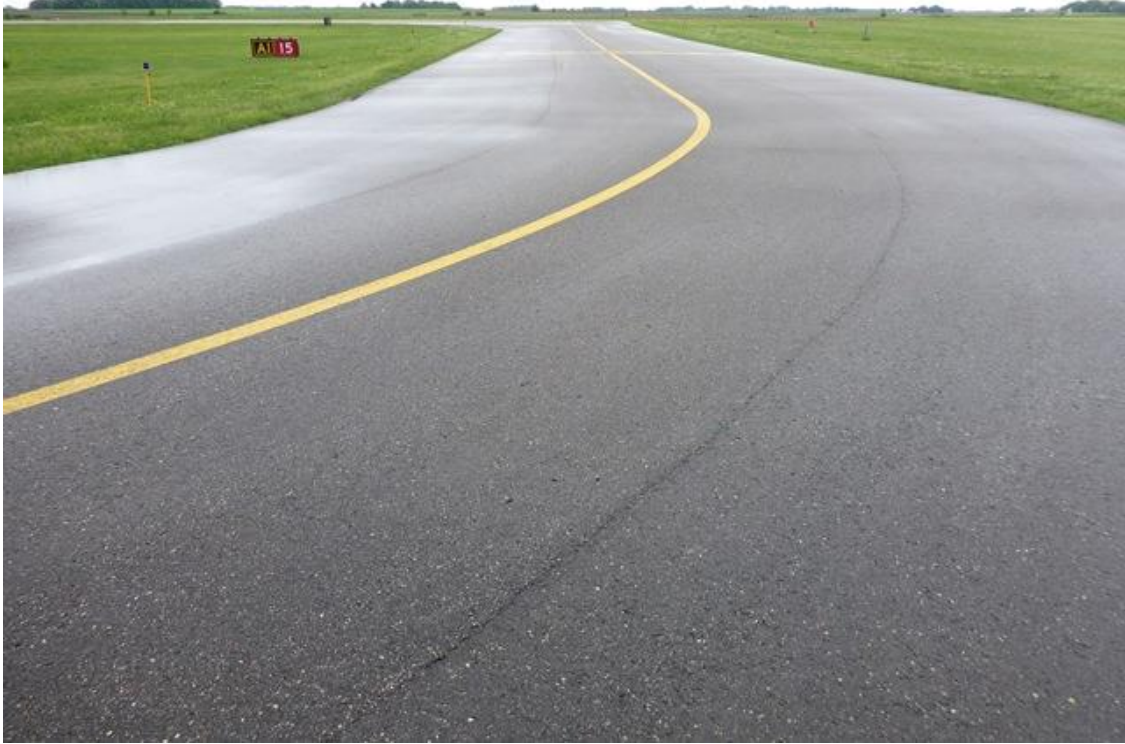
ULM PTA 001 (PCI = 100)

Network:	ULM	Name:	NEW ULM					
Branch:	PTA	Name:	PARALLEL TAXIWAY A	Use:	TAXIWAY	Area:	237,820 SqFt	
Section:	001	of 3	From:	100	To:	103	Last Const.:	7/30/2013
Surface:	AC	Family:	MN2013 Asphalt Taxiways	Zone:		Category:	Rank:	P
Area:	16,170 SqFt	Length:	345 Ft	Width:	40 Ft			
Slabs:		Slab Length:	Ft	Slab Width:	Ft	Joint Length:	Ft	
Shoulder:		Street Type:		Grade:	0	Lanes:	0	
Section Comments:								
Last Insp. Date:	5/27/2016	TotalSamples:	4	Surveyed:	2			
Conditions:	PCI: 100							
Inspection Comments:								
Sample Number:	101	Type:	R	Area:	4000.00 SqFt	PCI:	100	
Sample Comments:								
<No Distress>								
Sample Number:	103	Type:	R	Area:	4000.00 SqFt	PCI:	100	
Sample Comments:								
<No Distress>

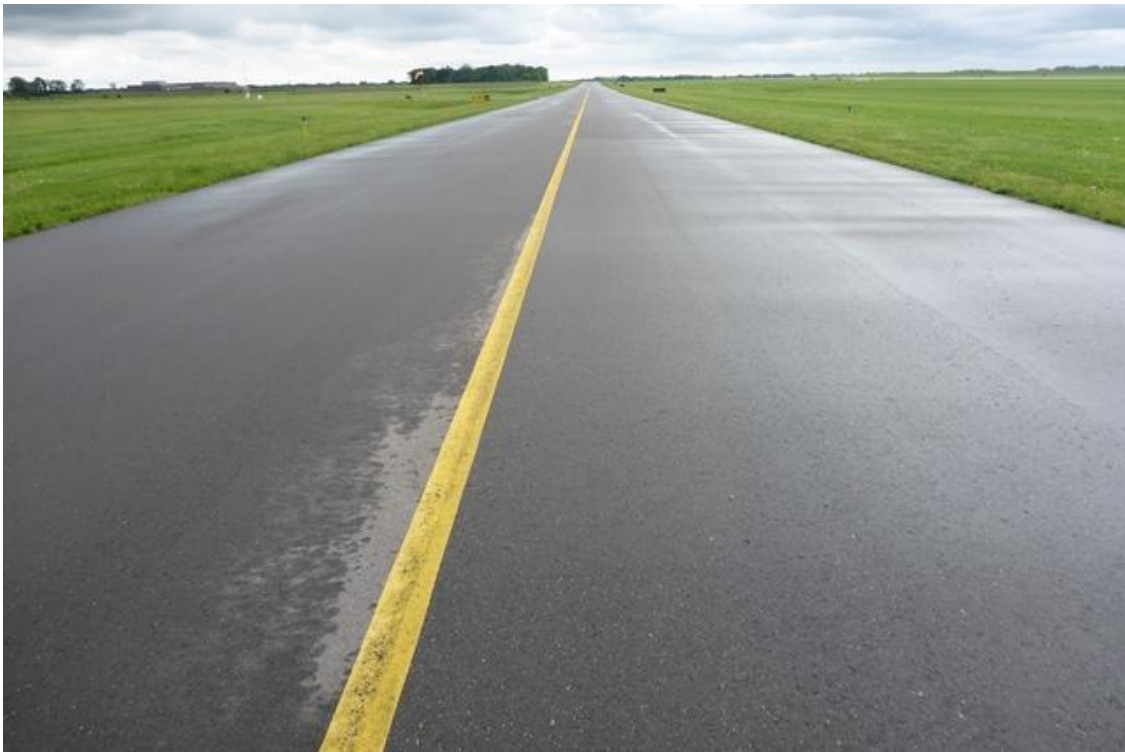
ULM PTA 002 (PCI = 100)

Conditions: PCI: 100

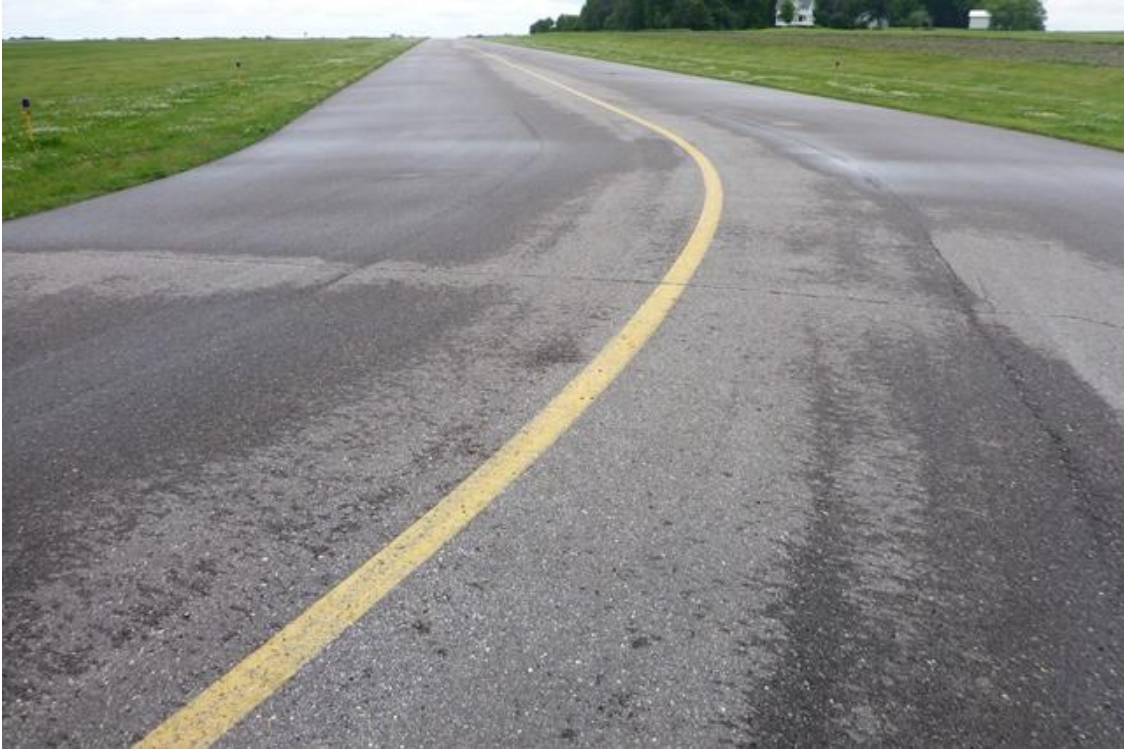
ULM PTA 003 (PCI = 97)

Conditions: PCI: 97

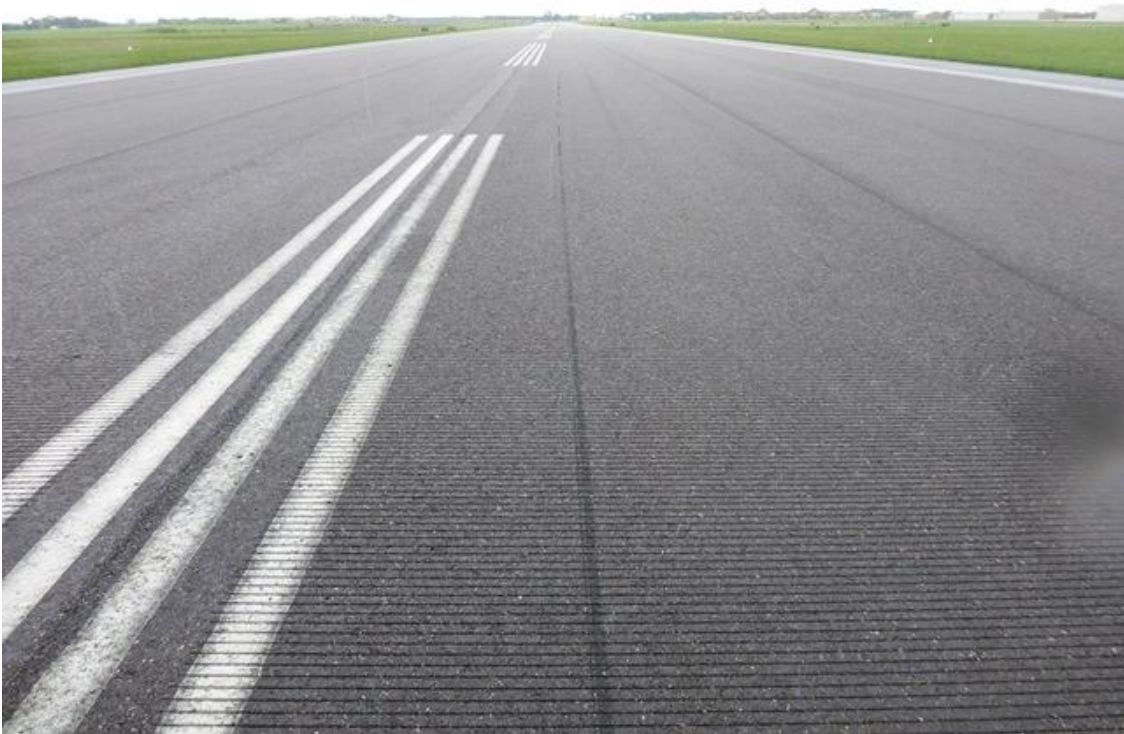
ULM RY1533 001 (PCI = 96)

Network:	ULM		Name:	NEW ULM					
Branch:	RY1533	Name:	RUNWAY 15-33	Use:	RUNWAY	Area:	540,100 SqFt		
Section:	001	of 1	From:	100	To:	208	Last Const.:	7/30/2013	
Surface:	AC	Family:	MN2013 Asphalt Runways	Zone:	S	Category:	3	Rank:	P
Area:	540,100 SqFt	Length:	5,401 Ft	Width:	100 Ft				
Slabs:		Slab Length:	Ft	Slab Width:	Ft	Joint Length:	Ft		
Shoulder:		Street Type:		Grade:	0	Lanes:	0		
Section Comments:									
Last Insp. Date:	5/27/2016	TotalSamples:	108	Surveyed:	10				
Conditions:	PCI: 96								
Inspection Comments:									
Sample Number:	104	Type:	R	Area:	3750.00 SqFt	PCI:	85		
Sample Comments:									
48	L & T CR	M	56.00	Ft					
48	L & T CR	L	14.00	Ft					
Sample Number:	114	Type:	R	Area:	3750.00 SqFt	PCI:	100		
Sample Comments:									
<No Distress>									
Sample Number:	119	Type:	R	Area:	3750.00 SqFt	PCI:	91		
Sample Comments:									
48	L & T CR	L	100.00	Ft					
Sample Number:	130	Type:	R	Area:	3750.00 SqFt	PCI:	95

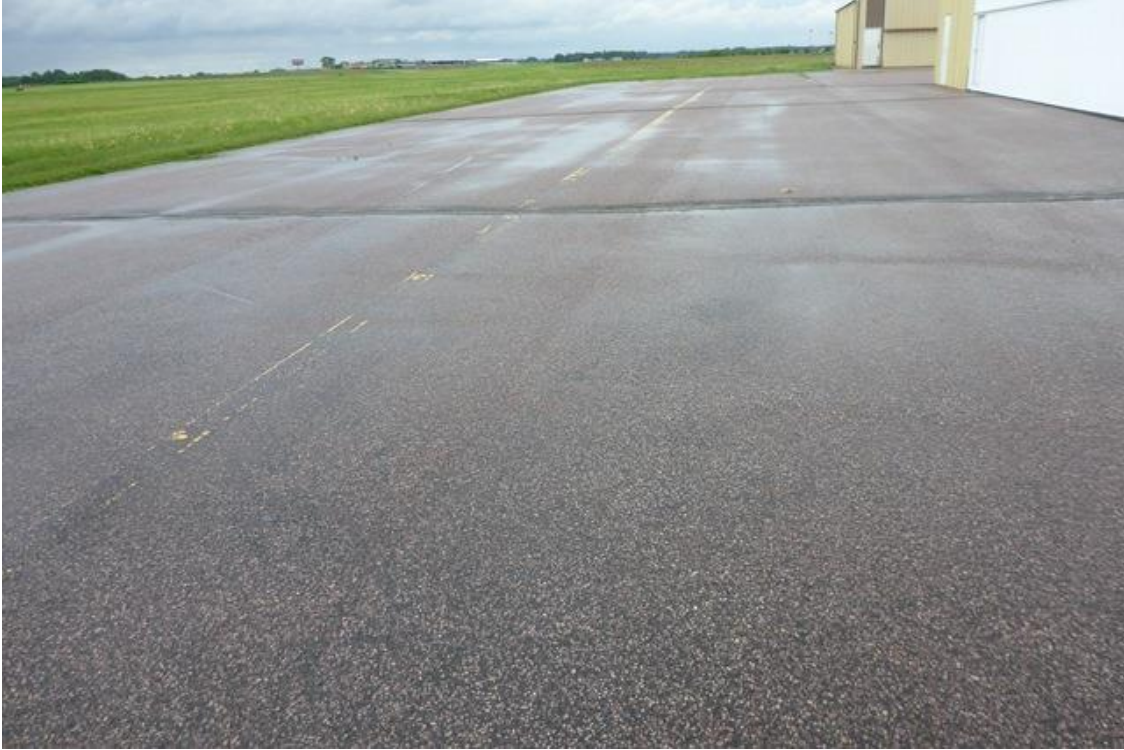
ULM TLA 001 (PCI = 63)

Conditions: PCI: 63

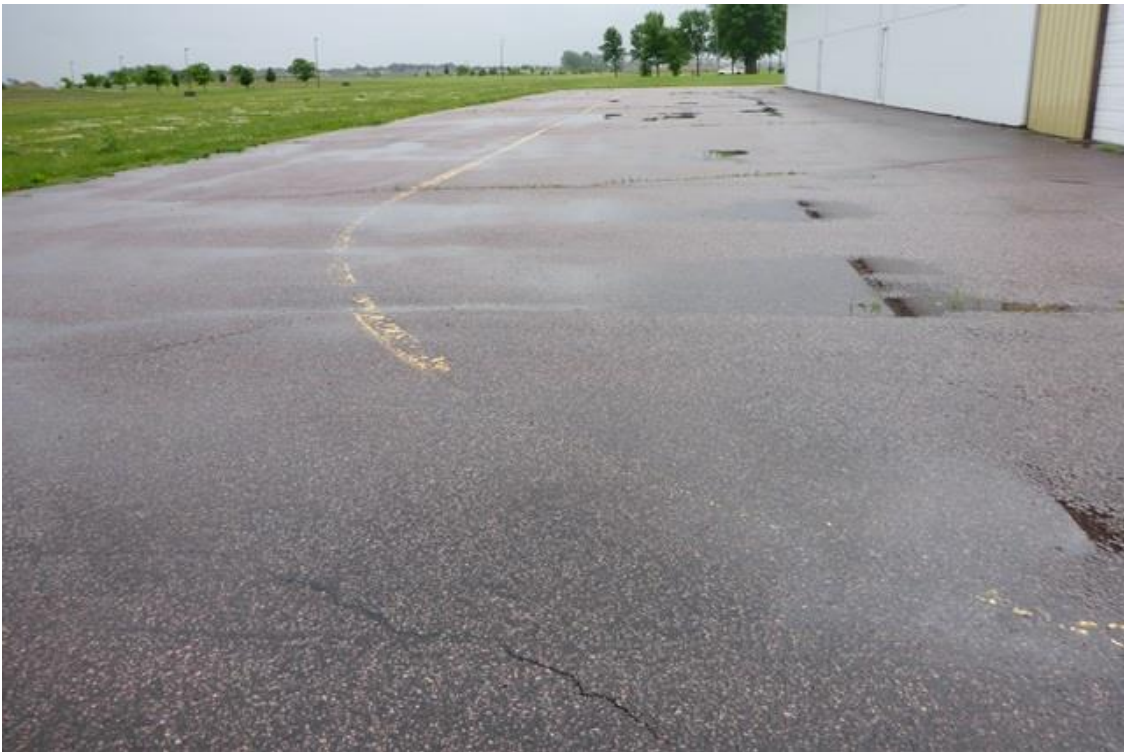
ULM TLB 001 (PCI = 58)

Conditions: PCI: 58

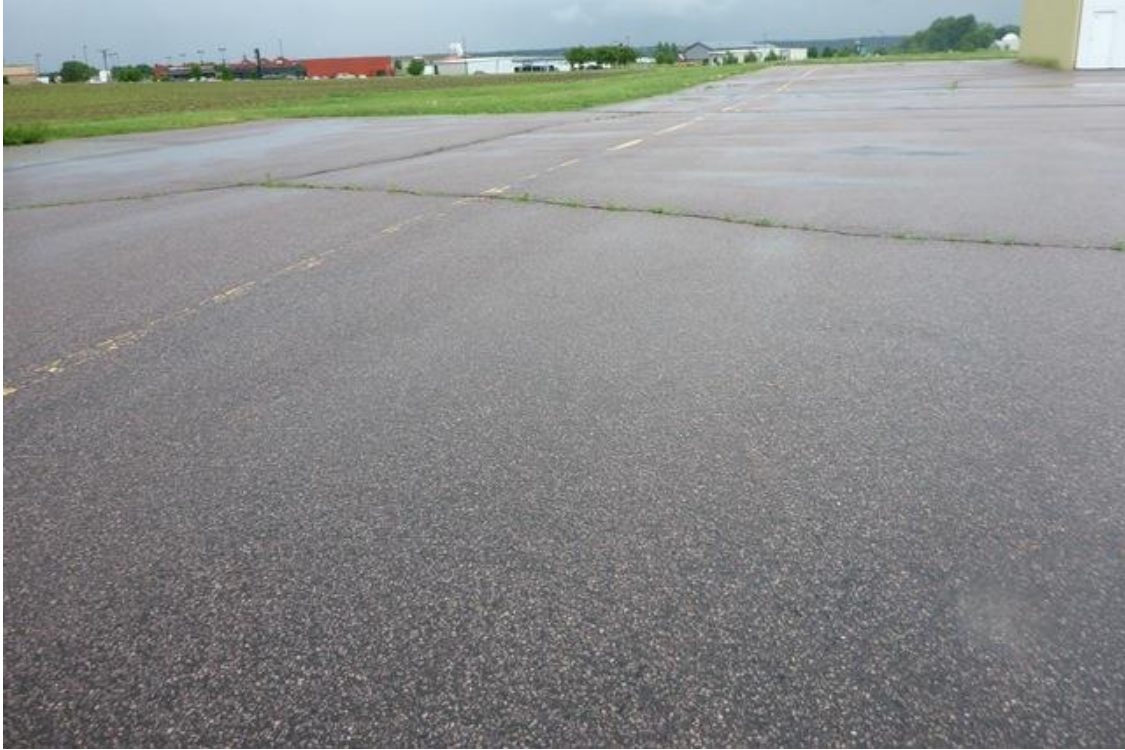
ULM TLC 001 (PCI = 64)

Conditions: PCI: 64
