Pavement Condition Report

Fillmore County Airport (FKA)

Applied Research Associates, Inc.
6314 Odana Rd
Madison, WI 53719
(608) 274-6409

December 2017

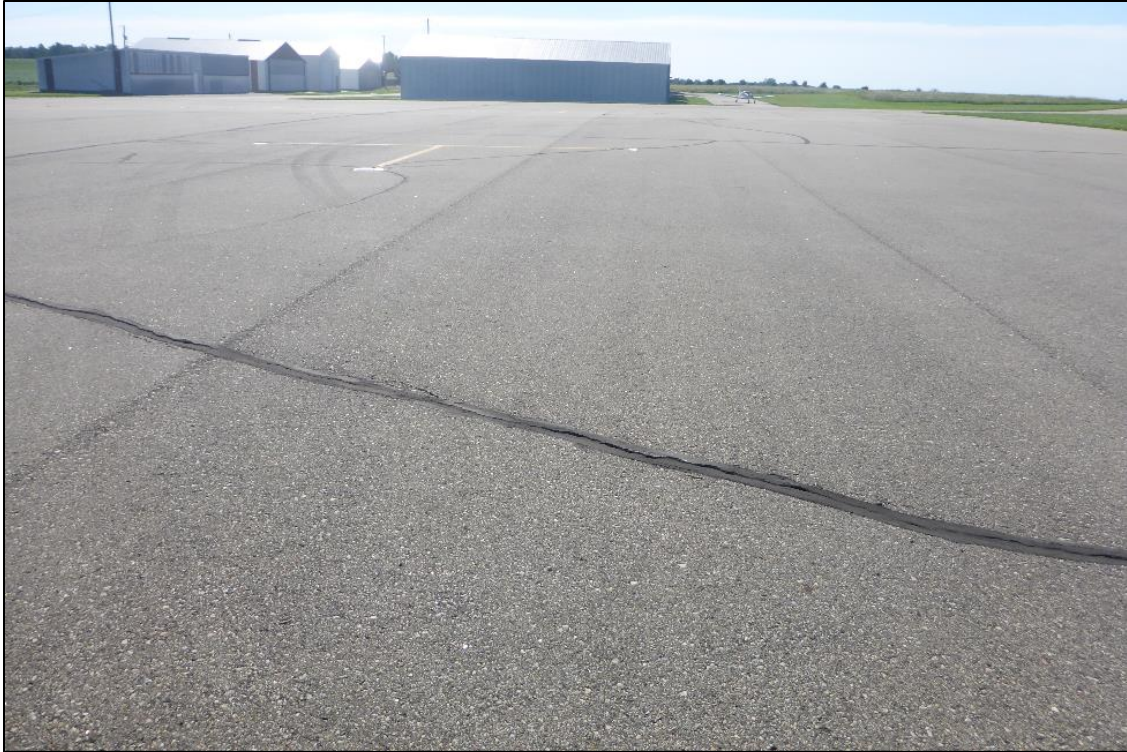
FKA APA 001 (PCI = 79)

Network: FKA				Name: FILLMORE COUNTY		
Branch: APA	Name: APRON A	Use: APRON	Area: 65,500 SqFt			
Section: 001	of 1	From: 100	To: 401	Last Const.: 10/1/2007		
Surface: AAC	Family: MN2013 Asphalt Aprons	Zone: S	Category: 1	Rank: S		
Area: 65,500 SqFt	Length: 317 Ft	Width: 220 Ft				
Slabs:	Slab Length: Ft	Slab Width: Ft	Joint Length: Ft			
Shoulder:	Street Type:	Grade: 0	Lanes: 0			
Section Comments:						
Last Insp. Date: 6/22/2017	Total Samples: 12	Surveyed: 4				
Conditions: PCI: 79						
Inspection Comments:						
Sample Number: 100	Type: R	Area: 5000.00 SqFt	PCI: 74			
Sample Comments:						
48	L & T CR	L	210.00 Ft			
48	L & T CR	M	25.00 Ft			
48	L & T CR	H	10.00 Ft			
52	RAVELING	M	10.00 SqFt			
Sample Number: 201	Type: R	Area: 5000.00 SqFt	PCI: 74			
Sample Comments:						
48	L & T CR	H	2.00 Ft			
48	L & T CR	M	106.00 Ft			
48	L & T CR	L	162.00 Ft			
Sample Number: 300	Type: R	Area: 5000.00 SqFt	PCI: 84

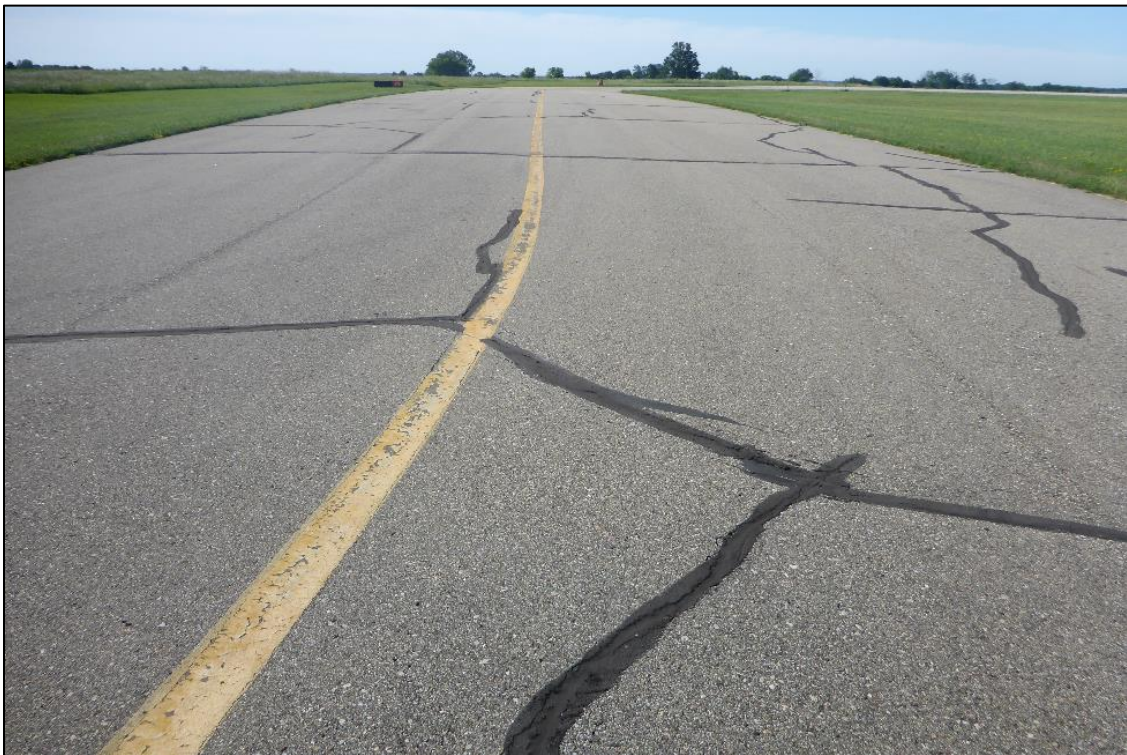
FKA CTA 001 (PCI = 71)

Conditions: PCI: 71

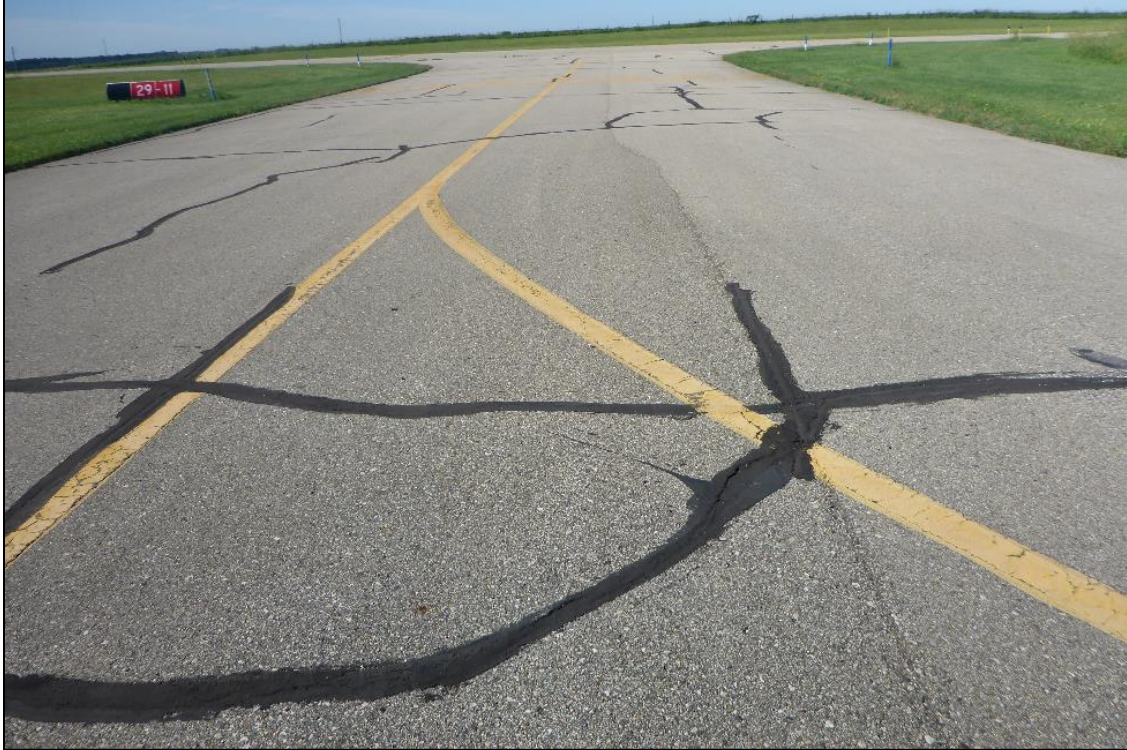
FKA CTB 001 (PCI = 71)

Network:	FKA	Name:	FILLMORE COUNTY						
Branch:	CTB	Name:	CONNECTING TXWY B	Use:	TAXIWAY	Area:	15,100 SqFt		
Section:	001	of 1	From:	100	To:	103	Last Const.:	10/1/2007	
Surface:	AAC	Family:	MN2013 Asphalt Taxiways	Zone:	S	Category:	1	Rank:	P
Area:	15,100 SqFt	Length:	360 Ft	Width:	40 Ft				
Slabs:		Slab Length:	Ft	Slab Width:	Ft	Joint Length:	Ft		
Shoulder:		Street Type:		Grade:	0	Lanes:	0		
Section Comments:									
Last Insp. Date:	6/22/2017	TotalSamples:	4	Surveyed:	1				
Conditions:	PCI: 71								
Inspection Comments:									
Sample Number:	101	Type:	R	Area:	4000.00 SqFt	PCI:	71		
Sample Comments:									
48	L & T CR	M	39.00	Ft					
48	L & T CR	L	422.00	Ft

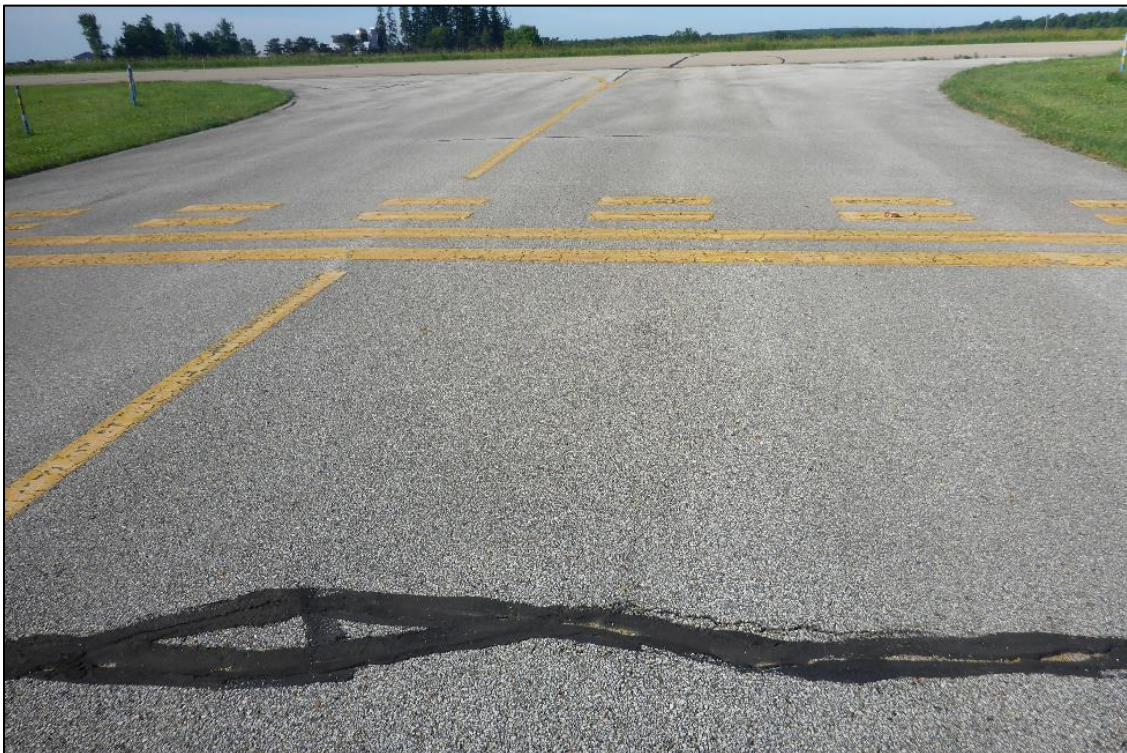
FKA CTC 001 (PCI = 65)

Conditions: PCI: 65

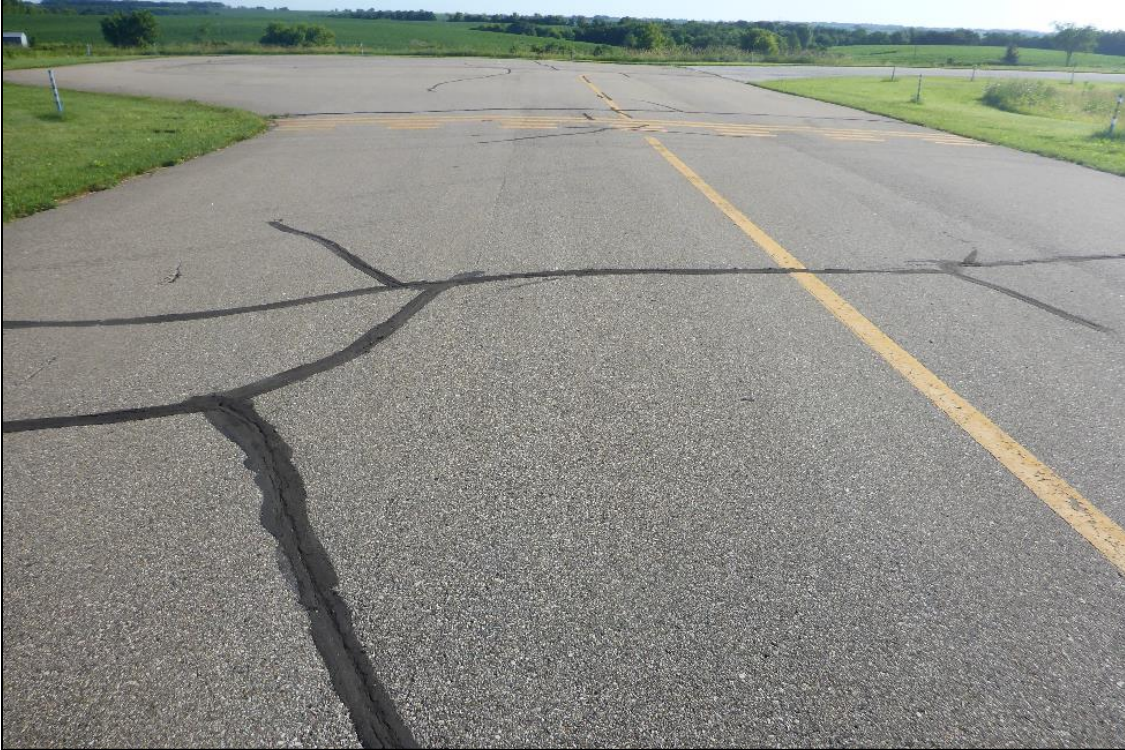
FKA CTD 001 (PCI = 67)

Conditions: PCI: 67

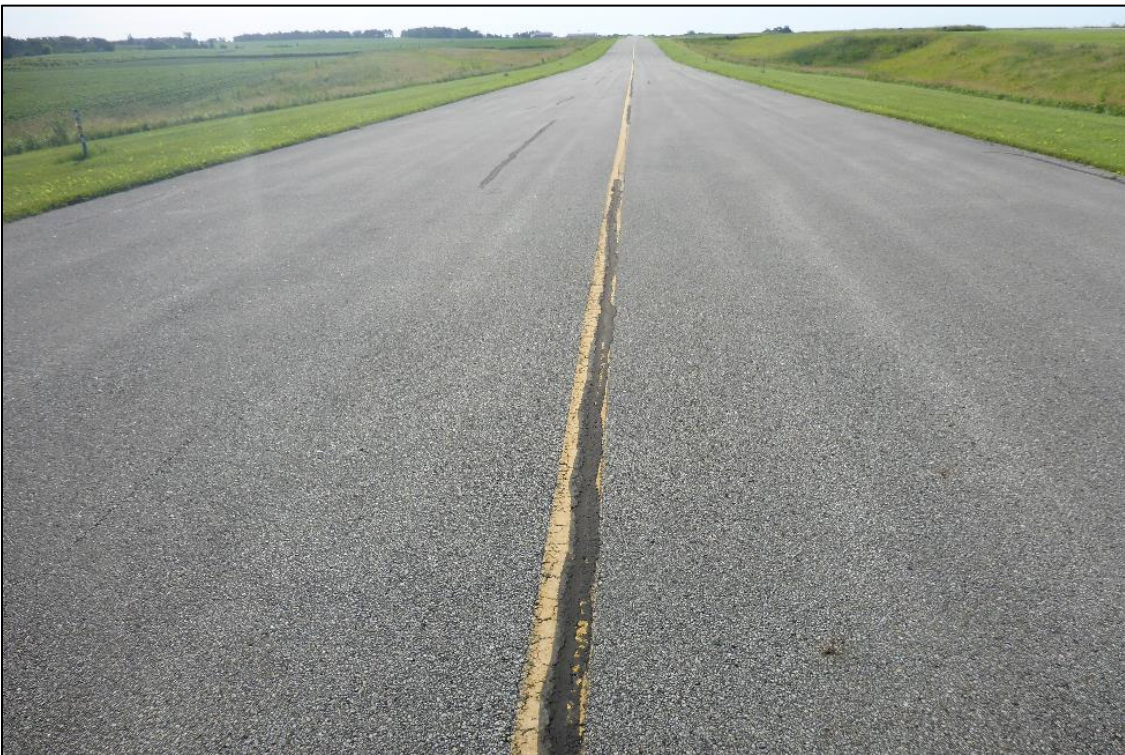
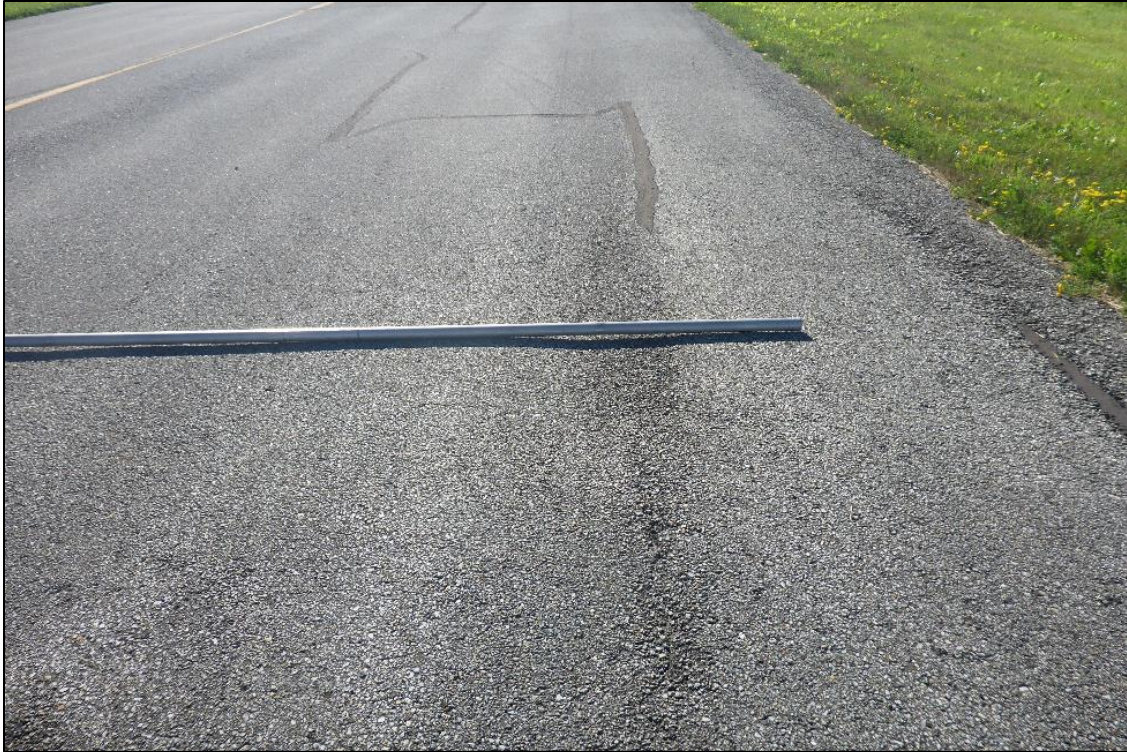
FKA PTA 001 (PCI = 68)

Network:	FKA	Name:	FILLMORE COUNTY				
Branch:	PTA	Name:	PARALLEL TAXIWAY A	Use:	TAXIWAY	Area:	132,600 SqFt
Section:	001	of 1	From:	100	To:	132	Last Const.: 6/30/2004
Surface:	AC	Family:	MN2013 Asphalt Taxiways	Zone:	S	Category:	1
Area:	132,600 SqFt	Length:	3,315 Ft	Width:	40 Ft	Joint Length:	Ft
Slabs:		Slab Length:	Ft	Slab Width:	Ft	Joint Length:	Ft
Shoulder:		Street Type:		Grade:	0	Lanes:	0
Section Comments:							
Last Insp. Date:	6/23/2017	TotalSamples:	33	Surveyed:	4		
Conditions:	PCI: 68	Inspection Comments:					
Sample Number:	105	Type:	R	Area:	4000.00 SqFt	PCI:	85
Sample Comments:							
57	WEATHERING	M	300.00	SqFt			
57	WEATHERING	L	3500.00	SqFt			
48	L & T CR	L	52.00	Ft			
Sample Number:	113	Type:	R	Area:	4000.00 SqFt	PCI:	81
Sample Comments:							
48	L & T CR	L	105.00	Ft			
57	WEATHERING	L	3500.00	SqFt			
57	WEATHERING	M	350.00	SqFt			
Sample Number:	120	Type:	R	Area:	4000.00 SqFt	PCI:	46
Sample Comments:

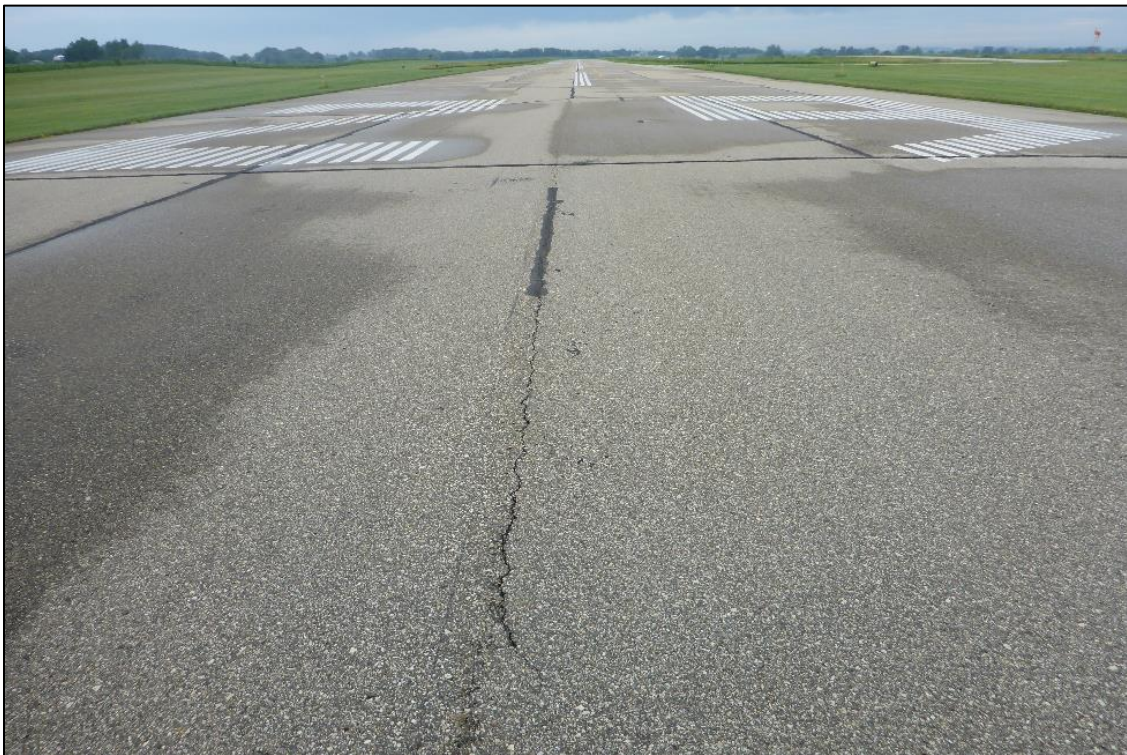
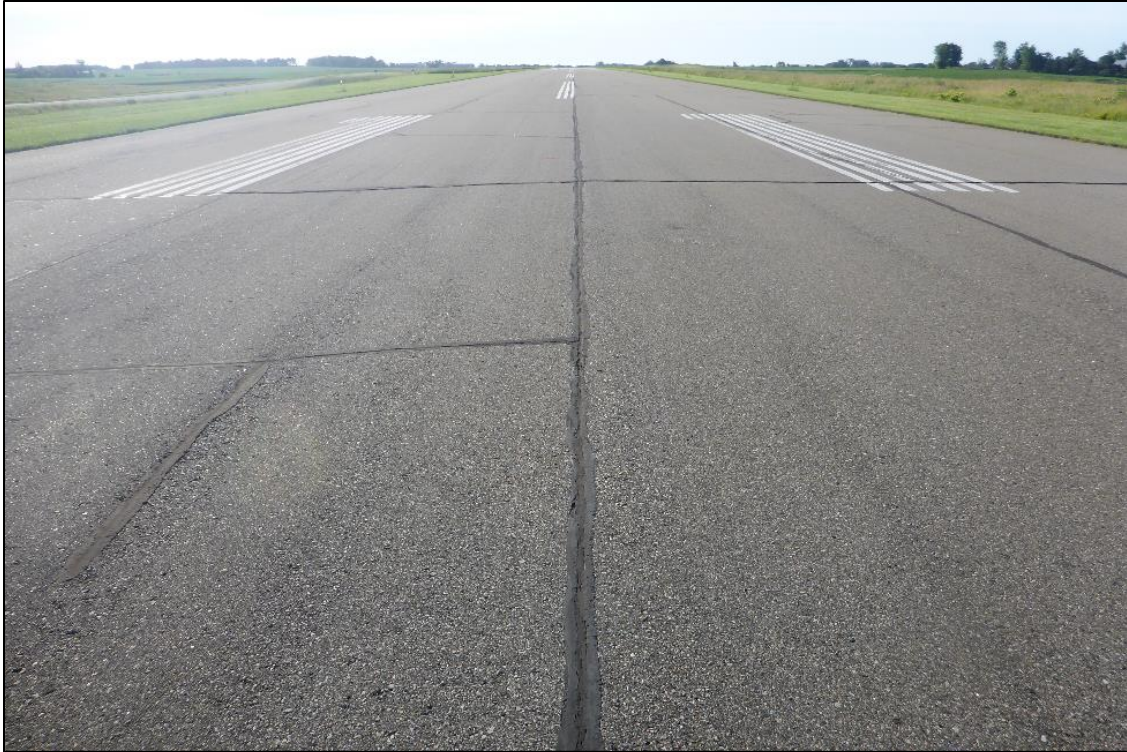
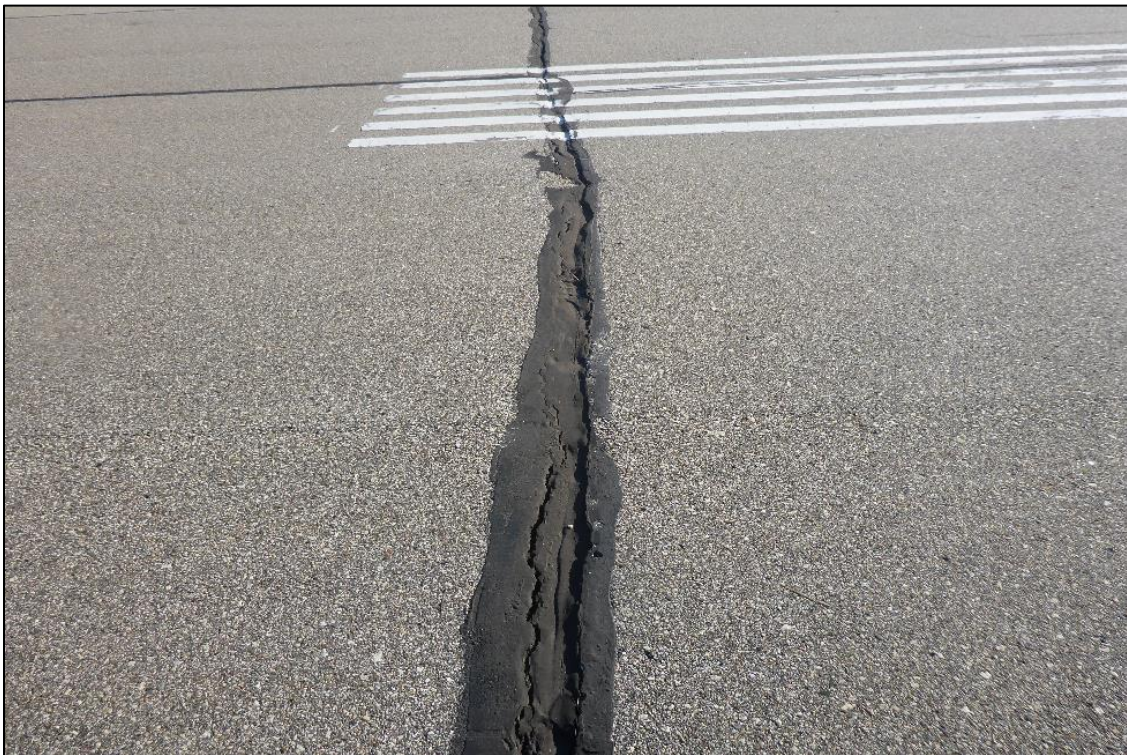
FKA RY1129 001 (PCI = 72)

Network:	FKA		Name:	FILLMORE COUNTY					
Branch:	RY1129	Name:	RUNWAY 11-29	Use:	RUNWAY	Area:	300,000 SqFt		
Section:	001	of 1	From:	100	To:	179	Last Const.:	10/1/2006	
Surface:	AAC	Family:	MN2013 Asphalt Runways	Zone:	S	Category:	1	Rank:	P
Area:	300,000 SqFt	Length:	4,000 Ft	Width:	75 Ft				
Slabs:		Slab Length:	Ft	Slab Width:	Ft	Joint Length:	Ft		
Shoulder:		Street Type:		Grade:	0	Lanes:	0		
Section Comments:									
Last Insp. Date:	6/22/2017	TotalSamples:	80	Surveyed:	12				
Conditions:	PCI: 72								
Inspection Comments:									
Sample Number:	105	Type:	R	Area:	3750.00 SqFt	PCI:	76		
Sample Comments:									
48	L & T CR	L	149.00	Ft					
48	L & T CR	M	60.00	Ft					
57	WEATHERING	L	3000.00	SqFt					
Sample Number:	115	Type:	R	Area:	3750.00 SqFt	PCI:	78		
Sample Comments:									
48	L & T CR	L	140.00	Ft					
48	L & T CR	M	28.00	Ft					
57	WEATHERING	L	3000.00	SqFt					
Sample Number:	116	Type:	R	Area:	3750.00 SqFt	PCI:	65

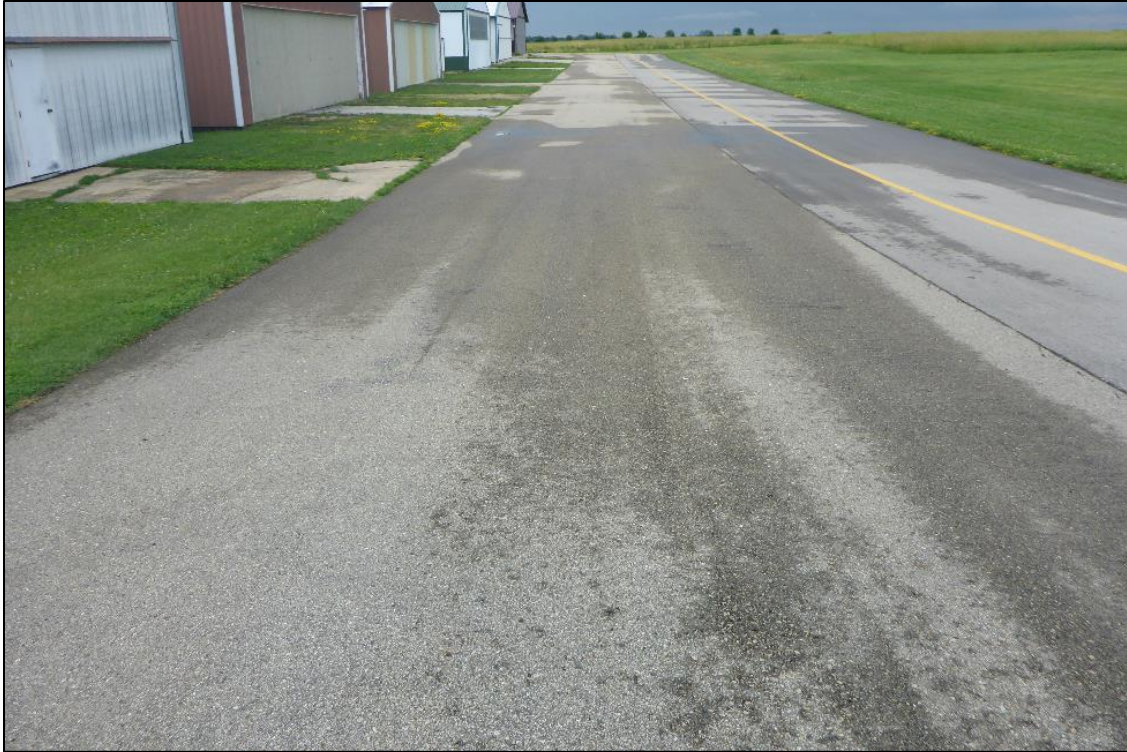
FKA TLA 001 (PCI = 86)

Conditions: PCI: 86

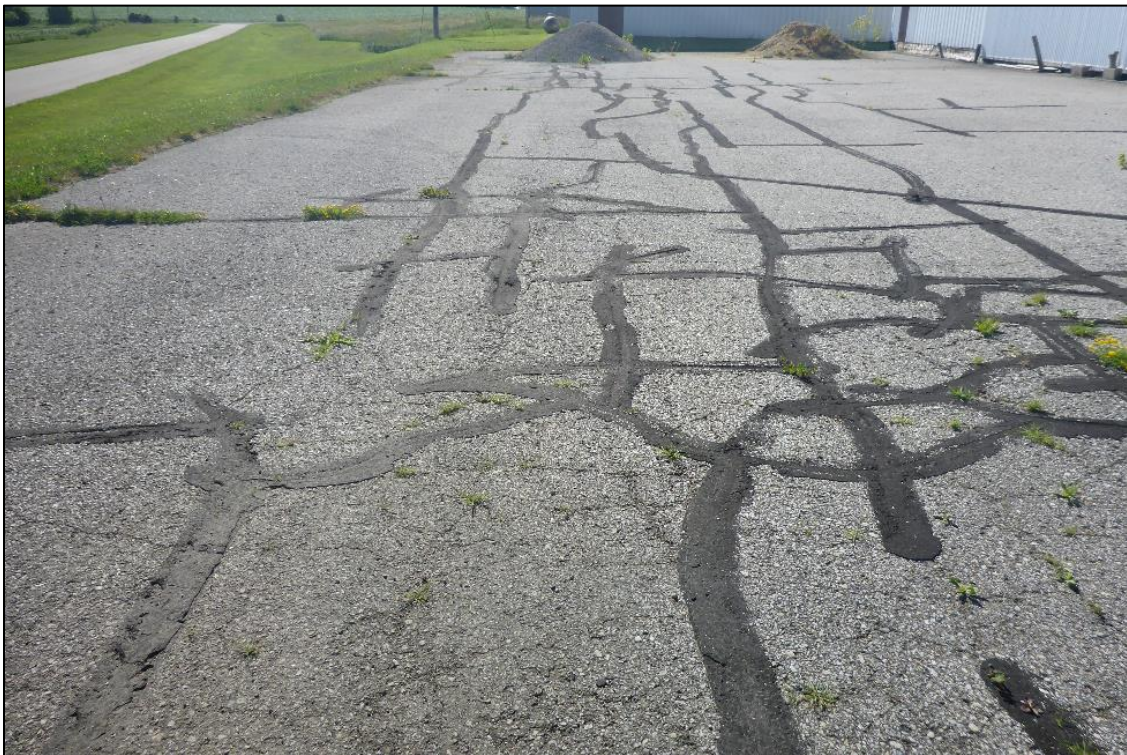
FKA TLA 002 (PCI = 41)

Conditions: PCI: 41

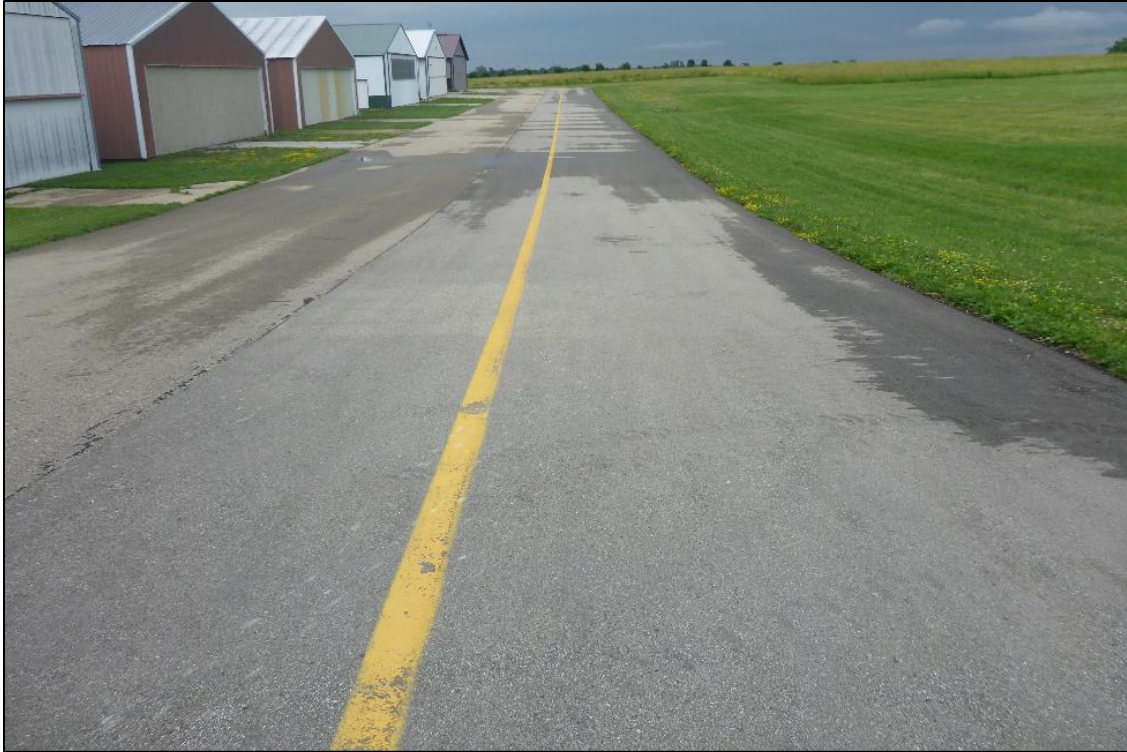
FKA TLA 003 (PCI = 100)

Conditions: PCI: 100
