# Pavement Condition Report

## Dodge Center Airport (TOB)

**December 2017**

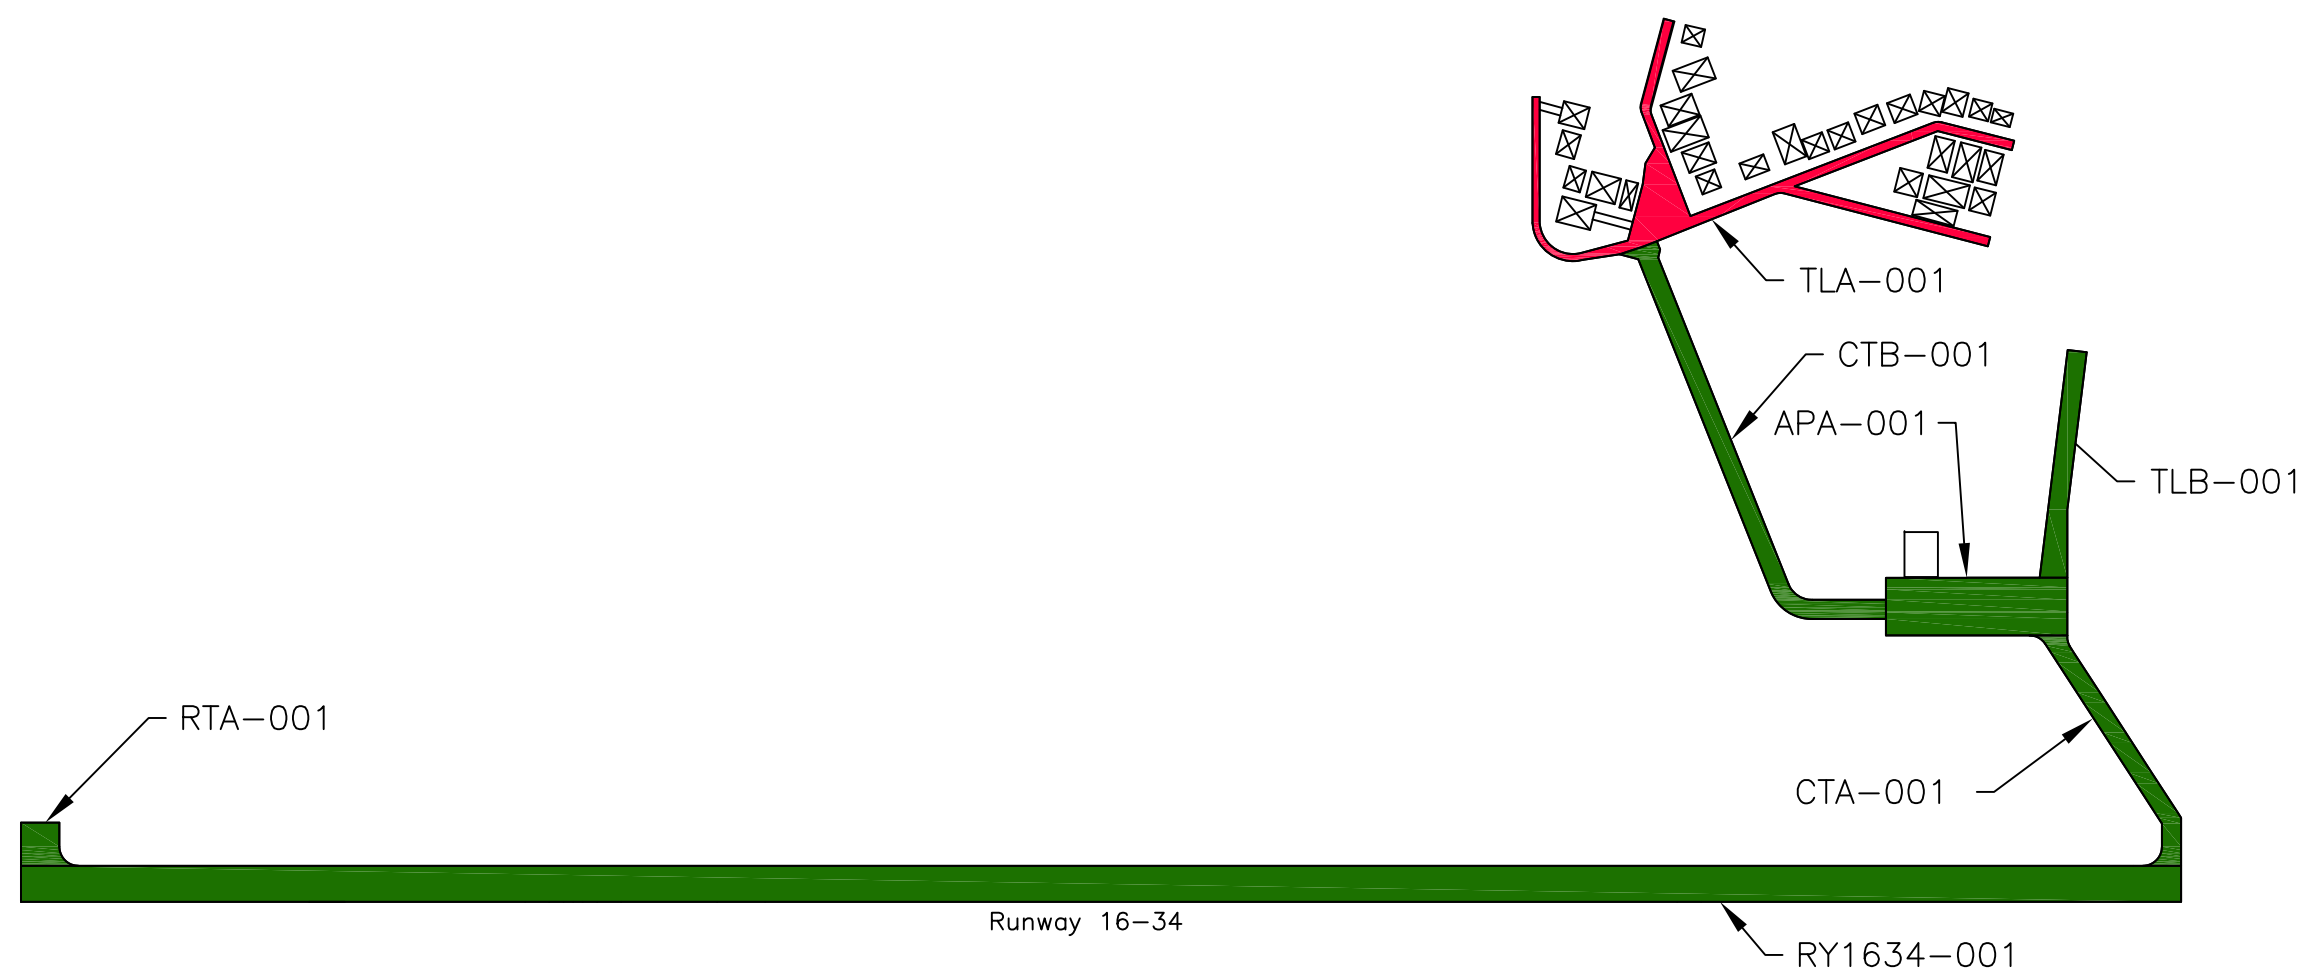
Figure 4. 2017 Pavement Condition Index Rating at Dodge Center Municipal Airport (TOB).

Figures 5 and 6 present the overall PCI for TOB by area distribution and pavement use, respectively. Table 3 presents the PCI summary for each section at TOB, including the drop in PCI per year. Generally, pavement sections will deteriorate between 1 and 3 PCI points per year. Sections deteriorating at higher rates may need maintenance above the normal application rates and should be closely monitored in case major repairs become necessary earlier than expected.

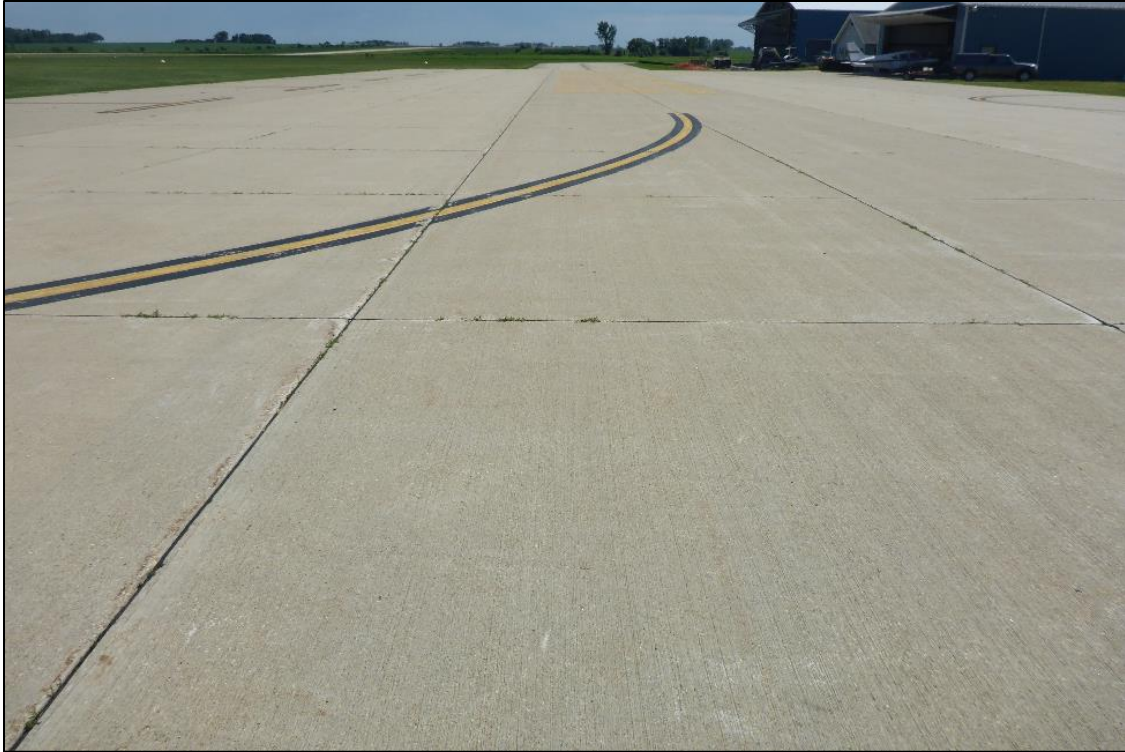
TOB APA 001 (PCI = 90)

74 JOINT SPALL M 1.00 Slabs  
65 JT SEAL DMG M 24.00 Slabs
