# Pavement Condition Report

## Olivia Regional Airport (OVL)

**December 2018**

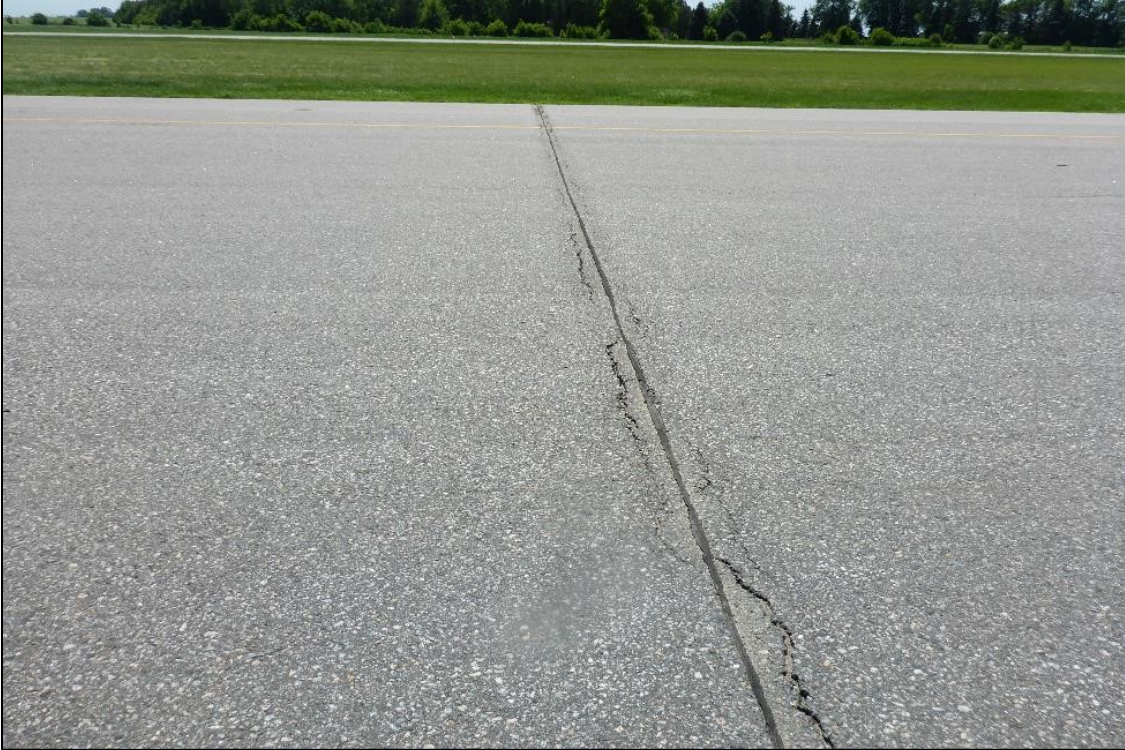
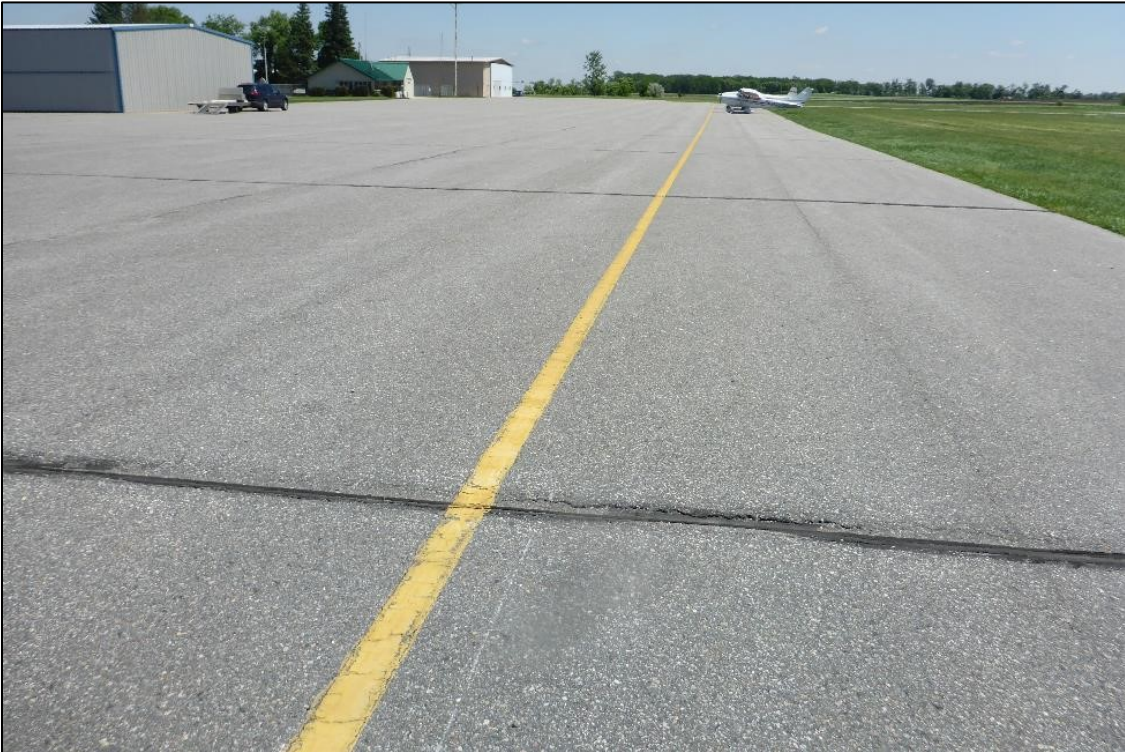
OVL APA 001 (PCI = 66)

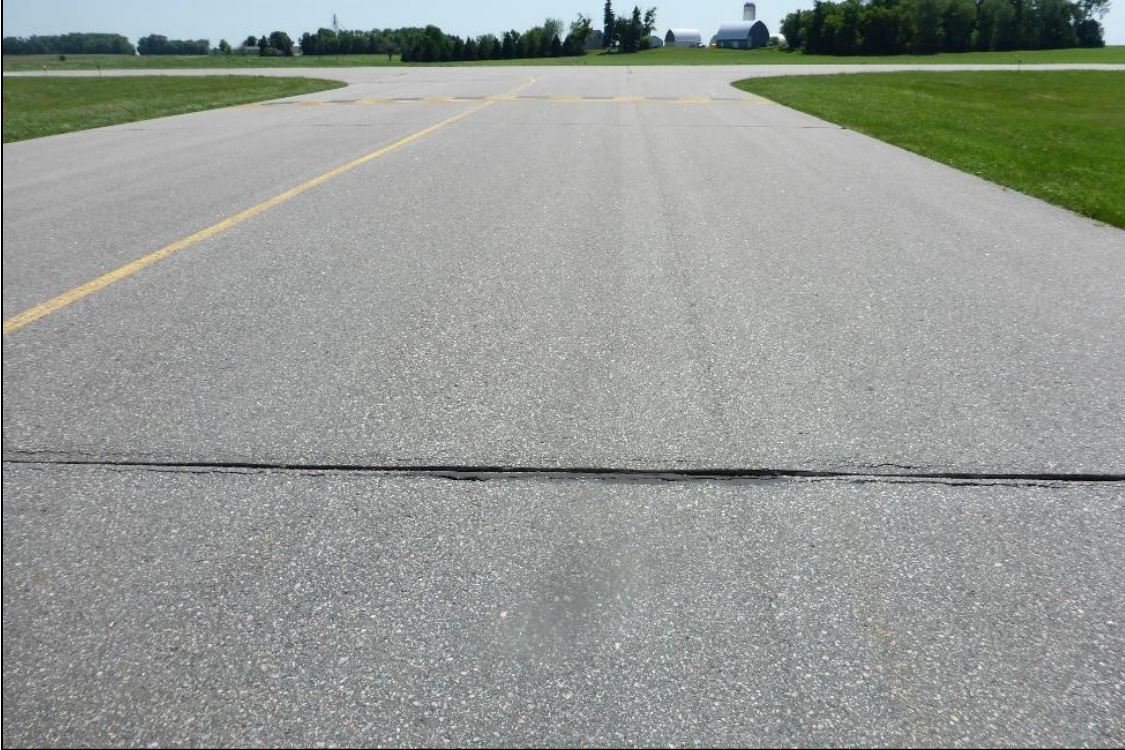
OVL CTA 001 (PCI = 74)

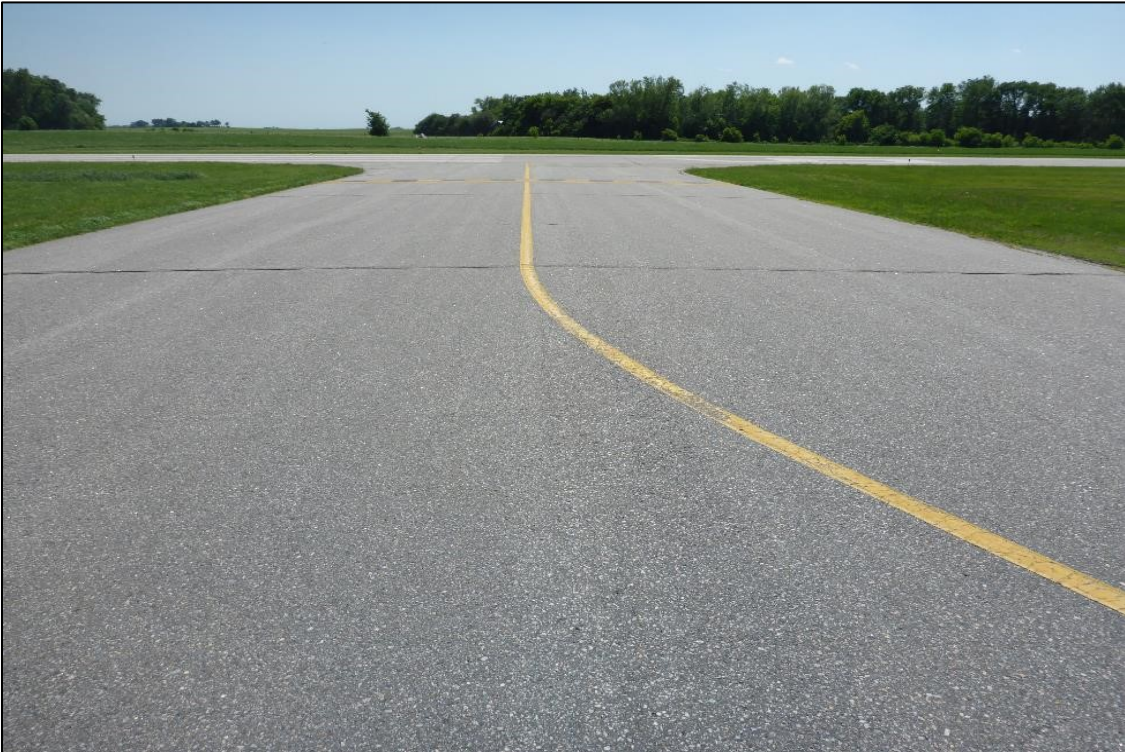
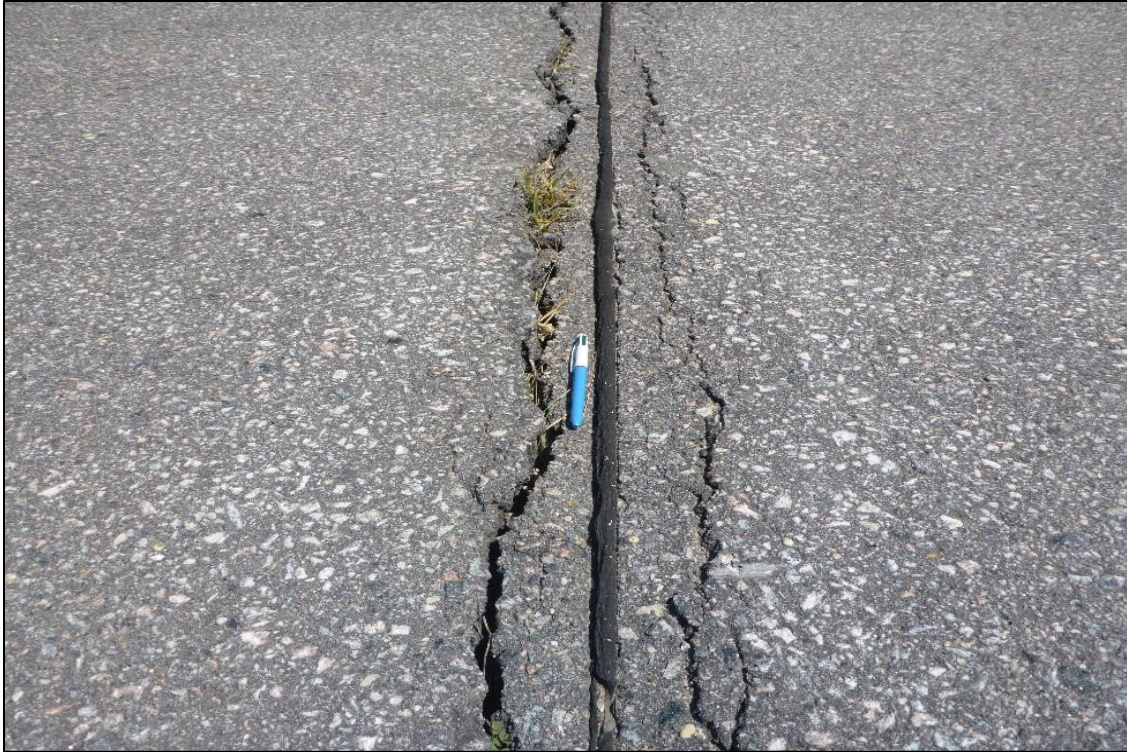
OVL CTB 001 (PCI = 56)

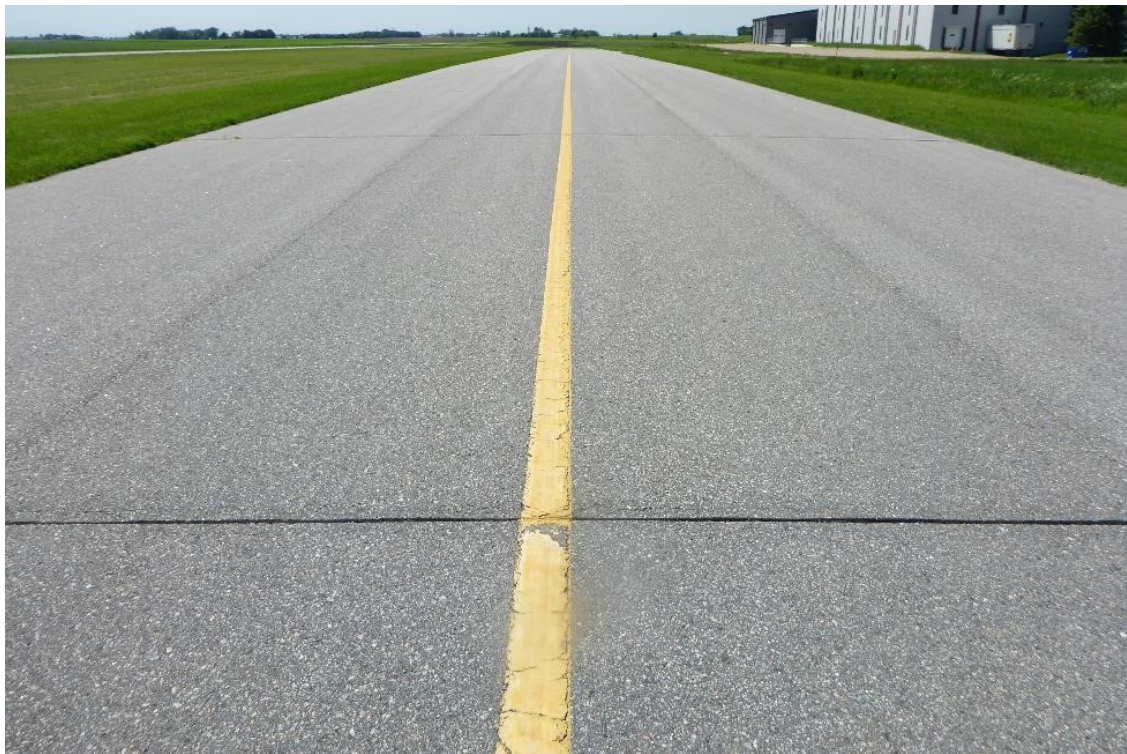
OVL PPTA 001 (PCI = 65)

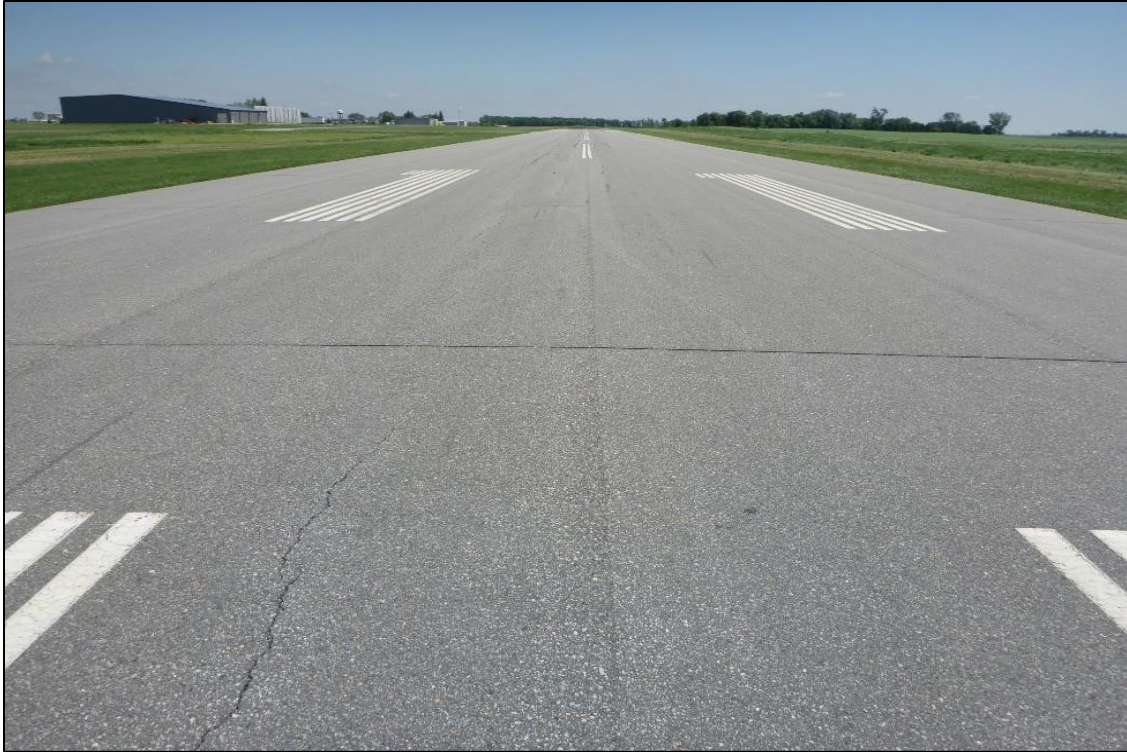
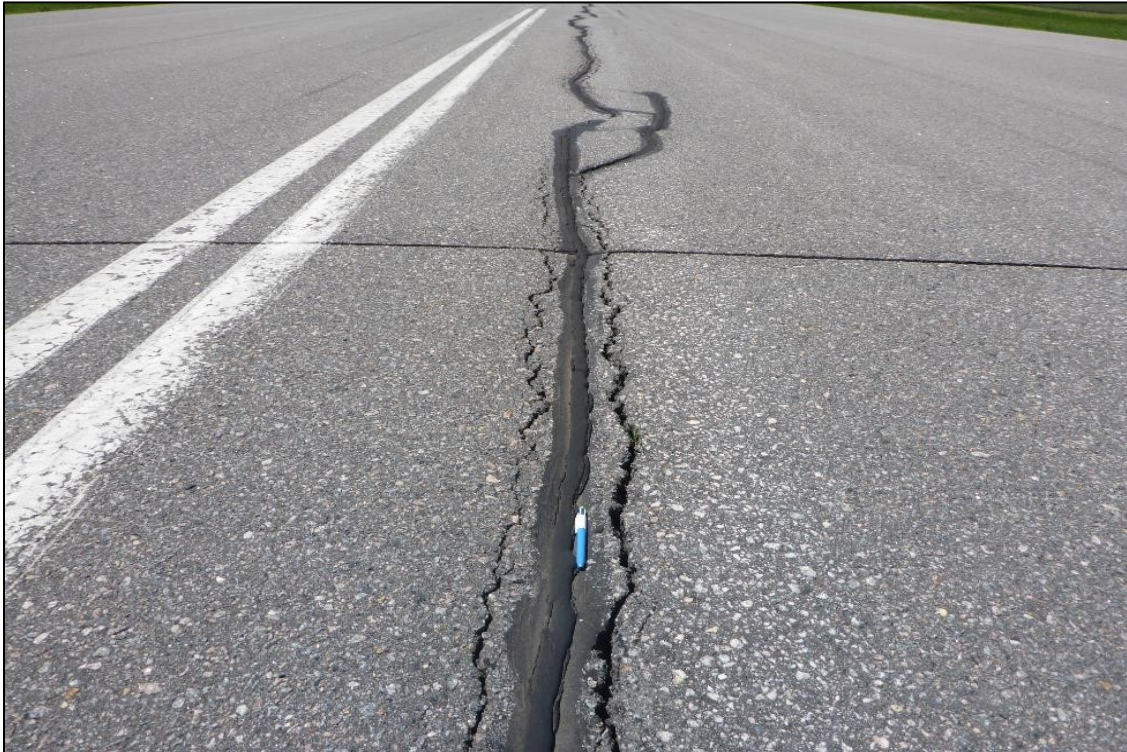
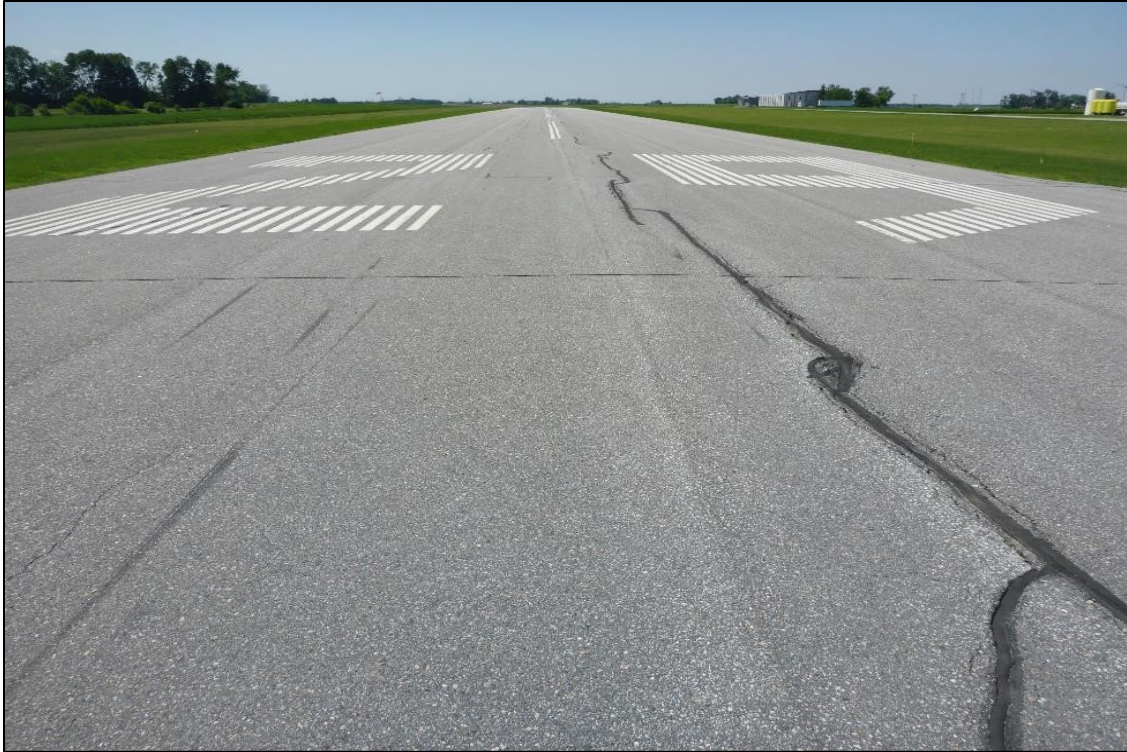
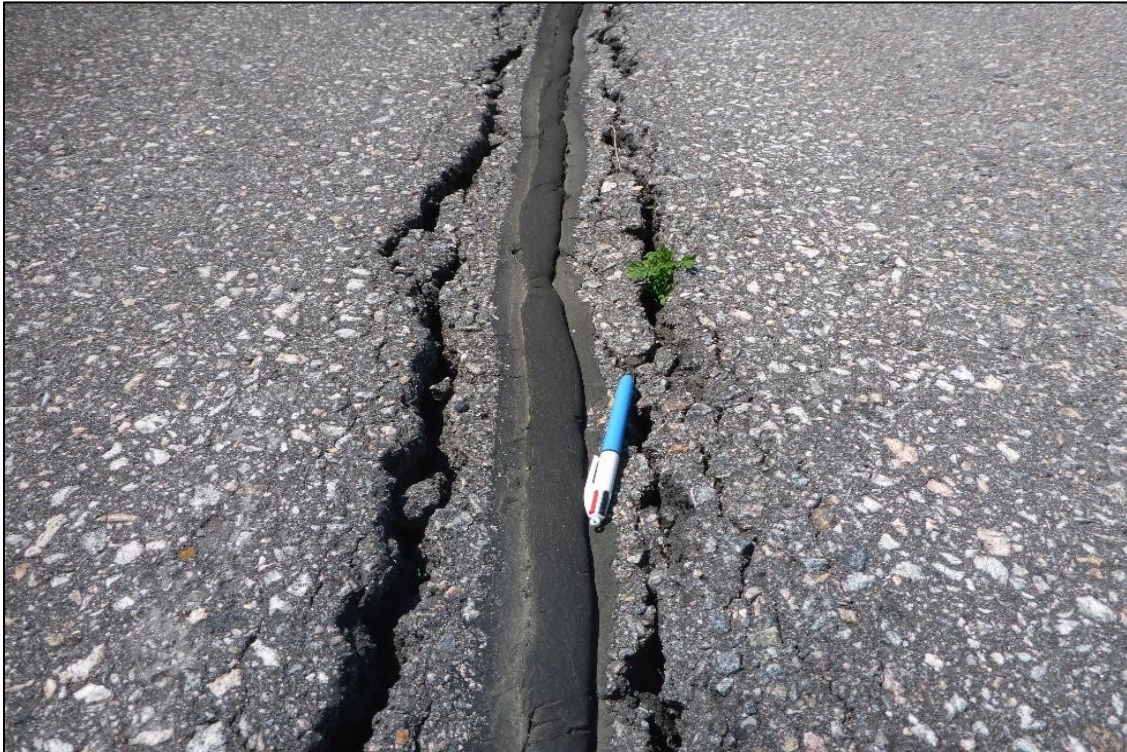
OVL RY1129 001 (PCI = 67)

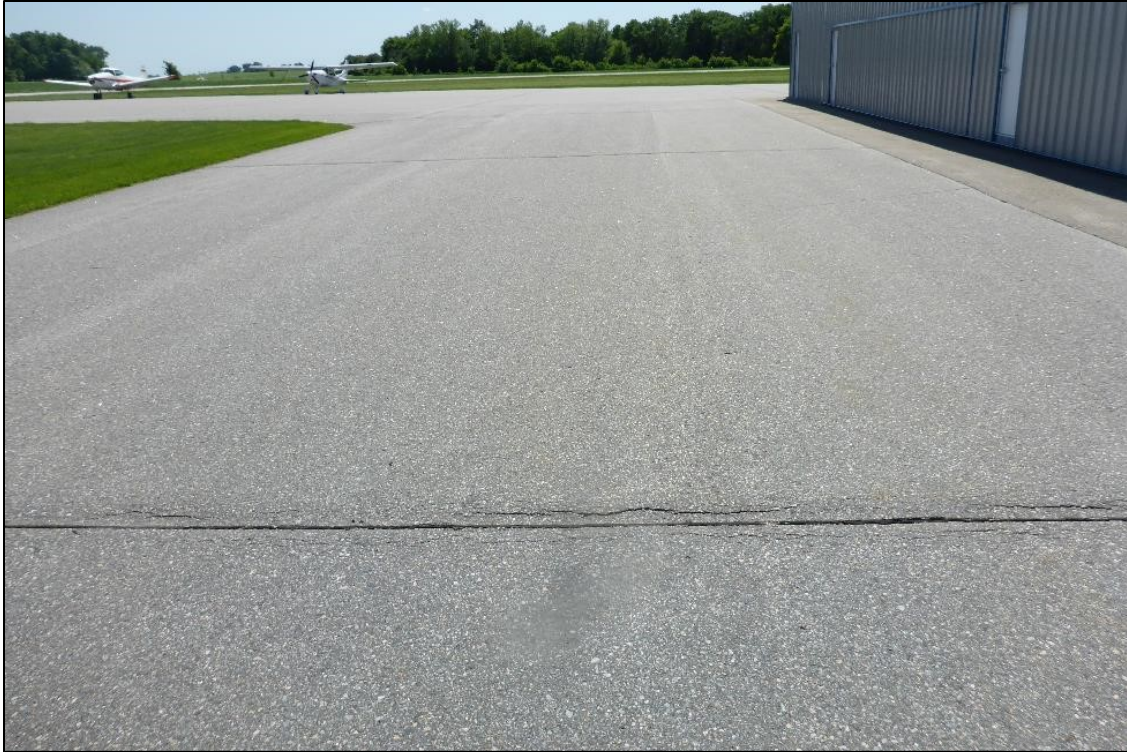
OVL TLA 001 (PCI = 64)

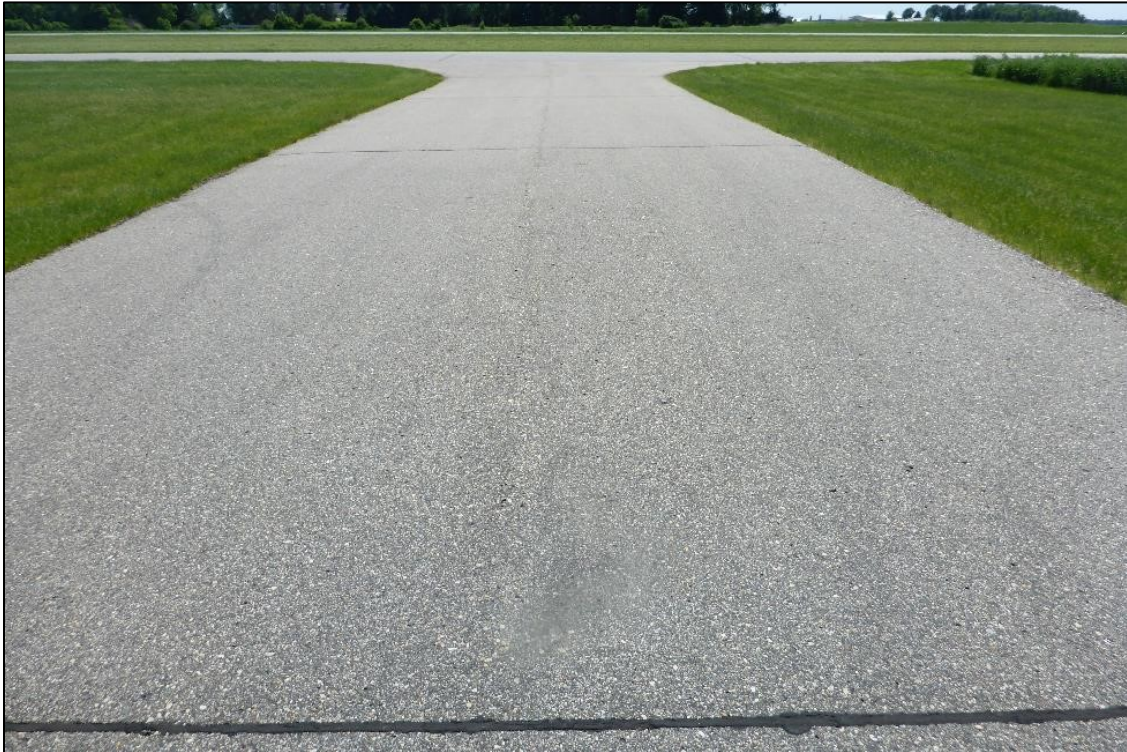
OVL TLB 001 (PCI = 81)
