# Pavement Condition Report

## Stephen Municipal Airport (D41)

**December 2019**

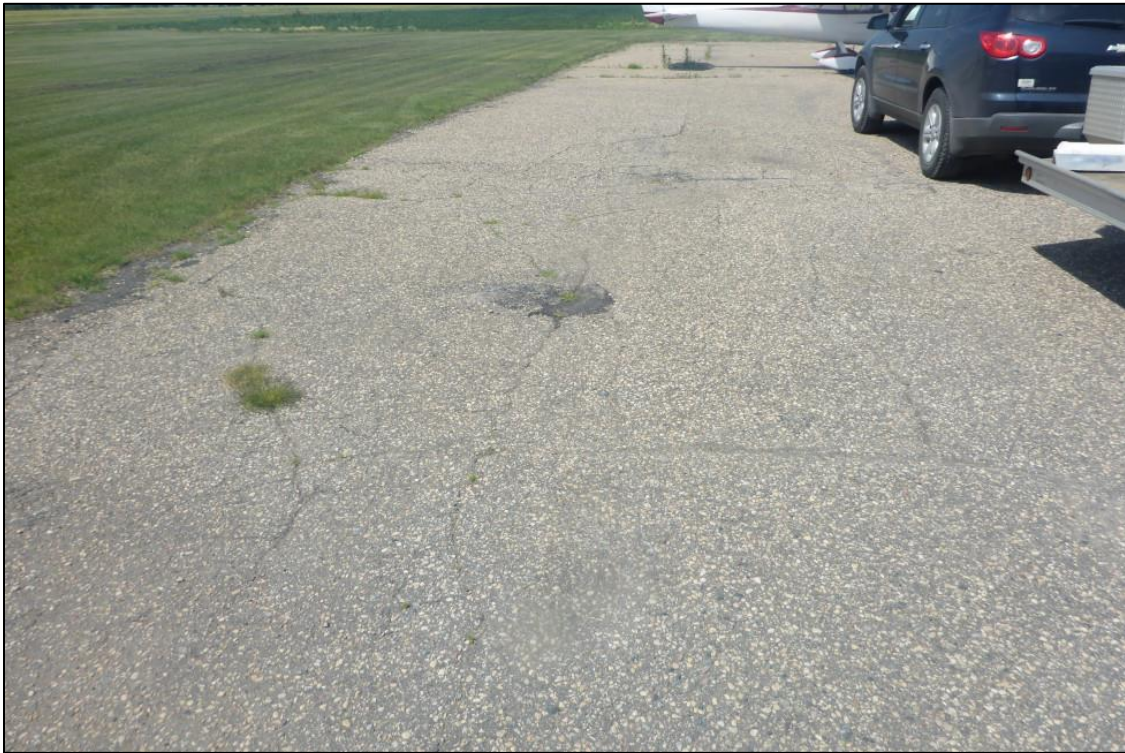
D41 APA 001 (PCI = 17)

**Conditions:** PCI: 17

Branch	Section	Treatment	Quantity	Unit	Cost
APA	001	Crack Sealing - AC	578	Ft	\$746
APA	001	Patching - AC Deep	390	SqFt	\$4,702
APA	001	Patching - AC Shallow	8,500	SqFt	\$68,935
<b>Stopgap</b>		<b>PCI Before: 17 After: 48</b>	<b>-</b>	<b>Total</b>	<b>\$74,383</b>
APA	002	Crack Sealing - AC	115	Ft	\$148
<b>Preventive</b>		<b>PCI Before: 57 After: 61</b>	<b>-</b>	<b>SqFt</b>	<b>\$148</b>
CTA	001	Crack Sealing - AC	199	Ft	\$257
<b>Preventive</b>		<b>PCI Before: 71 After: 77</b>	<b>-</b>	<b>Total</b>	<b>\$257</b>
PTA	001	Crack Sealing - AC	741	Ft	\$956
<b>Preventive</b>		<b>PCI Before: 73 After: 81</b>	<b>-</b>	<b>Total</b>	<b>\$956</b>
PTA	002	Crack Sealing - AC	1,680	Ft	\$2,167
<b>Preventive</b>		<b>PCI Before: 76 After: 86</b>	<b>-</b>	<b>Total</b>	<b>\$2,167</b>
PTA	003	Crack Sealing - AC	85	Ft	\$110
PTA	003	Patching - AC Deep	97	SqFt	\$1,156
<b>Stopgap</b>		<b>PCI Before: 46 After: 57</b>	<b>-</b>	<b>Total</b>	<b>\$1,266</b>

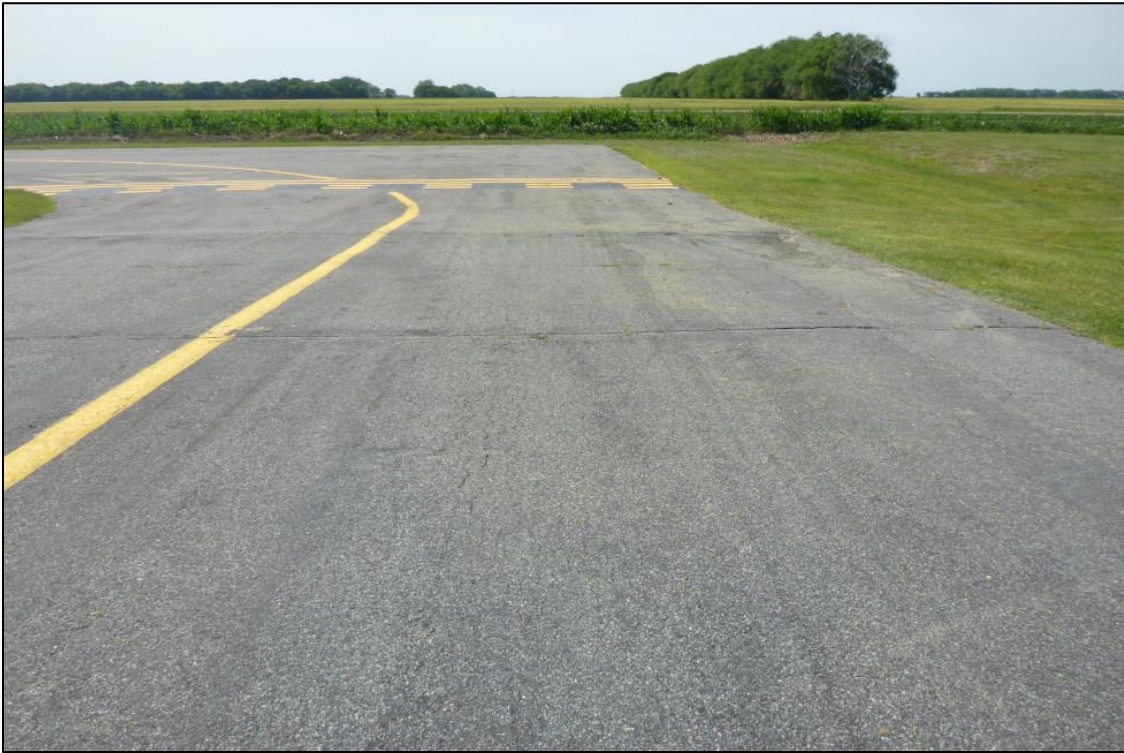
D41 PTA 003 (PCI = 46)

**Conditions:** PCI: 46
