Pavement Condition Report

Glencoe Municipal Airport (GYL)

December 2019

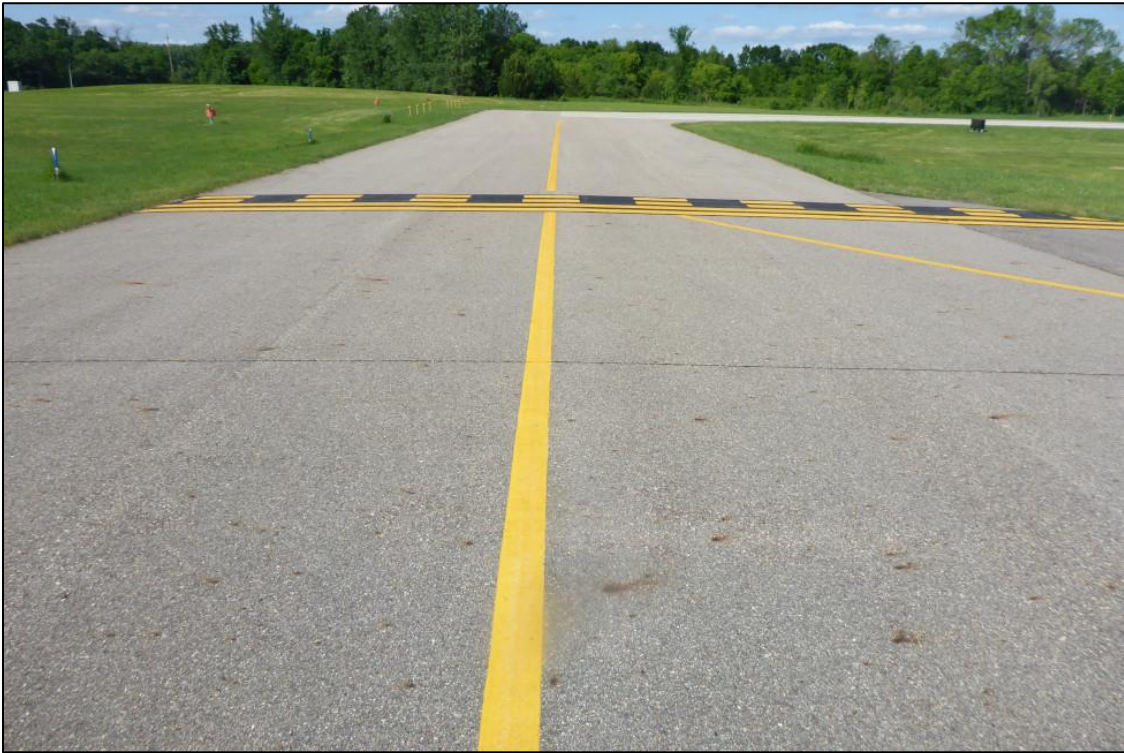
GYL CTA1 001 (PCI = 94)

Network:	GYL	Name:	GLENCOE						
Branch:	CTA1	Name:	CONNECTING TAXIWAY A1	Use:	TAXIWAY	Area:	12,275 SqFt		
Section:	001	of 1	From:	200	To:	202	Last Const.: 10/1/2014		
Surface:	AC	Family:	MN2018 Asphalt Runway- Taxiways	Zone:	S	Category:	3	Rank:	P
Area:	12,275 SqFt	Length:	300 Ft	Width:	40 Ft				
Slabs:		Slab Length:	Ft	Slab Width:	Ft	Joint Length:	Ft		
Shoulder:		Street Type:		Grade:	0	Lanes:	0		
Section Comments:	2009 slurry seal masked true condition of pvmt.								
Last Insp. Date:	6/11/2019	TotalSamples:	3	Surveyed:	1				
Conditions:	PCI: 94								
Inspection Comments:									
Sample Number:	201	Type:	R	Area:	4000.00 SqFt	PCI:	94		
Sample Comments:	p869								
48	L & T CR	L	45.00 Ft						
57	WEATHERING	L	250.00 SqFt

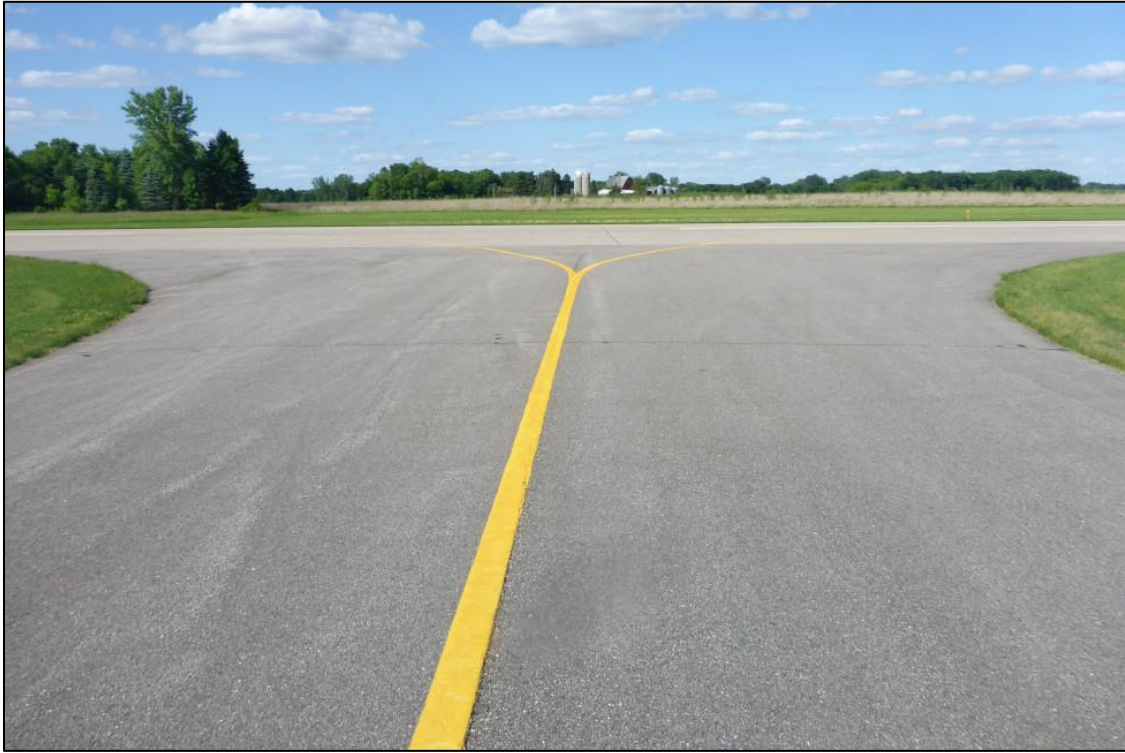
GYL CTA2 001 (PCI = 92)

Network:	GYL	Name:	GLENCOE				
Branch:	CTA2	Name:	CONNECTING TAXIWAY A2	Use:	TAXIWAY	Area:	7,940 SqFt
Section:	001	of 1	From:	100	To:	101	Last Const.: 10/1/2015
Surface:	AC	Family:	MN2018 Asphalt Runway- Taxiways	Zone:		Category:	Rank: S
Area:	7,940 SqFt	Length:	188 Ft	Width:	35 Ft		
Slabs:		Slab Length:	Ft	Slab Width:	Ft	Joint Length:	Ft
Shoulder:		Street Type:		Grade:	0	Lanes:	0
Section Comments:							
Last Insp. Date:	6/11/2019	TotalSamples:	2	Surveyed:	1		
Conditions:	PCI: 92						
Inspection Comments:							
Sample Number:	100	Type:	R	Area:	3500.00 SqFt	PCI:	92
Sample Comments:	p871,872,873						
48	L & T CR	L	45.00 Ft				
57	WEATHERING	L	550.00 SqFt

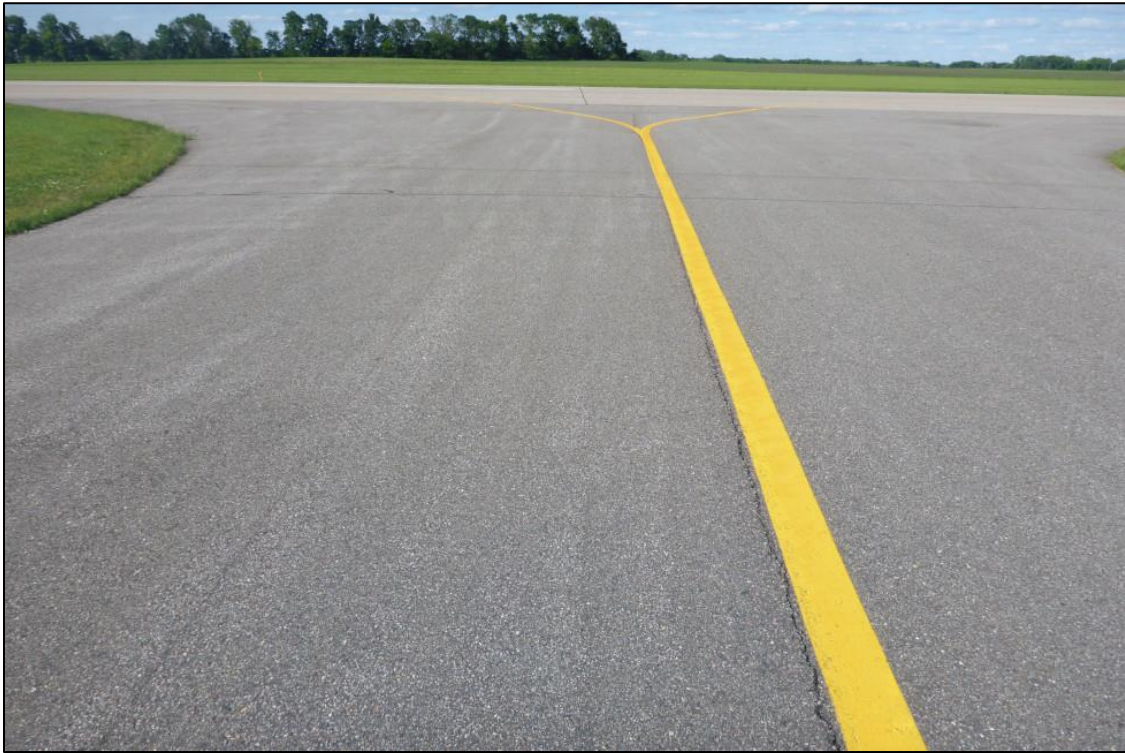
GYL CTA3 001 (PCI = 89)

Network:	GYL	Name:	GLENCOE				
Branch:	CTA3	Name:	CONNECTING TAXIWAY A3	Use:	TAXIWAY	Area:	7,940 SqFt
Section:	001	of 1	From:	100	To:	101	Last Const.: 10/1/2015
Surface:	AC	Family:	MN2018 Asphalt Runway- Taxiways	Zone:		Category:	Rank: S
Area:	7,940 SqFt	Length:	188 Ft	Width:	35 Ft		
Slabs:		Slab Length:	Ft	Slab Width:	Ft	Joint Length:	Ft
Shoulder:		Street Type:		Grade:	0	Lanes:	0
Section Comments:							
Last Insp. Date:	6/11/2019	TotalSamples:	2	Surveyed:	1		
Conditions:	PCI: 89						
Inspection Comments:							
Sample Number:	100	Type:	R	Area:	3500.00 SqFt	PCI:	89
Sample Comments:	p287						
48	L & T CR	L	124.00	Ft

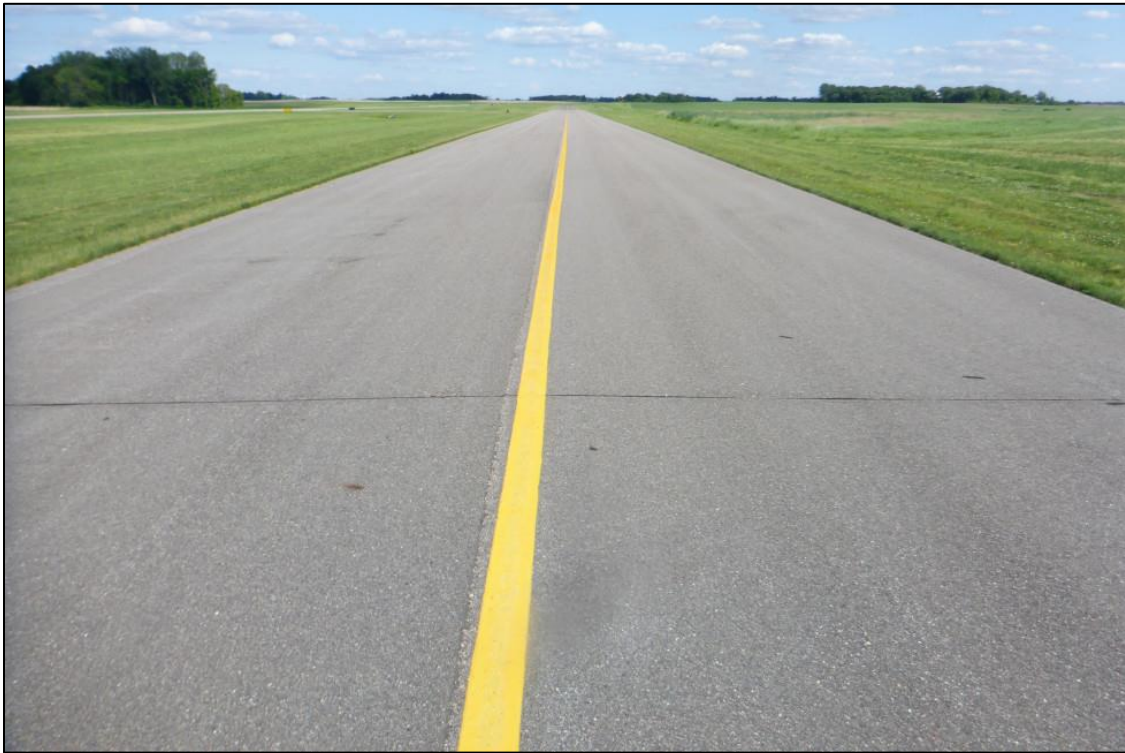
GYL PTA 001 (PCI = 93)

Network:	GYL	Name:	GLENCOE					
Branch:	PTA	Name:	PARALLEL TAXIWAY A	Use:	TAXIWAY	Area:	117,980 SqFt	
Section:	001	of 1	From:	A	To:	B	Last Const.:	10/1/2015
Surface:	AC	Family:	MN2018 Asphalt Runway- Taxiways	Zone:		Category:	Rank:	P
Area:	117,980 SqFt	Length:	3,323 Ft	Width:	35 Ft			
Slabs:		Slab Length:	Ft	Slab Width:	Ft	Joint Length:	Ft	
Shoulder:		Street Type:		Grade:	0	Lanes:	0	
Section Comments:								
Last Insp. Date:	6/11/2019	TotalSamples:	34	Surveyed:	7			
Conditions:	PCI: 93							
Inspection Comments:								
Sample Number:	102	Type:	R	Area:	3500.00 SqFt	PCI:	91	
Sample Comments:	p286							
48	L & T CR	L	91.00	Ft				
Sample Number:	108	Type:	R	Area:	3500.00 SqFt	PCI:	93	
Sample Comments:								
48	L & T CR	L	70.00	Ft				
Sample Number:	112	Type:	R	Area:	3500.00 SqFt	PCI:	94	
Sample Comments:								
48	L & T CR	L	44.00	Ft				
Sample Number:	116	Type:	R	Area:	3500.00 SqFt	PCI:	94	
Sample Comments:

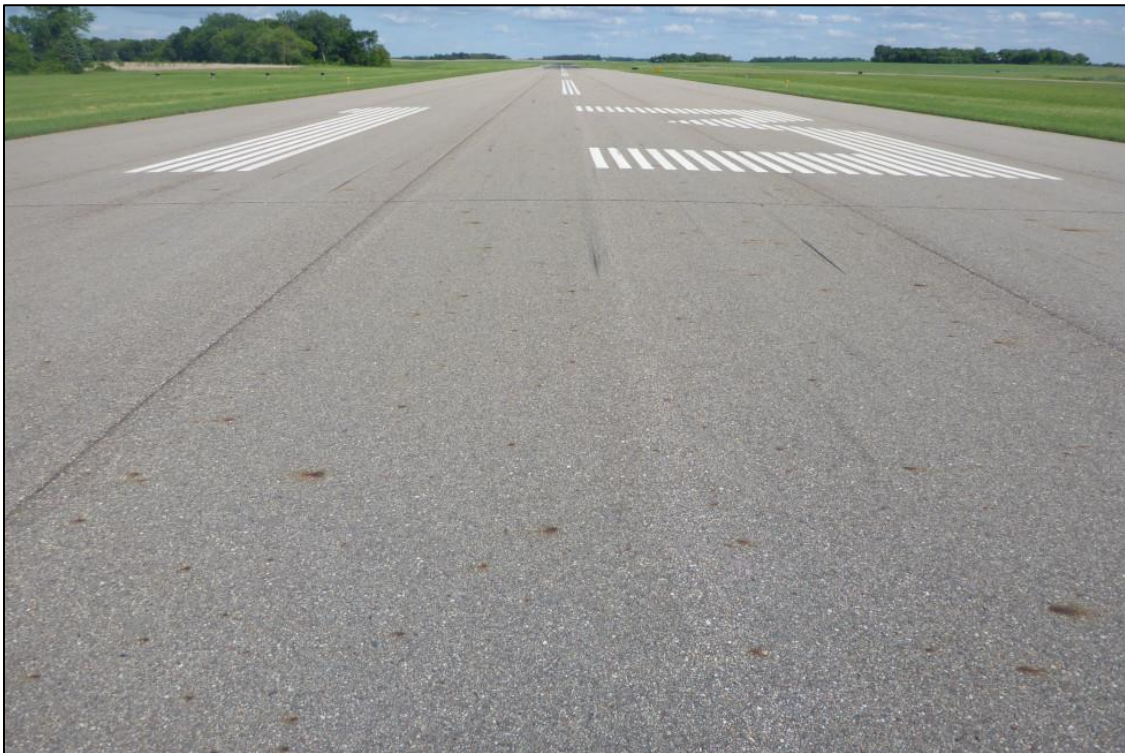
GYL RY1331 001 (PCI = 85)

Network:	GYL	Name:	GLENCOE						
Branch:	RY1331	Name:	RUNWAY 13-31	Use:	RUNWAY	Area:	252,750 SqFt		
Section:	001	of 1	From:	100	To:	165	Last Const.:	10/1/2014	
Surface:	AC	Family:	MN2018 Asphalt Runway- Taxiways	Zone:	S	Category:	3	Rank:	P
Area:	252,750 SqFt	Length:	3,300 Ft	Width:	75 Ft				
Slabs:		Slab Length:	Ft	Slab Width:	Ft	Joint Length:	Ft		
Shoulder:		Street Type:		Grade:	0	Lanes:	0		
Section Comments:	2009 slurry seal masked true condition of pvmt.								
Last Insp. Date:	6/11/2019	TotalSamples:	67	Surveyed:	7				
Conditions:	PCI: 85								
Inspection Comments:									
Sample Number:	101	Type:	R	Area:	3750.00 SqFt	PCI:	91		
Sample Comments:	p282 p283 numbers								
48	L & T CR	L	93.00	Ft					
Sample Number:	111	Type:	R	Area:	3750.00 SqFt	PCI:	83		
Sample Comments:									
48	L & T CR	L	220.00	Ft					
Sample Number:	121	Type:	R	Area:	3750.00 SqFt	PCI:	86		
Sample Comments:									
48	L & T CR	L	182.00	Ft

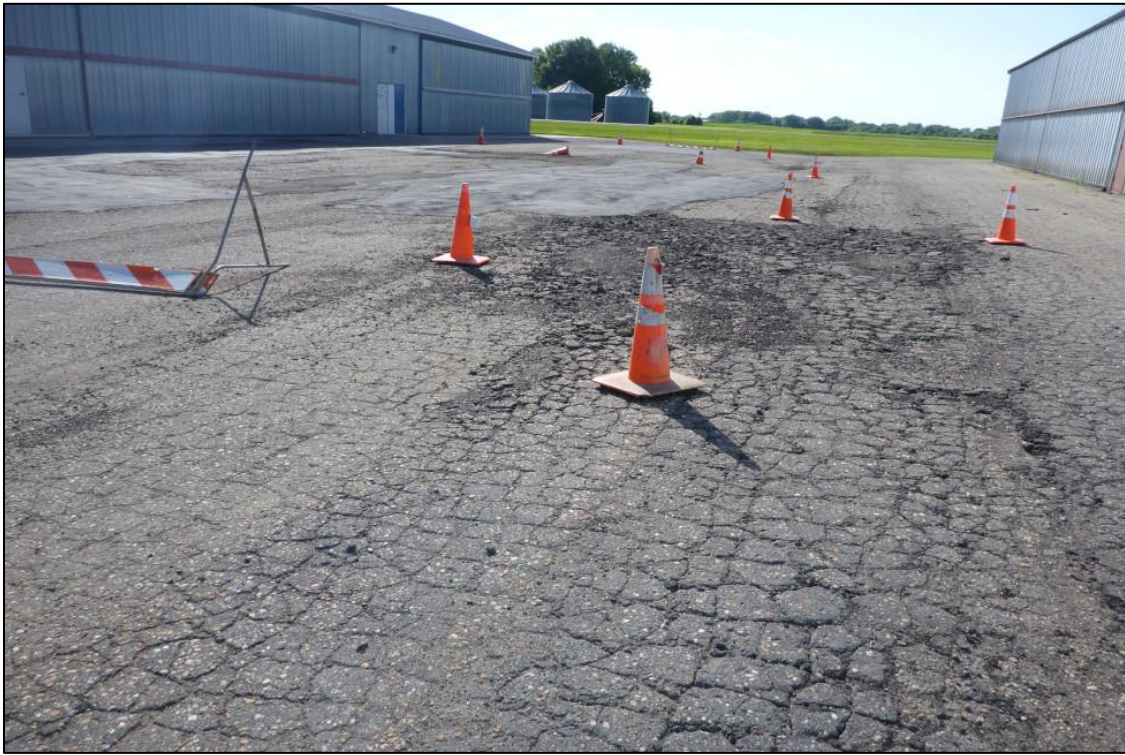
GYL TLA 001 (PCI = 0)

Network:	GYL	Name:	GLENCOE						
Branch:	TLA	Name:	Taxilane A	Use:	TAXILANE	Area:	89,225 SqFt		
Section:	001	of 2	From:	202	To:	406	Last Const.: 9/30/1995		
Surface:	AC	Family:	MN2018 Asphalt Taxilanes	Zone:	S	Category:	3	Rank:	T
Area:	70,300 SqFt	Length:	650 Ft	Width:	130 Ft				
Slabs:	Slab Length:	Ft	Slab Width:	Ft	Joint Length:	Ft			
Shoulder:	Street Type:	Grade:	0	Lanes:	0				
Section Comments:	Estimated LCD								
Last Insp. Date:	6/11/2019	TotalSamples:	16	Surveyed:	3				
Conditions:	PCI: 0								
Inspection Comments:									
Sample Number:	204	Type:	R	Area:	5000.00 SqFt	PCI:	0		
Sample Comments:	p290								
41	ALLIGATOR CR	M	2500.00	SqFt					
41	ALLIGATOR CR	H	1500.00	SqFt					
52	RAVELING	L	1000.00	SqFt					
53	RUTTING	L	75.00	SqFt					
Sample Number:	302	Type:	R	Area:	5000.00 SqFt	PCI:	1		
Sample Comments:									
41	ALLIGATOR CR	M	4000.00	SqFt					
41	ALLIGATOR CR	H	500.00	SqFt					
52	RAVELING	M	200.00	SqFt
