Pavement Condition Report

Park Rapids Municipal Airport (PKD)

December 2019

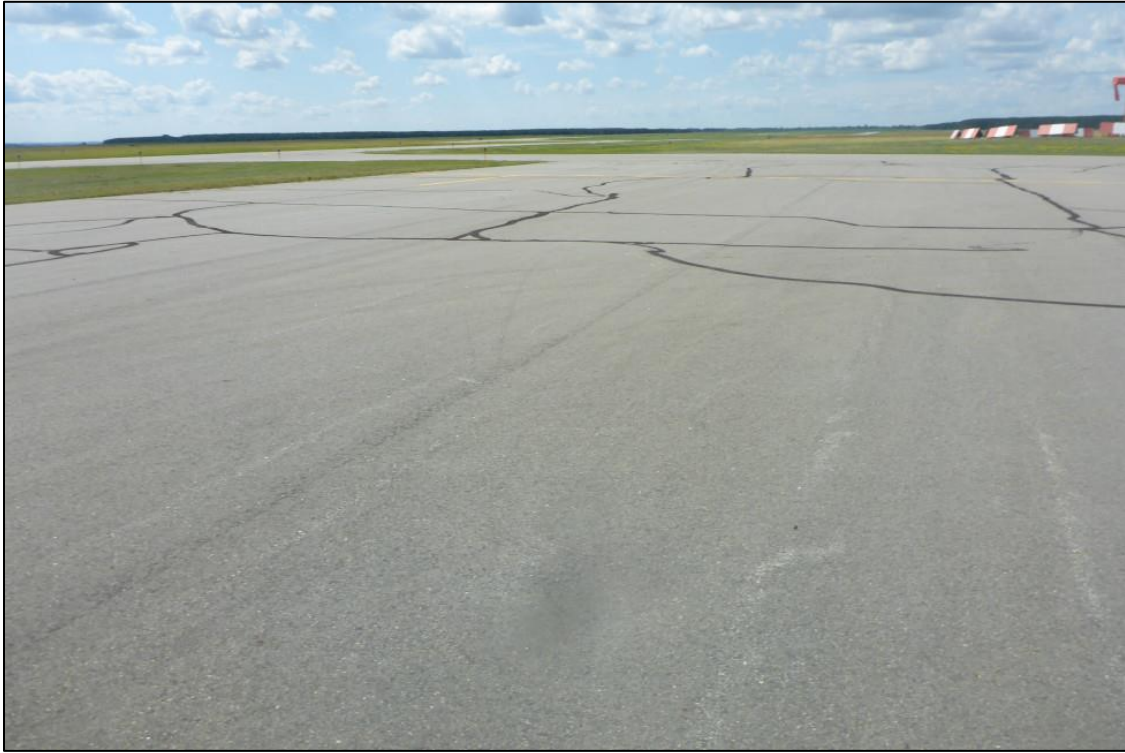
PKD APA 001 (PCI = 79)

Conditions: PCI: 79

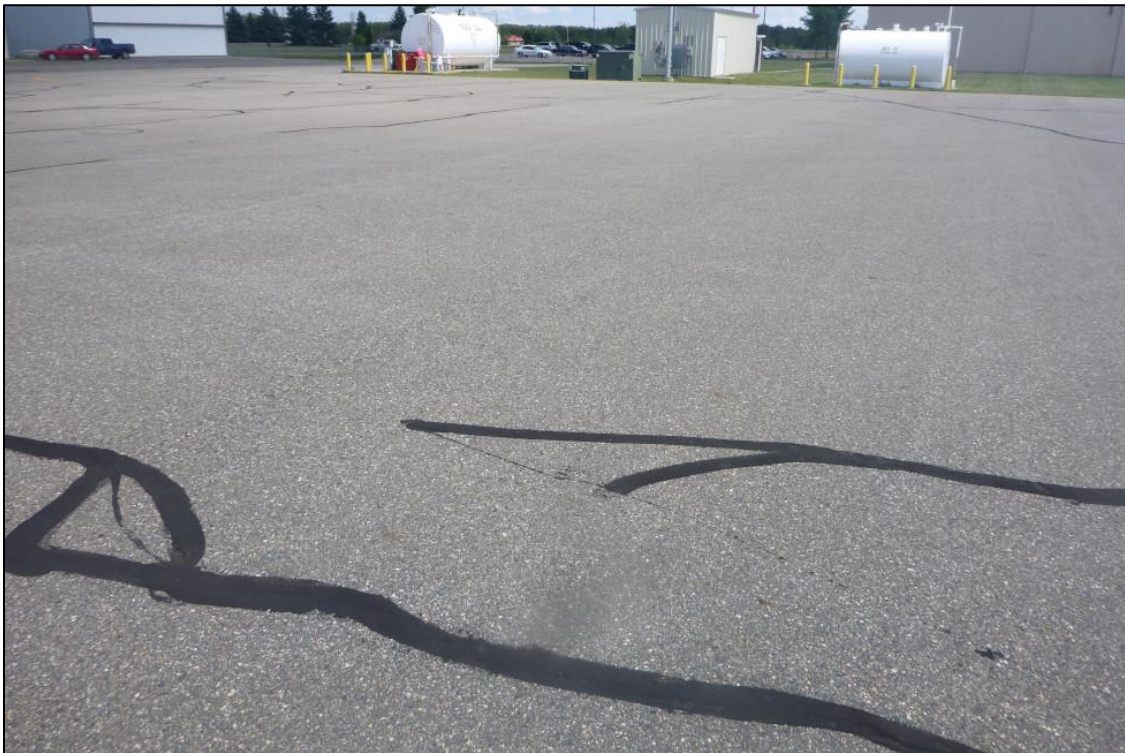
PKD APA 003 (PCI = 74)

Network:	PKD	Name:	PARK RAPIDS						
Branch:	APA	Name:	APRON A	Use:	APRON	Area:	333,375 SqFt		
Section:	003	of 2	From:	100	To:	403	Last Const.:	6/1/2007	
Surface:	AC	Family:	MN2018 Asphalt Aprons	Zone:	N	Category:	3	Rank:	S
Area:	82,645 SqFt	Length:	315 Ft	Width:	223 Ft				
Slabs:	Slab Length:	Ft	Slab Width:	Ft	Joint Length:	Ft			
Shoulder:	Street Type:	Grade:	0	Lanes:	0				
Section Comments:	maint. (R&E) CS								
Last Insp. Date:	7/16/2019	TotalSamples:	15	Surveyed:	3				
Conditions:	PCI: 74								
Inspection Comments:									
Sample Number:	101	Type:	R	Area:	5000.00 SqFt	PCI:	70		
Sample Comments:	p060								
48	L & T CR	L	362.00	Ft					
48	L & T CR	M	10.00	Ft					
57	WEATHERING	L	2000.00	SqFt					
57	WEATHERING	M	20.00	SqFt					
Sample Number:	202	Type:	R	Area:	5000.00 SqFt	PCI:	76		
Sample Comments:	p061								
48	L & T CR	L	265.00	Ft					
48	L & T CR	M	3.00	Ft					
57	WEATHERING	L	2000.00	SqFt

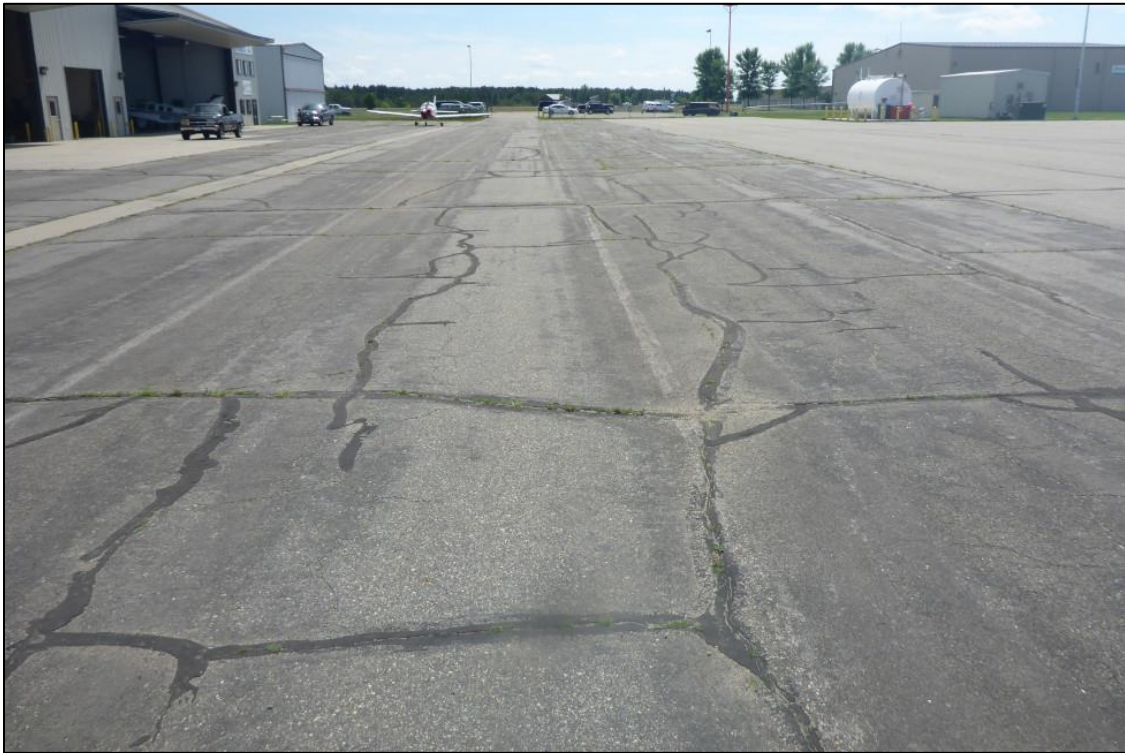
PKD APB 001 (PCI = 57)

Network:	PKD	Name:	PARK RAPIDS						
Branch:	APB	Name:	APRON B	Use:	APRON	Area:	45,666 SqFt		
Section:	001	of 1	From:	100	To:	206	Last Const.:	9/30/1998	
Surface:	AC	Family:	MN2018 Asphalt Aprons	Zone:	N	Category:	3	Rank:	S
Area:	45,666 SqFt	Length:	531 Ft	Width:	86 Ft				
Slabs:	Slab Length:	Ft	Slab Width:	Ft	Joint Length:	Ft			
Shoulder:	Street Type:	Grade:	0	Lanes:	0				
Section Comments:	drainage improvement project since 2010								
Last Insp. Date:	7/16/2019	TotalSamples:	10	Surveyed:	2				
Conditions:	PCI: 57								
Inspection Comments:									
Sample Number:	103	Type:	R	Area:	5000.00 SqFt	PCI:	61		
Sample Comments:	p057								
48	L & T CR	L	317.00	Ft					
48	L & T CR	M	443.00	Ft					
Sample Number:	205	Type:	R	Area:	3600.00 SqFt	PCI:	52		
Sample Comments:									
45	DEPRESSION	L	108.00	SqFt					
48	L & T CR	L	337.00	Ft					
48	L & T CR	M	288.00	Ft					
50	PATCHING	L	400.00	SqFt

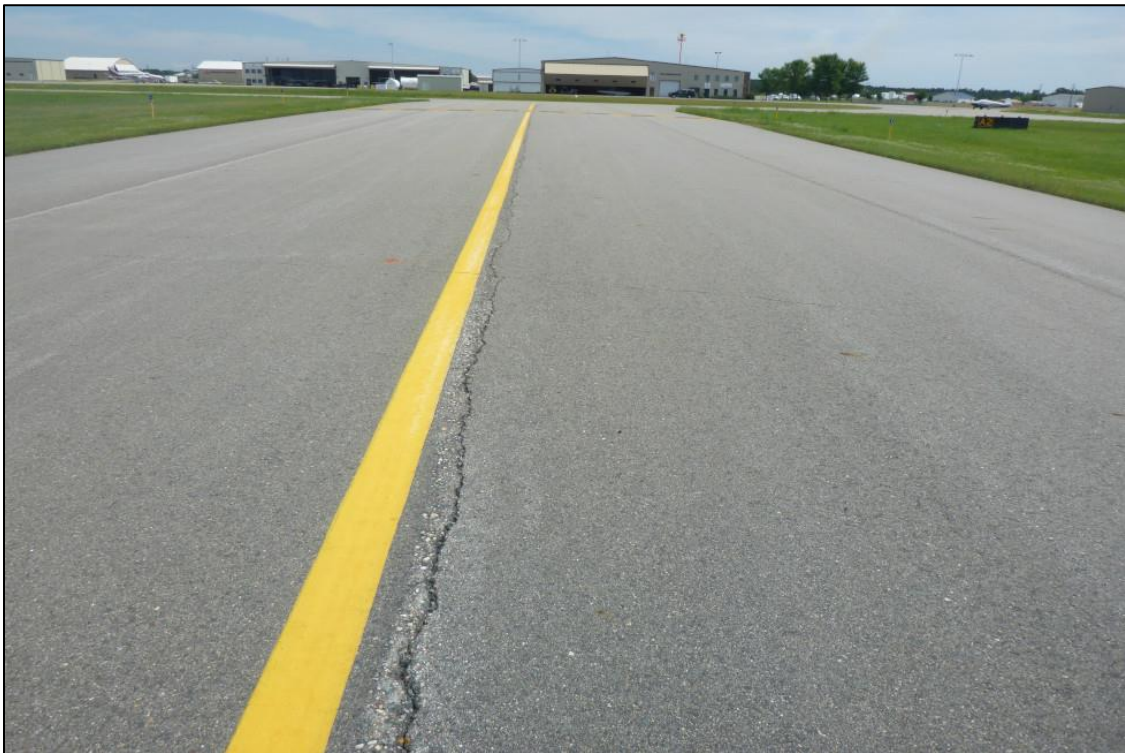
PKD CTA2 001 (PCI = 85)

Network:	PKD	Name:	PARK RAPIDS						
Branch:	CTA2	Name:	CONNECTING TAXIWAY A2	Use:	TAXIWAY	Area:	19,200 SqFt		
Section:	001	of 1	From:	200	To:	202	Last Const.:	8/30/2016	
Surface:	AC	Family:	MN2018 Asphalt Runway- Taxiways	Zone:	N	Category:	3	Rank:	P
Area:	19,200 SqFt	Length:	250 Ft	Width:	50 Ft				
Slabs:		Slab Length:	Ft	Slab Width:	Ft	Joint Length:	Ft		
Shoulder:		Street Type:		Grade:	0	Lanes:	0		
Section Comments:	maint. (R&E) CS								
Last Insp. Date:	7/16/2019	TotalSamples:	3	Surveyed:	1				
Conditions:	PCI: 85								
Inspection Comments:									
Sample Number:	101	Type:	R	Area:	5000.00 SqFt	PCI:	85		
Sample Comments:	pic 494								
48	L & T CR	L	256.00	Ft

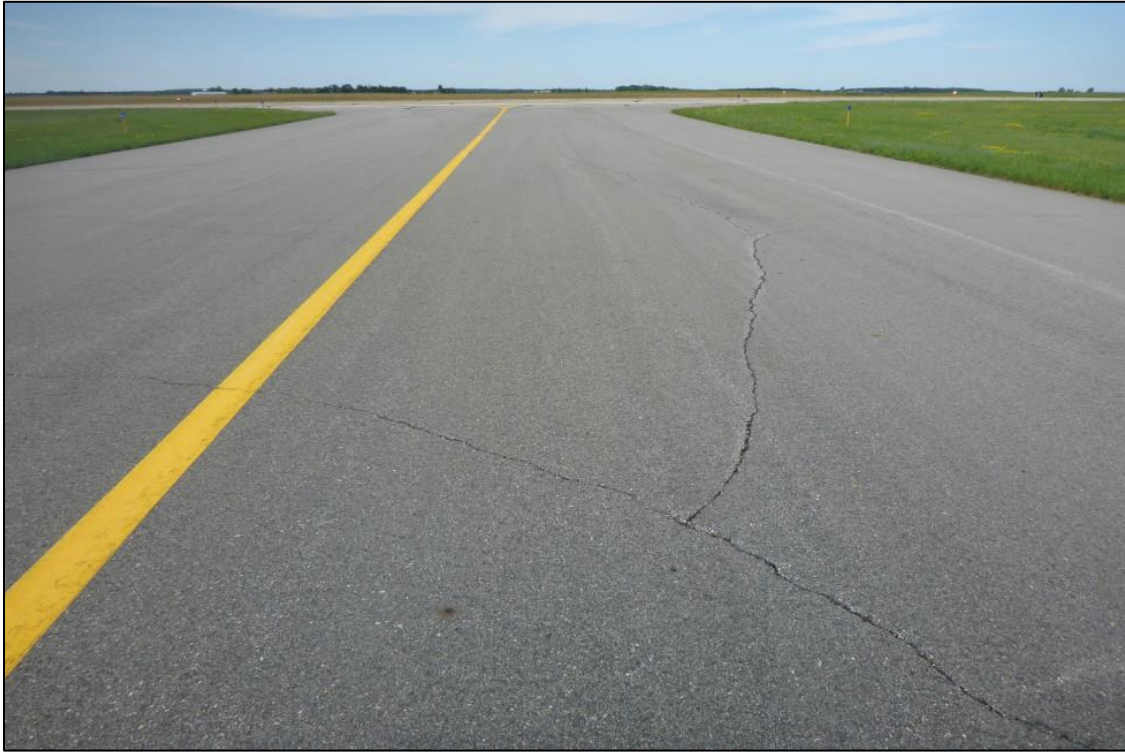
PKD CTA3 001 (PCI = 81)

Network:	PKD	Name:	PARK RAPIDS						
Branch:	CTA3	Name:	CONNECTING TAXIWAY A3	Use:	TAXIWAY	Area:	15,500 SqFt		
Section:	001	of 1	From:	100	To:	102	Last Const.: 8/30/2016		
Surface:	AC	Family:	MN2018 Asphalt Runway- Taxiways	Zone:	N	Category:	3	Rank:	S
Area:	15,500 SqFt	Length:	300 Ft	Width:	50 Ft				
Slabs:		Slab Length:	Ft	Slab Width:	Ft	Joint Length:	Ft		
Shoulder:		Street Type:		Grade:	0	Lanes:	0		
Section Comments:	maint. (R&E) CS								
Last Insp. Date:	7/16/2019	TotalSamples:	3	Surveyed:	1				
Conditions:	PCI: 81								
Inspection Comments:									
Sample Number:	102	Type:	R	Area:	5000.00 SqFt	PCI:	81		
Sample Comments:	pic 493								
48	L & T CR	L	362.00	Ft

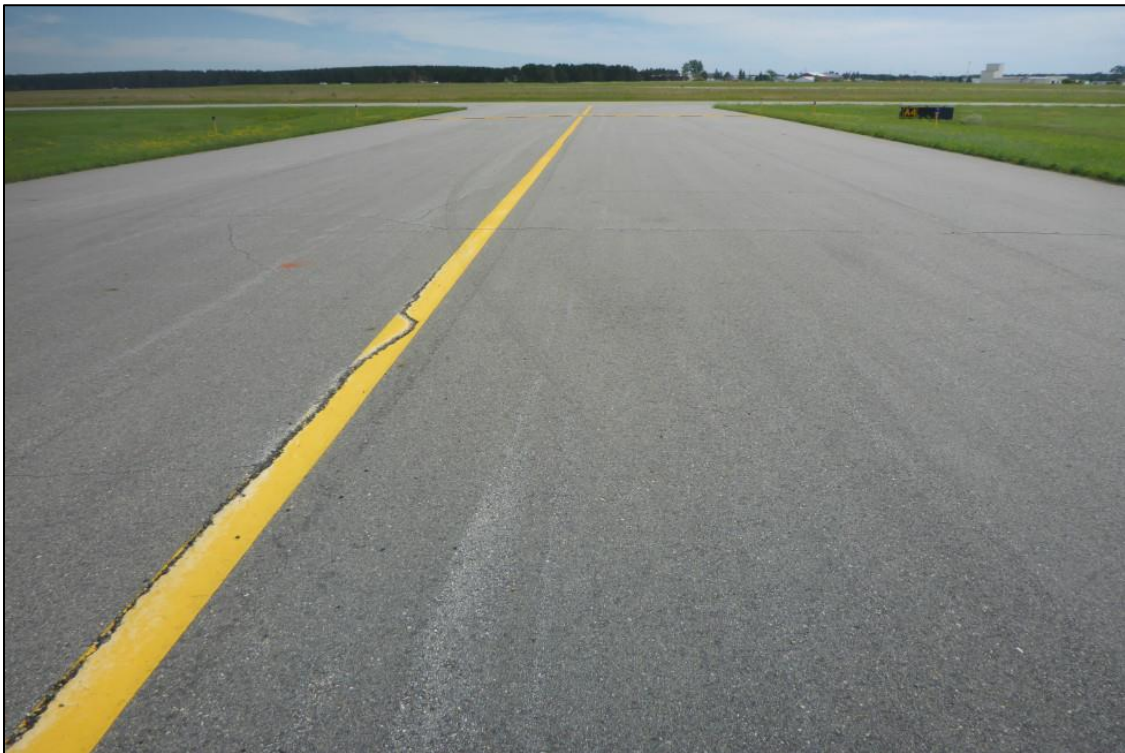
PKD CTA4 001 (PCI = 77)

Network:	PKD	Name:	PARK RAPIDS						
Branch:	CTA4	Name:	CONNECTING TAXIWAY A4	Use:	TAXIWAY	Area:	21,350 SqFt		
Section:	001	of 1	From:	200	To:	202	Last Const.: 8/30/2016		
Surface:	AC	Family:	MN2018 Asphalt Runway- Taxiways	Zone:	N	Category:	3	Rank:	S
Area:	21,350 SqFt	Length:	300 Ft	Width:	50 Ft				
Slabs:		Slab Length:	Ft	Slab Width:	Ft	Joint Length:	Ft		
Shoulder:		Street Type:		Grade:	0	Lanes:	0		
Section Comments:	maint. (R&E) CS								
Last Insp. Date:	7/16/2019	TotalSamples:	3	Surveyed:	1				
Conditions:	PCI: 77								
Inspection Comments:									
Sample Number:	101	Type:	R	Area:	5000.00 SqFt	PCI:	77		
Sample Comments:	pic 492								
48	L & T CR	L	340.00	Ft					
48	L & T CR	M	10.00	Ft

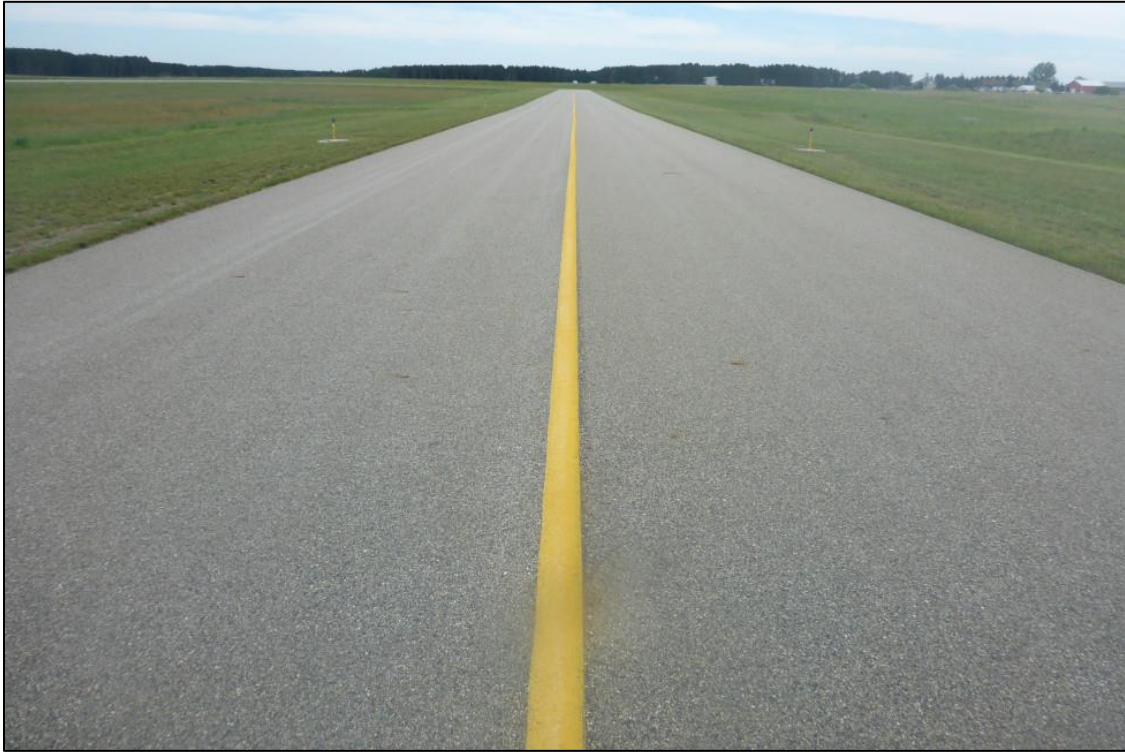
PKD PPTB 001 (PCI = 98)

Network:	PKD	Name:	PARK RAPIDS					
Branch:	PPTB	Name:	PARALLEL TAXIWAY B	Use:	TAXIWAY	Area:	65,780 SqFt	
Section:	001	of 1	From:	A	To:	b	Last Const.:	10/1/2014
Surface:	AC	Family:	MN2018 Asphalt Runway- Taxiways	Zone:		Category:	Rank:	P
Area:	65,780 SqFt	Length:	1,879 Ft	Width:	35 Ft			
Slabs:		Slab Length:	Ft	Slab Width:	Ft	Joint Length:	Ft	
Shoulder:		Street Type:		Grade:	0	Lanes:	0	
Section Comments:								
Last Insp. Date:	7/16/2019	TotalSamples:	19	Surveyed:	4			
Conditions:	PCI: 98							
Inspection Comments:								
Sample Number:	102	Type:	R	Area:	3500.00 SqFt	PCI:	97	
Sample Comments: p046								
57	WEATHERING	L		300.00	SqFt			
57	WEATHERING	M		6.00	SqFt			
Sample Number:	106	Type:	R	Area:	3500.00 SqFt	PCI:	97	
Sample Comments:								
57	WEATHERING	L		300.00	SqFt			
57	WEATHERING	M		15.00	SqFt			
Sample Number:	110	Type:	R	Area:	3500.00 SqFt	PCI:	98	
Sample Comments:								
57	WEATHERING	L		300.00	SqFt

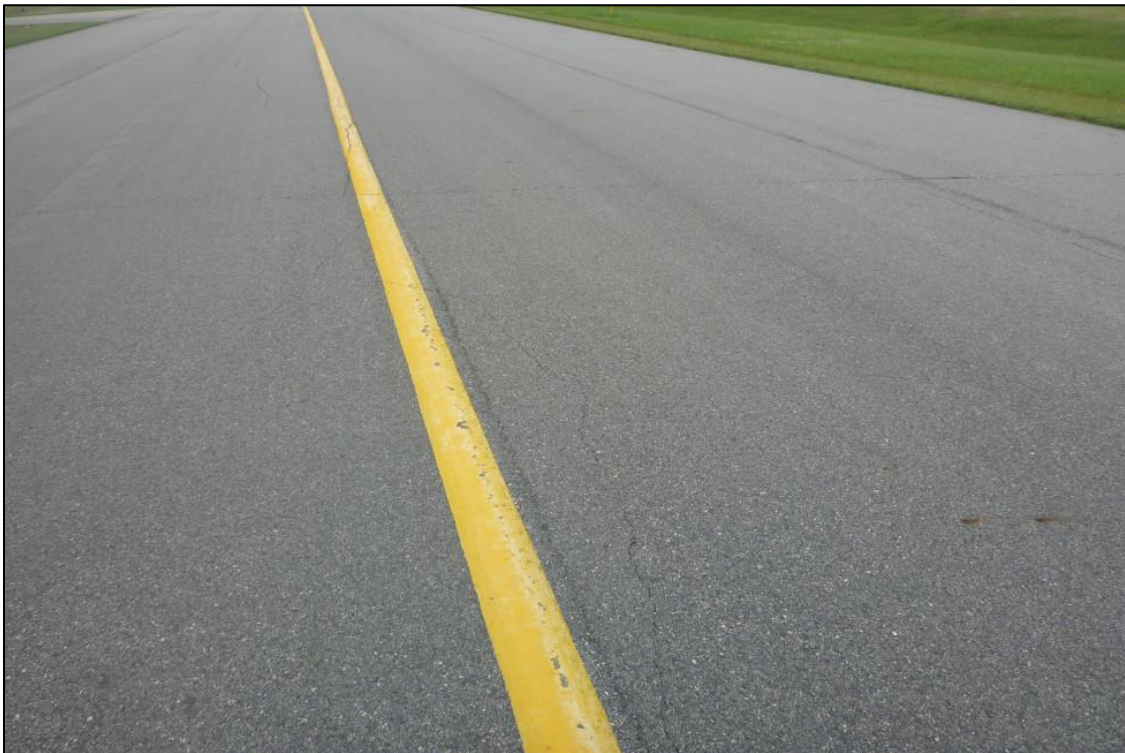
PKD PTA 001 (PCI = 80)

Network:	PKD	Name:	PARK RAPIDS						
Branch:	PTA	Name:	PARTIAL TAXIWAY A	Use:	TAXIWAY	Area:	336,600 SqFt		
Section:	001	of 2	From:	100	To:	164	Last Const.: 8/30/2016		
Surface:	AC	Family:	MN2018 Asphalt Runway- Taxiways	Zone:	N	Category:	3	Rank:	P
Area:	311,170 SqFt	Length:	6,220 Ft	Width:	50 Ft				
Slabs:		Slab Length:	Ft	Slab Width:	Ft	Joint Length:	Ft		
Shoulder:		Street Type:		Grade:	0	Lanes:	0		
Section Comments:	maint. (R&E) CS Sample Units renumbered with 2016 Construction								
Last Insp. Date:	7/16/2019	TotalSamples:	65	Surveyed:	7				
Conditions:	PCI: 80								
Inspection Comments:									
Sample Number:	105	Type:	R	Area:	5850.00 SqFt	PCI:	82		
Sample Comments:	pic491								
48	L & T CR	L	399.00	Ft					
Sample Number:	115	Type:	R	Area:	5000.00 SqFt	PCI:	78		
Sample Comments:									
48	L & T CR	L	471.00	Ft					
Sample Number:	125	Type:	R	Area:	5000.00 SqFt	PCI:	77		
Sample Comments:

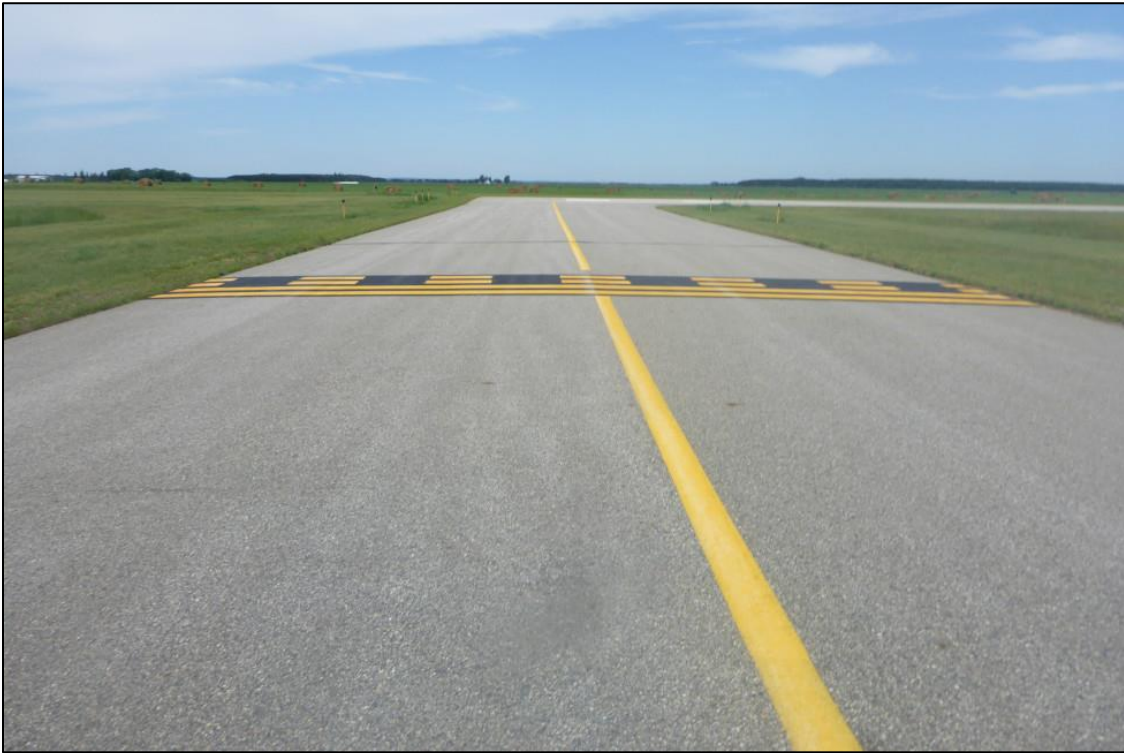
PKD RTA 001 (PCI = 94)

Network:	PKD	Name:	PARK RAPIDS						
Branch:	RTA	Name:	RUNWAY TURNAROUND A	Use:	TAXIWAY	Area:	21,750 SqFt		
Section:	001	of 1	From:	268	To:	568	Last Const.:	8/1/2017	
Surface:	AC	Family:	DEFAULT	Zone:		Category:		Rank:	P
Area:	21,750 SqFt	Length:	375 Ft	Width:	58 Ft				
Slabs:		Slab Length:	Ft	Slab Width:	Ft	Joint Length:	Ft		
Shoulder:		Street Type:		Grade:	0	Lanes:	0		
Section Comments:									
Last Insp. Date:	7/16/2019	TotalSamples:	6	Surveyed:	2				
Conditions:	PCI: 94								
Inspection Comments:									
Sample Number:	368	Type:	R	Area:	3500.00 SqFt	PCI:	94		
Sample Comments:	p052								
57	WEATHERING	L		3500.00	SqFt				
Sample Number:	567	Type:	R	Area:	5625.00 SqFt	PCI:	94		
Sample Comments:	larger sectin than defined on map similar distress as runway, so constructed same time add new section p053,054								
57	WEATHERING	L		5625.00	SqFt

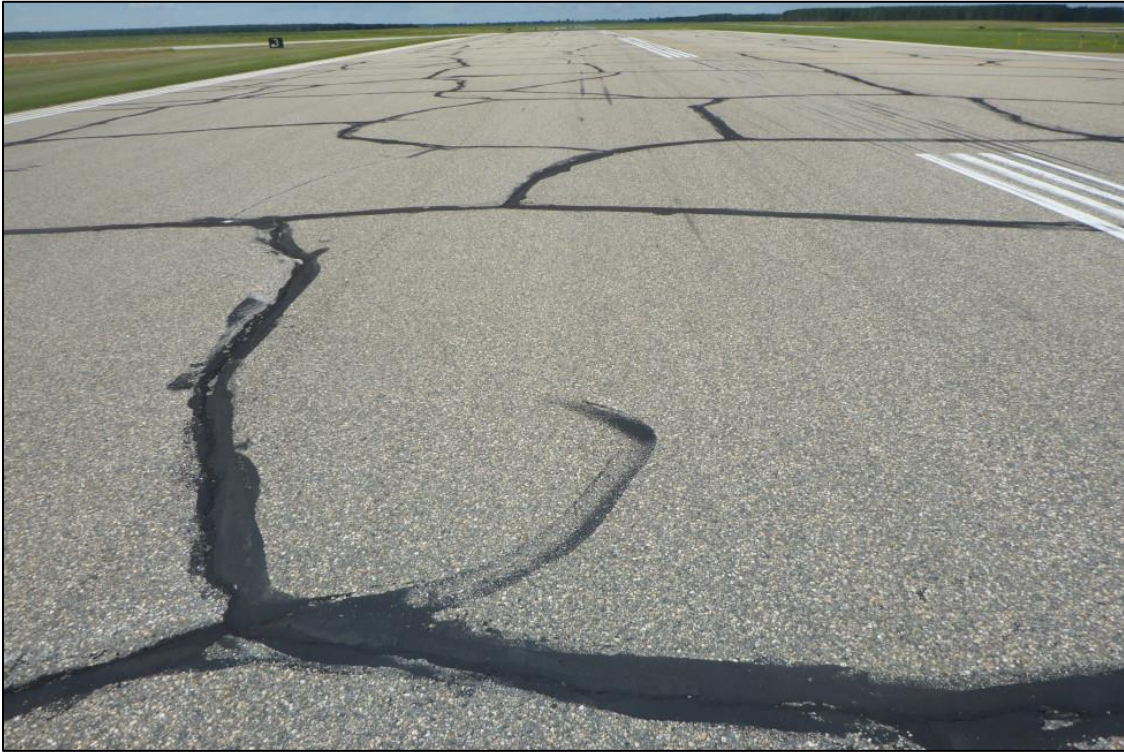
PKD RY1331 001 (PCI = 64)

Network:	PKD	Name:	PARK RAPIDS						
Branch:	RY1331	Name:	RUNWAY 13-31	Use:	RUNWAY	Area:	550,000 SqFt		
Section:	001	of 4	From:	100	To:	142	Last Const.:	9/30/1998	
Surface:	AAC	Family:	MN2018 Asphalt Runway- Taxiways	Zone:	N	Category:	3	Rank:	P
Area:	161,250 SqFt	Length:	2,150 Ft	Width:	75 Ft				
Slabs:		Slab Length:	Ft	Slab Width:	Ft	Joint Length:	Ft		
Shoulder:		Street Type:		Grade:	0	Lanes:	0		
Section Comments:	maint. (R&E) CS								
Last Insp. Date:	7/16/2019	TotalSamples:	43	Surveyed:	5				
Conditions:	PCI: 64								
Inspection Comments:									
Sample Number:	103	Type:	R	Area:	3750.00 SqFt	PCI:	68		
Sample Comments:	pic 503								
48	L & T CR	L	345.00	Ft					
48	L & T CR	M	43.00	Ft					
57	WEATHERING	L	3600.00	SqFt					
Sample Number:	112	Type:	R	Area:	3750.00 SqFt	PCI:	65		
Sample Comments:									
48	L & T CR	L	295.00	Ft					
48	L & T CR	M	18.00	Ft					
57	WEATHERING	L	3300.00	SqFt					
57	WEATHERING	M	300.00	SqFt
