Pavement Condition Report

New Ulm Municipal Airport (ULM)

December 2019

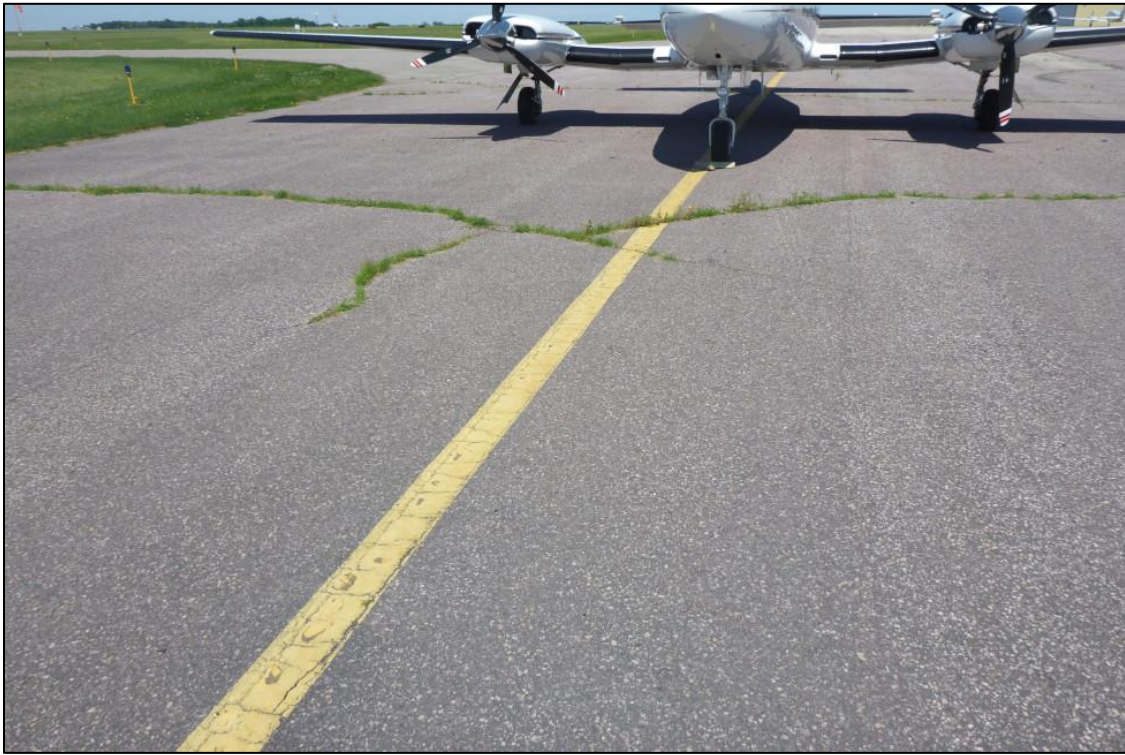
ULM APA 001 (PCI = 58)

Conditions: PCI: 58

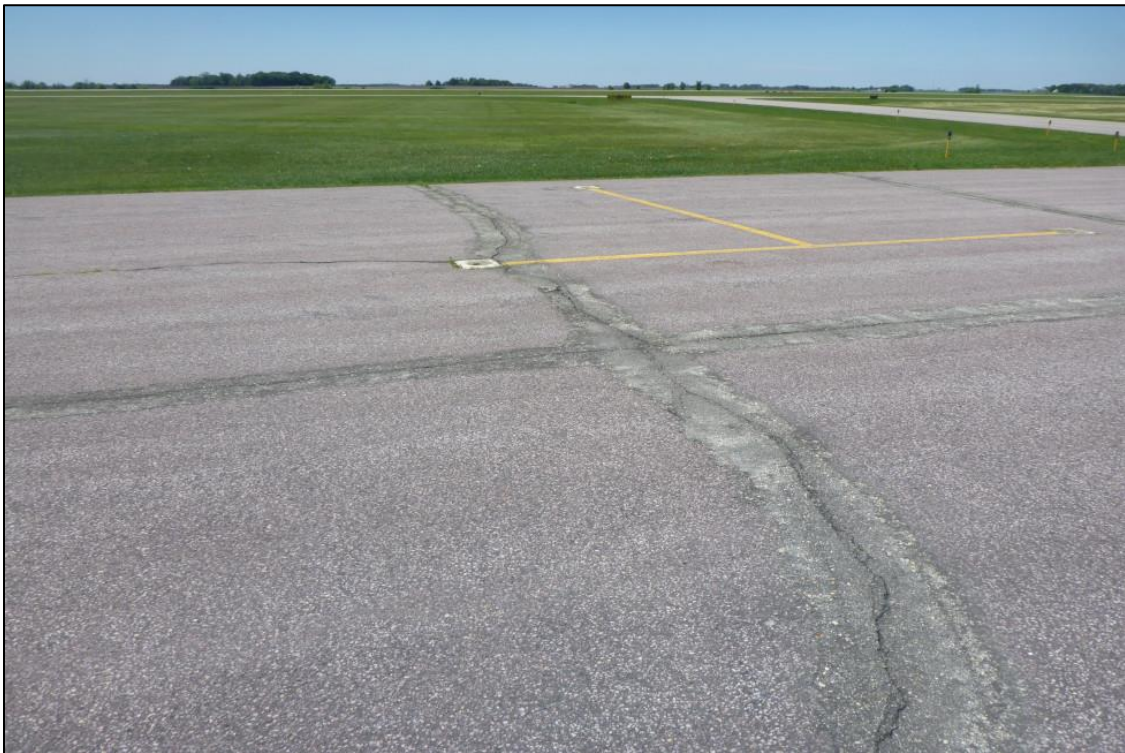
ULM APA 002 (PCI = 60)

Conditions: PCI: 60

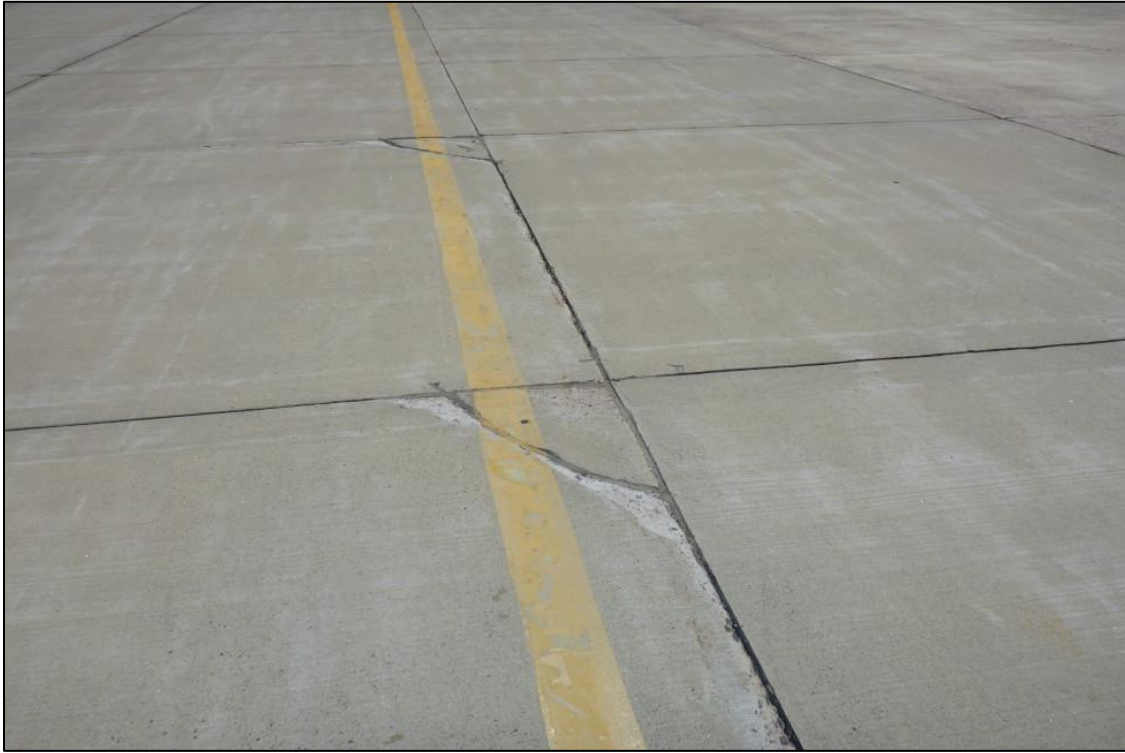
ULM APA 003 (PCI = 73)

Conditions: PCI: 73

Sample Comments: 4 replacement slabs p300

63 LINEAR CR M 1.00 Slabs
65 JT SEAL DMG H 24.00 Slabs
71 FAULTING L 3.00 Slabs
75 CORNER SPALL H 1.00 Slabs

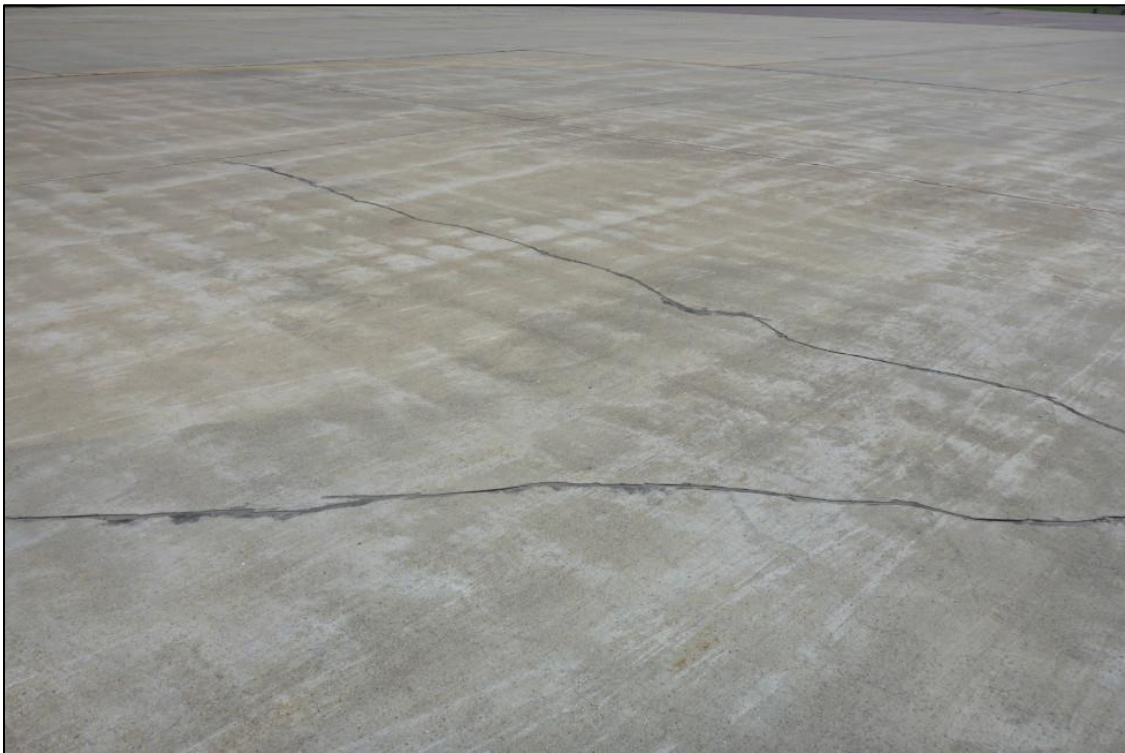
ULM APA 004 (PCI = 20)

Conditions: PCI: 20

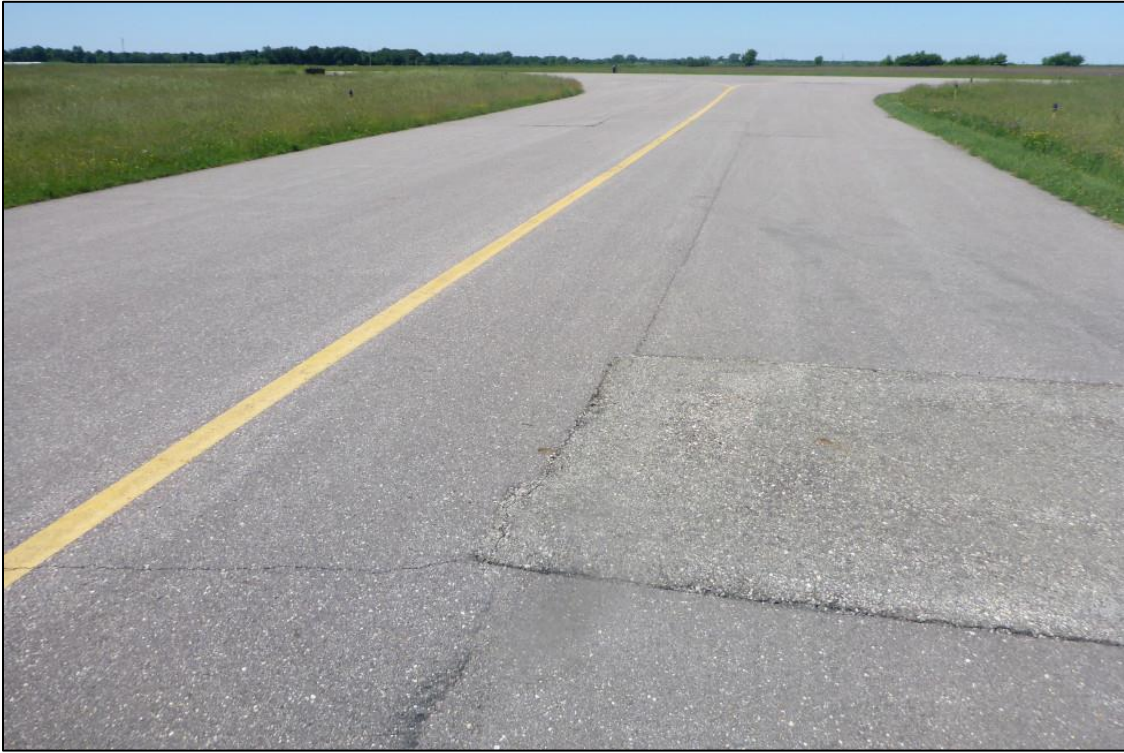
ULM CTA3 001 (PCI = 72)

Conditions: PCI: 72

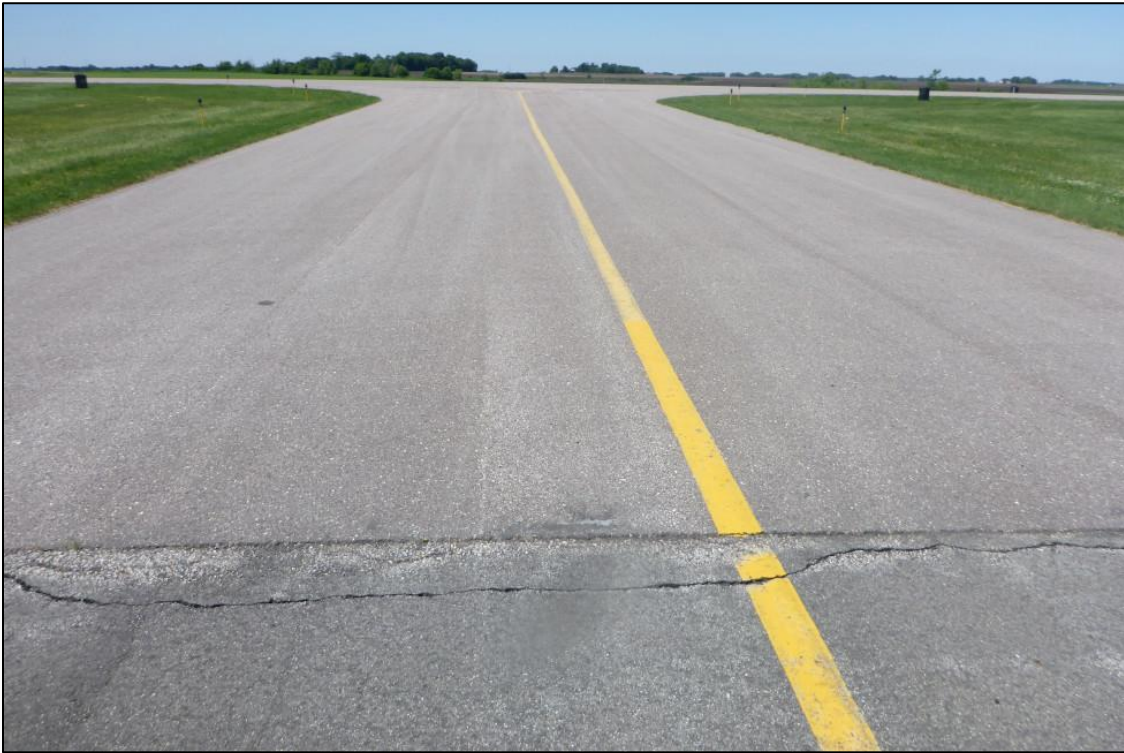
ULM CTB 001 (PCI = 89)

Network:	ULM	Name:	NEW ULM						
Branch:	CTB	Name:	CONNECTING TAXIWAY B	Use:	TAXIWAY	Area:	42,310 SqFt		
Section:	001	of 2	From:	300	To:	303	Last Const.: 7/30/2013		
Surface:	AC	Family:	MN2018 Asphalt Runway- Taxiways	Zone:	S	Category:	3	Rank:	P
Area:	9,080 SqFt	Length:	357 Ft	Width:	40 Ft				
Slabs:		Slab Length:	Ft	Slab Width:	Ft	Joint Length:	Ft		
Shoulder:		Street Type:		Grade:	0	Lanes:	0		
Section Comments:									
Last Insp. Date:	6/11/2019	TotalSamples:	2	Surveyed:	1				
Conditions:	PCI: 89								
Inspection Comments:									
Sample Number:	301	Type:	R	Area:	4000.00 SqFt	PCI:	89		
Sample Comments:	Med Crack at Feature Line p883								
48	L & T CR	M	40.00	Ft

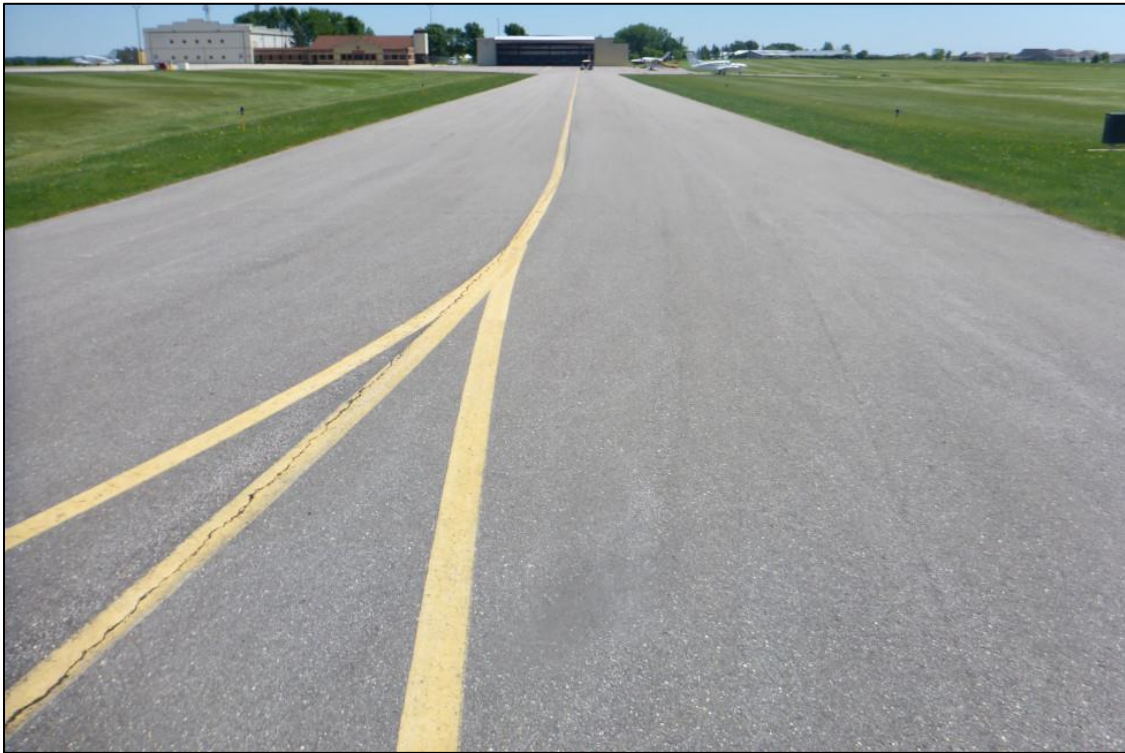
ULM CTB 002 (PCI = 87)

Network:	ULM	Name:	NEW ULM						
Branch:	CTB	Name:	CONNECTING TAXIWAY B	Use:	TAXIWAY	Area:	42,310 SqFt		
Section:	002	of 2	From:	304	To:	309	Last Const.:	10/1/2013	
Surface:	AC	Family:	MN2018 Asphalt Runway- Taxiways	Zone:	S	Category:	3	Rank:	P
Area:	33,230 SqFt	Length:	592 Ft	Width:	40 Ft				
Slabs:		Slab Length:	Ft	Slab Width:	Ft	Joint Length:	Ft		
Shoulder:		Street Type:		Grade:	0	Lanes:	0		
Section Comments:	slated for recon in Fall 2013								
Last Insp. Date:	6/11/2019	TotalSamples:	7	Surveyed:	3				
Conditions:	PCI: 87								
Inspection Comments:									
Sample Number:	304	Type:	R	Area:	4500.00 SqFt	PCI:	88		
Sample Comments:	p884								
48	L & T CR	L	172.00	Ft					
Sample Number:	306	Type:	R	Area:	4000.00 SqFt	PCI:	86		
Sample Comments:	p885								
48	L & T CR	L	183.00	Ft					
Sample Number:	308	Type:	R	Area:	4000.00 SqFt	PCI:	88		
Sample Comments:									
48	L & T CR	L	155.00	Ft

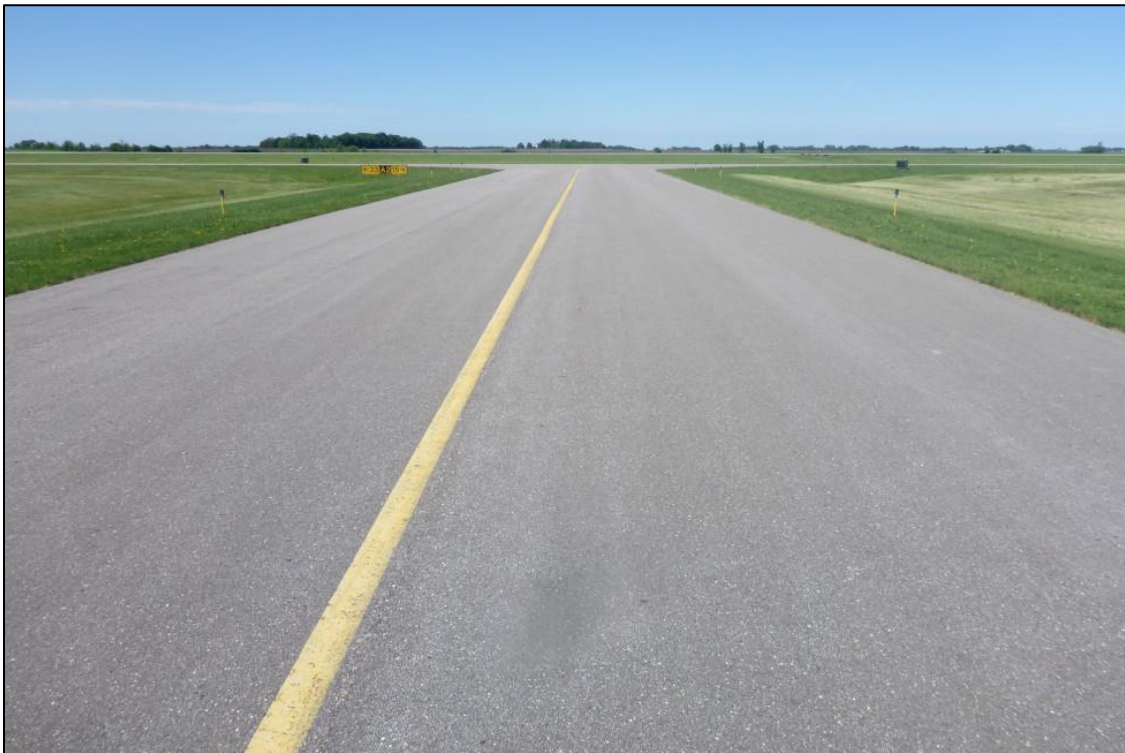
ULM CTC 001 (PCI = 92)

Network:	ULM	Name:	NEW ULM						
Branch:	CTC	Name:	CONNECTING TAXIWAY C	Use:	TAXIWAY	Area:	18,980 SqFt		
Section:	001	of 1	From:	200	To:	203	Last Const.:	10/1/2003	
Surface:	AC	Family:	MN2018 Asphalt Runway- Taxiways	Zone:	S	Category:	3	Rank:	S
Area:	18,980 SqFt	Length:	400 Ft	Width:	40 Ft				
Slabs:		Slab Length:	Ft	Slab Width:	Ft	Joint Length:	Ft		
Shoulder:		Street Type:		Grade:	0	Lanes:	0		
Section Comments:	slated for recon in Fall 2013								
Last Insp. Date:	6/11/2019	TotalSamples:	4	Surveyed:	2				
Conditions:	PCI: 92								
Inspection Comments:									
Sample Number:	201	Type:	R	Area:	4000.00 SqFt	PCI:	91		
Sample Comments:									
48	L & T CR	L	109.00	Ft					
Sample Number:	202	Type:	R	Area:	4000.00 SqFt	PCI:	94		
Sample Comments:	p874								
48	L & T CR	L	60.00	Ft

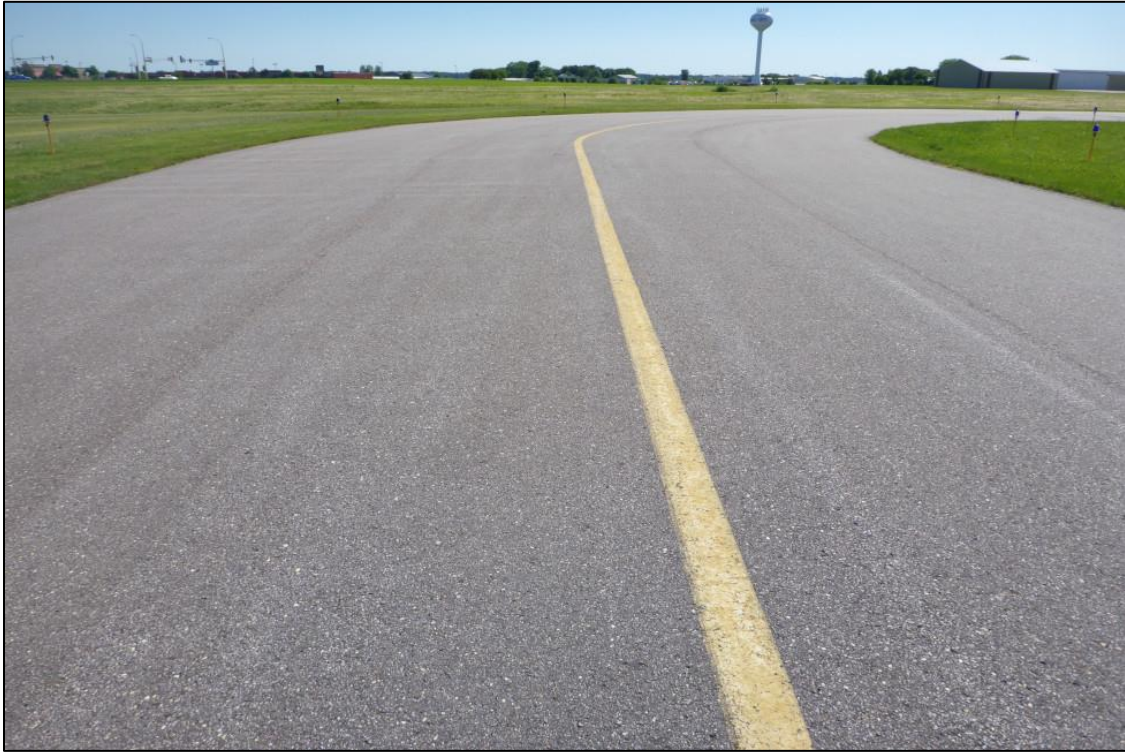
ULM PTA 001 (PCI = 92)

Network:	ULM	Name:	NEW ULM						
Branch:	PTA	Name:	PARALLEL TAXIWAY A	Use:	TAXIWAY	Area:	237,820 SqFt		
Section:	001	of 3	From:	100	To:	103	Last Const.:	7/30/2013	
Surface:	AC	Family:	MN2018 Asphalt Runway- Taxiways	Zone:		Category:		Rank:	P
Area:	16,170 SqFt	Length:	345 Ft	Width:	40 Ft				
Slabs:		Slab Length:	Ft	Slab Width:	Ft	Joint Length:		Ft	
Shoulder:		Street Type:		Grade:	0	Lanes:	0		
Section Comments:									
Last Insp. Date:	6/11/2019	TotalSamples:	4	Surveyed:	2				
Conditions:	PCI: 92								
Inspection Comments:									
Sample Number:	101	Type:	R	Area:	4000.00 SqFt	PCI:	98		
Sample Comments:	p292								
57	WEATHERING	L		600.00	SqFt				
Sample Number:	103	Type:	R	Area:	4000.00 SqFt	PCI:	87		
Sample Comments:									
48	L & T CR	L		15.00	Ft				
48	L & T CR	M		40.00	Ft

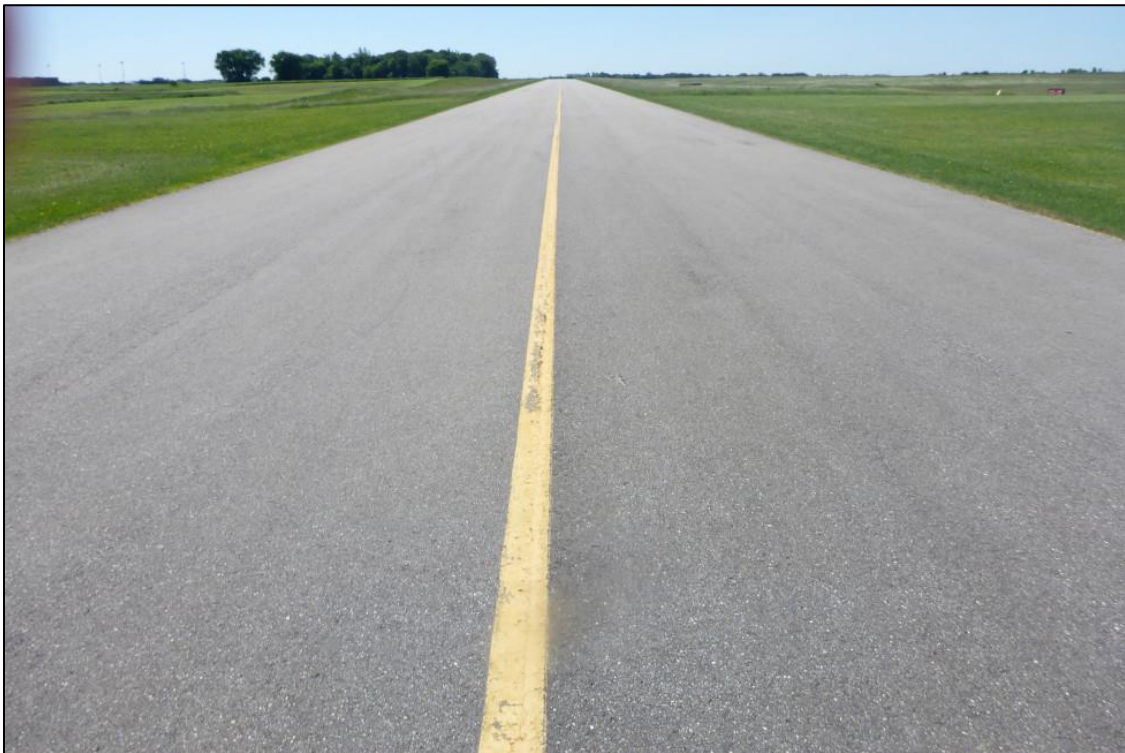
ULM PTA 002 (PCI = 88)

Network:	ULM	Name:	NEW ULM						
Branch:	PTA	Name:	PARALLEL TAXIWAY A	Use:	TAXIWAY	Area:	237,820 SqFt		
Section:	002	of 3	From:	100	To:	148	Last Const.:	10/1/2015	
Surface:	AC	Family:	MN2018 Asphalt Runway- Taxiways	Zone:	S	Category:	3	Rank:	P
Area:	159,600 SqFt	Length:	4,400 Ft	Width:	40 Ft				
Slabs:		Slab Length:	Ft	Slab Width:	Ft	Joint Length:	Ft		
Shoulder:		Street Type:		Grade:	0	Lanes:	0		
Section Comments:	slated for recon in Fall 2013								
Last Insp. Date:	6/11/2019	TotalSamples:	40	Surveyed:	7				
Conditions:	PCI: 88								
Inspection Comments:									
Sample Number:	104	Type:	R	Area:	4000.00 SqFt	PCI:	95		
Sample Comments:									
48	L & T CR	L	20.00	Ft					
57	WEATHERING	L	300.00	SqFt					
Sample Number:	109	Type:	R	Area:	4000.00 SqFt	PCI:	91		
Sample Comments:									
48	L & T CR	L	109.00	Ft					
Sample Number:	119	Type:	R	Area:	4000.00 SqFt	PCI:	89		
Sample Comments:	p875								
48	L & T CR	L	80.00	Ft

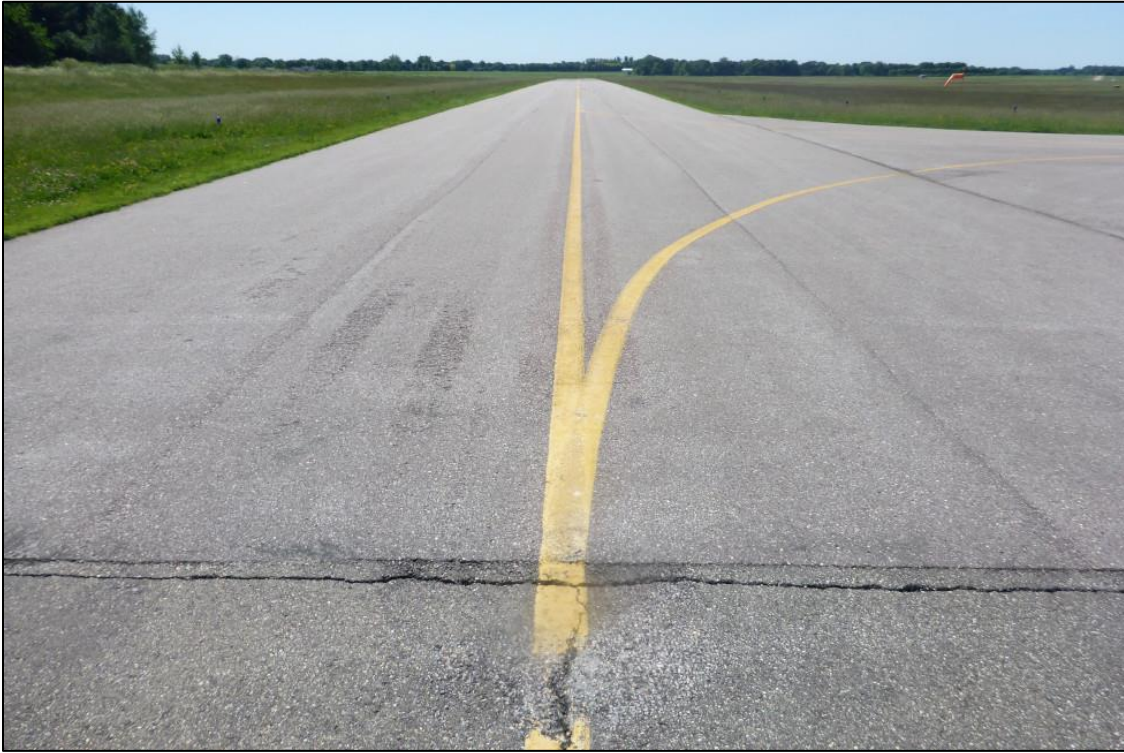
ULM PTA 003 (PCI = 81)

Network:	ULM	Name:	NEW ULM				
Branch:	PTA	Name:	PARALLEL TAXIWAY A	Use:	TAXIWAY	Area:	237,820 SqFt
Section:	003	of 3	From:	-	To:	-	Last Const.: 7/30/2013
Surface:	AC	Family:	MN2018 Asphalt Runway- Taxiways	Zone:		Category:	Rank: P
Area:	62,050 SqFt	Length:	1,530 Ft	Width:	40 Ft		
Slabs:		Slab Length:	Ft	Slab Width:	Ft	Joint Length:	Ft
Shoulder:		Street Type:		Grade:	0	Lanes:	0
Section Comments:							
Last Insp. Date:	6/11/2019	TotalSamples:	16	Surveyed:	4		
Conditions:	PCI: 81						
Inspection Comments:							
Sample Number:	144	Type:	R	Area:	4000.00 SqFt	PCI:	83
Sample Comments:	p877,878						
48	L & T CR	L	145.00	Ft			
48	L & T CR	M	27.00	Ft			
Sample Number:	148	Type:	R	Area:	4000.00 SqFt	PCI:	89
Sample Comments:							
48	L & T CR	L	135.00	Ft			
Sample Number:	154	Type:	R	Area:	4000.00 SqFt	PCI:	77
Sample Comments:	old runway numbers paint removed causing weathering p879						
48	L & T CR	L	177.00	Ft

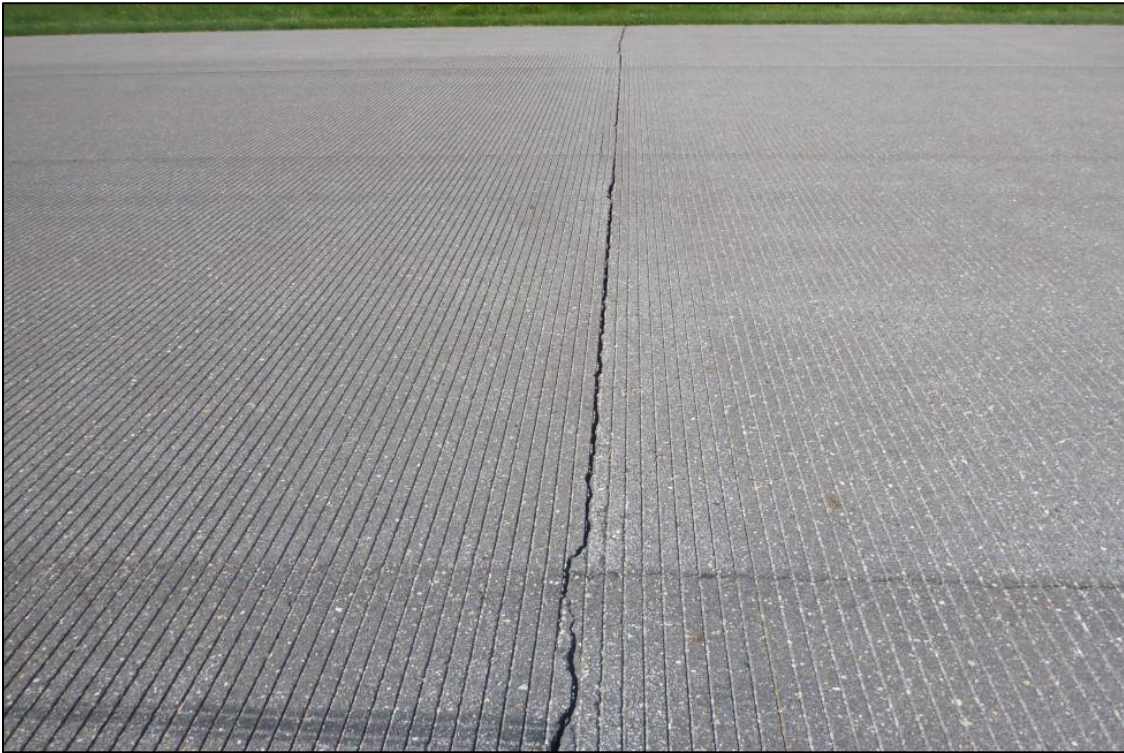
ULM RY1533 001 (PCI = 80)

Network:	ULM		Name:	NEW ULM					
Branch:	RY1533	Name:	RUNWAY 15-33	Use:	RUNWAY	Area:	540,100 SqFt		
Section:	001	of 1	From:	100	To:	208	Last Const.:	7/30/2013	
Surface:	AC	Family:	MN2018 Asphalt Runway- Taxiways	Zone:	S	Category:	3	Rank:	P
Area:	540,100 SqFt	Length:	5,401 Ft	Width:	100 Ft				
Slabs:		Slab Length:	Ft	Slab Width:	Ft	Joint Length:	Ft		
Shoulder:		Street Type:		Grade:	0	Lanes:	0		
Section Comments:									
Last Insp. Date:	6/11/2019		TotalSamples:	108		Surveyed:	11		
Conditions:	PCI:	80							
Inspection Comments:									
Sample Number:	104	Type:	R	Area:	3750.00 SqFt	PCI:	76		
Sample Comments:									
48	L & T CR	L	179.00	Ft					
48	L & T CR	M	48.00	Ft					
57	WEATHERING	M	500.00	SqFt					
Sample Number:	105	Type:	A	Area:	3750.00 SqFt	PCI:	70		
Sample Comments: p296									
48	L & T CR	L	94.00	Ft					
48	L & T CR	M	59.00	Ft					
48	L & T CR	H	41.00	Ft					
57	WEATHERING	L	500.00	SqFt					
Sample Number:	114	Type:	R	Area:	3750.00 SqFt	PCI:	86

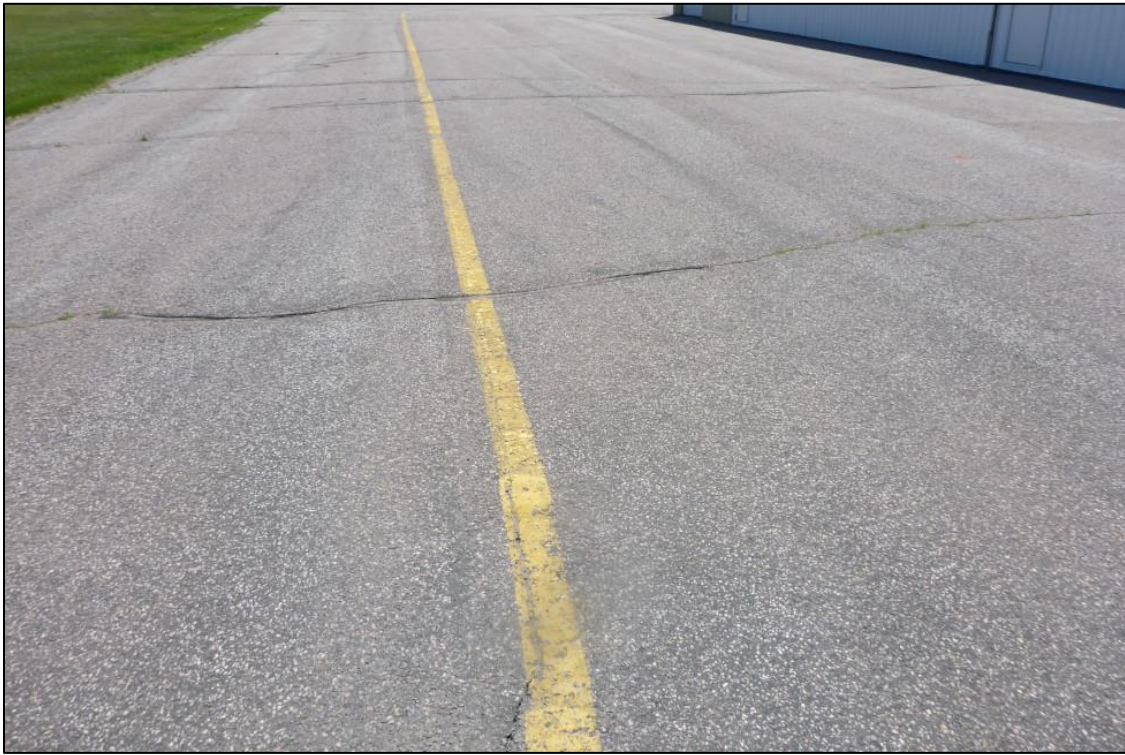
ULM TLA 001 (PCI = 57)

Conditions: PCI: 57

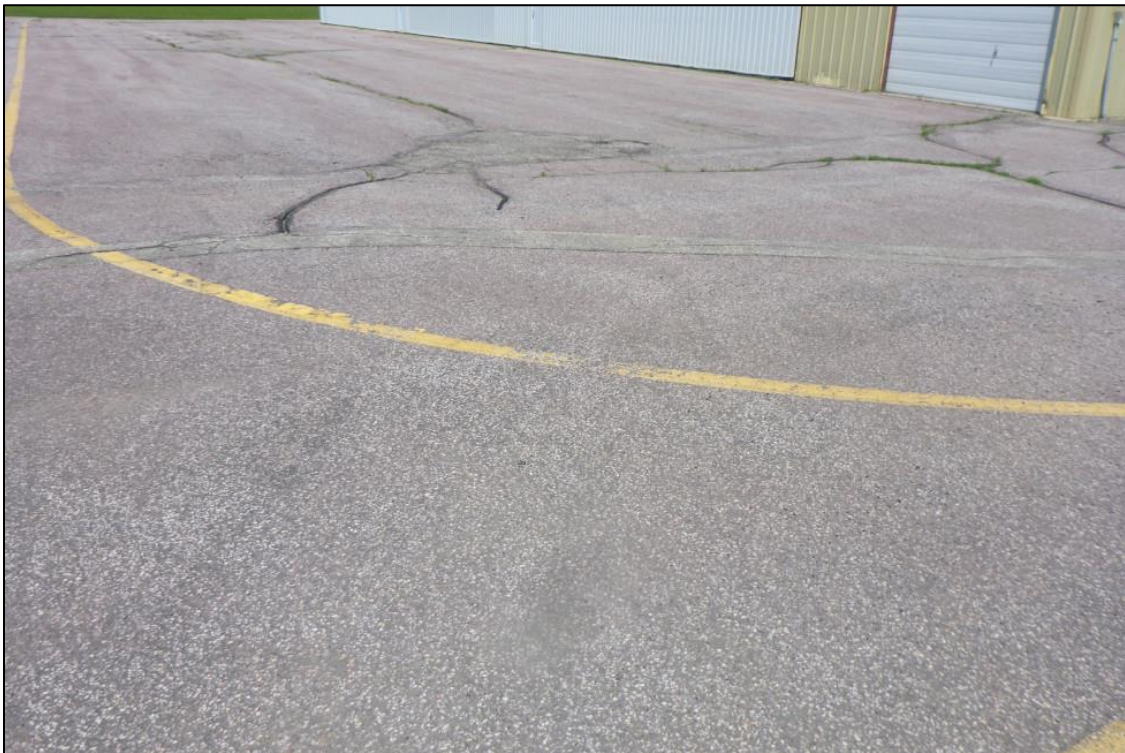
ULM TLB 001 (PCI = 52)

Conditions: PCI: 52
