# Minnesota Department of Transportation (MnDOT) Local Historic Bridge Report

Bridge Number: 90592

**Bridge 90592 – 28<sup>TH</sup> AVE S over MINNEHAHA CREEK**

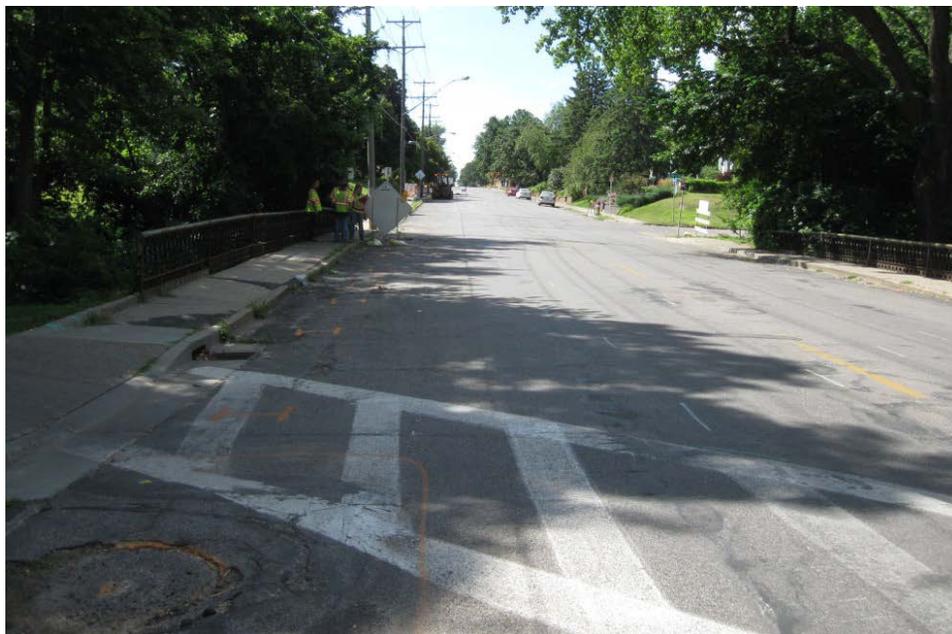
*Condition 1: North approach, looking south*

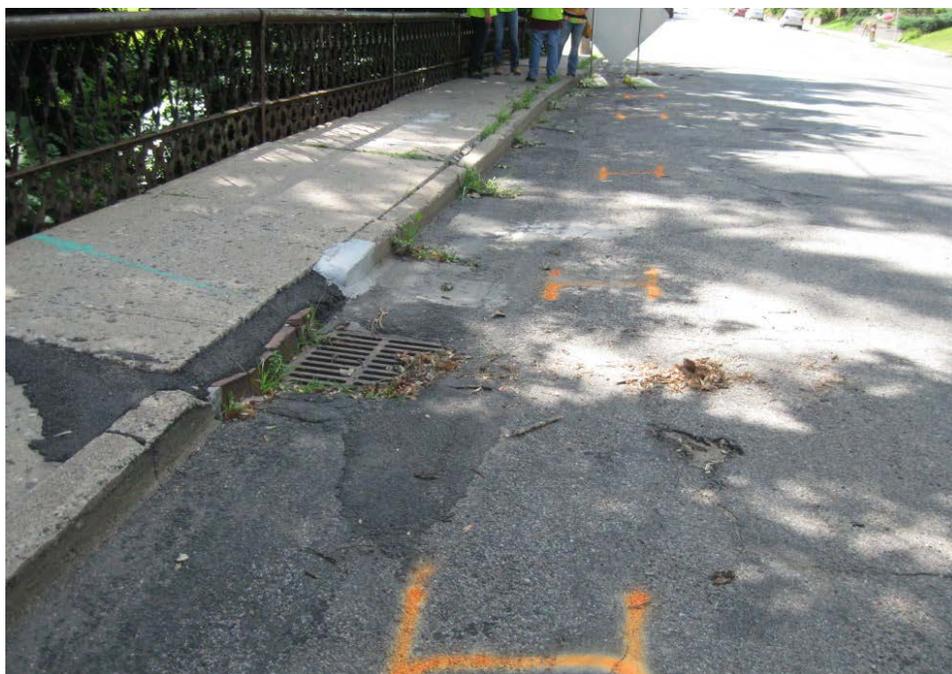
The concrete sidewalks and curb are in overall fair condition with some panels in poor condition (approximately 24 feet on each side). These panels have settled and cracked, leaving tripping hazards on the walking surface. Additionally, some curb sections have settled on both the east and west sides of the bridge. There is a steel support beam held by knee bracing under the outside edge of the sidewalk. The beam and bracing has heavy paint peeling and severe pack rust and section loss (especially at the ends where the beam meets the wingwalls). The joint between the sidewalk and curb has vegetation growing

*Condition 2: Catch basin, curb, sidewalk, and railing, looking southeast*

The sidewalk and curb are in fair to poor condition. Due to the settlement observed and the deterioration of the steel support beam and select sidewalk panels, it is recommended that the sidewalk be replaced in the next 5 years. Due to the deteriorated and settled condition, it does not seem feasible to salvage the sidewalks. However, the sidewalk support beam and structure (or portions) may be suitable for repair and repainting in place, depending on their condition at the time of rehabilitation. This work is recommended to be coordinated with the timing of the roadway replacement and arch waterproofing.

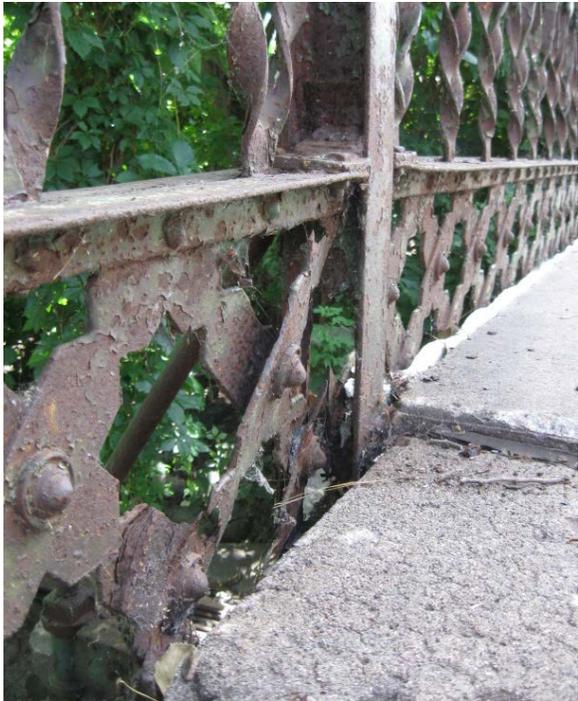
The ornamental metal railings are in poor condition. There is an open gap (laterally), where the rail meets the sidewalk, of approximately 2 inches. The lower 6 inches of the railing lattice is completely separated from the lower angle and the majority of this steel has severe section loss. The lower 6 inches of the rail posts also have severe section loss of their webs. The paint system of the rail is completely deteriorated. A concrete infill curb has been placed at the southwest and northeast corners of the bridge, presumably due to deterioration of railing steel.

*Condition 3: Bridge ornamental railing deterioration (note section loss at sidewalk level)*

Due to the deteriorated condition of the metal railings it is recommended that they be removed, restored and then reinstalled with historic fabric reused to the greatest extent feasible. It is always preferred to retain historic fabric where possible. Prior to a future rehabilitation project, a full study will be required to determine the extent of repair. Since the ornamental rail is a character-defining feature of the bridge, it is recommended that this railing be salvaged and reused. The rail should be removed, repaired, and repainted. It is likely that the lower 6 inches of the lattice and posts will not be salvageable due to their advanced deterioration. The deteriorated portions of the lattice are recommended to be replaced in kind.

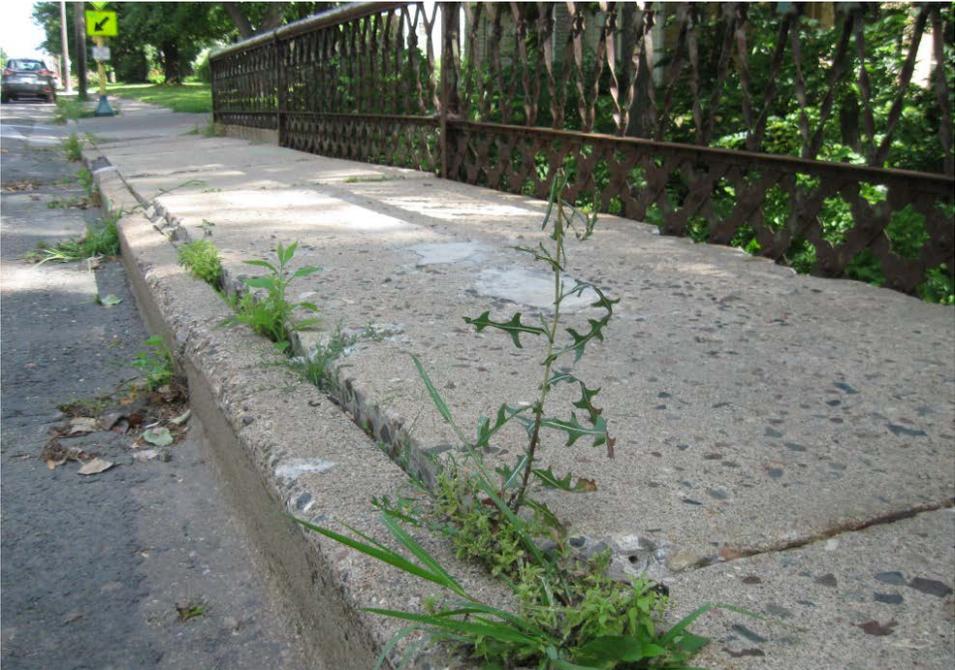
*Condition 4: Ornamental bridge railing and sidewalk, looking northeast (note concrete added at bottom of rail at last panel, in the background, presumably due to deterioration)*

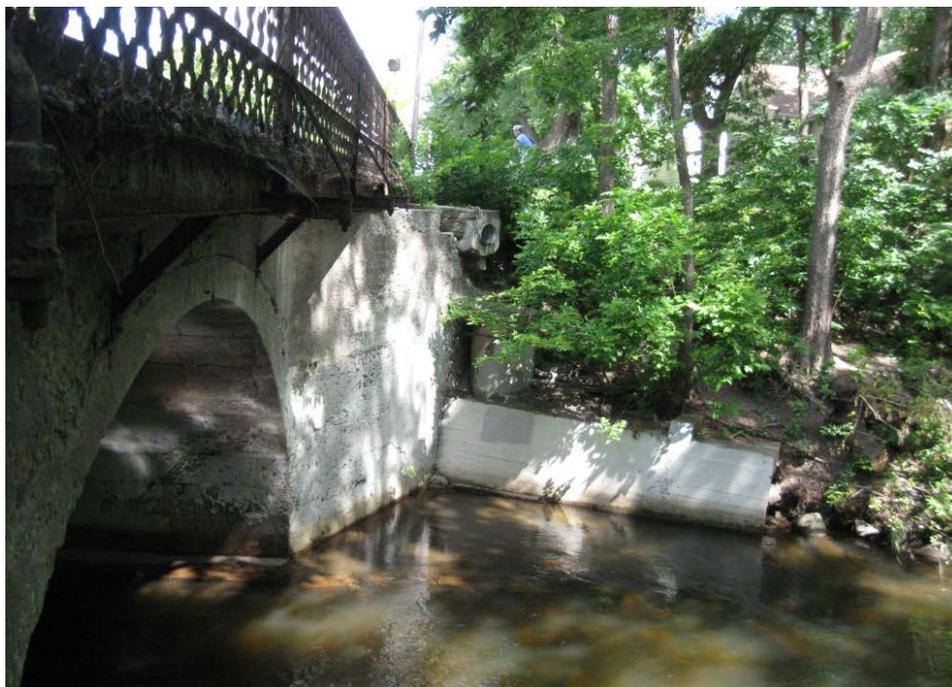
The headwalls are in poor condition. The west headwall is 75 to 100 percent deteriorated in the top 3 feet and the lower portion is pitted, but sound. The east headwall is 75 to 100 percent deteriorated over the entire surface.

*Condition 5: East elevation, looking north*

There are numerous areas of concrete deterioration in the headwalls, wingwalls and closure walls. Prior to any rehabilitation, it is recommended that a detailed study be conducted to determine the original thickness of the walls and the best repair for their level of deterioration at the time of the study. From the field survey conducted, it is recommended that concrete surface repairs be performed on these walls. It is estimated that 680 square feet of repair will be required. The northwest wingwall condition may be found to be too poor to perform a concrete surface repair. If, during a detailed study, it is determined the

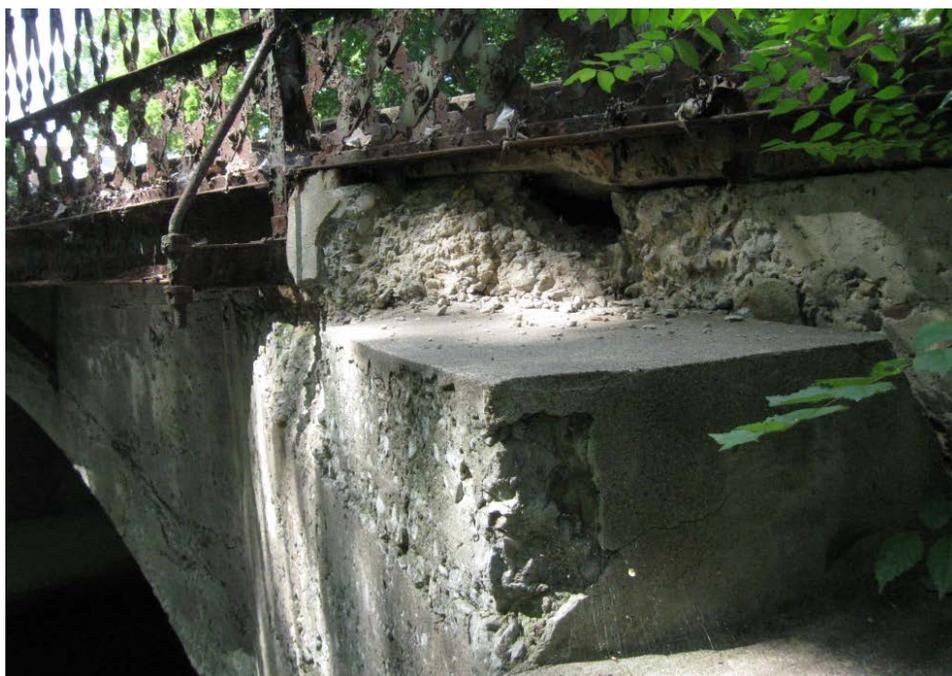
Work on stormwater drains and catch basins in the 1970s, along with deterioration and erosion, has altered the original stepped wingwalls and removed the stepped top configuration.

The wingwalls and closure walls are in overall poor condition. There are large areas of concrete deterioration, spalling and delamination in all four corners of the bridge. The worst deterioration appears to be at the storm sewer outlets, where the wingwall concrete is eroded anywhere from 12 inches to 18 inches deep. According to previous inspection reports, the catch basin drains and slope protection was installed in 1970. In the northeast corner, there is a 4-square-foot area of deteriorated concrete where the closure wall meets the headwall. Beyond this 12-inch-thick cavity in the concrete, there is a void under the sidewalk that measures up to 4 feet deep. The southwest and northwest closure walls appear to be newer and are in good condition. The northwest wingwall, however, is in very poor condition.

*Condition 6: Top of northeast wingwall (note original stepped top and concrete deterioration)*

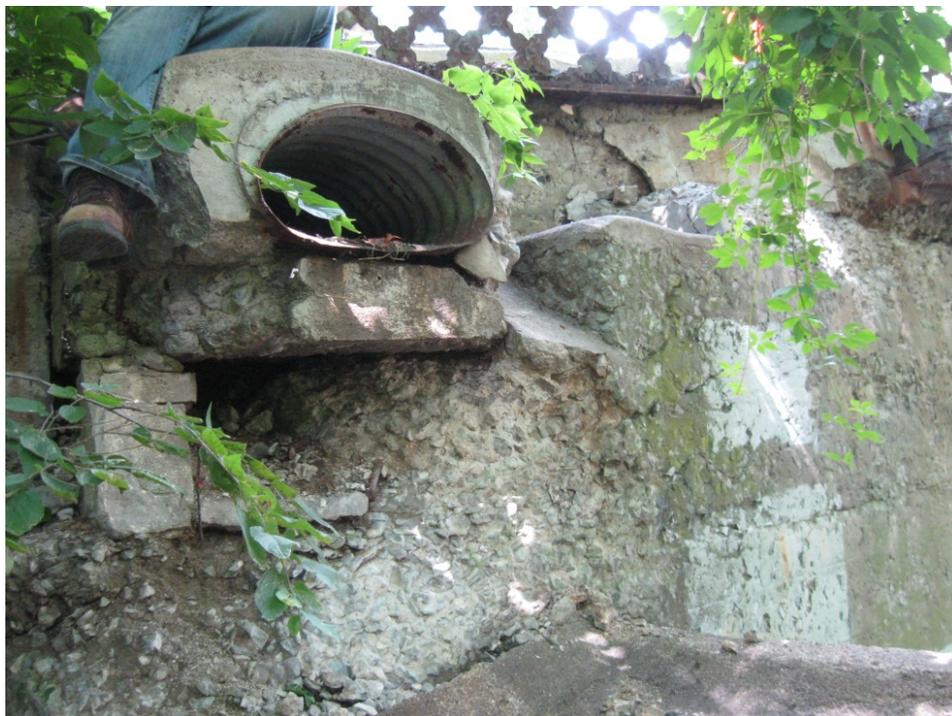
*Condition 7: Southeast catch basin outlet through wingwall*

existing concrete is too deteriorated (full depth) to allow for an effective repair to be made, it may be required to replace this wingwall. For purposes of this estimate, concrete surface repair is assumed, as it is the preferred rehabilitation over replacement. The concrete surface repair will require removal of deteriorated concrete to reach sound concrete, blasting clean and epoxy coating of rusting reinforcing steel, supplementing and doweling with replacement reinforcing where necessary and then replacement with repair concrete of matching color and forming so as to match the existing finished surface. At the time of future rehabilitation, it is recommended to replace all four outlet structures with structures that do not cause damage to the wingwalls.

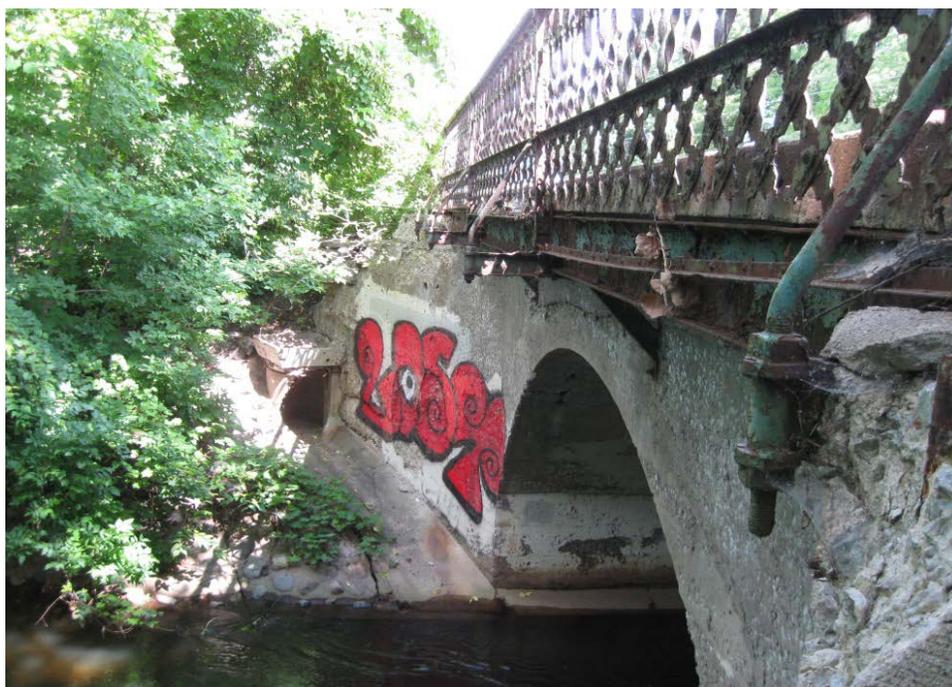
*Condition 8: West elevation, looking north (note catch basin structure)*

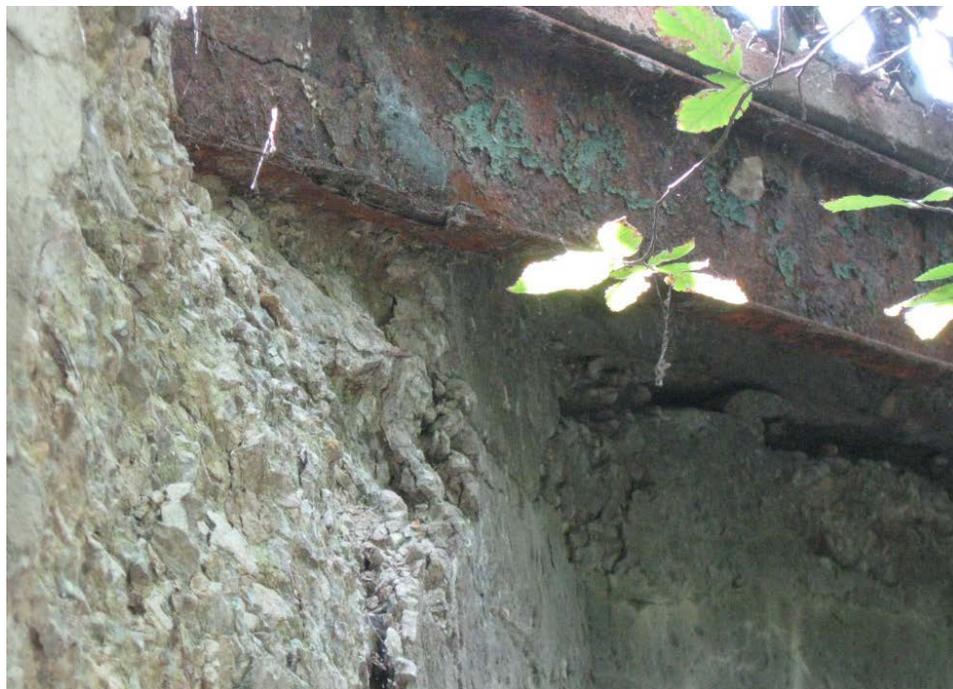
*Condition 9: Sidewalk support beam, northwest (note deterioration of steel and concrete)*

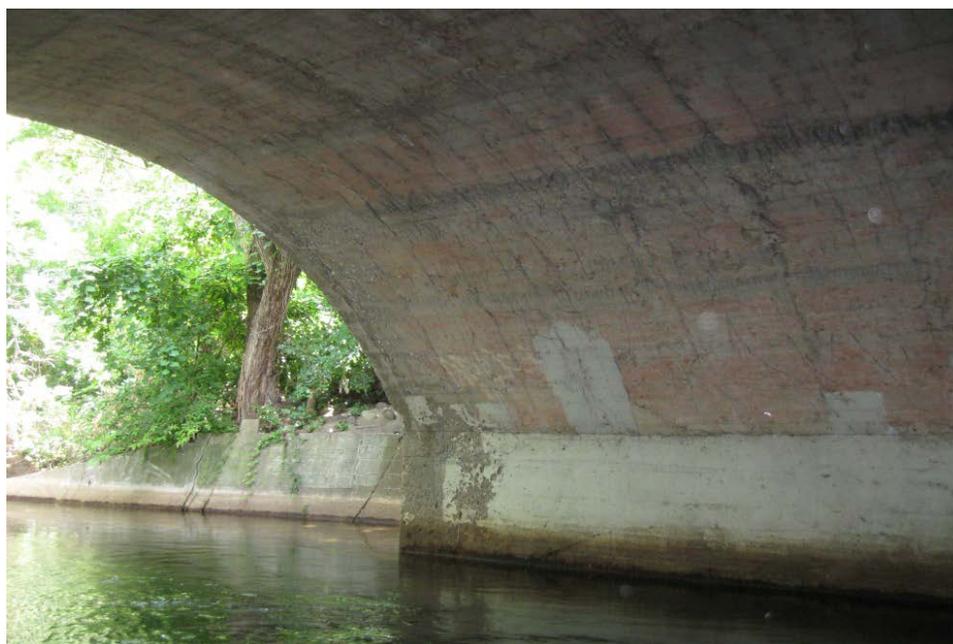
The concrete arch is in fair condition. There is a transverse crack through the southern two-thirds of the width and there were minor areas of unsound concrete found. From afar, it appears that there is extensive cracking on the surface of the concrete. However, this is actually a texture/imprint left behind from the original formwork of the cast-in-place arch.

The abutments are in fair condition. There is some minor scaling of the concrete but no major defects were noted. Past inspection reports note that the abutment footings were repaired in 1987.

*Condition 10: Arch and abutment, looking southeast*

The lower portion of the concrete arch was accessible and sounded, but the remainder of the arch was only visually assessed. From this assessment, it is estimated that approximately 60 square feet of the concrete surface will require a concrete surface repair. This estimate includes the transverse crack which will require an approximate 6-inch-wide repair. When repairs are programmed the entire underside should be sounded and all deteriorated concrete repaired. These repairs will likely require removal of 3 to 4 inches of deteriorated concrete to reach sound concrete, blasting clean and epoxy coating of rusting reinforcing steel, and then replacement with repair concrete of matching color and forming (including the texture from forming) so as to match the existing finished surface.

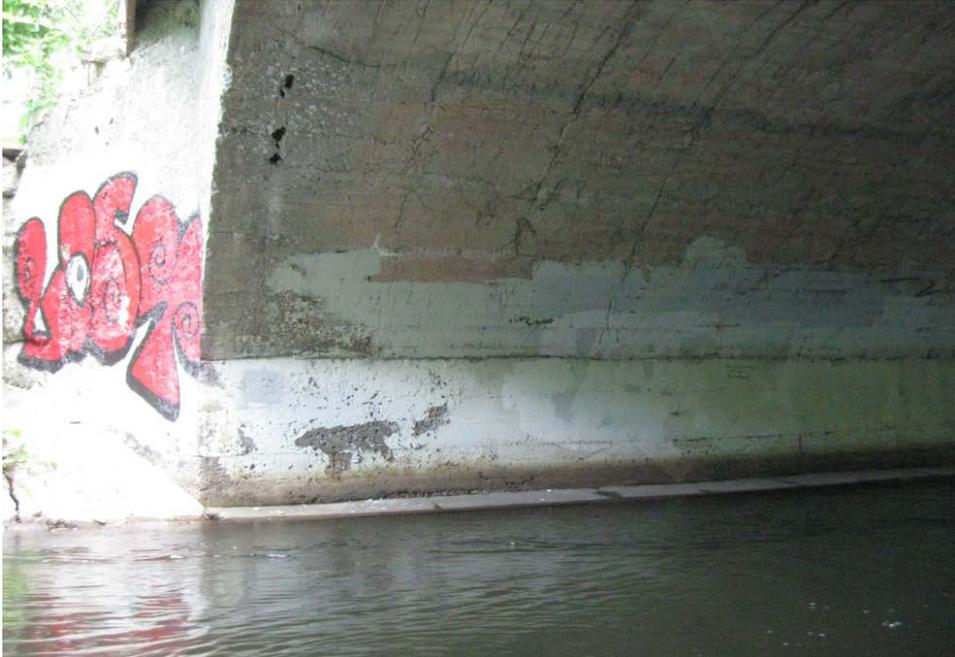
*Condition 11: Arch and abutment, looking northwest*

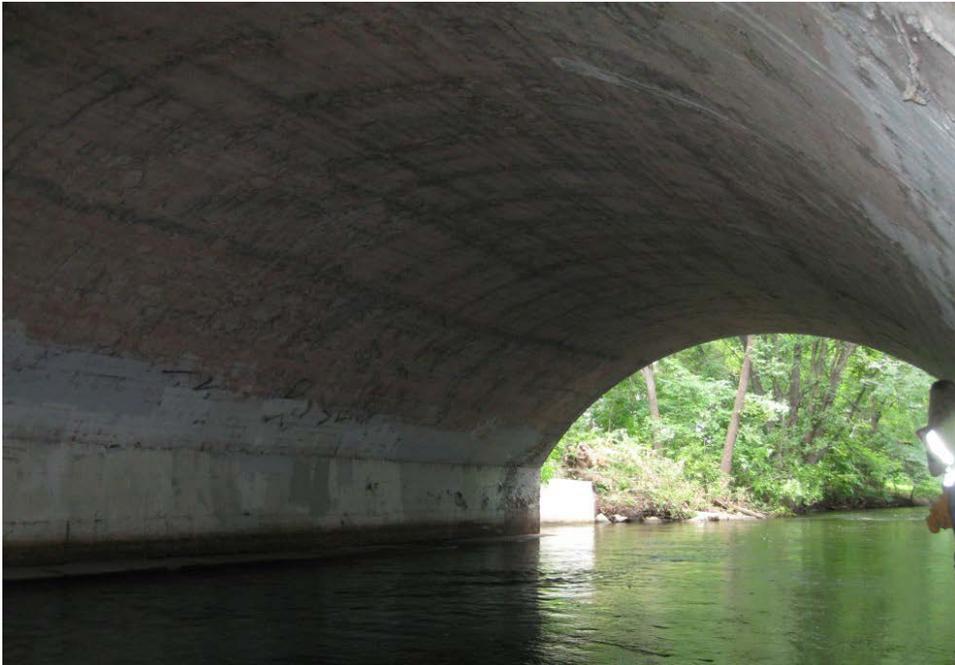
*Condition 12: Arch underside*

The top of the concrete arch is not accessible. There are no records of any rehabilitation or waterproofing performed on this surface in the past. The condition of the arch underside indicates that there is no immediate cause for concern of the condition of the top of the arch. However, during future replacement of the roadway and sidewalk, excavation to the top of the concrete arch and installation of an applied waterproofing system should be strongly considered. This work scope has been included in the preservation cost estimate.
