ORR ROADSIDE PARKING AREA

SHPO INV. # SL-ORC-005

Architect's Survey Date: September 15, 1999

**MNDOT HISTORIC ROADSIDE DEVELOPMENT
STRUCTURES INVENTORY**

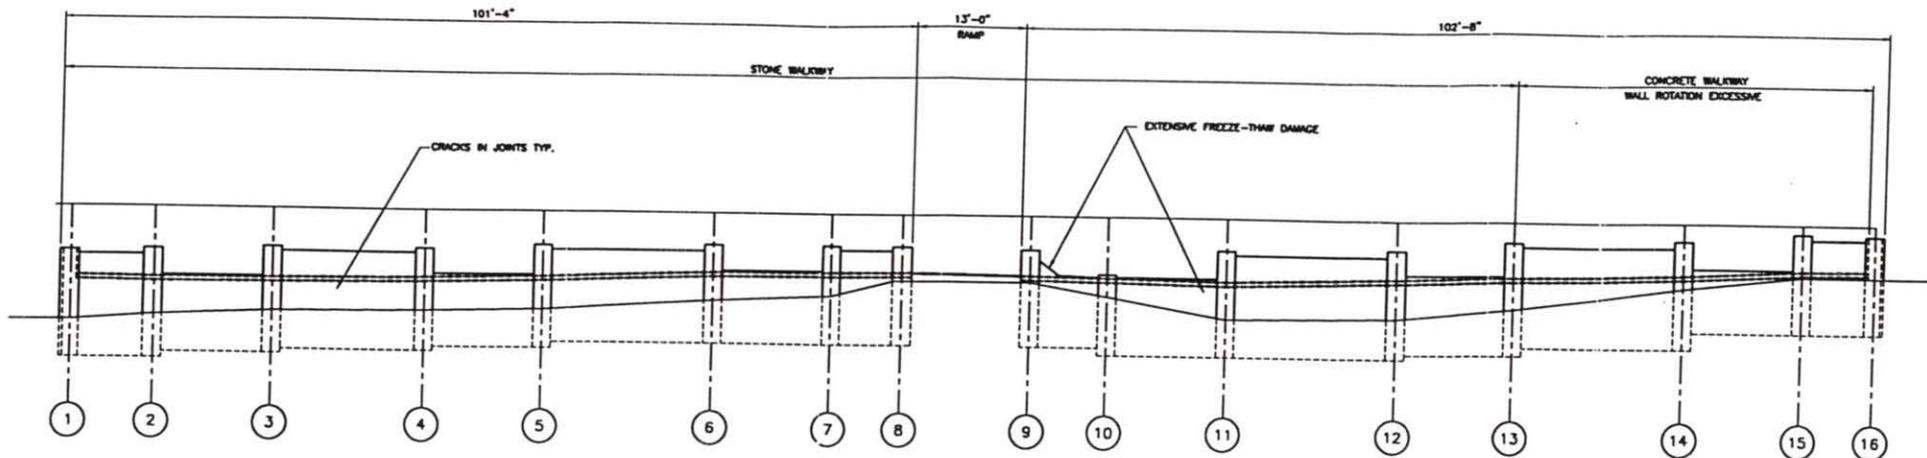
ELEVATION (LOOKING EAST)

PIER NUMBER	HT TO GRADE (INCHES)	HT TO WALK (INCHES)	PLUMP (INCHES)	ROTATION (PERCENT)
PIER 1	99"	36"	2" WEST	2.0%
PIER 2	94"	40"	1.25" WEST	1.3%
PIER 3	91"	44"	1.5" WEST	1.7%
PIER 4	86"	41"	1.25" WEST	1.4%
PIER 5	91"	44"	0.5" WEST	0.8%
PIER 6	79"	36"	1.5" WEST	1.8%
PIER 7	71"	36"	1.5" WEST	2.1%
PIER 8	48"	37"	1" WEST	2.1%
PIER 9	46"	37"	0.5" WEST	1.1%
PIER 10	BROKEN			
PIER 11	97"	44"	2" WEST	2.1%
PIER 12	97"	41"	2" WEST	2.1%
PIER 13	95"	50"	4" WEST	4.2%
PIER 14	88"	48"	4.25" WEST	6.2%
PIER 15	81"	53"	3" WEST	4.8%
PIER 16	98"	50"	3.25" WEST	5.5%

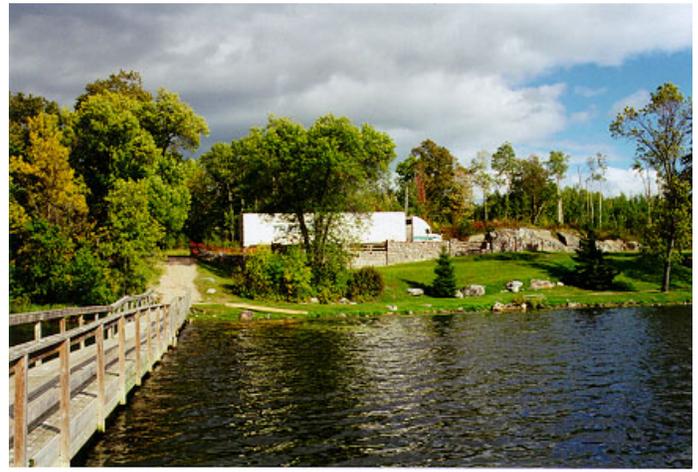
2. View of Overlook Wall and Site from Fishing Dock looking East
(note: north half of wall is obscured by heavy vegetation)

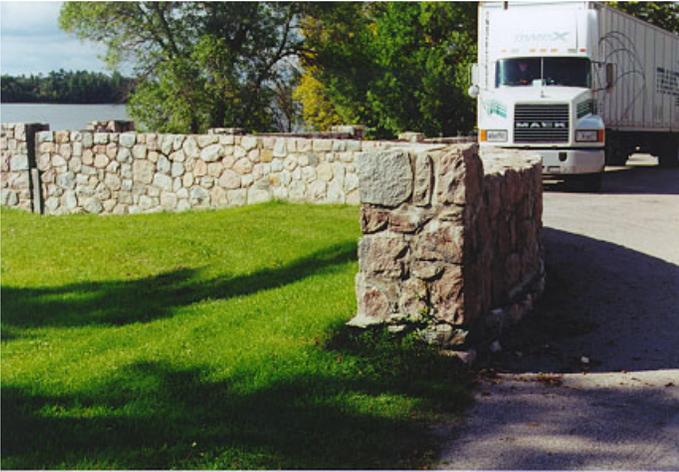
7. South curved Wall Section (note: vertical board at the far left pier is placed to partially cover the space between the corner joint)

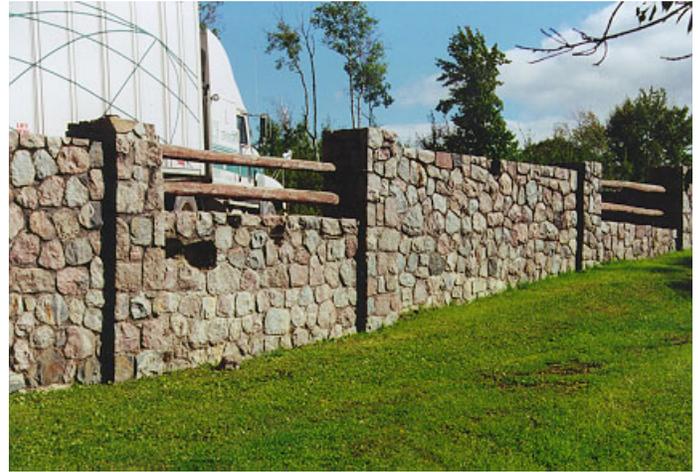
8. View of Southwest Wall showing missing stones

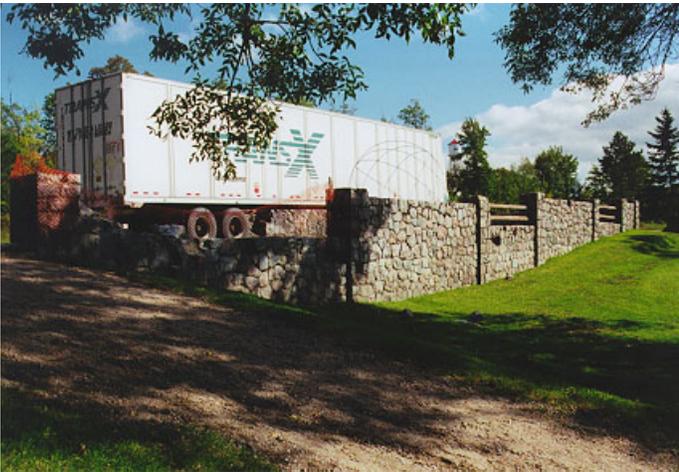
- f. Overlook Wall **Note: overlook wall rehabilitated in 2002**
- Assessment: The wall was not built according to either the preliminary or final design plans. It's in poor condition. A section of stone directly south of the gravel ramp has collapsed. The log railings in the next section are missing. Both sections are surrounded by orange construction fence. The next 70 feet of wall leans toward the water and has pulled away from the curved return wall leaving a gap of about 3". Refer to Barr Engineering's report and drawing. Various other sections of the wall have either single or multiple stones missing. The mortar (grout) is in poor condition. The top of the wall is covered by moss, thick in some locations, thus weakening the mortar. The incised data stone marker is in good condition. Dirt fill has been placed at the southern end of the wall to presumably prevent the wall from overturning any further.

9. View of Gravel Ramp and Collapsed Section of Wall

The original source of stone is from nearby gravel pit.
 - Recommendations:
Stabilization: Structurally pin the leaning sections of wall to prevent further failure. This may be nearly the same amount of work that Preservation will entail. Work period: 1 - 3 years.
Preservation: structurally secure the wall; rebuild missing portion of the stone wall, install new matching wooden logs. Remove sections of failing mortar joints and repoint; install missing stones with those that remain on site; clean off moss and repoint top of wall. All mortar shall match existing in color, compressive strength and texture. Install new stones that match existing in color size and form—these units should be selectively determined if possible to obscure their replacement in the original wall. Reinstall missing log rails and restore as required for strength and safety and provide appropriate stain to match original color. Remove paint or stain coating from other logs and stain to match the original color. Remove extra fill and berm at southern end of wall following the preservation work. Work period: 1 - 3 years.

Restoration: Remove entire southern straight section of wall salvaging all granite veneer. Stabilize the grade and compacted backfill and fill; pour new foundations; improve the drainage on the high side of the wall and provide an outlet for the water to flow; install the salvaged granite veneer onto the new wall insuring that the pattern and mortar joints match the original wall's. Make only necessary repairs to the remaining wall. Provide newly secured log bearing plates and anchors and replace all logs with new ones painting to match. This recommendation will provide the best long-term solution and maintain the historic appearance and size of the original wall and its design. Remove extra fill and berm at southern end of wall following the preservation work. Work period: 3 - 5 years.

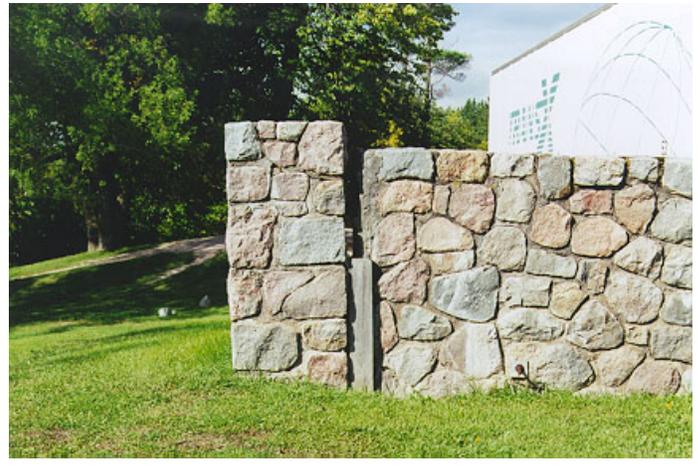
10. Space in SW corner Wall where straight wall is rotating and leaning toward the lake

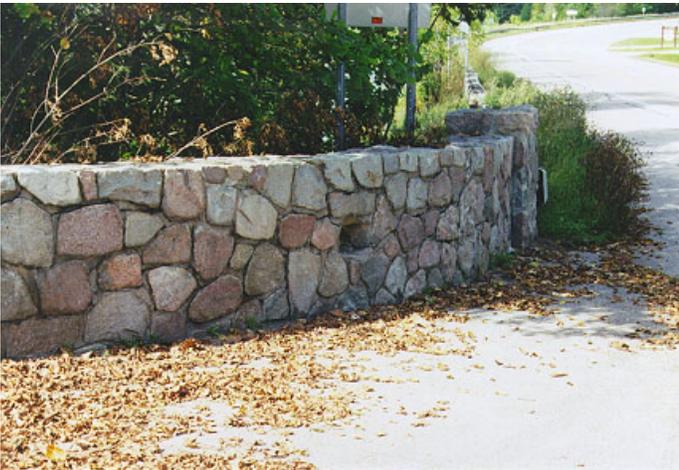
11. North Curved Wall Section (note: missing stone and overgrown vegetation along guard rail beyond)

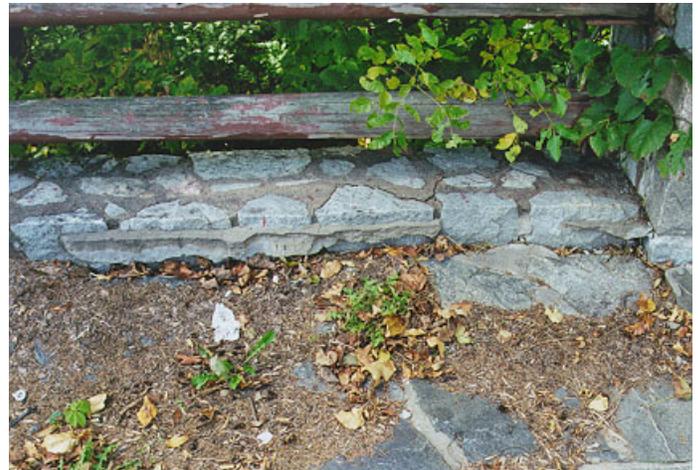
- **Assessment:** The overlook wall was designed with a 5'-wide flagstone walkway (with stone curbing) along its inner face. The southern 40' of flagstone has been removed and replaced with concrete. The remaining flagstone has heaved and/or settled in several locations and its edges are overgrown with weeds.

12. Flagstone Walk (note: settling and excess vegetation)

Preservation: Clear all weeds from the flagstone walkway. Work period: as soon as possible.

Restoration: Remove the concrete and flagstone from the walkway, regrade the sand base, and reinstall flagstone. Replace missing pieces with matching stone and replicate original mortar treatment. Provide a sensitively designed curb cut near one end of the walkway for wheelchair access. Work period: 1 - 3 years.

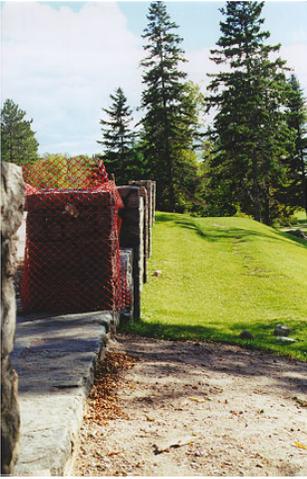
13. Looking South toward the rotating (leaning) Wall section

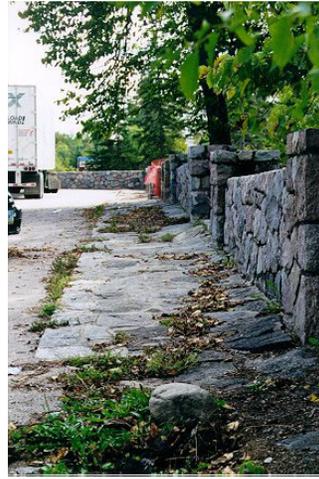
15. Flagstone Walk looking South

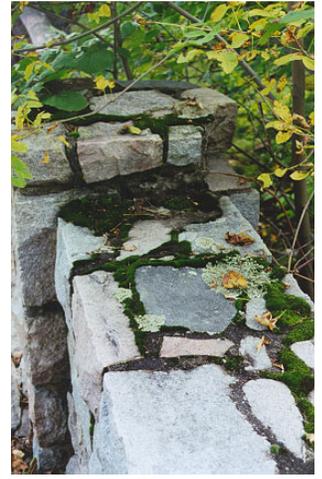
16. Top of Wall (*note: excess moss growth*)
