UNDERWATER BRIDGE INSPECTION REPORT

STRUCTURE NO. 1811

KETTLE RIVER

DISTRICT 1 - PINE COUNTY

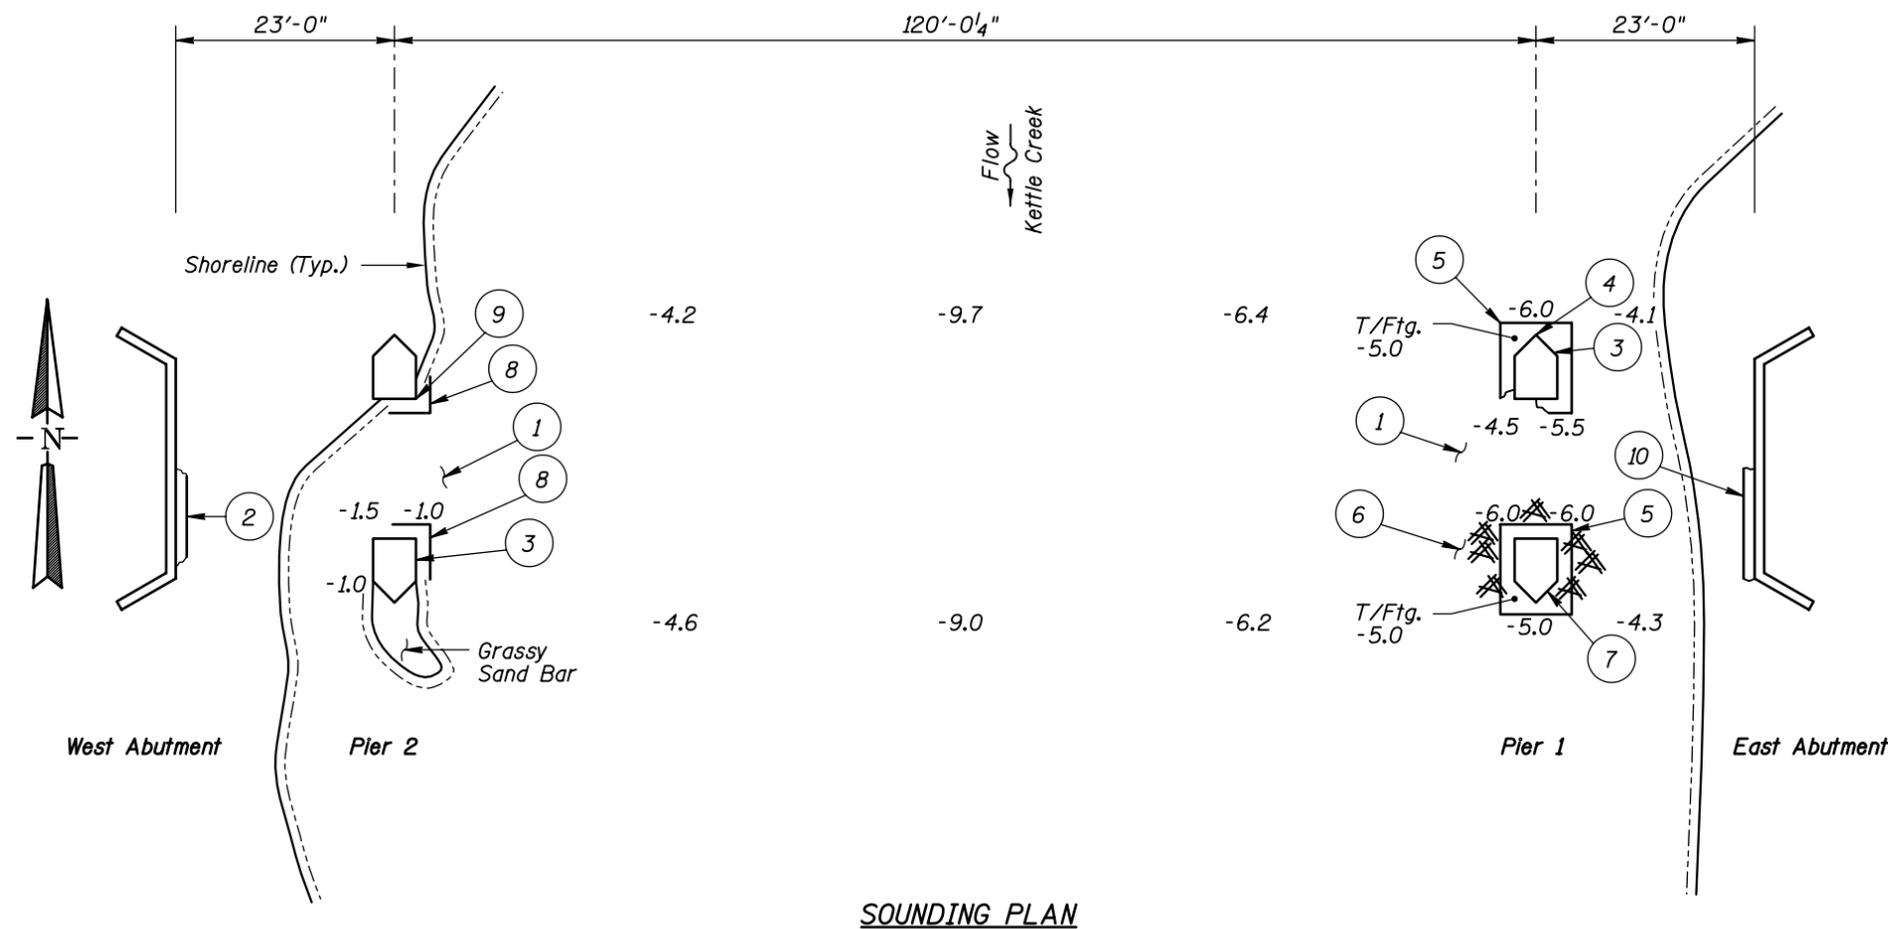
SOUNDING PLAN

- 1 The channel bottom consisted of sand and gravel with random riprap.
- 2 The footing of the West Abutment was exposed along 4 feet of the southern portion of the abutment with 6 inches of vertical face exposed.

- 3 A 1-foot-high band of heavy scaling, with up to 4 inches of penetration and exposed reinforcing steel, was observed 1 foot below the waterline.
- 4 The concrete of upstream nose exhibited several areas of section loss with penetrations up to 1 inch.

- 5 The footing of Pier 1 was exposed and exhibited up to 1 foot of vertical face exposure at the upstream end of each column.
- 6 A moderate accumulation of timber debris consisting of 8-inch-diameter and smaller branches was observed around the downstream column of Pier 1.

- 7 A 1-foot-high band of moderate scaling, with up to 1 inch of penetration with no exposed reinforcing steel, was observed 1 foot below the waterline.

- 8 Top of timber cofferdam was detected protruding from channel bottom.
- 9 The southeast corner of the upstream column exhibited an area of section loss extending 2 feet on each face and from 1 foot above the waterline to the channel bottom with up to 5 inches of penetration and exposed reinforcing steel.

- 10 The footing of the East Abutment was exposed along the southern portion of the abutment wall, and exhibited an area of undermining with approximately 4 inches of penetration.

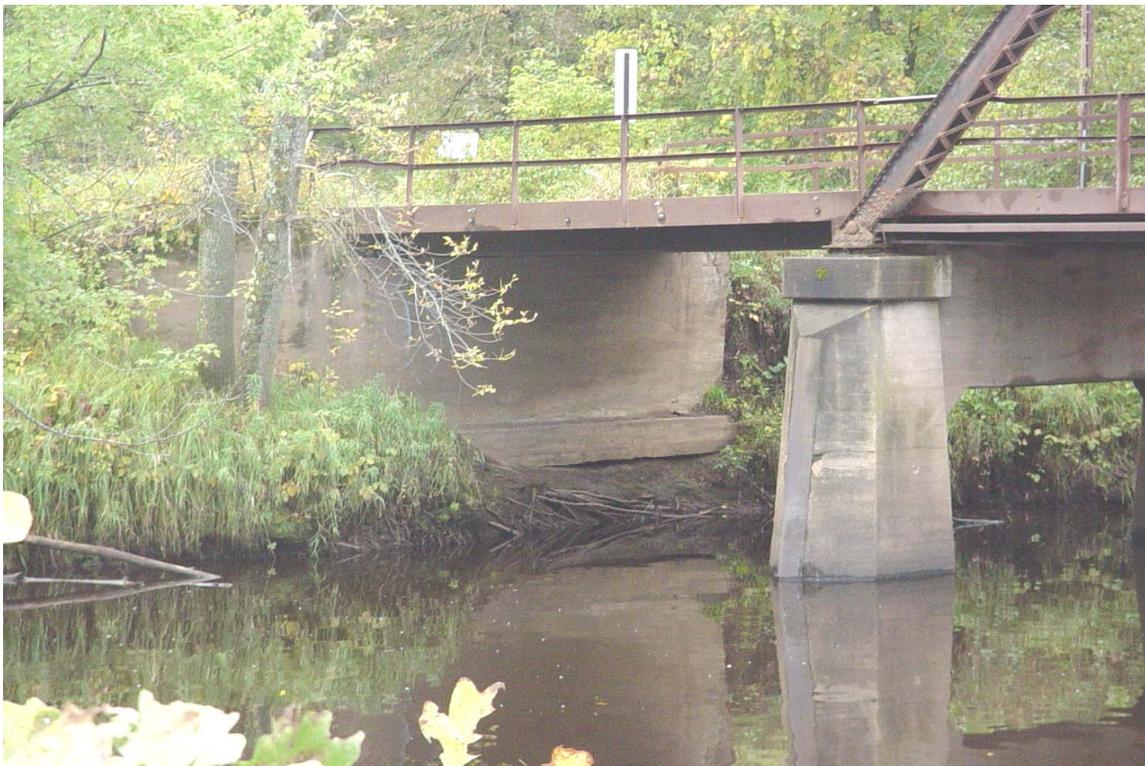
Photograph 2. View of East Abutment, Looking Southeast.

Armor the East and West Abutments with riprap to prevent further undermining and erosion of the embankments.

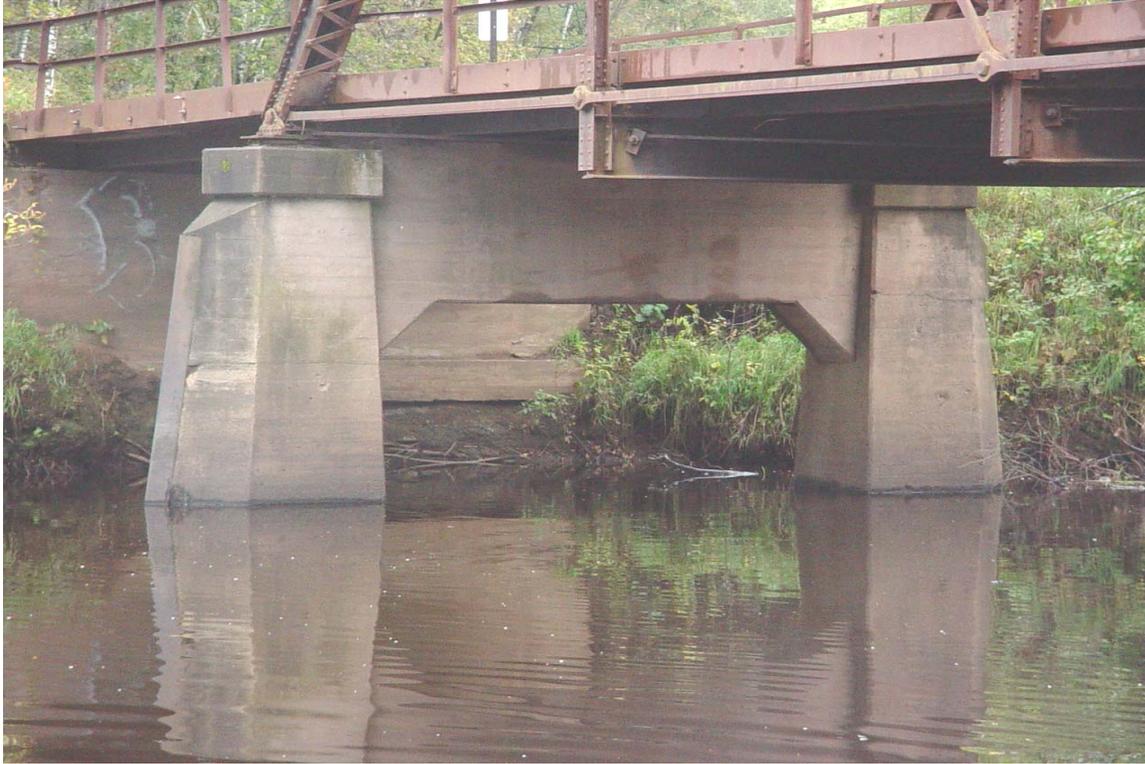
Photograph 3. View of Pier 1, Looking Southeast.

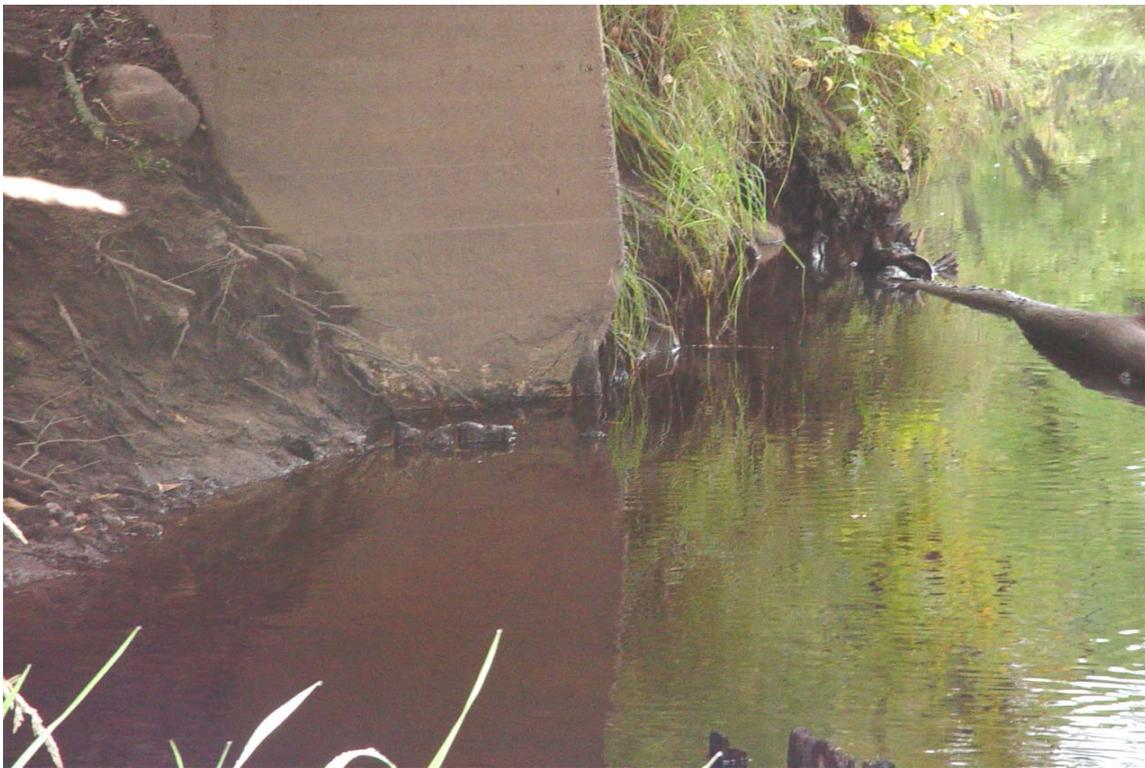
Photograph 6. View of Section Loss at the Southeast Corner of the Upstream Column of Pier 2, Looking North.

Repair areas of section loss with exposed reinforcing steel on both piers by patching and recasting with a concrete mix of high durability and low permeability.
