UNDERWATER BRIDGE INSPECTION REPORT

STRUCTURE NO. 31512
CSAH NO. 18
OVER THE
MISSISSIPPI RIVER
DISTRICT 1 - ITASCA COUNTY

PREPARED FOR THE
MINNESOTA DEPARTMENT OF TRANSPORTATION
BY
COLLINS ENGINEERS, INC.
JOB NO. 3512 (CEI 30)

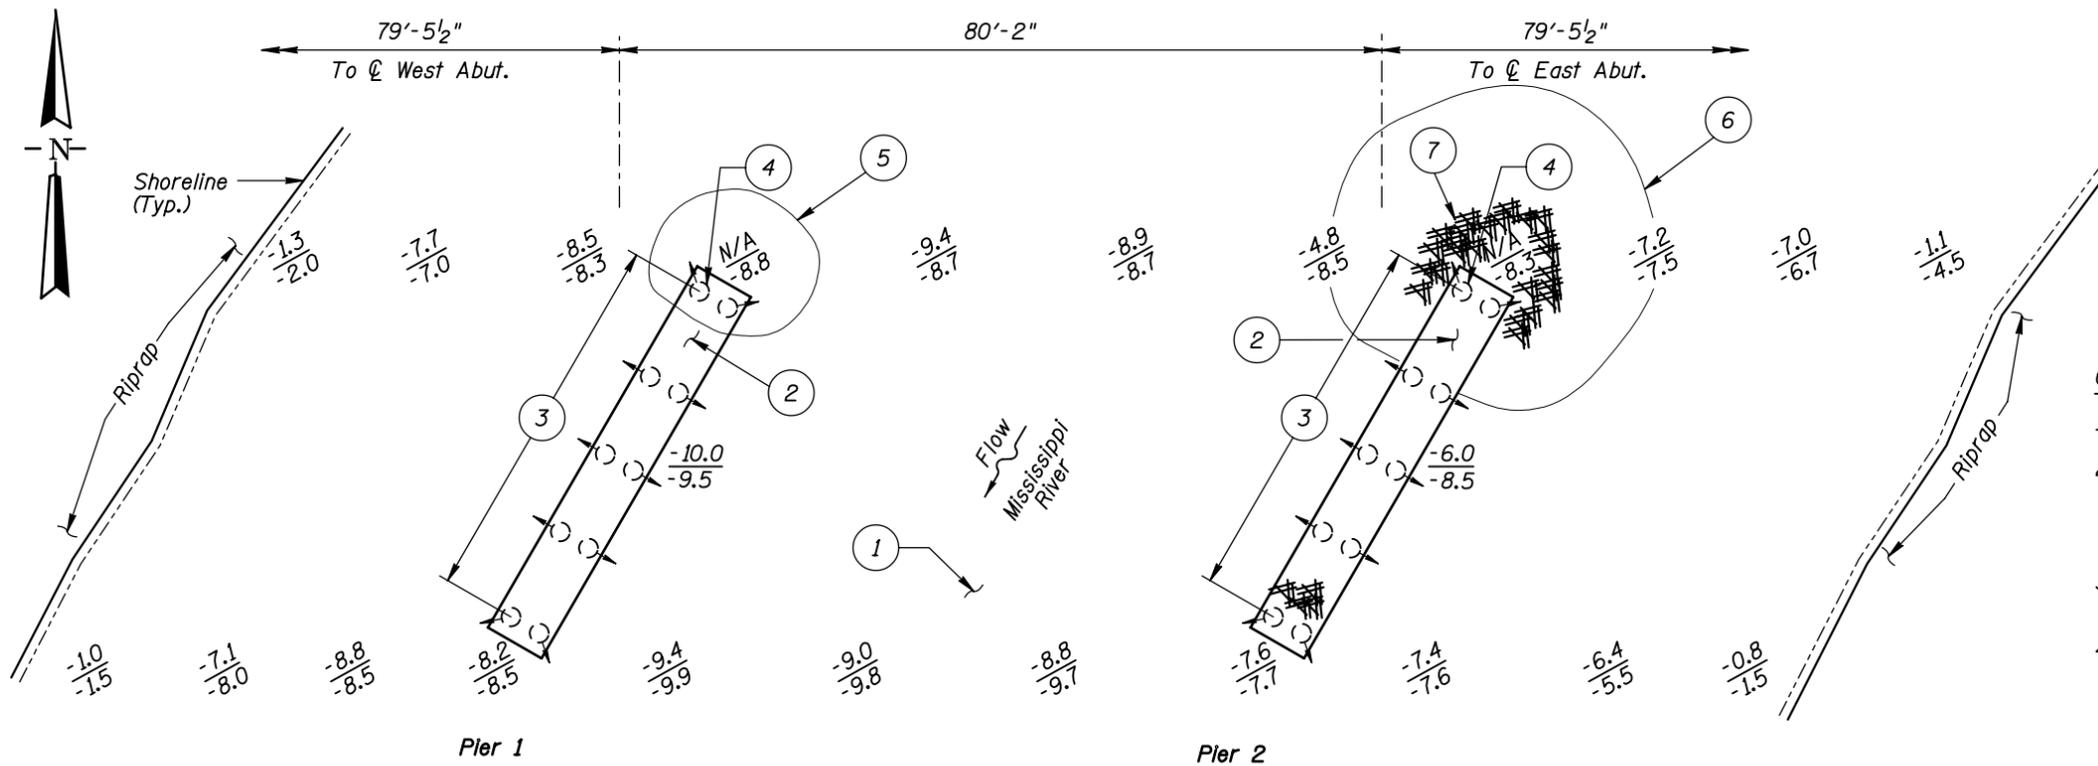
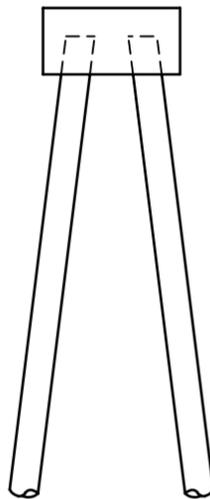
SOUNDING PLAN

- 1 The channel bottom material consisted of firm sandy gravel with scattered 6 inch cobbles and a probe rod penetration of approximately 1 inch.
- 2 Soft sandy infilling present, approximately 2 to 3 feet high with a maximum probe rod penetration of 1 foot.

- 3 All piles exhibited paint coating deterioration, corrosion, and rust nodules on 50 to 100 percent of the surface area, from 1 foot above the waterline to the channel bottom. Heaviest corrosion (+/- 100 percent) was present between 1 foot above and 4 feet below the waterline. Random pitting with a maximum of 1/32 inch penetration was observed on the steel pipe piles.

- 4 There was a moderate accumulation of weeds on the upstream end of each pier extending from the waterline to the channel bottom.
- 5 A 10 foot diameter by 6 feet height pile of organic accumulation and vegetation consisting of a dense roots and organic material was observed at the mudline.

- 6 A 10 foot diameter pile of organic accumulation and vegetation consisting of dense roots and organic material was observed extended from the mudline to 3 feet above the waterline.

- 7 A heavy accumulation of timber drift consisting of 1 inch to 3 inch diameter branches. The timber drift appears to be a beaver den and extends approximately 3 feet above the waterline.

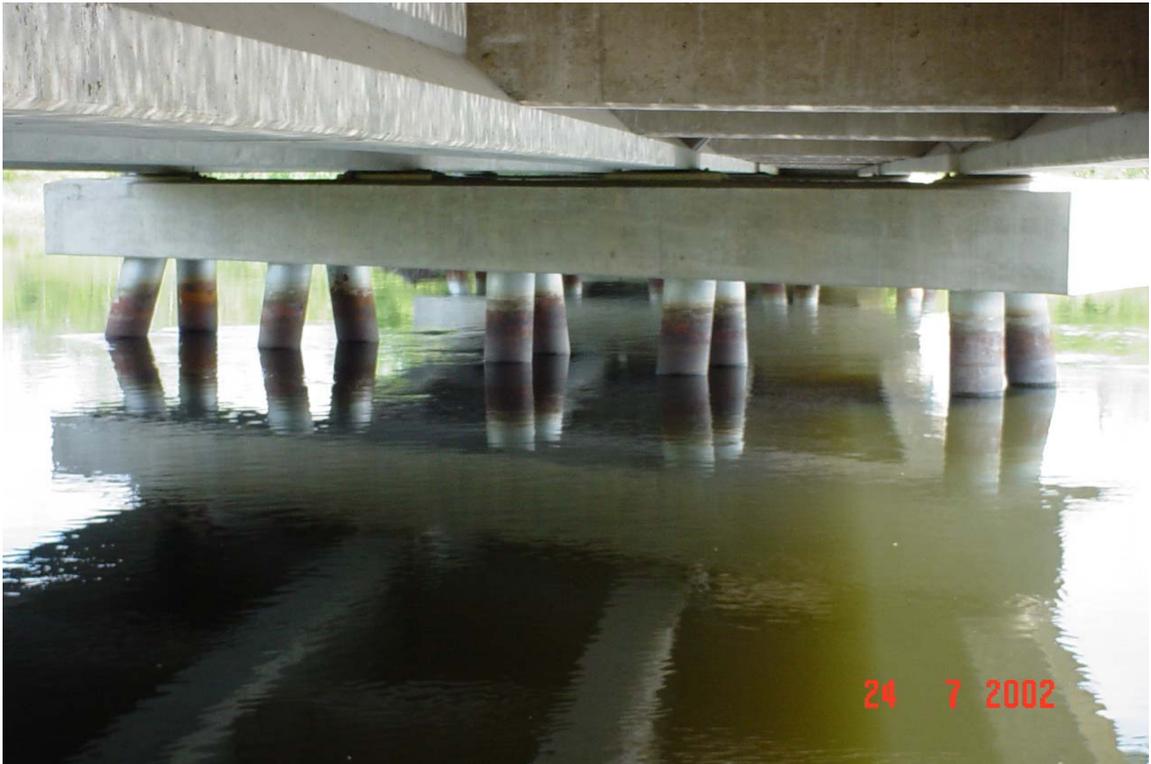
Photograph 2. View of Pier 1, Looking East.

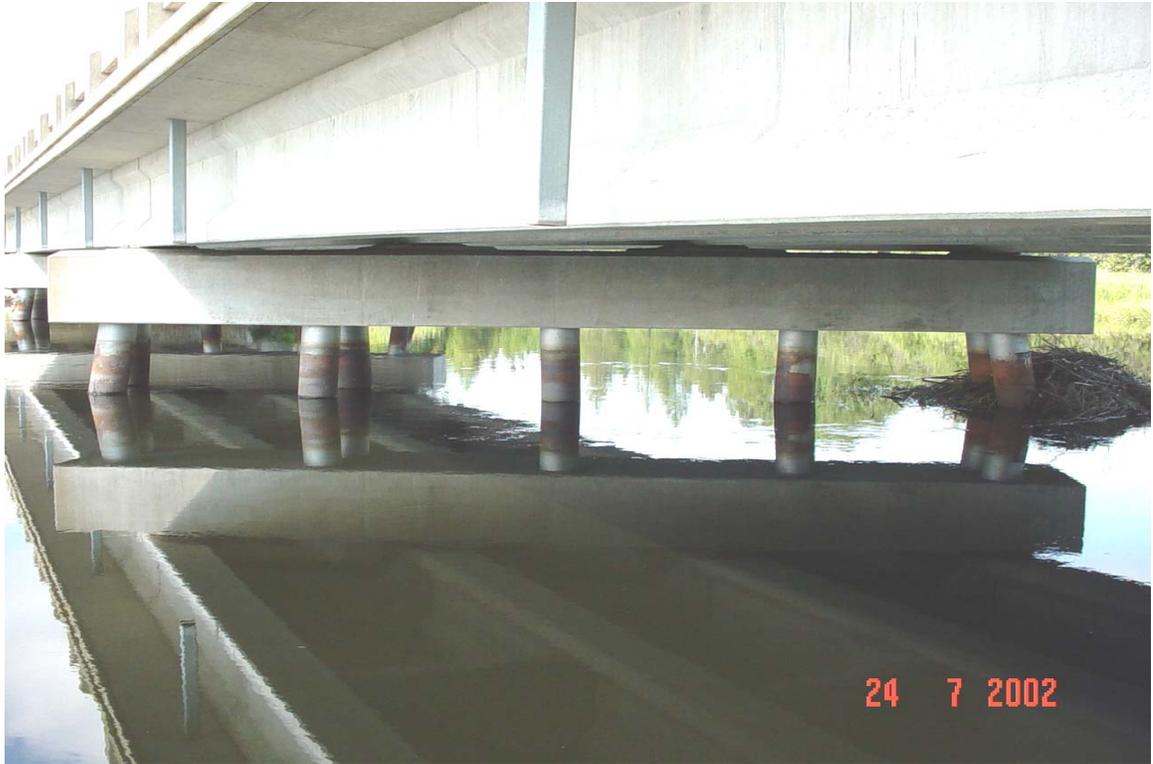
Photograph 3. View of Pier 2, Looking West.

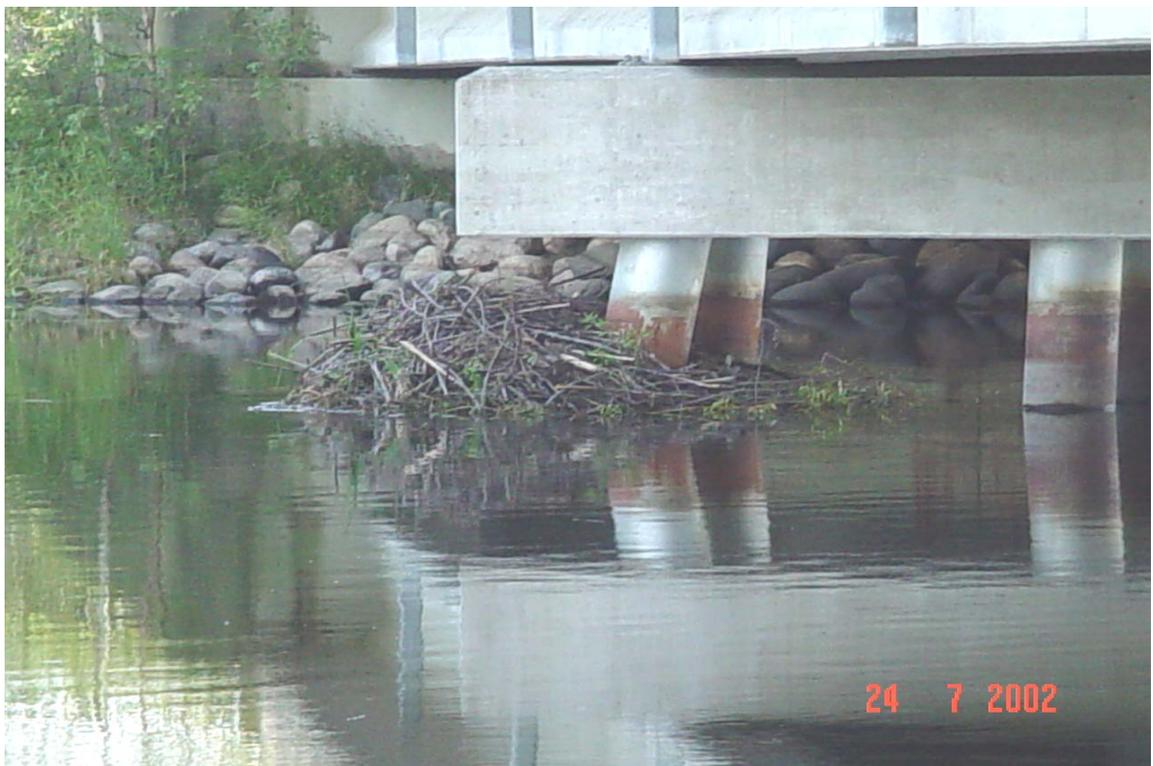
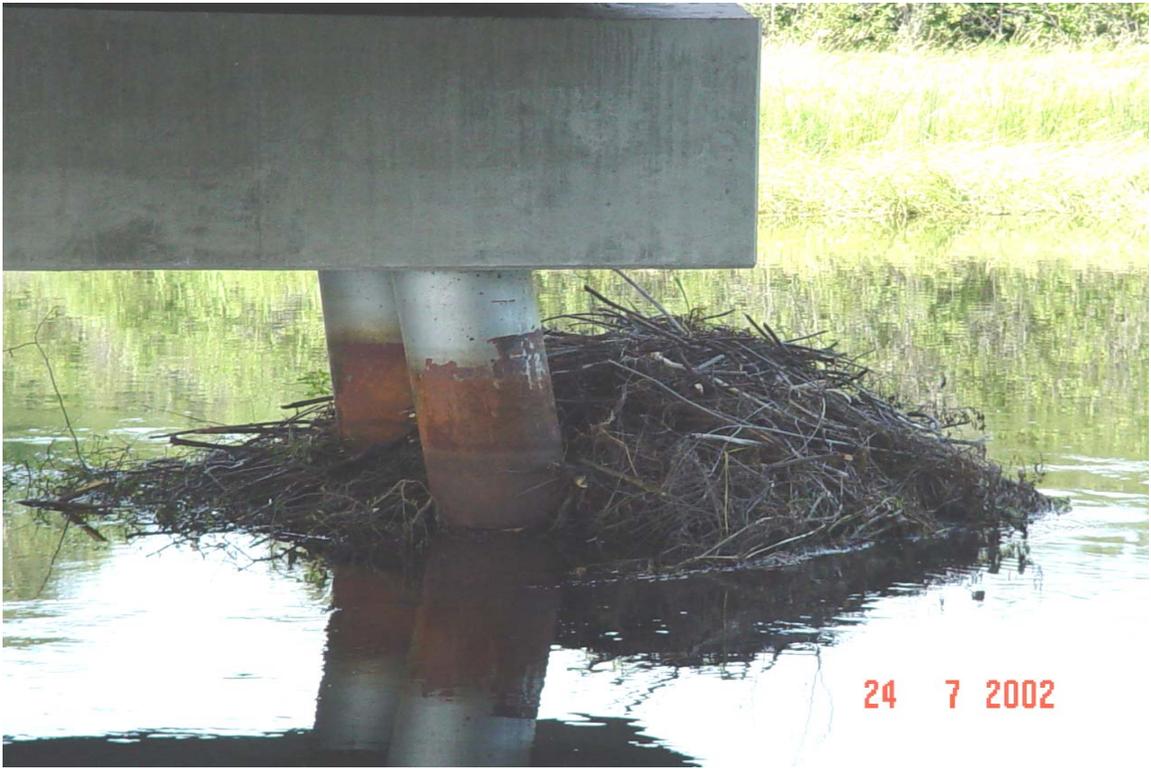
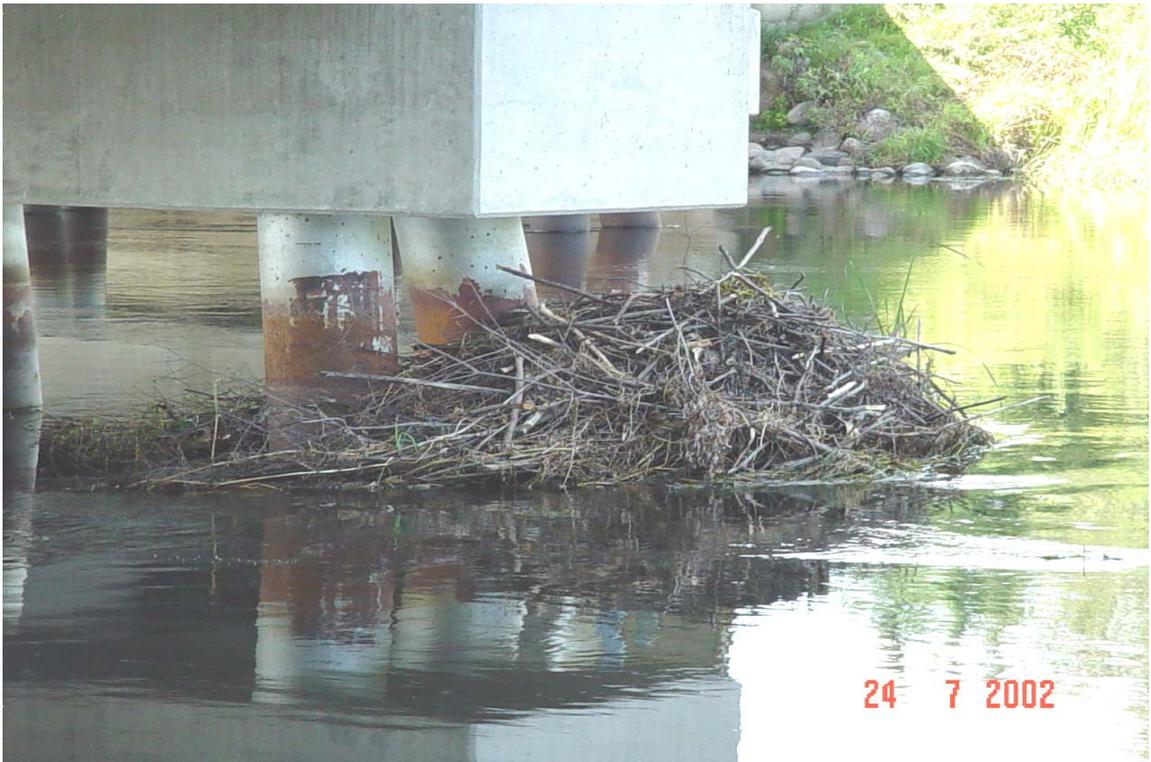
Photograph 4. View of Timber Drift at the Upstream Nose of Pier 2, Looking East.

Photograph 5. View of Timber Drift at the Upstream Nose of Pier 2, Looking Northwest.

Photograph 6. View of Timber Drift at the Upstream Nose of Pier 2, Looking Southwest.

The combination of the organic material build-up and beaver den (timber drift accumulation) at Pier 2 is becoming excessive and could continue to progress and influence scour, restrict flow, and exert lateral load on the pier. Therefore, it is recommended that the accumulation of organic and drift at Pier 2 be closely monitored during future inspections and if found to be increasing in extant, removal may be warranted at that time. (Similar measures could be accomplished at Pier 1 to prevent the same concerns).

- (A) Monitor the extent of corrosion on the piles, and if found to be progressing to the point where appreciable section loss is occurring, corrective measures to inhibit further deterioration may be warranted.
- (B) Monitor the accumulations of vegetation and organic materials at the upstream piles of the piers, so that they do not become excessive and exert large lateral loads or influence scour at the piers. If the accumulations progress in size in the future, removal may be warranted at that time.
