UNDERWATER BRIDGE INSPECTION REPORT

STRUCTURE NO. 36503

CR NO. 145

RAT ROOT RIVER

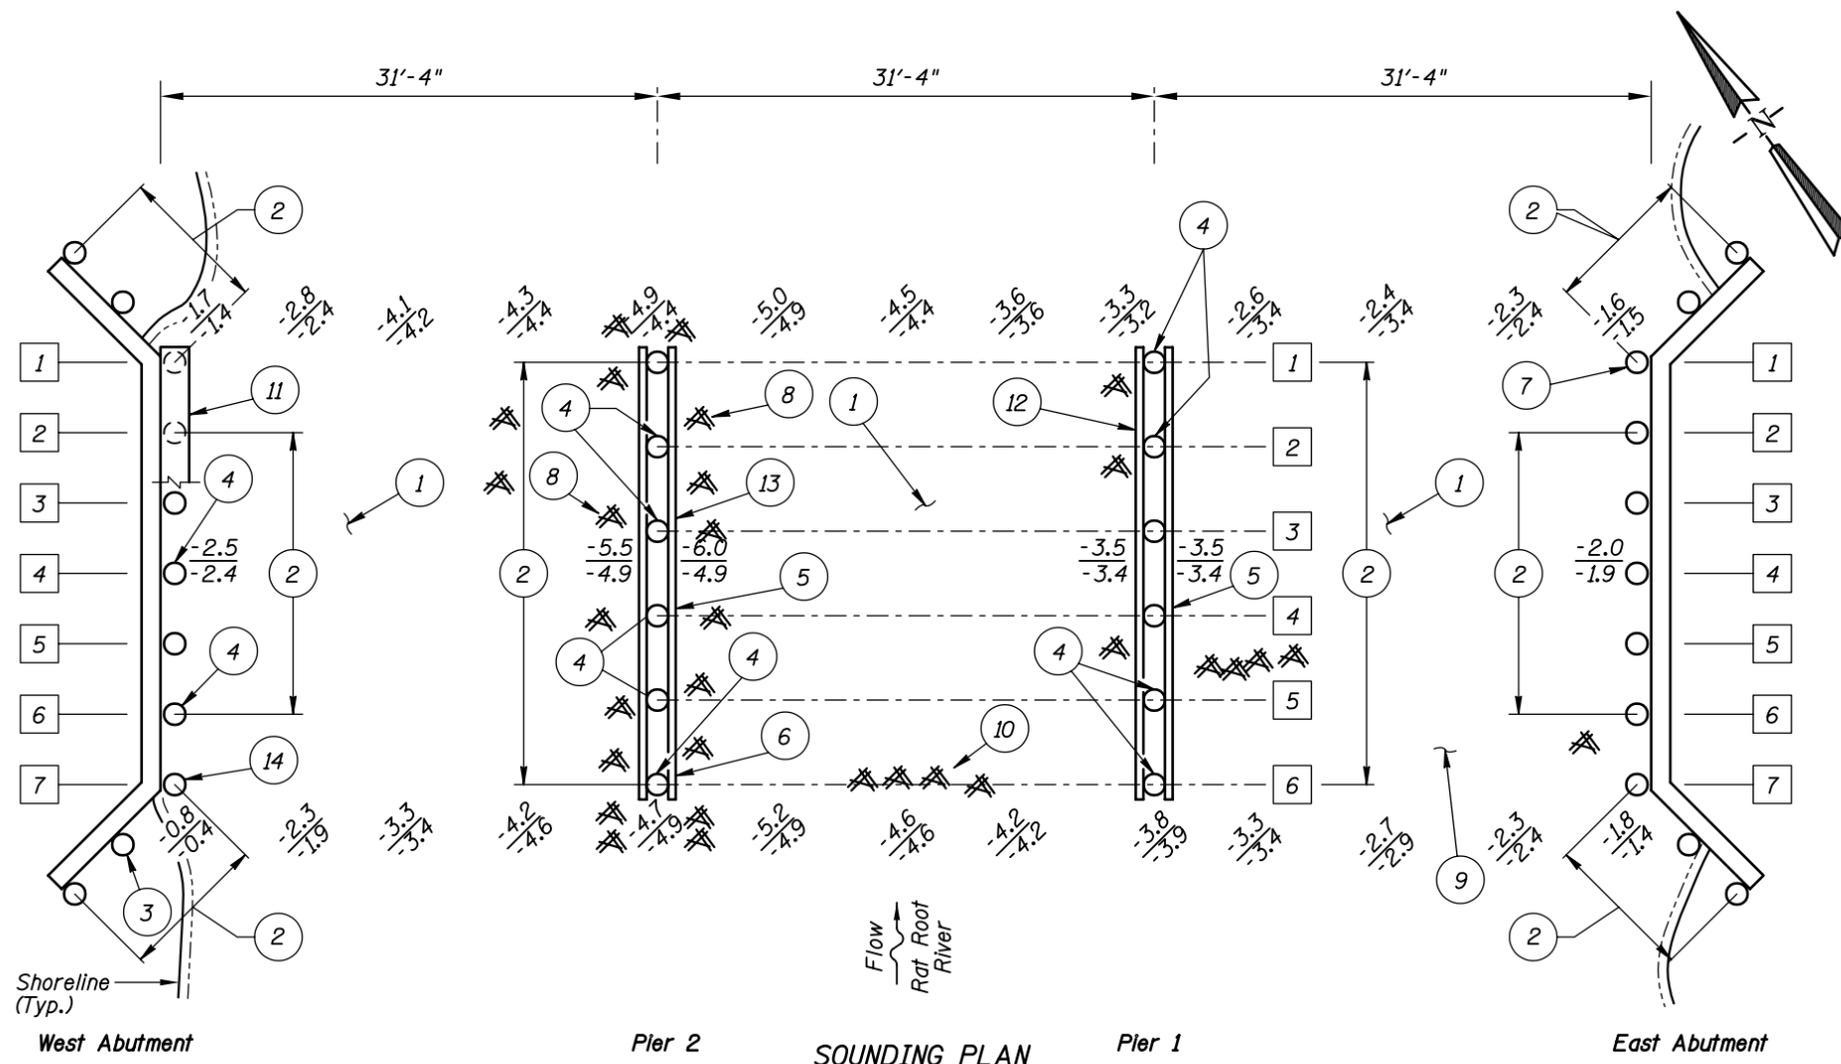
| INSPECTION AND SOUNDING PLAN | | |

| <p>1 The channel bottom material consisted of soft silty clay with random rock, 1 foot in diameter and smaller, with 1 foot of probe rod penetration.</p> <p>2 All piles exhibited random checking 1/8 inch wide typical and 1/4 inch wide maximum unless otherwise noted.</p> <p>3 Timber pile with 1/2 inch wide crack from the top down 6 feet with 4 inches penetration.</p> <p>4 Timber pile from approximately 4 feet below the waterline or the mudline to 2 feet above the waterline exhibited a 10 inch wide to half the pile circumference wide area of splintering and delaminating with up to 1 inch penetration. (ice abrasion damage)</p> <p>5 Timber cross bracing missing section near waterline, up to 3 feet long, 3 inches deep, and 1 inch remaining timber to fastener, due to ice abrasion damage.</p> <p>6 Timber cross bracing exhibited up to 3 foot long split below fastener.</p> <p>7 Timber pile with 1 inch wide split from the top down 6 feet with penetration through 1/2 of the pile.</p> <p>8 Moderate timber drift accumulation from the waterline to the mudline was observed on the east side and upstream end of Pier 2. In addition, 1 to 2 feet of drift was observed on the channel bottom on the west side of Pier 2.</p> | <p>9 Light timber drift accumulation between East Abutment and Pier 1 hung up on cut off piles. In addition, light timber debris up to 6 inches in diameter was scattered around Pier 1.</p> <p>10 Light timber debris on the channel bottom was observed at the midspan between Piers 1 and 2 along the upstream fascia of the bridge.</p> <p>11 The pile cap over piles 1 and 2 was rotated slightly to the west, with some minor diagonal torsional cracking along the south side, and as a result cap was not bearing directly on up to 50 percent of the top of the piles.</p> <p>12 Half of the timber cross bracing was broken away and was missing. The section that was remaining and still attached was split and was no longer engaged to the fasteners of piles 1 and 2.</p> <p>13 Timber cross bracing had a 3 inch by 1-1/2 foot area of timber missing and the fastener from the pile was no longer engaged to the cross bracing.</p> <p>14 A 1/2 inch wide split with 4 inches of penetration, extending 3 feet down from the top of the pile.</p> |

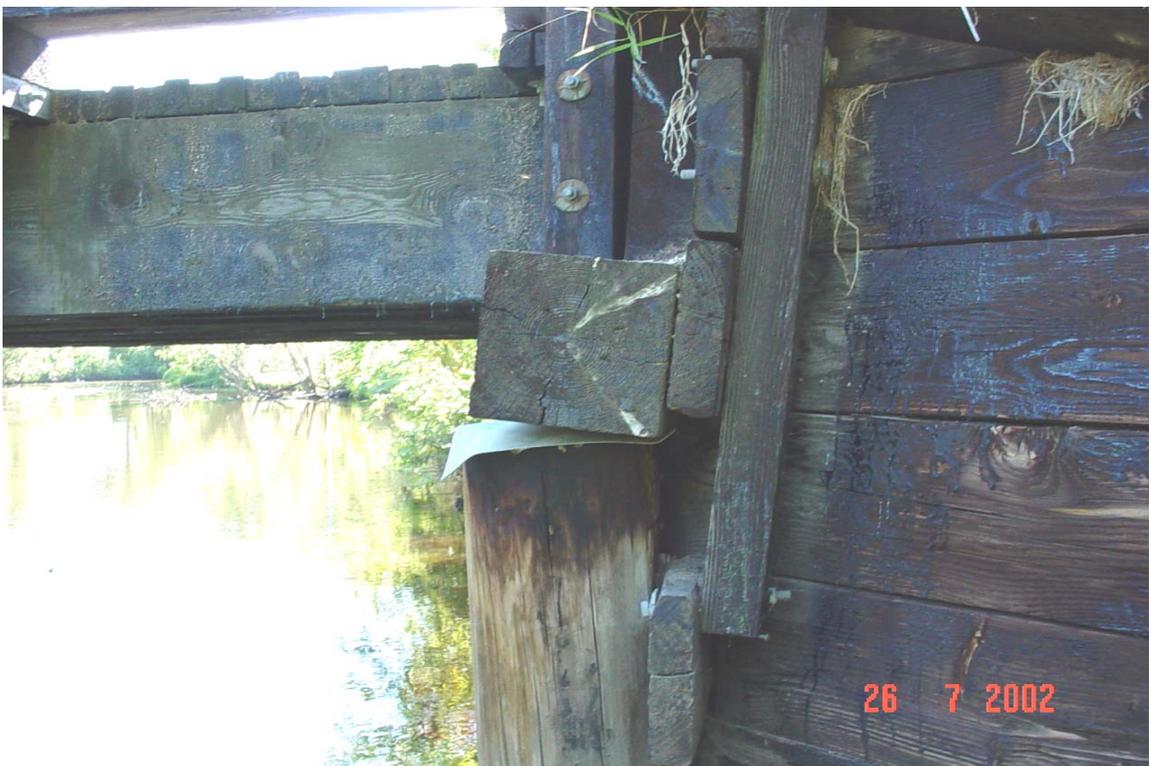
- (A) The timber piles were generally in satisfactory to good condition with moderate 1/8 to 1/4 inch wide splitting or checking.
- (B) The north end of the pile cap at the West Abutment was rotated to the west, reducing its bearing on the outer two piles to the north side by up to 50 percent.
- (C) Many of the cross bracing members of both piers were cracked and broken with a significant loss of section, all of which has compromised pile connection integrity.
- (D) A light to moderate accumulation of timber debris was observed along the channel bottom between the East Abutment and Pier 2, and along Piers 1 and 2.

Photograph 4. View of Pile Cap Rotation at the West Abutment, Looking Southwest.

- (B) Monitor the extent of the pile cap rotation at the West Abutment during future inspections and repair if bearing loss becomes excessive.
- (C) Monitor the extent of drift accumulation at the bridge during future inspections, and if found to be progressing, removal may be warranted at that time.
- (D) Reinspect the submerged substructure units at the normal maximum recommended (NBIS) interval of five (5) years.

Monitor the extent of the pile cap rotation at the West Abutment during future inspections and repair if bearing loss becomes excessive.

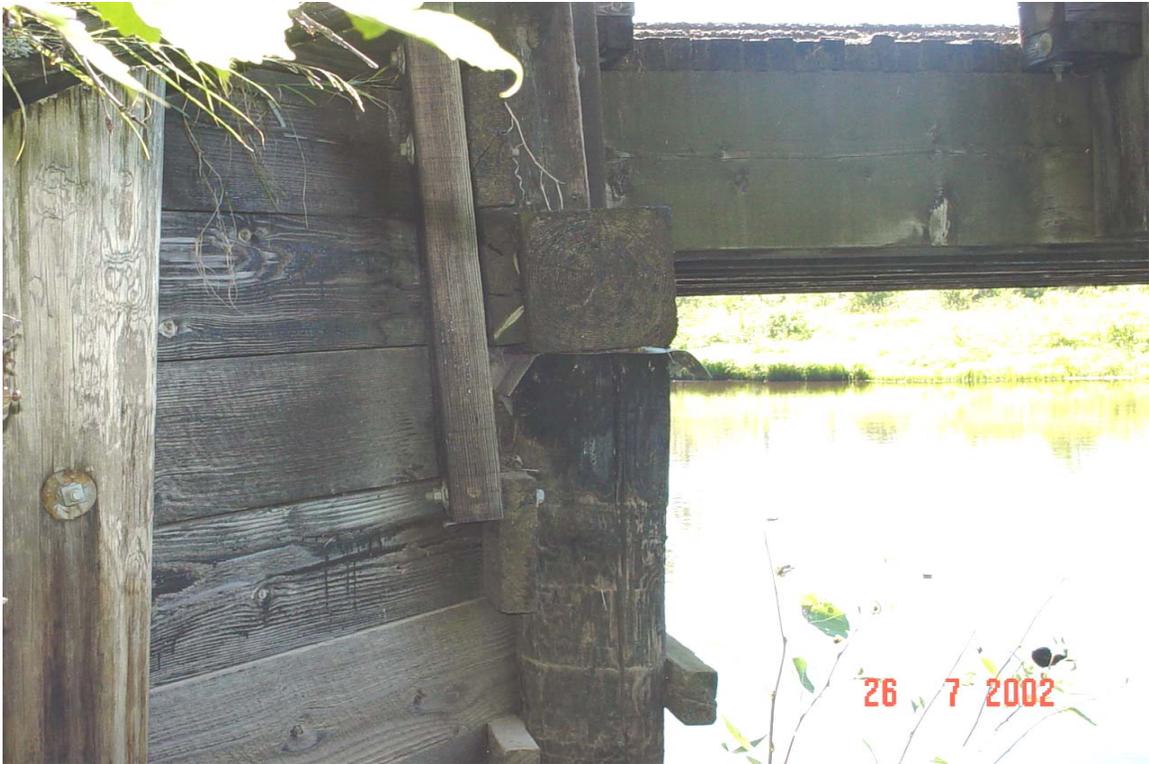
Photograph 5. View of Pile Cap Rotation at the East Abutment, Looking Southwest.

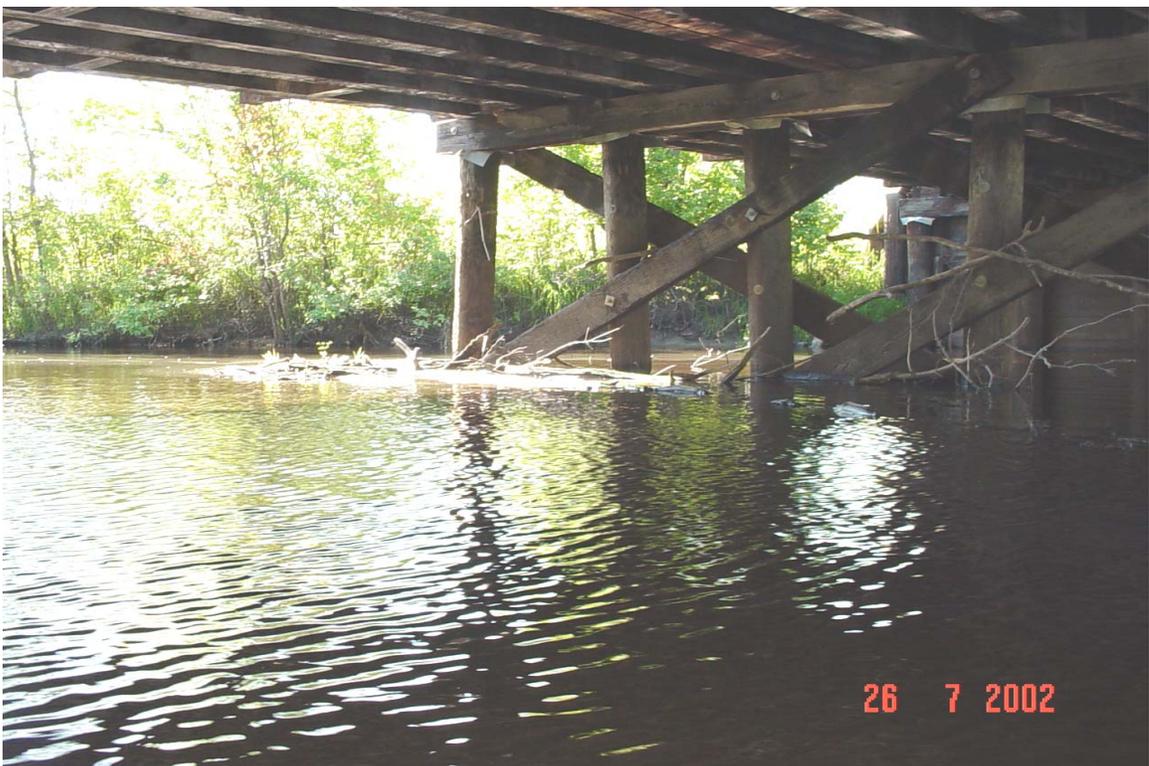
Photograph 6. View of Timber Drift at Pier 2, Looking West.

Monitor the drift accumulations at the bridge during future inspections, and if found to be progressing, removal may be warranted at that time.

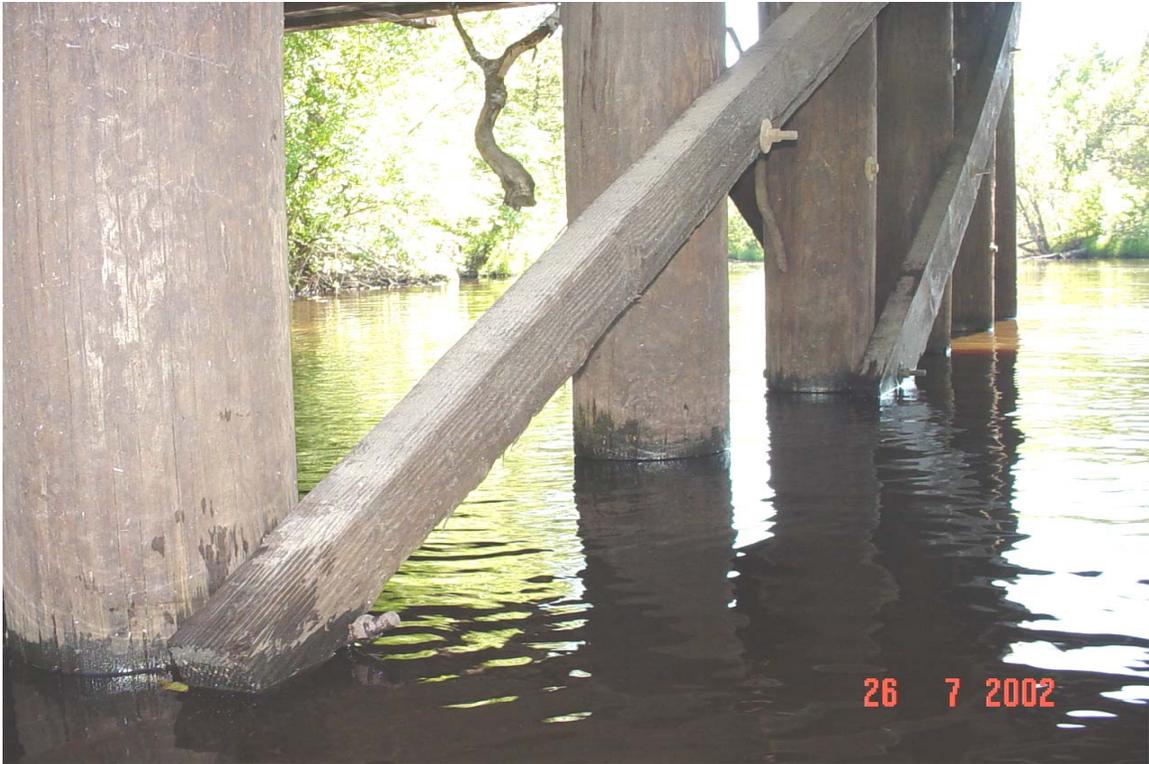
Photograph 7. View of Split in Timber Cross Bracing at Pier 1, Looking South

- (A) The timber cross bracing members that exhibited cracking or loss of section should be repaired or replaced during routine maintenance.

The timber cross bracing members that exhibited cracking or loss of section should be repaired or replaced during routine maintenance.

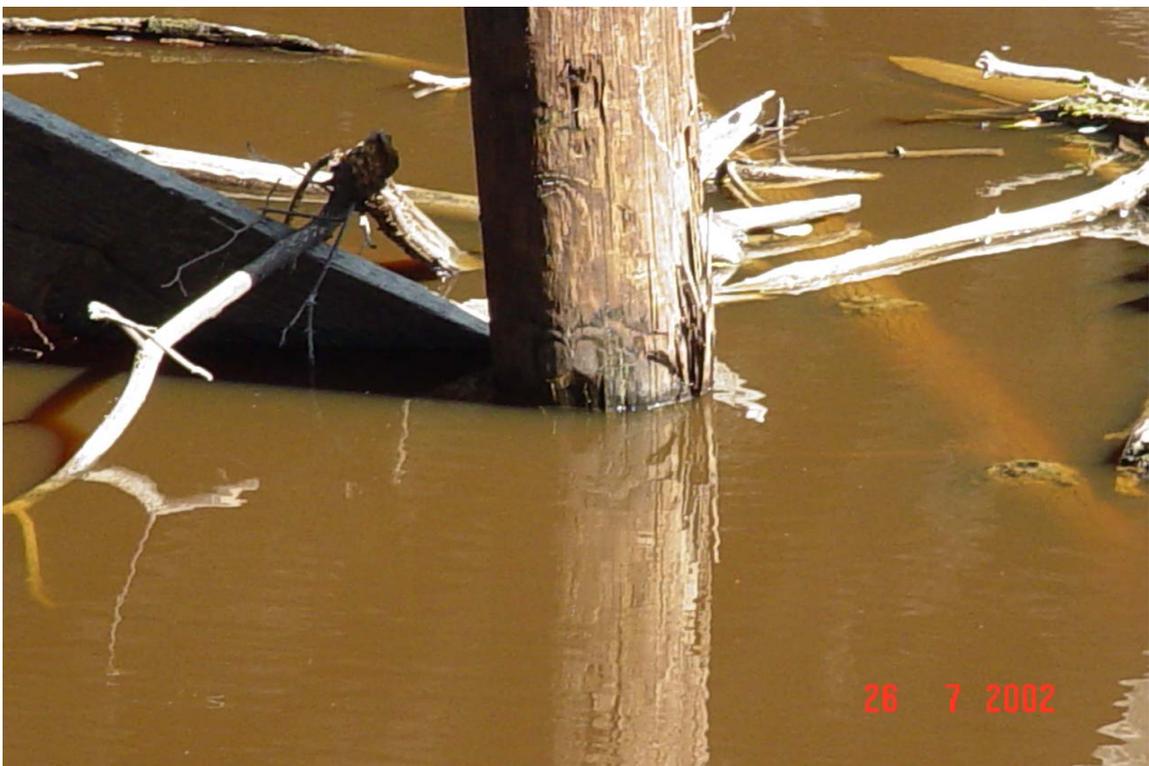
Photograph 8. View of Typical Delamination and Surface Softness Around Waterline at Upstream Pile of Pier 2, Looking East.
