UNDERWATER BRIDGE INSPECTION REPORT

STRUCTURE NO. 36504

RAT ROOT RIVER

MINNESOTA DEPARTMENT OF TRANSPORTATION
UNDERWATER BRIDGE INSPECTION

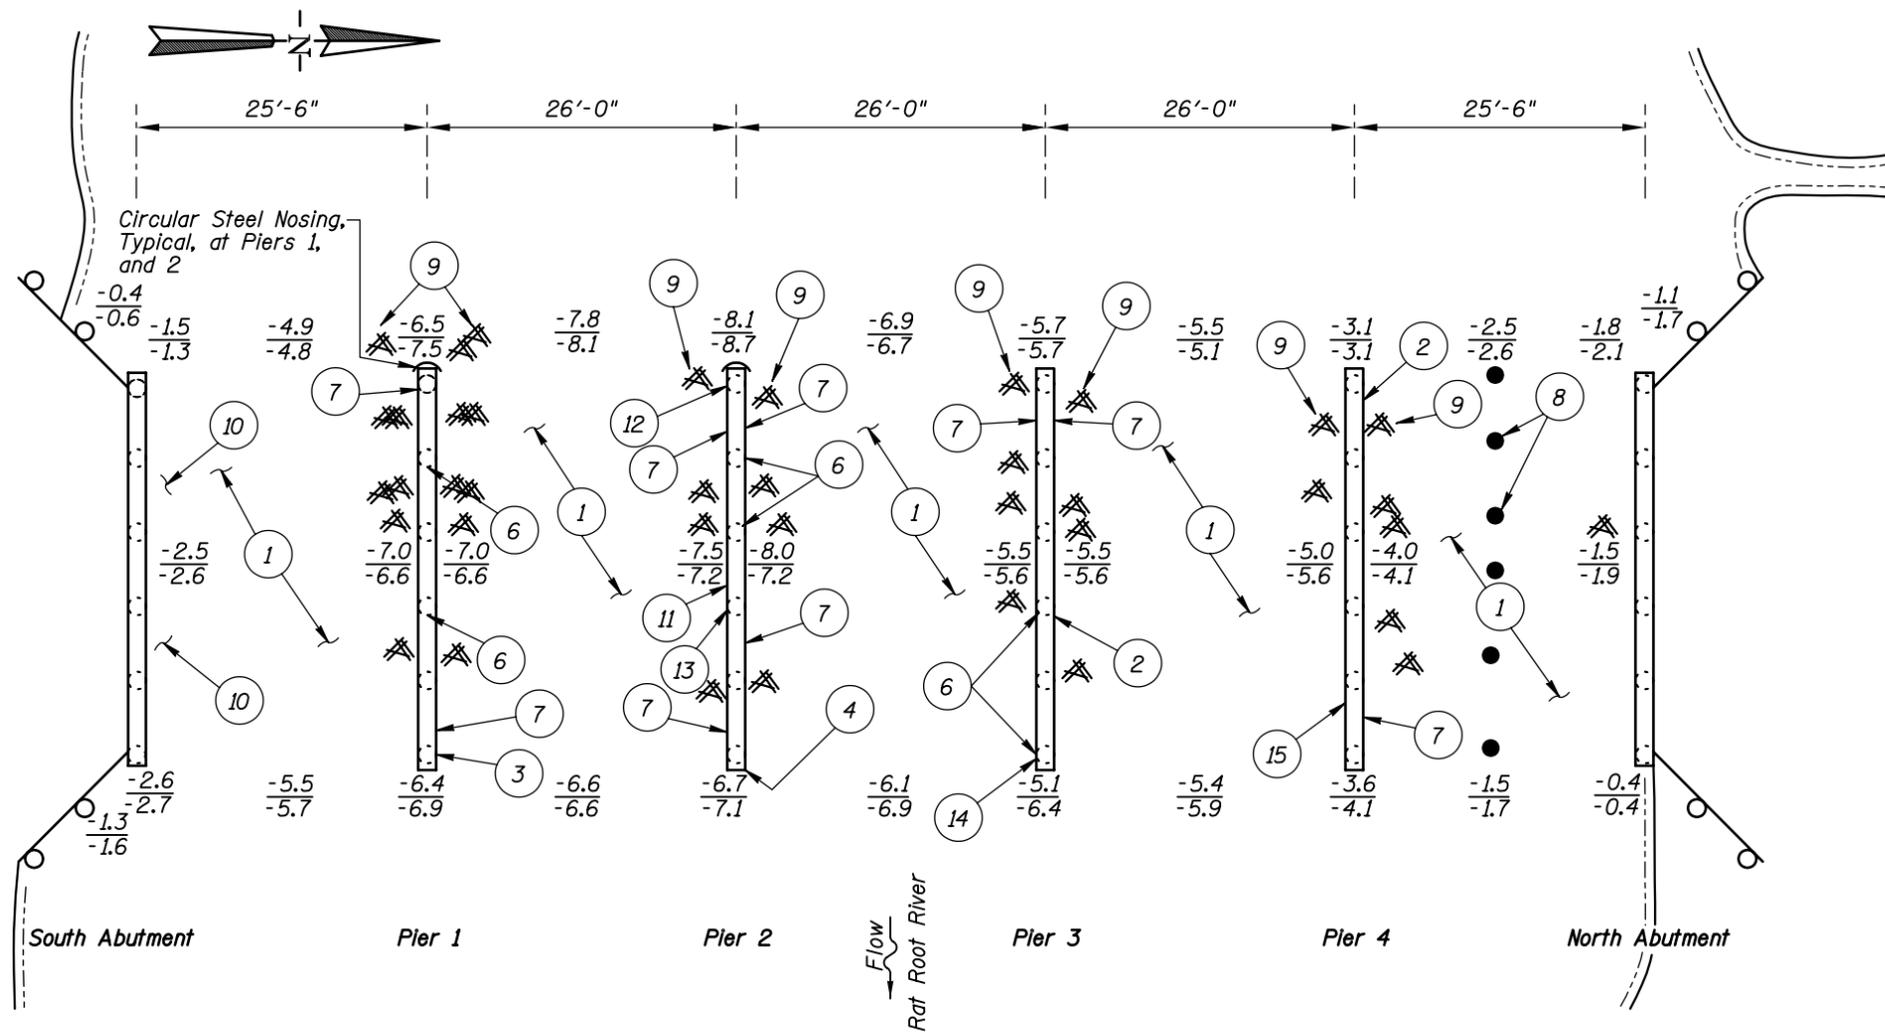
- 1 The channel bottom material around all of the piers typically consisted of silty clay with a maximum probe rod penetrations of 1 foot.
- 2 Bracing split over length of 5 feet with 1 inch check through pile fastener.

- 3 Outer layer of pile softer than typical with approximately 1/4 to 1/2 inch surface delamination from the waterline to the channel bottom. (ice related damage)

- 4 End of cap at above the easternmost pile has a 50 percent loss of section, that has reduced the cap's bearing capacity on the pile by 50%.
- 5 All of the timber piles around the waterline and below exhibited random 1/4 inch soft outer layer with checking and delamination due to normal weathering, age, and ice damage. Random 1/4 inch wide checking was also present at most piles.

- 6 Heavier surface splintering and delamination, as noted in Note 5, typically extending between 1 foot below and 4 feet below the waterline with penetration/depth of 1/2 inch.

- 7 Steel channel replacement cross bracing was used to replace the old timber cross bracing on the upstream south side and downstream north side of Pier 1, all of the timber cross bracing at Pier 2, and on the upstream north and south sides of Pier 3.

- 8 Old abandoned timber piles that were protruding 2 to 4 feet above the mudline.
- 9 Light timber debris consisting of branches up to 6 inches in diameter. Most of the debris extended from the channel bottom to 1 to 3 feet above the channel bottom.

- 10 The channel bottom at the South Abutment consisted of gravel and 1 foot diameter riprap.
- 11 The steel channel was deformed between the 3rd and 4th pile in from the upstream fascia, and was not engaged to the 4th pile in from the upstream fascia.

- 12 The steel channel was no longer engaged to the upstream pile and had been deformed by ice flow and drift.
- 13 The timber pile exhibited a 3 inch diameter, with 1 inch penetration, area of abrasion that was caused by rubbing contact with the unconnected steel channel, and was located 1-1/2 feet below the waterline.

- 14 A 10 feet long split in the timber cross bracing. The cross bracing was no longer engaged to the timber pile.
- 15 A 8 feet long by 2 inch wide split in the timber cross bracing. The split traveled through the fastener at the downstream pile back along the timber cross bracing.

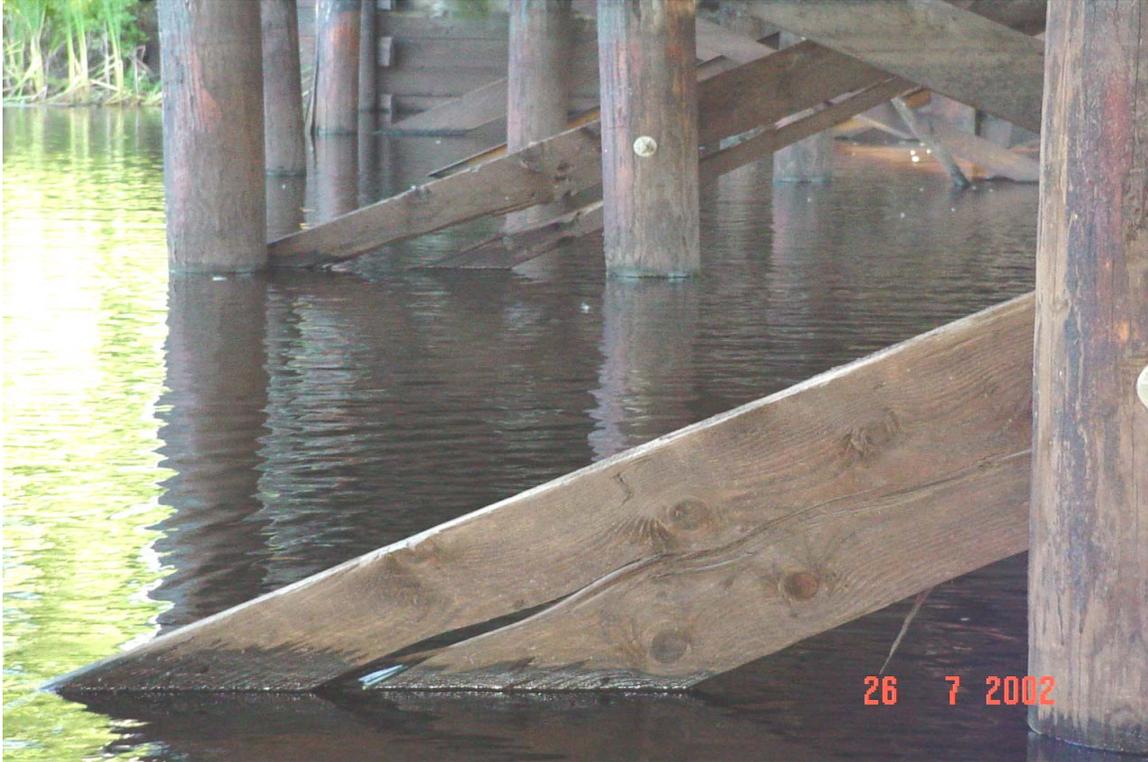
Photograph 7. View of Split Cross Bracing at the Downstream Piles of Piers 3 and 4, Looking South.

Replace the damaged and disconnected timber cross bracing and repair the disconnected steel channel cross bracing.

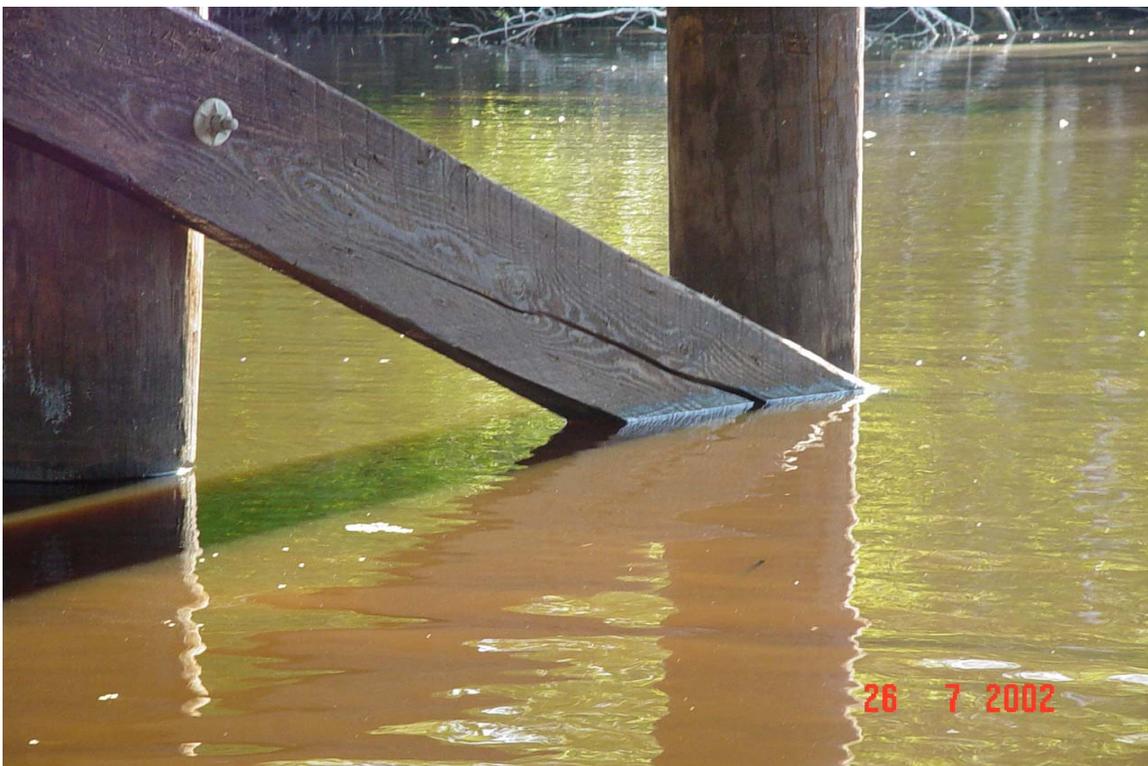
Photograph 8. View of Split Cross Bracing at the Upstream Pile of Pier 4, Looking Southwest.

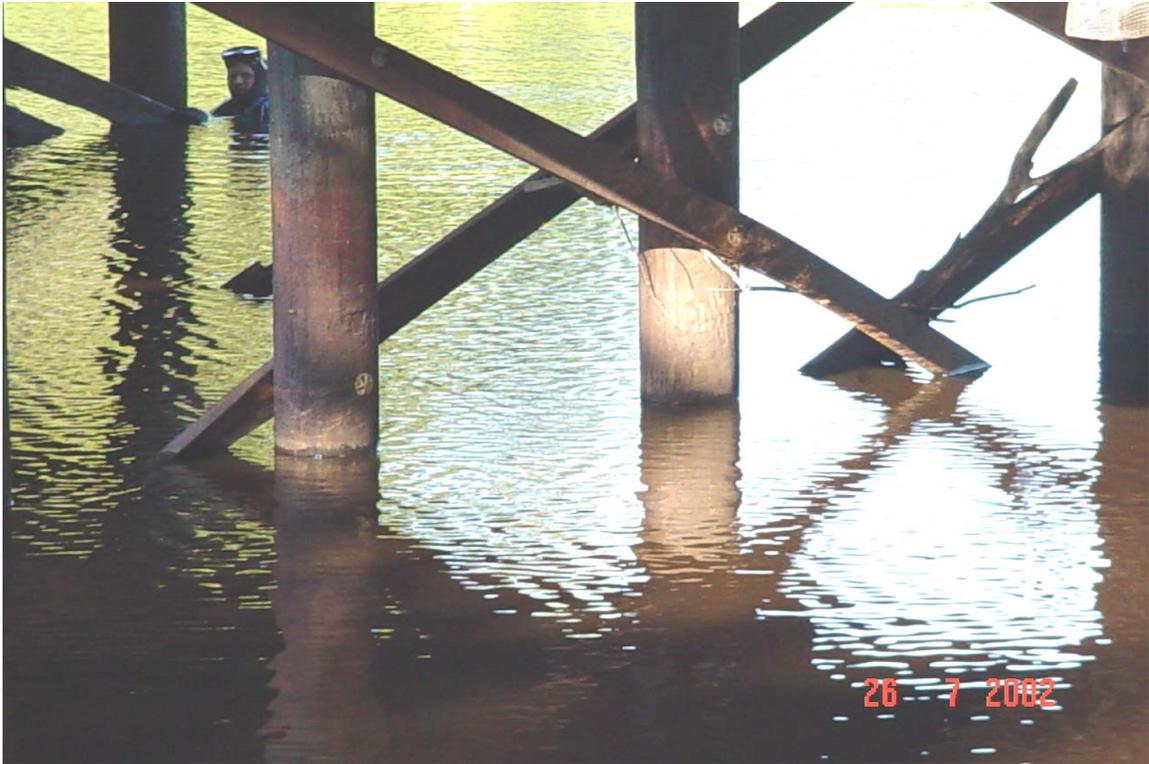
Photograph 9. View of Warped Steel Channel Cross Bracing at Pier 2, Looking Northeast.

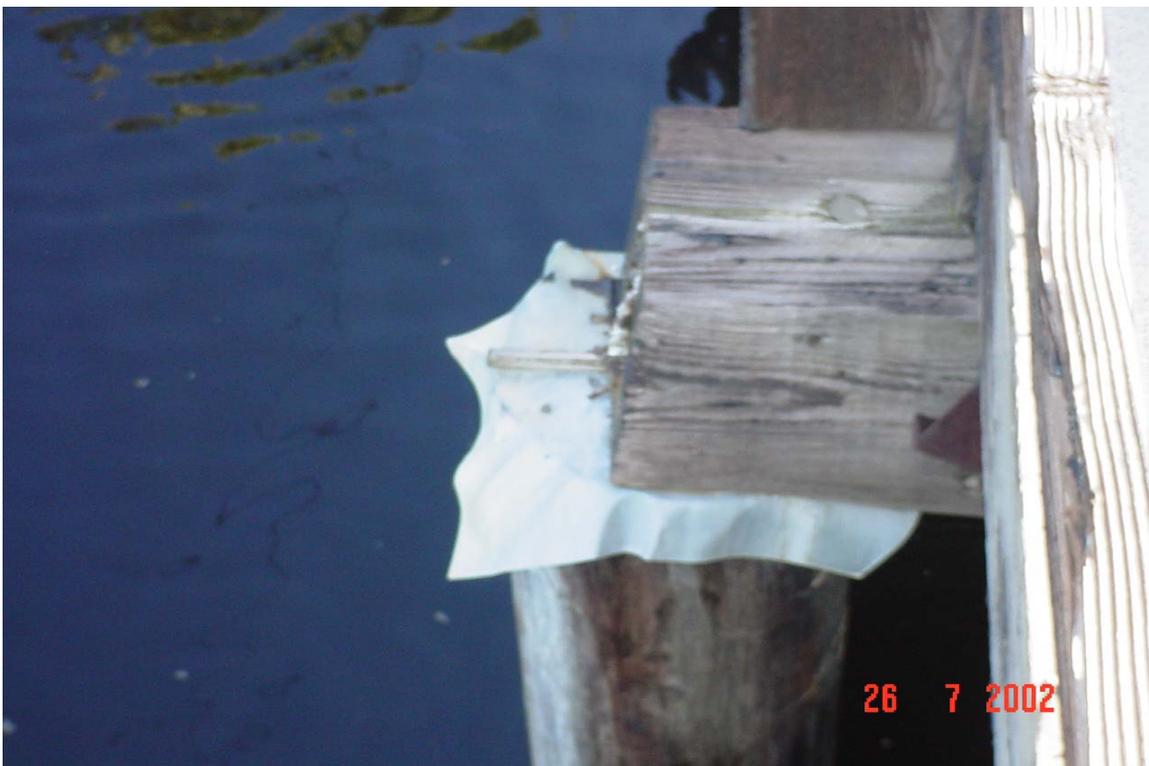
Photograph 10. View of Pile Cap not Bearing Fully on the Downstream Pile of Pier 2, Looking South.

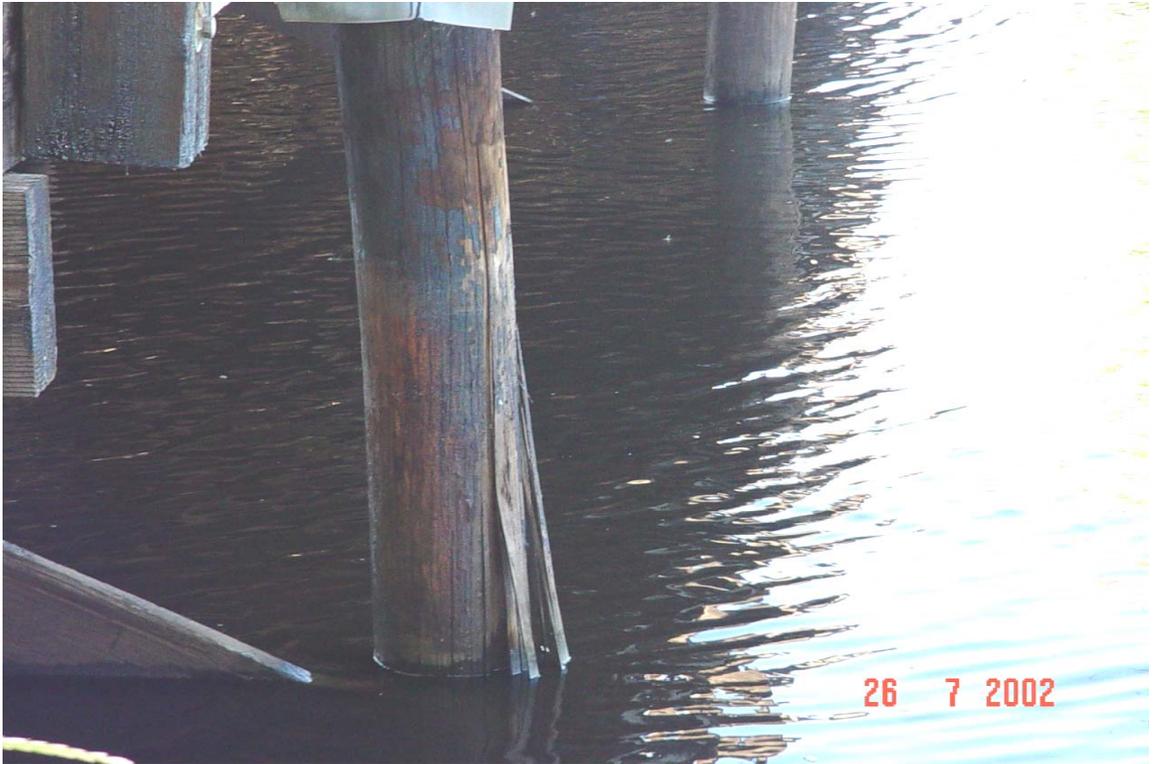
Photograph 11. View of Typical Delamination and Splitting Around Waterline at the Downstream Pile of Pier 1, Looking North.
