UNDERWATER BRIDGE INSPECTION REPORT

STRUCTURE NO. 36515
CR NO. 82
OVER THE
W. FORK OF THE BLACK RIVER
DISTRICT 1 - KOOCHICHING COUNTY

PREPARED FOR THE
MINNESOTA DEPARTMENT OF TRANSPORTATION
BY
COLLINS ENGINEERS, INC.
JOB NO. 3512

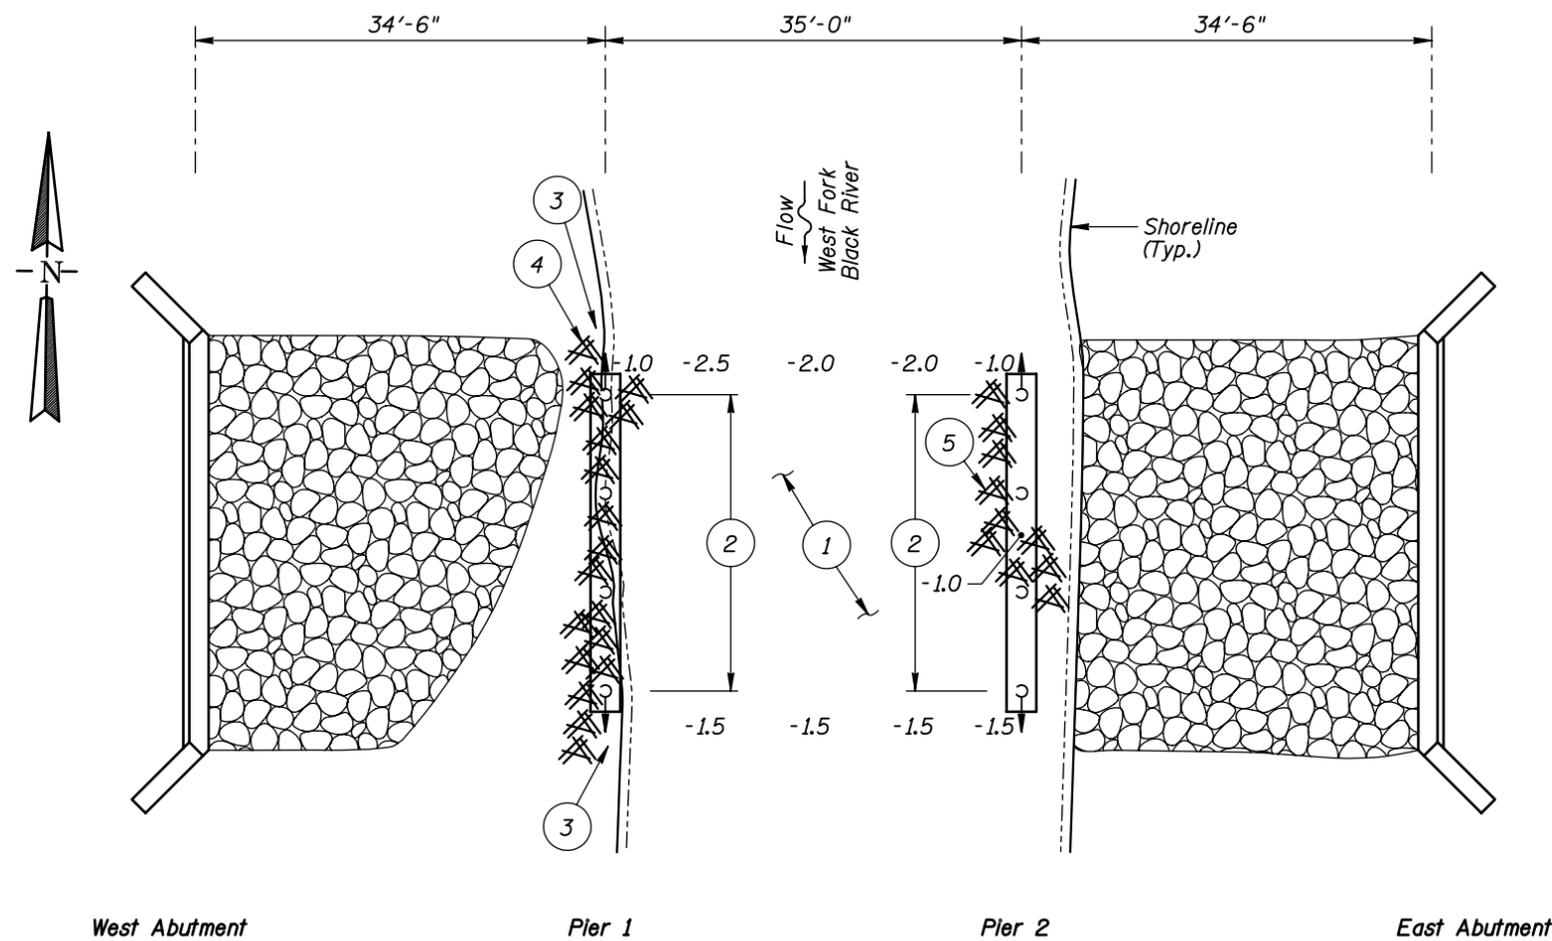
SOUNDING PLAN

- ① The channel bottom consisted of silty sand and gravel with approximately 3 to 6 inches of probe rod penetration.
- ② The steel pipe piles exhibited coating failure over 50 to 100 percent of their surface area with up to 1/4-inch-diameter corrosion nodules and 1/32-inch-deep pitting observed from 5 feet above the waterline to the channel bottom.
- ③ The west embankment exhibited minor vertical erosion extending 2 feet above the waterline at the upstream nose and 4 feet above the waterline at the downstream nose of Pier 1.
- ④ A moderate accumulation of 1-foot-diameter-and-smaller timber drift was scattered throughout Pier 1.
- ⑤ A light accumulation of timber drift was observed along the upstream piles of Pier 2.

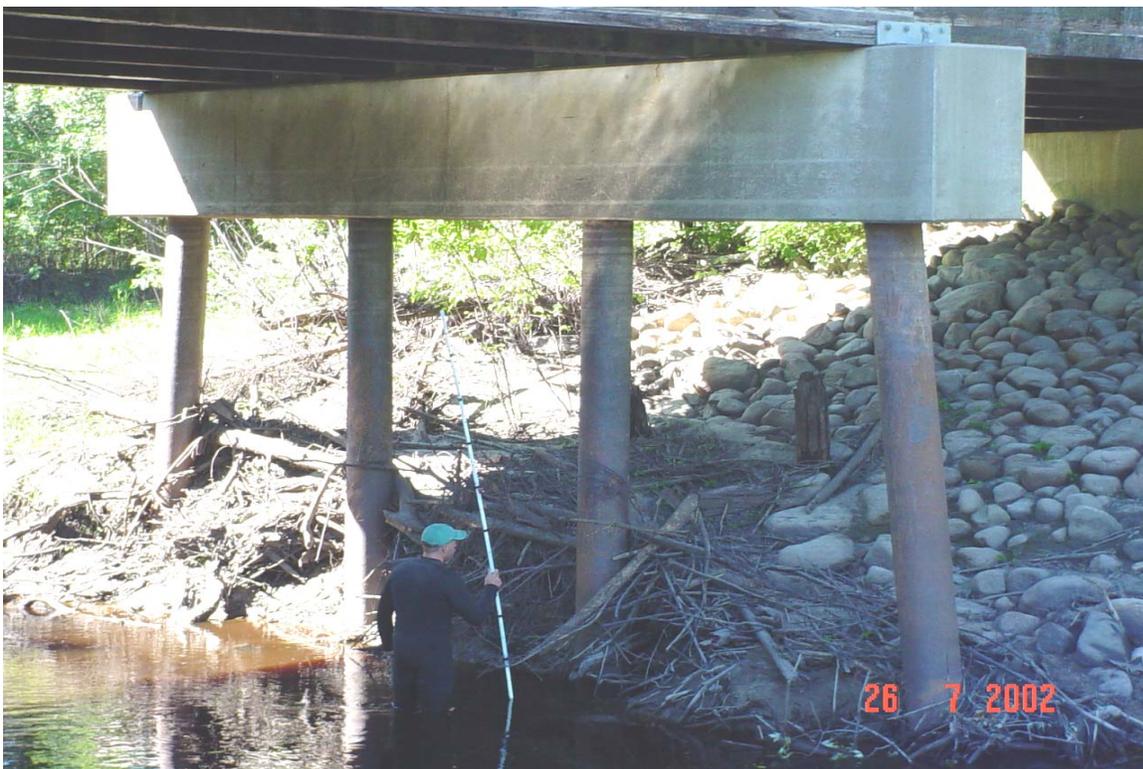
Photograph 2. View of Pier 1, Looking Southwest.

- (A) Monitor timber debris accumulations at the piers, and if found to be progressing (to an excessive extent), removal may be warranted at that time.

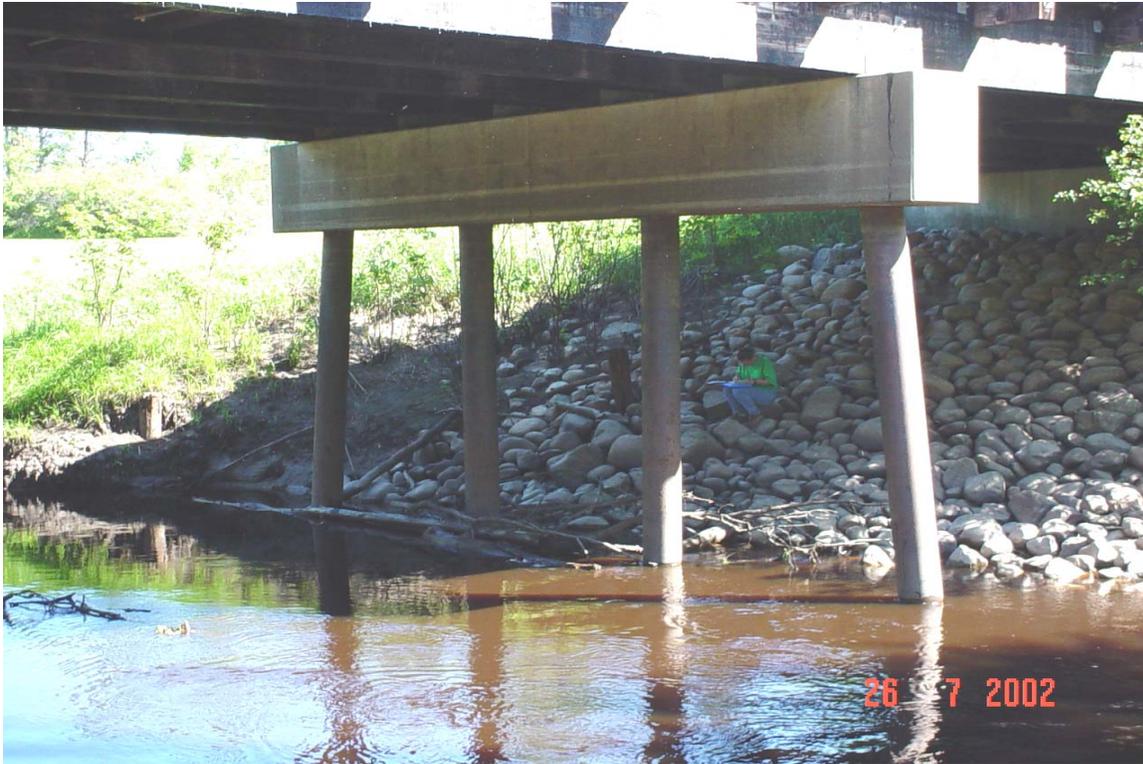
Photograph 3. View of Pier 2, Looking Northeast.

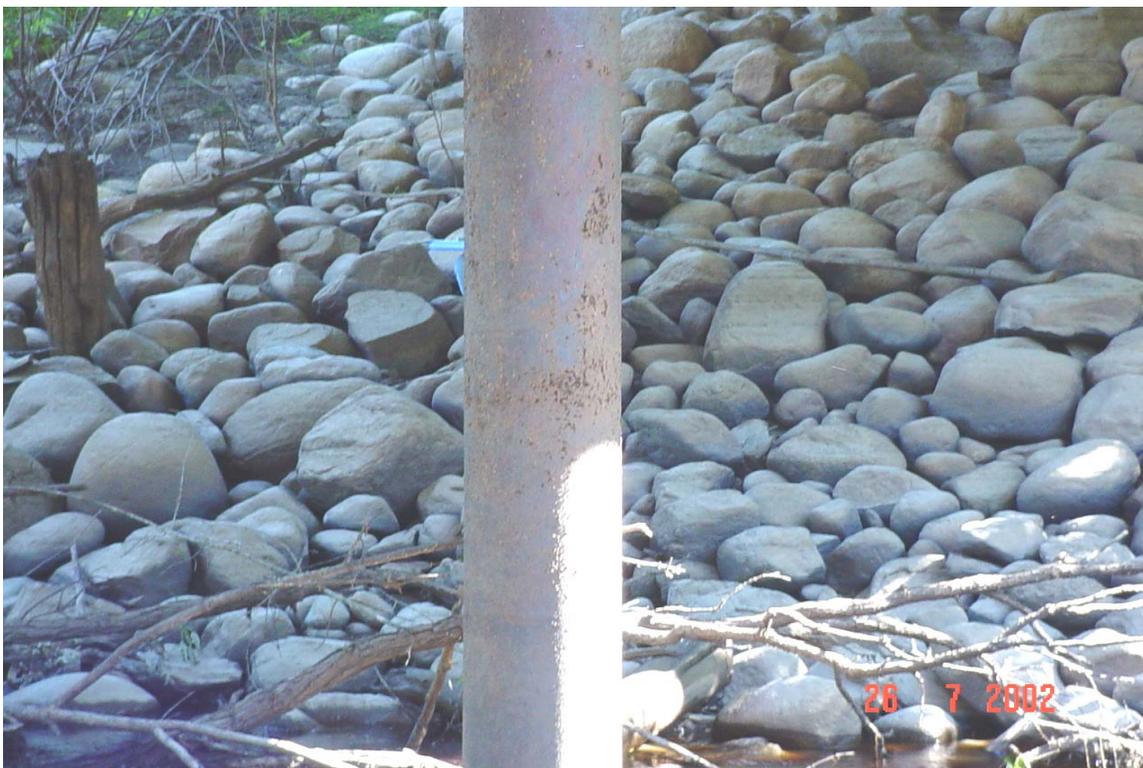
- (A) The steel pipe piles exhibited coating failure over 50 to 100 percent of their surface area with up to 1/4-inch-diameter corrosion nodules and 1/32-inch-deep pitting observed from 5 feet above the waterline to the channel bottom.
- (B) The west embankment was vertically eroded extending to 2 feet above the waterline at the upstream nose and to 4 feet above the waterline at the downstream nose of Pier 1.
- (C) A moderate accumulation of 1-foot-diameter-and-smaller timber debris was observed scattered throughout Pier 1 and a light accumulation of timber debris was observed along the upstream piles of Pier 2.

Photograph 4. View of Typical Corrosion of Steel Piles, Looking East.
