UNDERWATER BRIDGE INSPECTION REPORT

STRUCTURE NO. 36517
CSAH NO. 75
OVER THE
LITTLE FORK RIVER
DISTRICT 1 - KOOCHICHING COUNTY

PREPARED FOR THE
MINNESOTA DEPARTMENT OF TRANSPORTATION
BY
COLLINS ENGINEERS, INC.
JOB NO. 3512 (CEI 26)

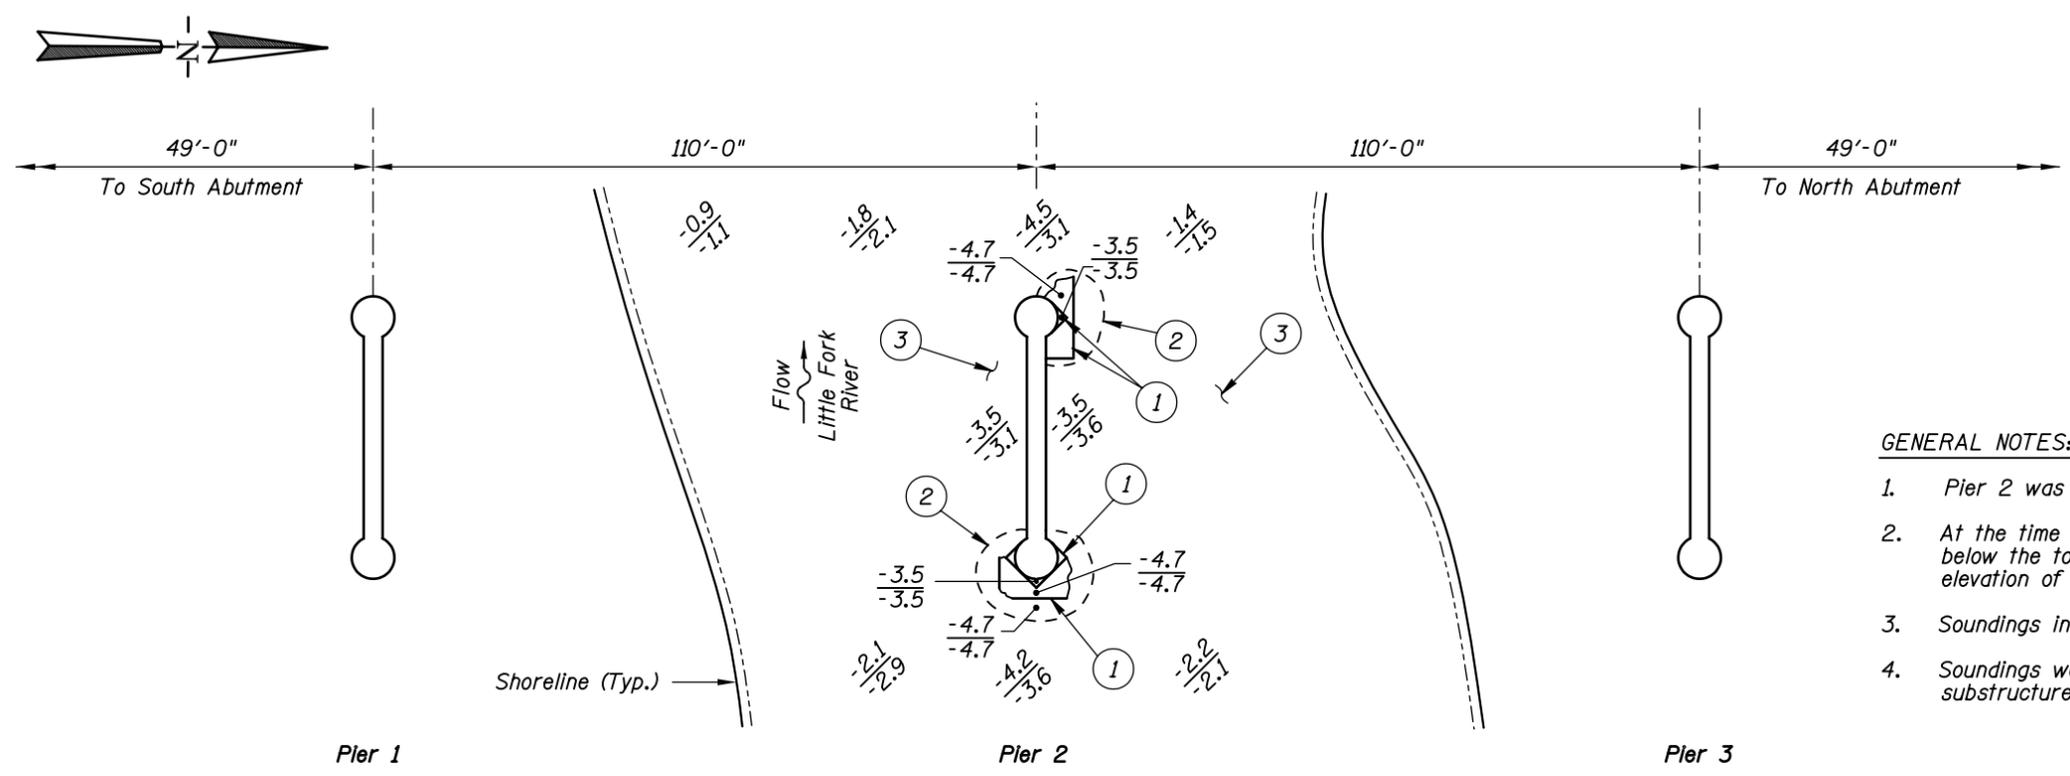
SOUNDING PLAN

- (A) There was minor footing exposure around upstream and downstream noses, with primarily the top of footing exposed at the upstream end and up to 3 inches of vertical height exposed at the downstream north face of the pier. The footing exposure was due to minor scour depressions up to 1 foot deep and 3 feet in radius at those locations.

- ① The footing was exposed at both noses of the pier. The exposure was primarily only the top of the footing and up to 3 inches of vertical exposure (at downstream site).
- ② Minor scour depressions, 3 feet in radius and 0.5 to 1 foot deep, were observed at the upstream end and downstream north face of the pier.
- ③ The channel bottom material consisted of a firm, sandy gravel and scattered riprap with up to approximately 1 inch probe rod penetration.

- (A) Footing exposures should be monitored during future inspections.
- (B) Reinspect the submerged substructure units at the normal maximum recommended (NBIS) interval of five (5) years.

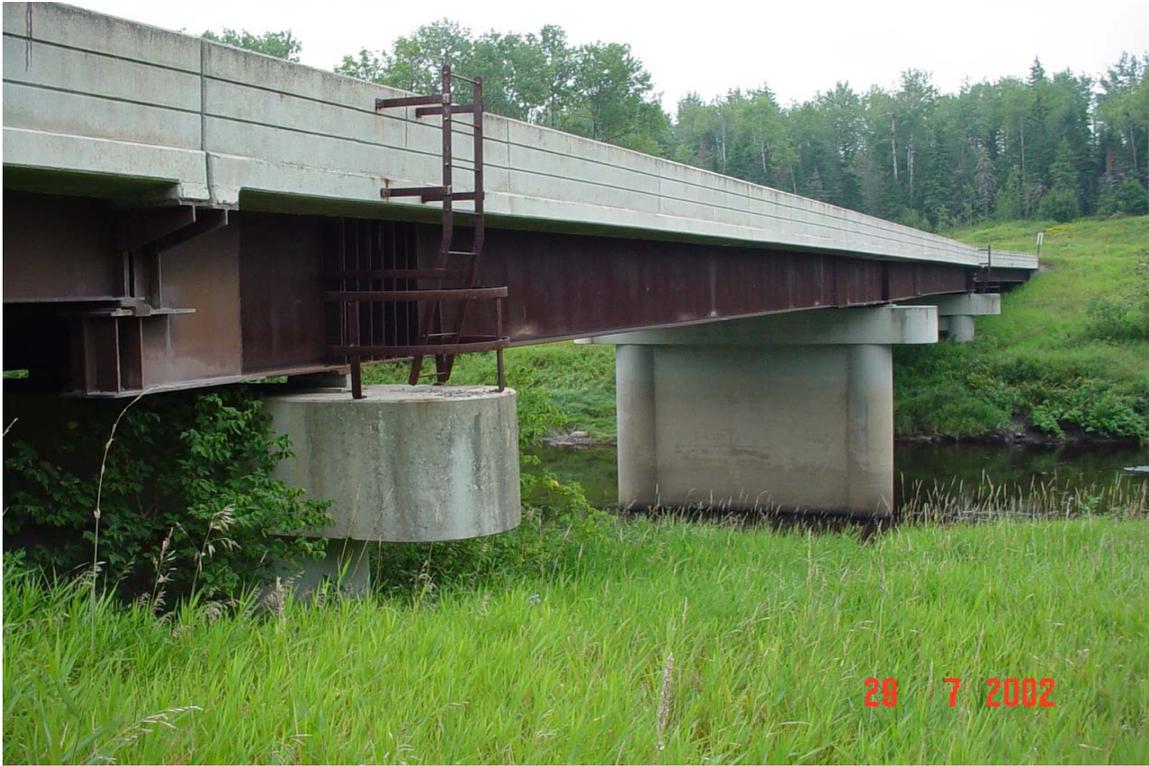
Photograph 1. Overall View, Looking Southeast.

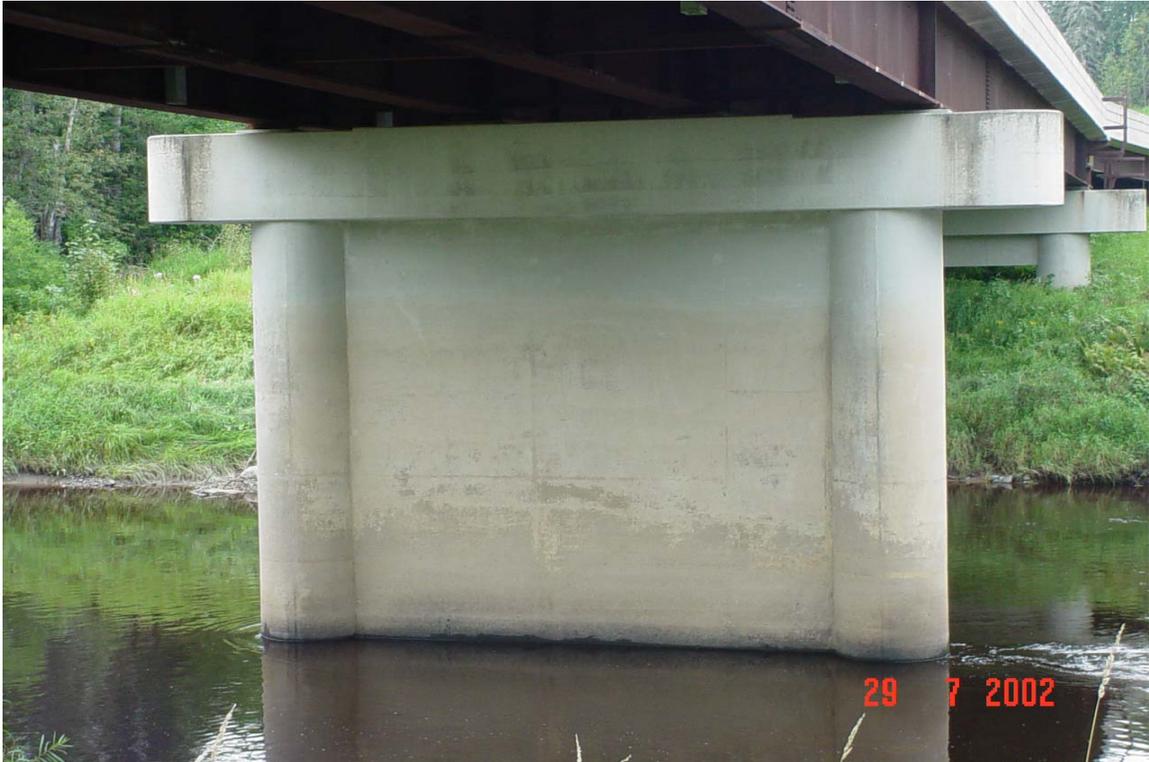
Photograph 2. Pier 2, Looking Southeast.
