UNDERWATER BRIDGE INSPECTION REPORT

STRUCTURE NO. 36523
CSAH NO. 18
OVER THE
EAST FORK OF THE RAPID RIVER
DISTRICT 1 - KOOCHICHING COUNTY

PREPARED FOR THE
MINNESOTA DEPARTMENT OF TRANSPORTATION

BY
COLLINS ENGINEERS, INC.

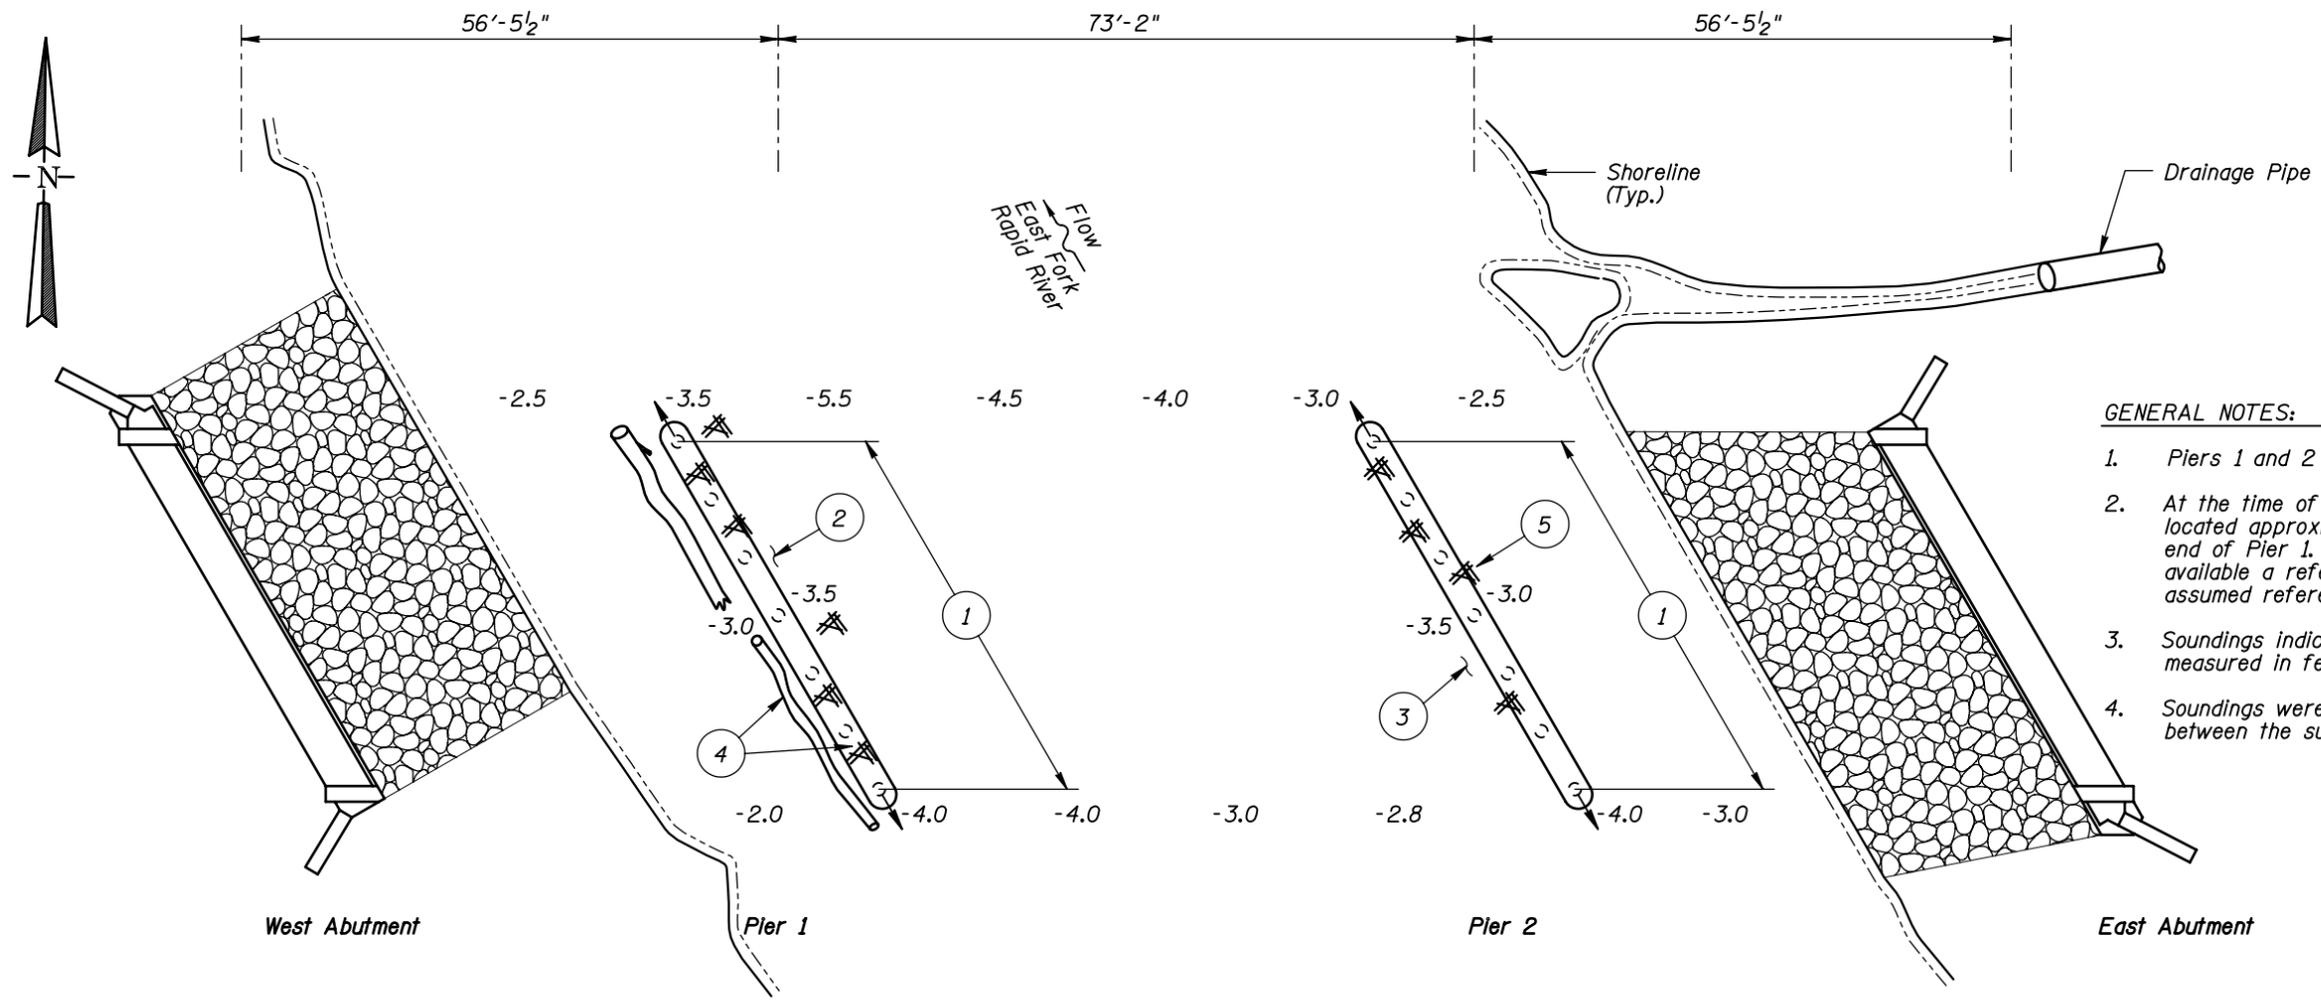
| INSPECTION AND SOUNDING PLAN | | |

- 1 The coating on the steel encased concrete piles (concrete filled pipe piles) exhibited initial signs of breakdown but no corrosion was observed.
- 2 The channel bottom at Pier 1 consisted of soft silt with a maximum probe rod penetration of 1 foot and occasional riprap.
- 3 The channel bottom at Pier 2 consisted of soft silt with a maximum probe rod penetration of 6 inches.
- 4 Two 1.5-foot-diameter tree trunks were observed along the west side of the pier and a light accumulation of 6-inch-diameter timber debris was observed scattered throughout the piles.
- 5 A light accumulation of 6-inch-diameter timber debris was observed scattered throughout the piles.

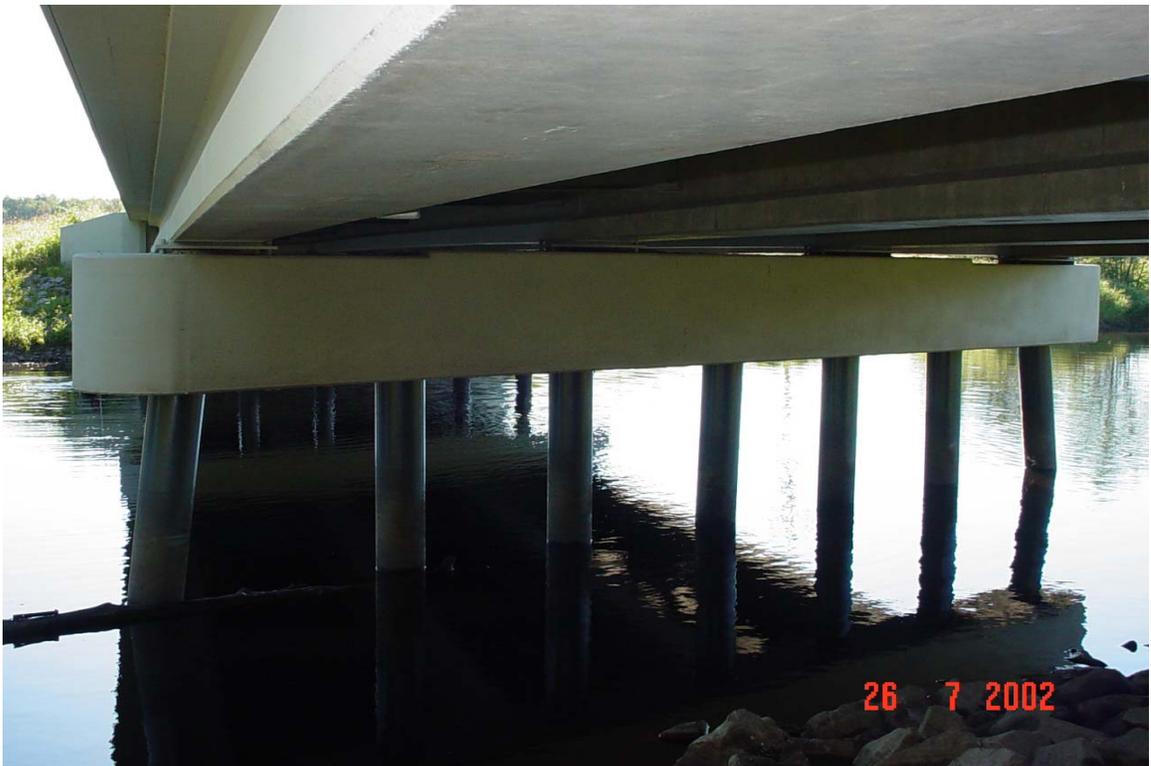
- (A) The outer coating on the steel encased concrete piles exhibited signs of initial breakdown, but no corrosion was observed.
- (B) Two 1.5-foot-diameter tree trunks were observed along the west side of Pier 1 and a light accumulation of 6-inch-diameter timber debris was observed scattered throughout the piles of both Piers 1 and 2.

Photograph 2. View of Pier 1, Looking Southeast.

- (A) Reinspect all substructure units underwater within the normal maximum (NBIS) interval of five (5) years. Monitor the drift accumulations and if found to be increasing in future, removal may be warranted at that time.

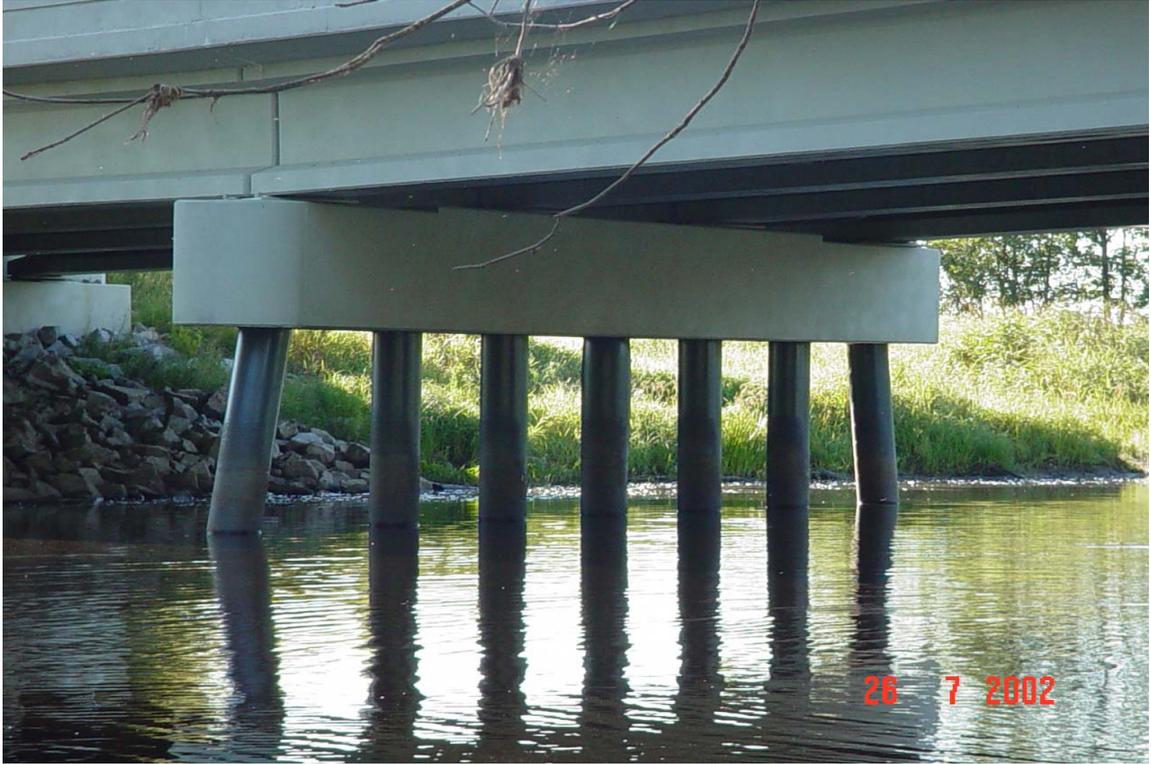
Photograph 3. View of Pier 2, Looking Southeast.
