UNDERWATER BRIDGE INSPECTION REPORT

STRUCTURE NO. 6665

ISLAND LAKE

JOB NO. 3512 (CEI 4)

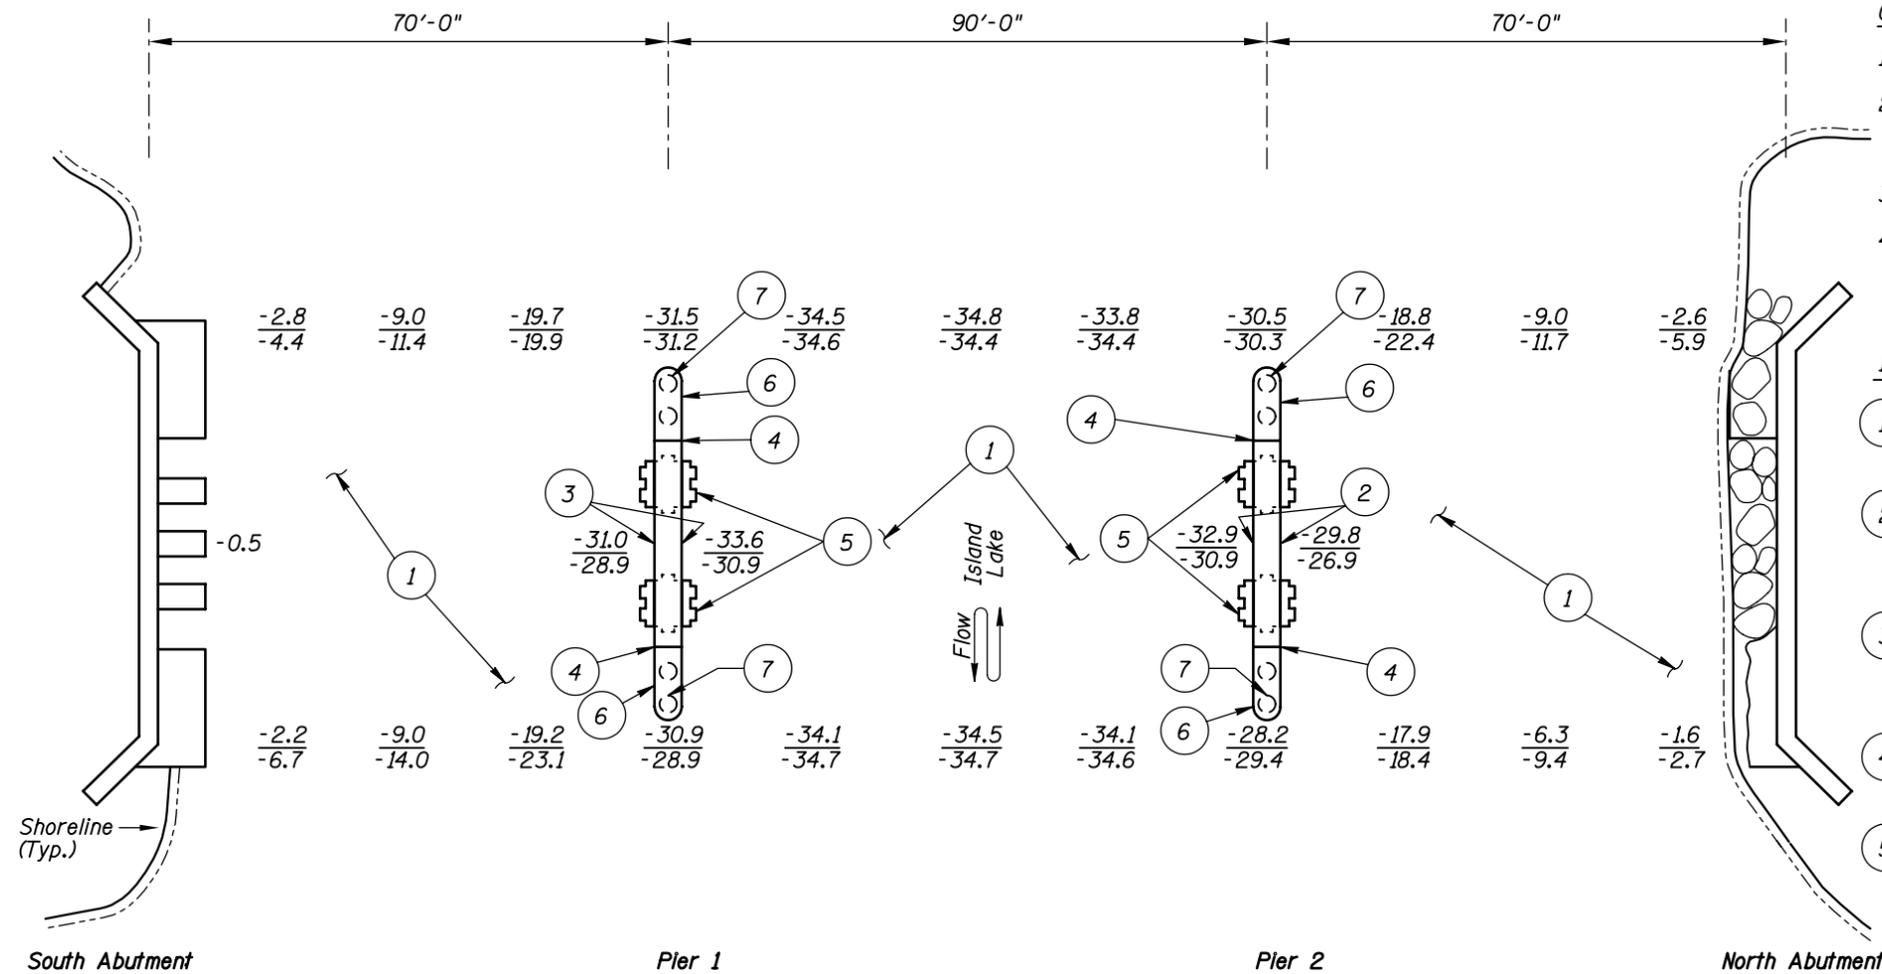
- The channel bottom consisted of sandy gravel with widespread 6 inch to 1 foot diameter riprap, overlaid with up to 1 inch of soft silt and 1 to 2 inches of probe rod penetration.

- Moderate scaling with typical penetrations of 1/4 inch and up to 1 inch maximum penetration with exposed aggregate on the older concrete surfaces in the middle of Pier 2, extending from approximately 1.5 feet above the waterline to 2 feet below the waterline.

- Moderate scaling with typical penetrations of 1/4 inch and up to 1/2 inch maximum penetration with exposed aggregate on the older concrete surfaces in the middle of Pier 1, extending from approximately 1.5 feet above the waterline to 2 feet below the waterline.

- Cracking between new and old concrete along entire interface, typically hairline to 1/8 inch wide with 1/4 inch maximum width (at south side of Pier 2).

- Rust nodules and surface corrosion were observed on all of the steel columns along the entire length, with the heaviest concentration (up to 1.5 inch diameter and/or uniform coverage) exhibited on the lower half, with 75 to 100 percent of the surface area covered and section losses up to 1/16 inch deep. On the upper half, lesser concentrations of up to 1/2 inch diameter nodules, with up to 50 percent of the surface area covered and section losses up to 1/8 inch deep.

- Light scaling with 1/8 inch of maximum penetration on the newer concrete surfaces at the end of Piers 1 and 2 in a 1.5 foot band at the waterline.
- Steel shell piles under pier widening additions exhibited surface corrosion ranging in coverage from 25 to 50 percent on upper 20 to 25 feet, and 80 to 100 percent with rust nodules on the bottommost 6 to 10 feet. Nodules typically have up to 1/32 inch deep pitting and a maximum of 1/16 inch deep pitting on the upper 10 feet of the piles.

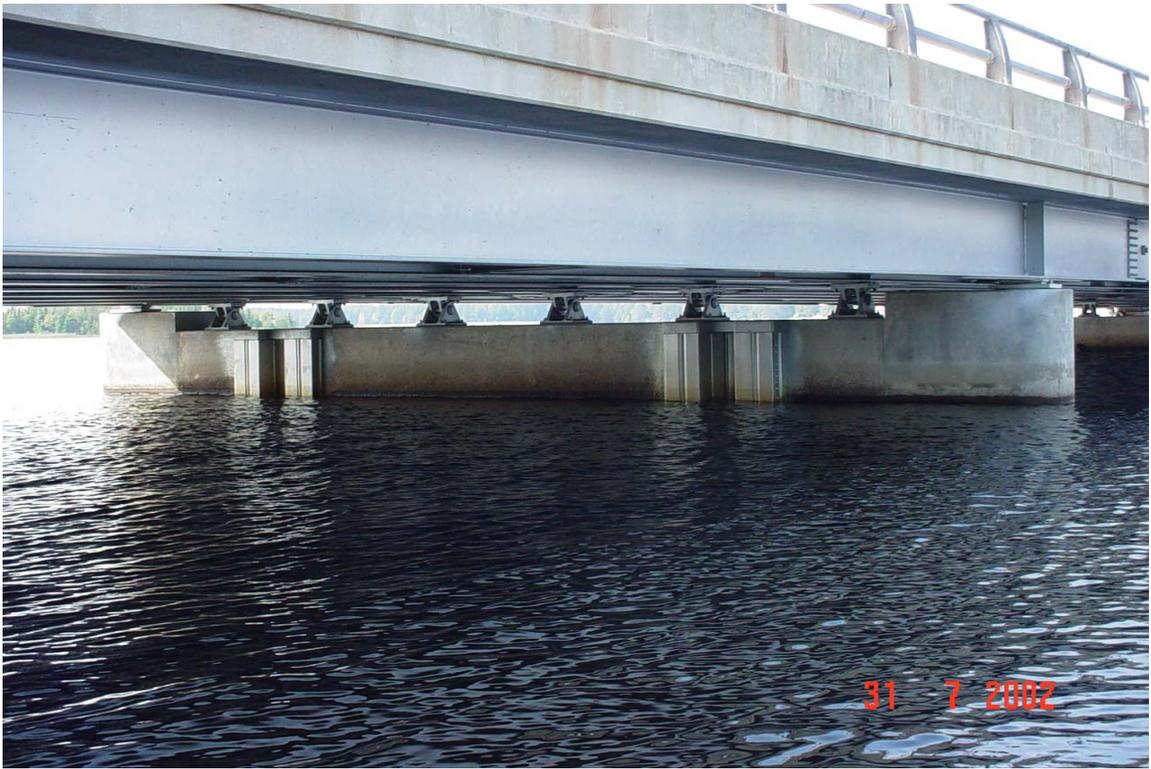
Photograph 3. View of Pier 1, Looking Northwest.

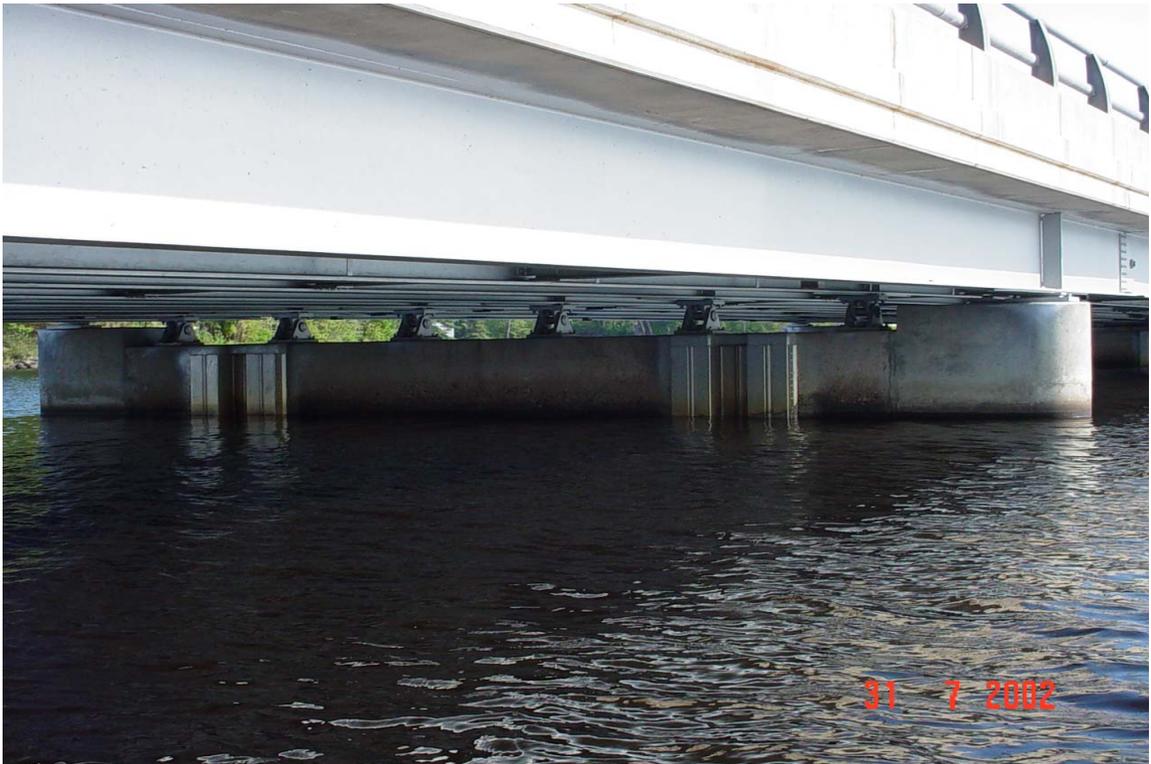
Photograph 4. View of Pier 2, Looking Southeast.

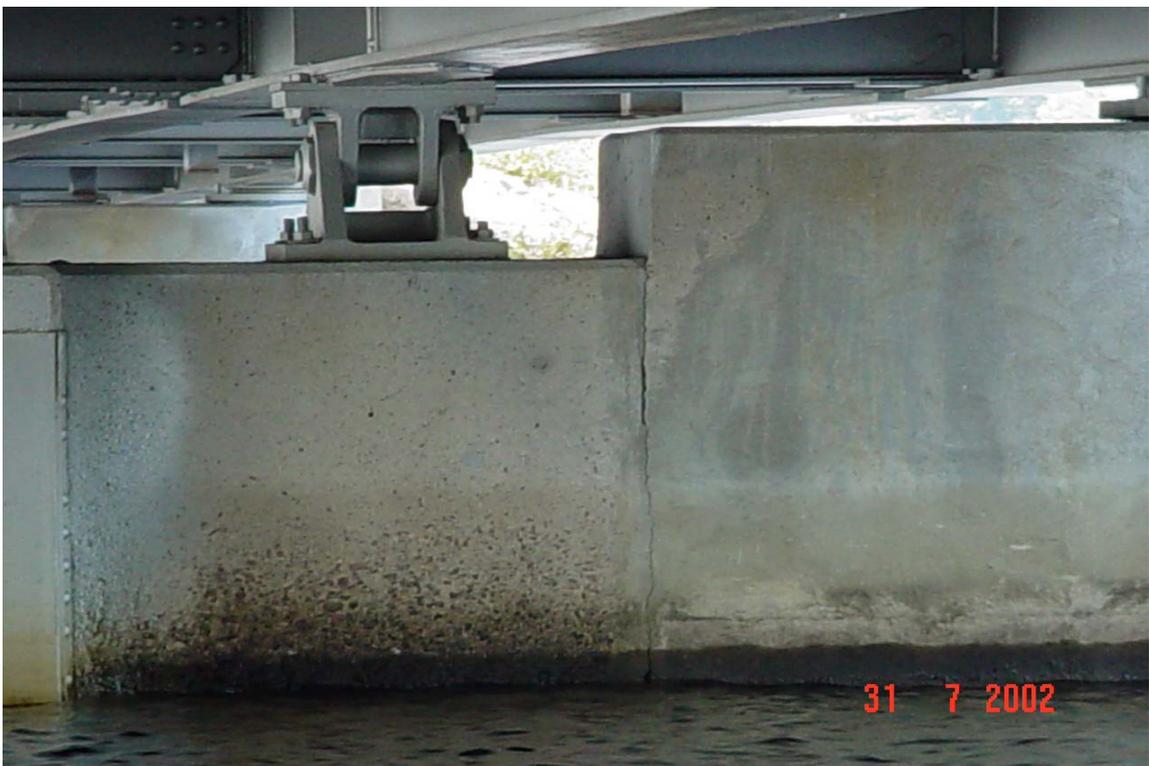
- (E) Vertical cracks were observed in the joint between the newer end concrete and the original middle concrete of the piers, with maximum widths of 1/8 to 1/4 inch.

Photograph 6. View of typical cracking on Pier 1, Looking Northwest.

- (A) Monitor cracking between the original and new concrete of piers, and if found to be worsening, repairs with epoxy based materials may be required. The cracking appears stable (same as last inspection, no differential movement), but could be aggravated by freeze/thaw action, and should therefore be monitored during future inspections.
- (B) Reinspect the submerged substructure units at the normal maximum recommended (NBIS) interval of five (5) years.
