UNDERWATER BRIDGE INSPECTION REPORT

STRUCTURE NO. 69505  
CSAH NO. 8  
OVER THE  
ST. LOUIS RIVER  
DISTRICT 1 – ST. LOUIS COUNTY

PREPARED FOR THE  
MINNESOTA DEPARTMENT OF TRANSPORTATION  
BY  
COLLINS ENGINEERS, INC.  
JOB NO. 3512 (CEI 2)

MINNESOTA DEPARTMENT OF TRANSPORTATION  
UNDERWATER BRIDGE INSPECTION

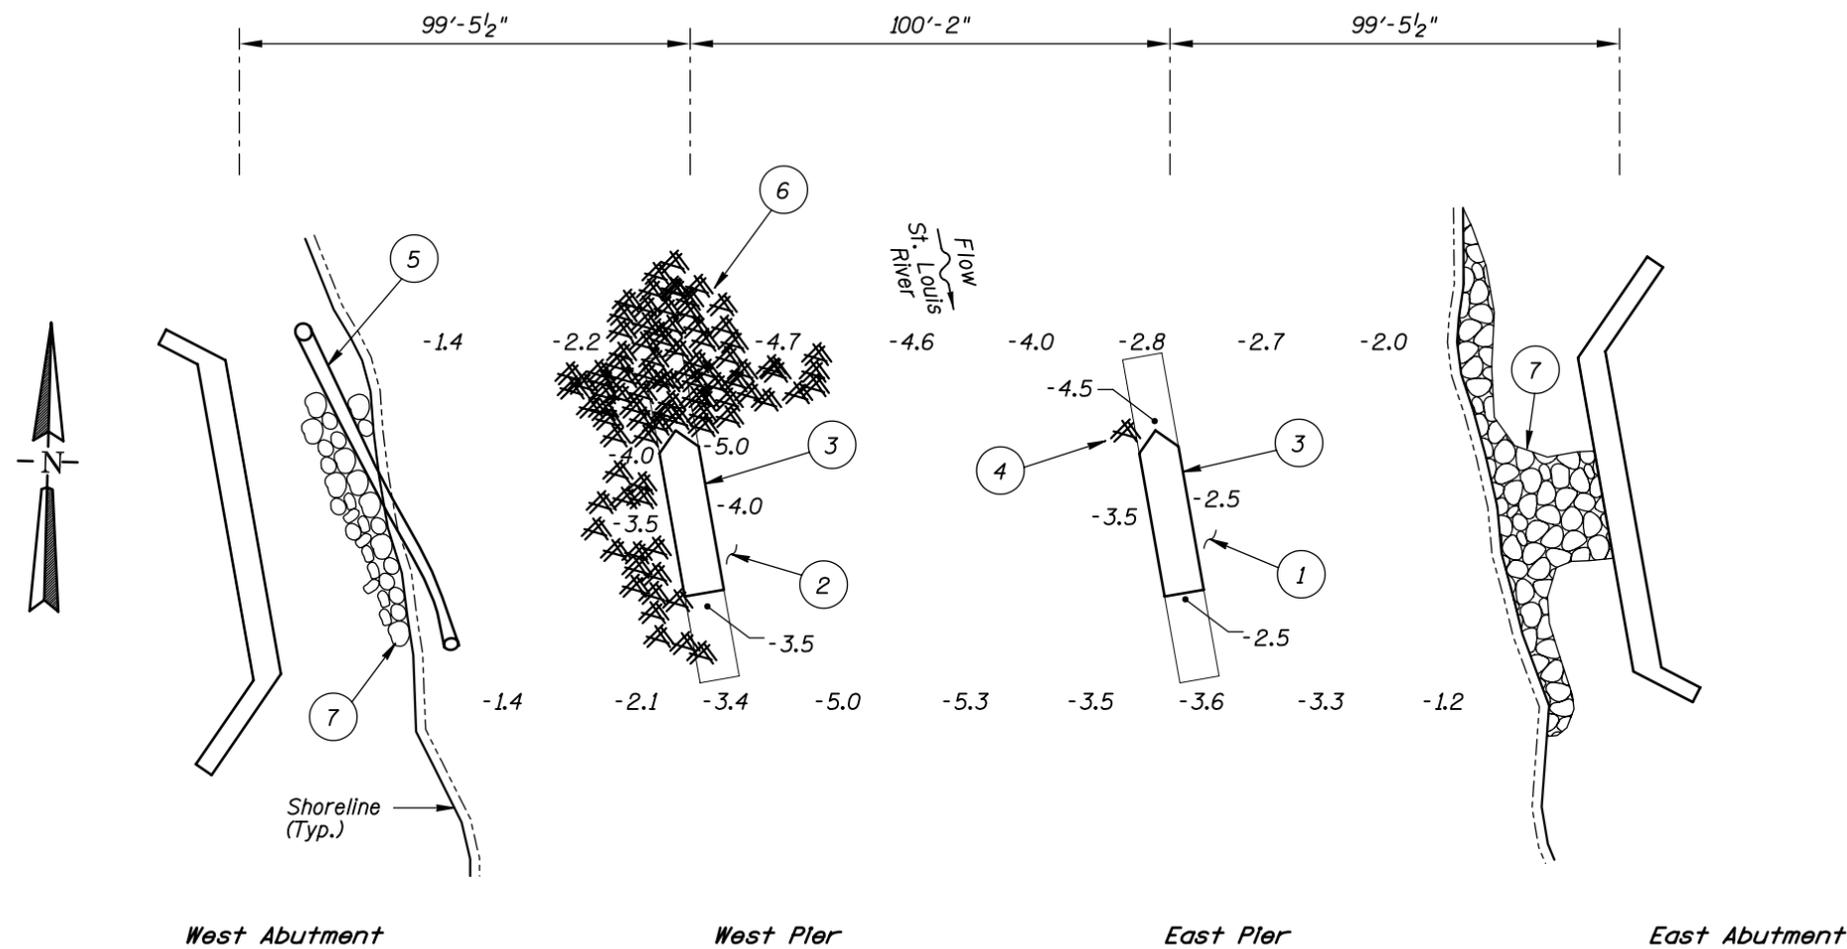
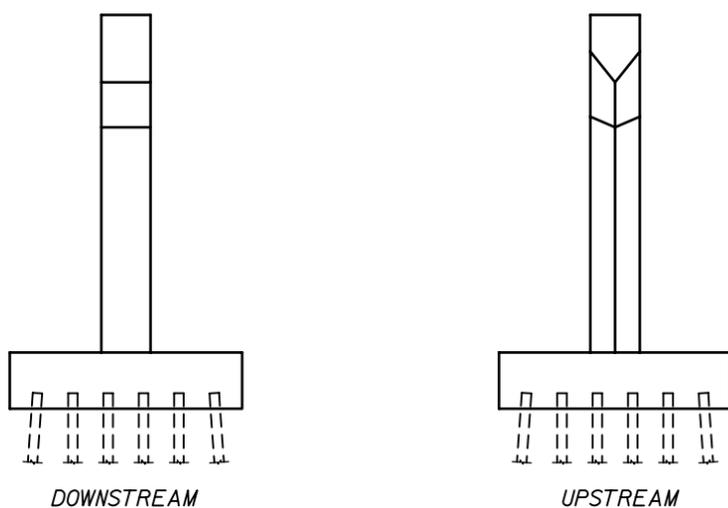
- 1 The channel bottom consisted of 1- to 2-foot-diameter riprap and cobbles.
- 2 The channel bottom consisted of 1 to 2 inches of soft silt over a firm mix of 1-to 2-foot-diameter riprap and cobbles.
- 3 The concrete exhibited light scaling 3 feet above the waterline to the channel bottom with exposed aggregate and typical penetrations of 1/8 inch and maximum penetrations of 1/4 inch.
- 4 A 1-foot-diameter log was observed on the channel bottom.
- 5 A 2-foot-diameter tree trunk was observed on the West shoreline.
- 6 A heavy accumulation of 2-foot-diameter and smaller timber debris was observed at the upstream end and along the shore side of the West Pier extending from the channel bottom to 8 feet above the waterline. The drift extended 20 feet upstream of the pier and 30 feet into the adjoining spans.
- 7 1- to 2-foot-diameter riprap and cobbles were observed at the embankments.

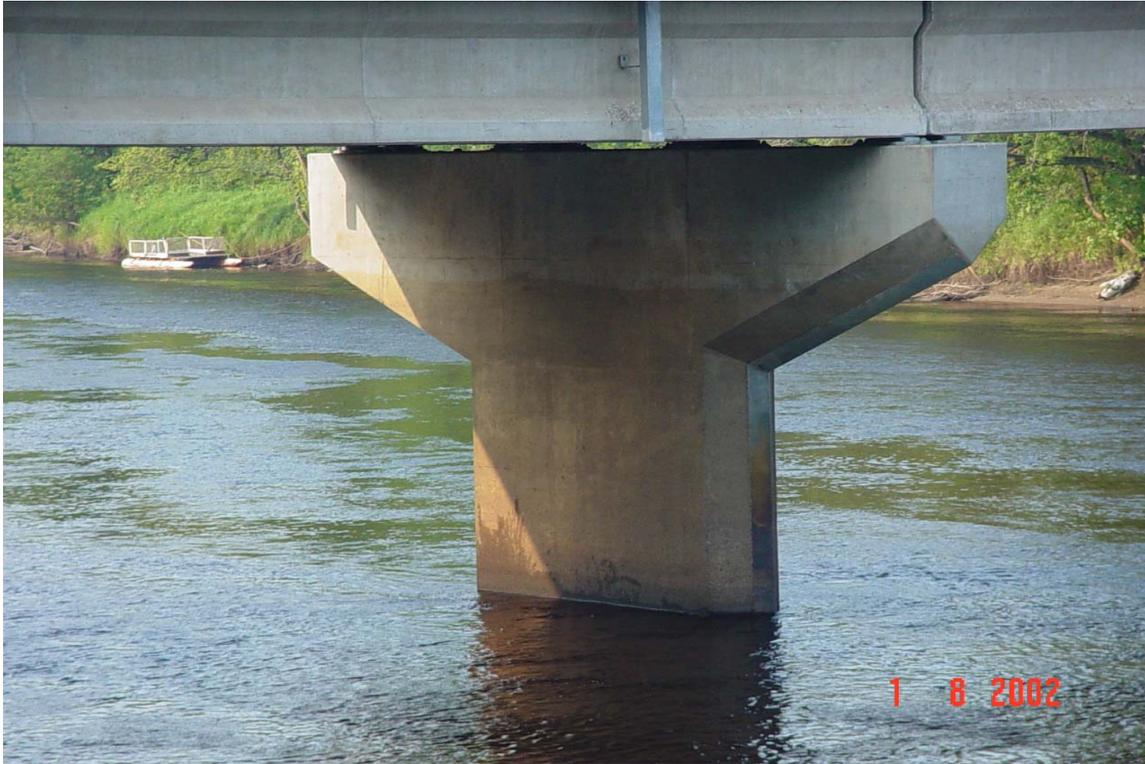
Photograph 2. View of East Pier, Looking Southwest.

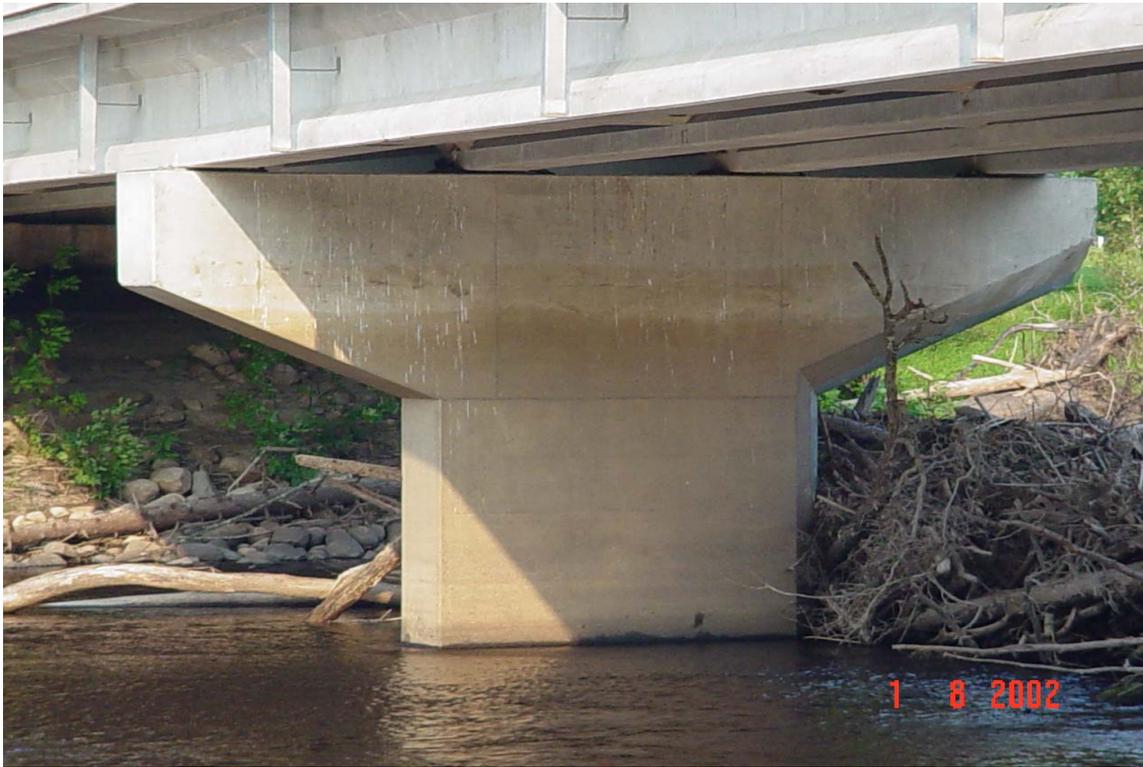
Photograph 3. View of West Pier, Looking Northwest.

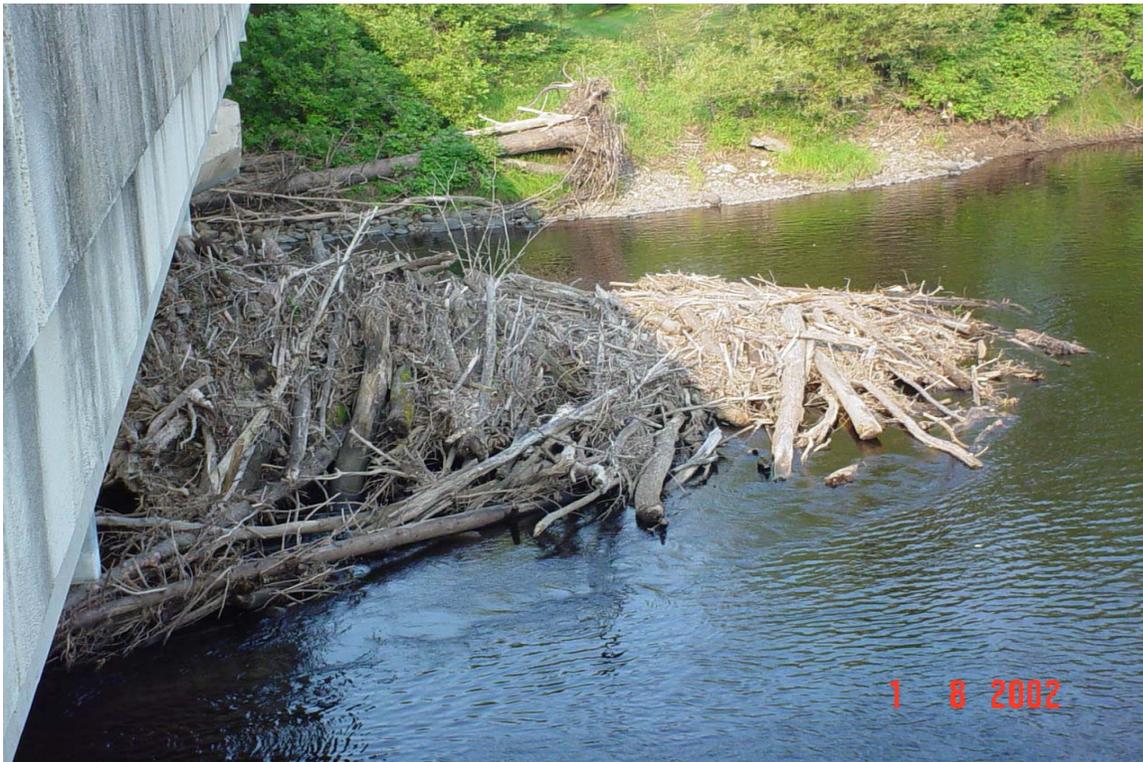
Photograph 4. View of Heavy Accumulation of Timber Debris at West Pier, Looking West.

REMARKS: Overall, the concrete was in good, sound condition with light scaling from 3 feet above the waterline to the channel bottom with exposed aggregate and typical penetrations of 1/8 inch and maximum penetrations of 1/4 inch. A very heavy accumulation of timber debris was observed extending 30 feet upstream, 30 feet into the spans and 8 feet above the waterline at the upstream end of the West Pier.

- (A) Remove heavy accumulation of timber debris from around the West Pier as soon as possible to alleviate flow restriction, to eliminate potential for scour, and to limit lateral force imposed in the substructure unit.

Remove heavy accumulation of timber debris from around the West Pier as soon as possible to alleviate flow restriction, to eliminate scour potential and to limit lateral force imposed in the substructure unit.
