UNDERWATER BRIDGE INSPECTION REPORT

STRUCTURE NO. 69530
CSAH NO. 139
OVER THE
LITTLE FORK RIVER
DISTRICT 1 - ST. LOUIS COUNTY

PREPARED FOR THE
MINNESOTA DEPARTMENT OF TRANSPORTATION
BY
COLLINS ENGINEERS, INC.
JOB NO. 3512 (CEI 11)

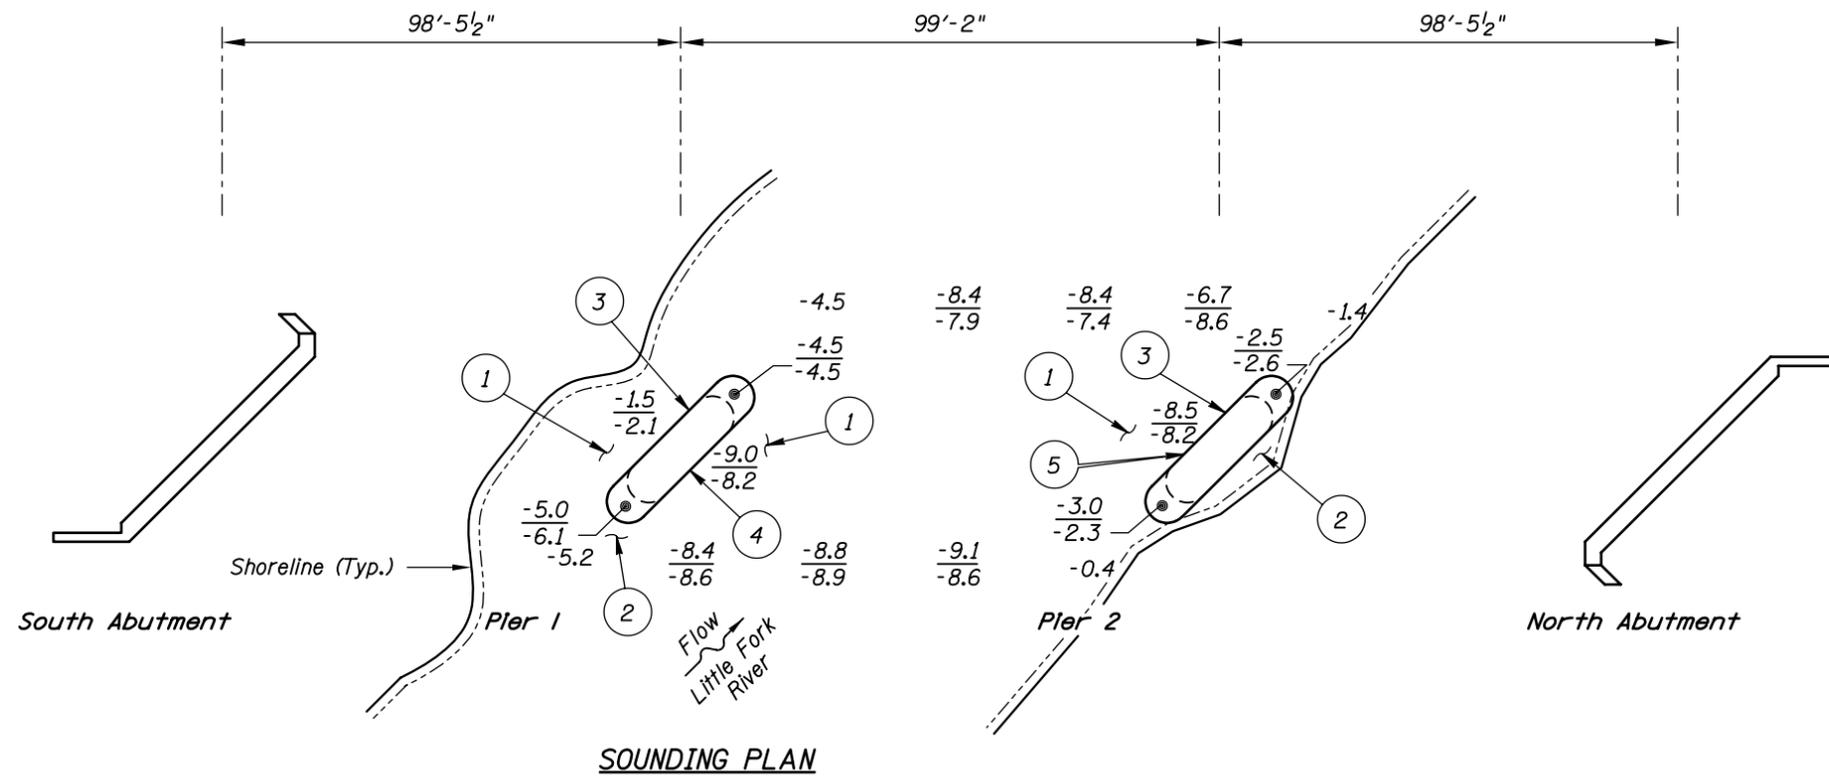
- 1 The channel bottom material consisted of soft silt and scattered riprap with probe rod penetrations up to 1 foot at Pier 2 and up to 1.5 feet at Pier 1.
- 2 The channel bottom material consisted of 6-inch to 1-foot-diameter riprap at the upstream nose of Pier 1 and along the north face of Pier 2.
- 3 The concrete at both piers was smooth and in good condition below water.
- 4 The top of the footing along the north face of Pier 1 was located with a probe rod below 1.5 feet of soft silt.
- 5 The top of the footing along the south face of Pier 2 was located with a probe rod below 1 foot of soft silt.

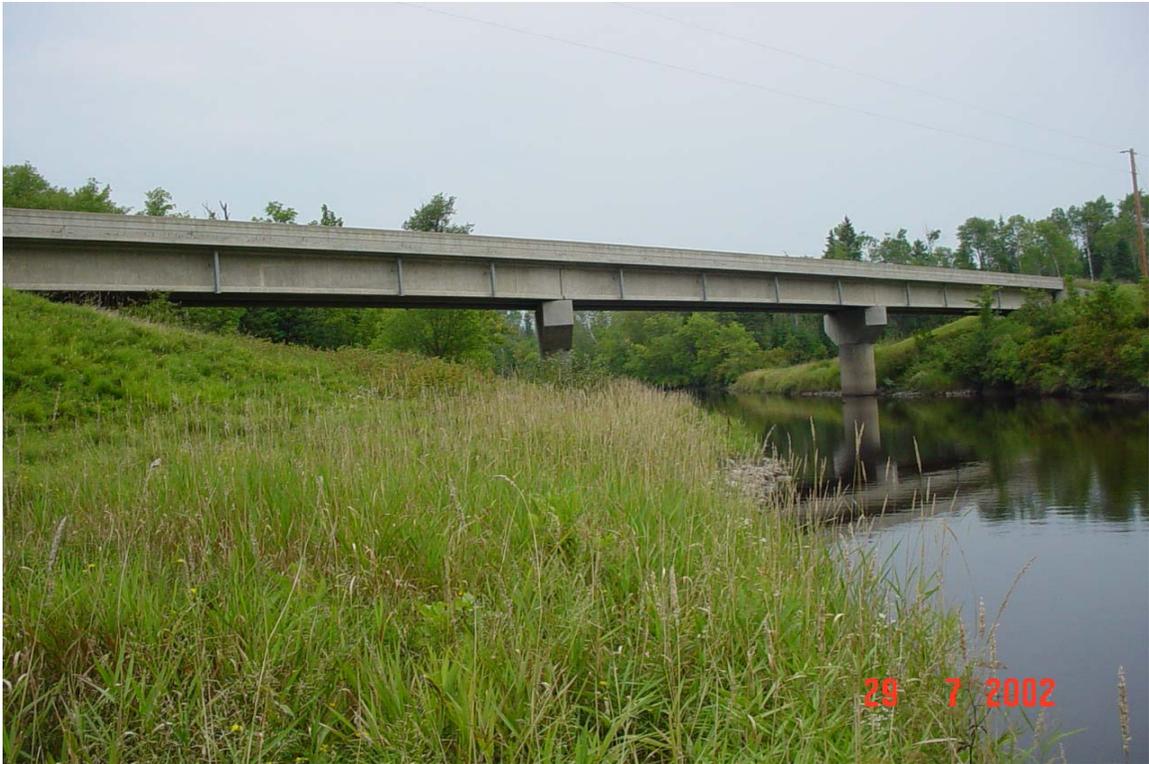
Photograph 1. Overall View of the Structure, Looking Northwest.

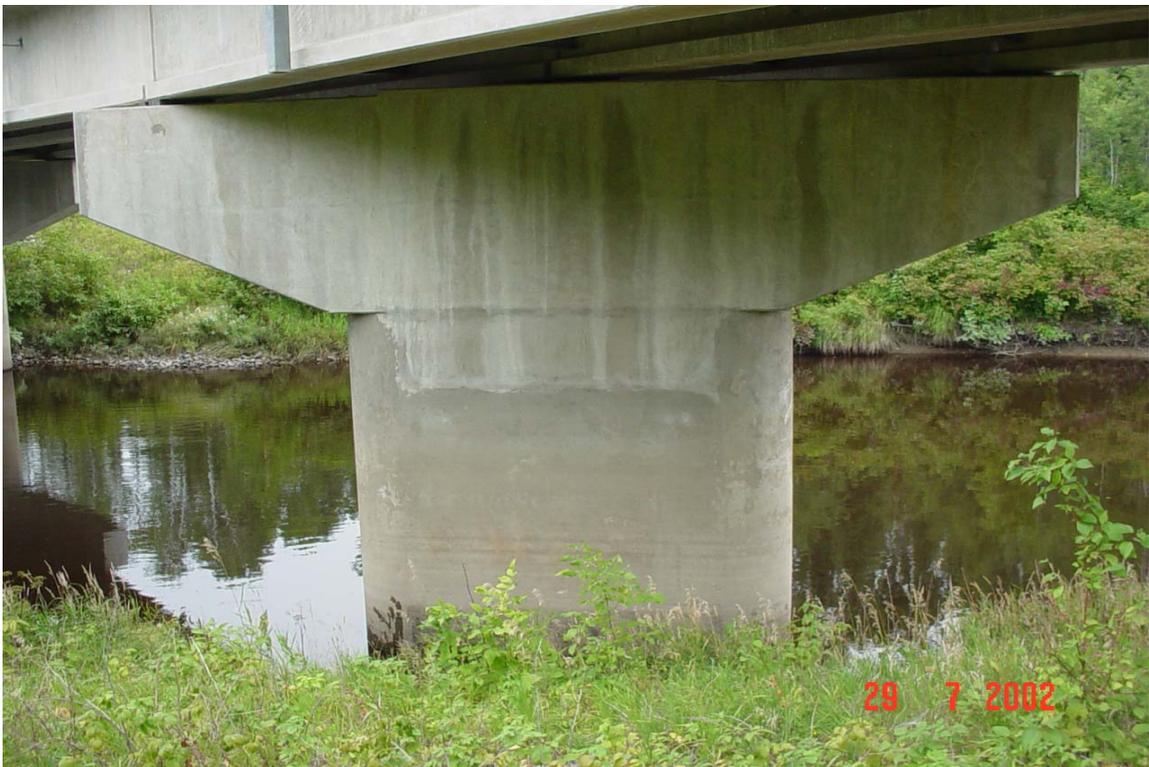
- (A) No defects of structural significance were detected.
- (B) The footing along the south side of Pier 2 was located below 1 foot of soft silt. The footing along the north side of Pier 1 was located below 1.5 feet of soft silt.

Photograph 2. View of Pier 1, Looking Northeast.

- (A) Monitor the footings for exposure during future underwater inspections.
- (B) Reinspect the submerged substructure units at the normal maximum recommended (NBIS) interval of five (5) years.

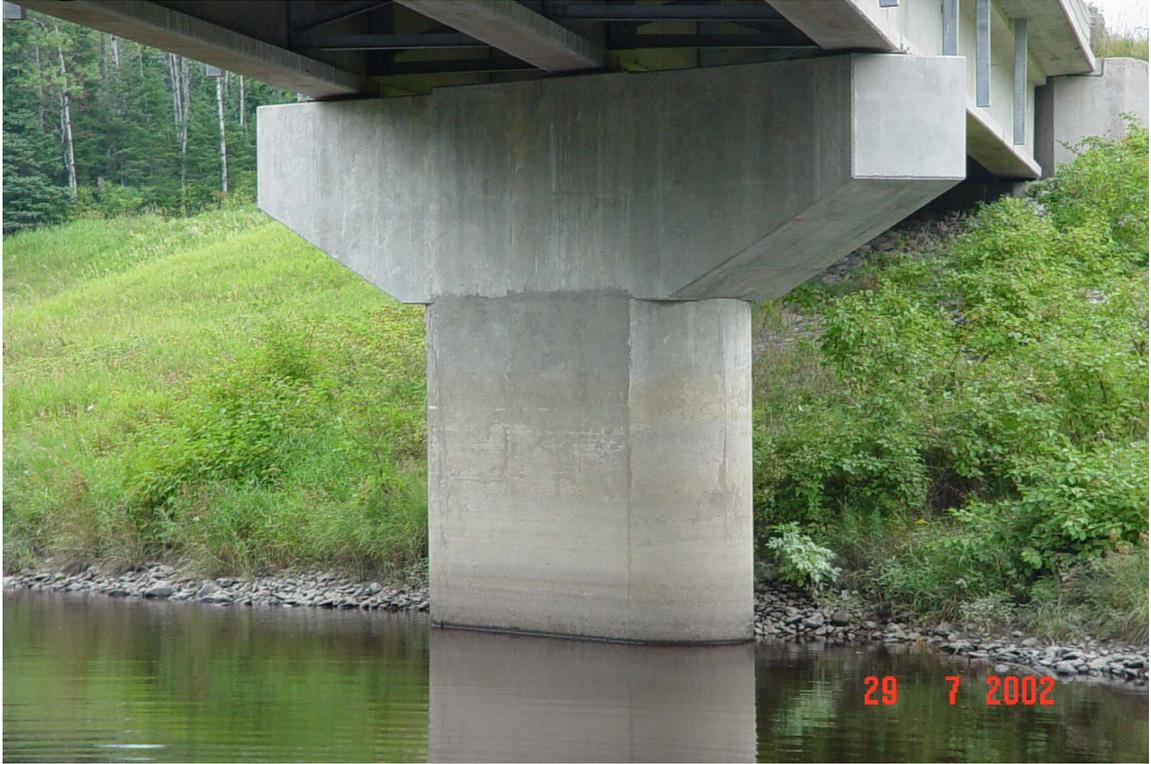
Photograph 3. View of Pier 2, Looking Northwest.
