UNDERWATER BRIDGE INSPECTION REPORT

STRUCTURE NO. 7054

CSAH 22

STURGEON RIVER

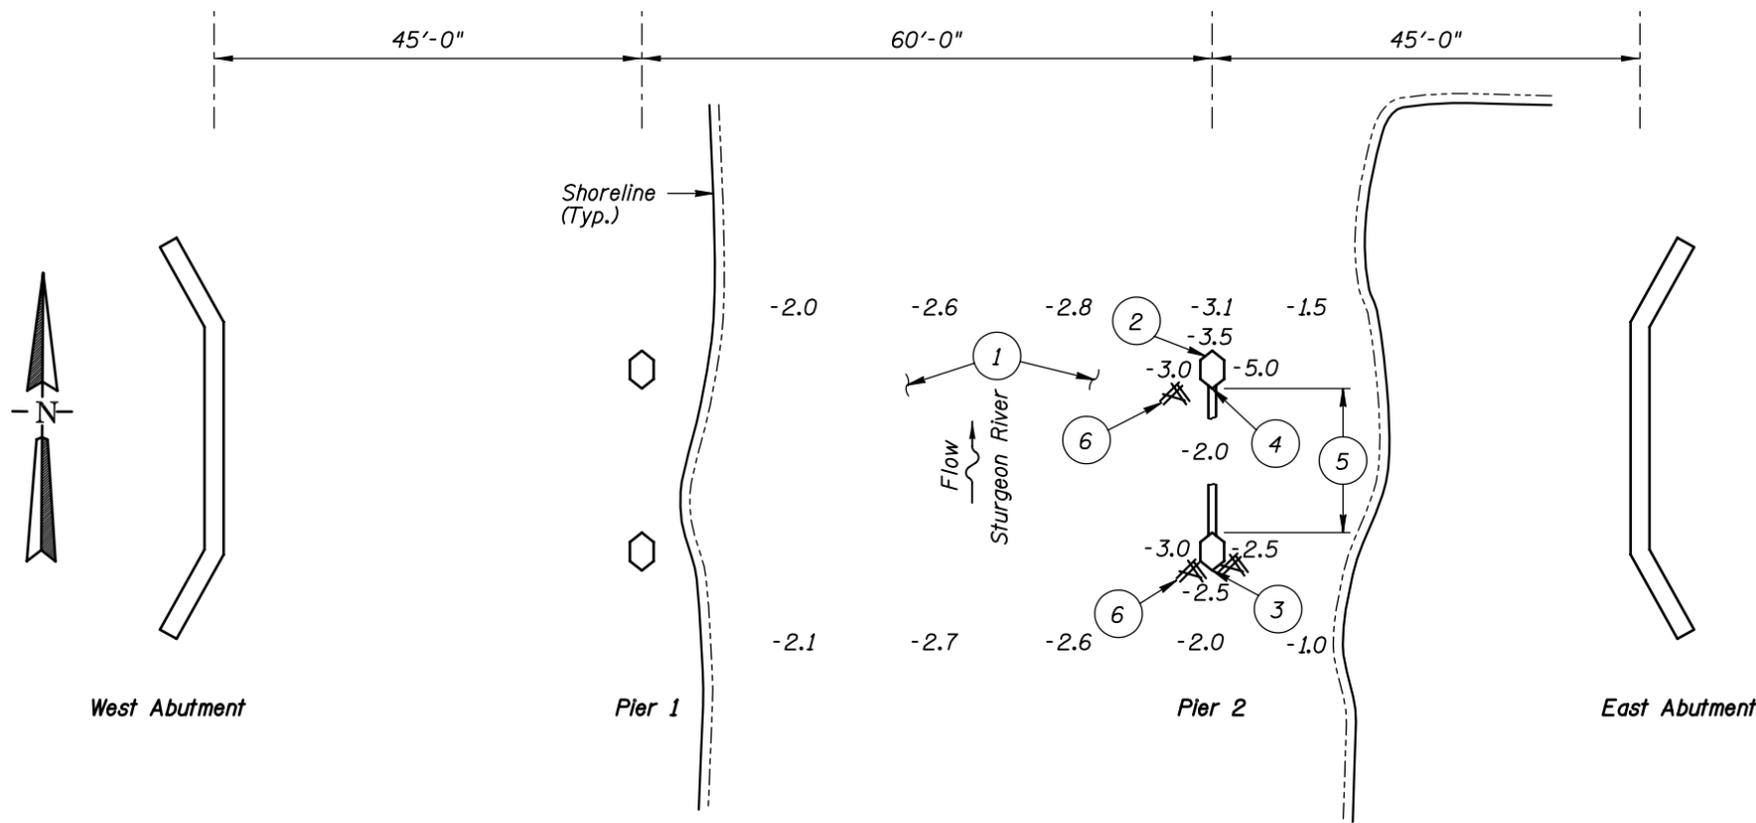
**TYPICAL END VIEW OF PIERS**

- ① The channel bottom consisted of silty sand with 0.5 to 1 foot of probe rod penetration.
- ② Light to moderate scaling with penetrations ranging from 1/8 inch to 1/4 inch, with a maximum penetration of 1/2 inch, was observed from 4 feet above the waterline to the mudline on both columns of Pier 2.

- ③ An area of section loss along the upstream column bevels was observed from 1.5 feet below the waterline to 1.5 feet above the waterline with a maximum penetration of 3 inches.

- ④ A 1-foot-wide void was observed on the upstream face of the downstream column from 1 foot above the waterline to the top of the strut with a maximum penetration of 6 inches.

- ⑤ The top portion of the horizontal strut was exposed from the upstream column to 4 feet downstream and from the downstream column to 4 feet upstream, and was covered by the channel bottom material along the center of the strut.

- ⑥ A light accumulation of 3-inch-diameter and smaller timber debris was observed at the upstream column and a 6-inch-diameter log was observed at the downstream column.

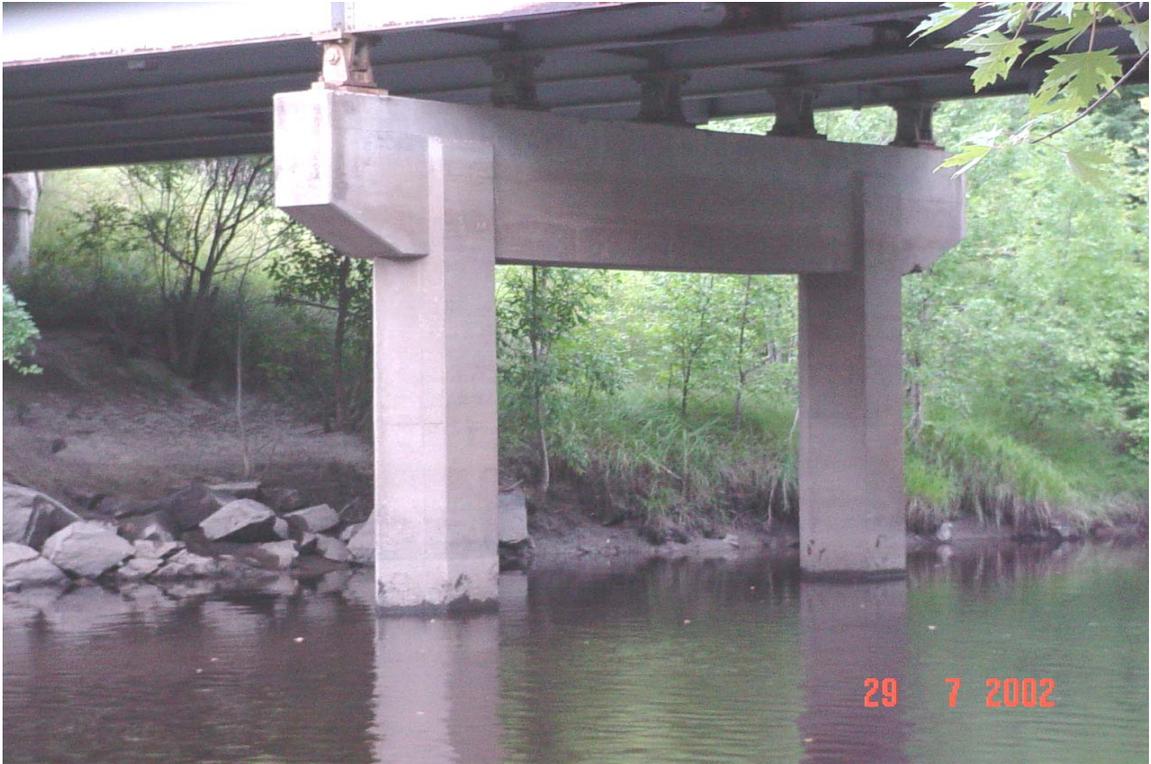
- (B) An area of section loss along the beveled sides of the upstream column, extending from 1.5 feet below the waterline to 1.5 feet above the waterline with a maximum penetration of 3 inches, was observed on the upstream side of the upstream column of Pier 2.

- (C) A void measuring from 1 foot above the waterline to the top of the horizontal strut between columns with a maximum penetration of 6 inches was observed on the upstream face of the downstream column of Pier 2.

- (D) The top portion of the horizontal strut connecting the columns of Pier 2 was exposed from the upstream column to 4 feet downstream and from the downstream column to 4 feet upstream, and was covered by the channel bottom material across the center portion of the pier.

Photograph 3. View of Pier 2, Looking Southeast.
