UNDERWATER BRIDGE INSPECTION REPORT

STRUCTURE NO. 7254

KETTLE RIVER

MINNESOTA DEPARTMENT OF TRANSPORTATION  
UNDERWATER BRIDGE INSPECTION

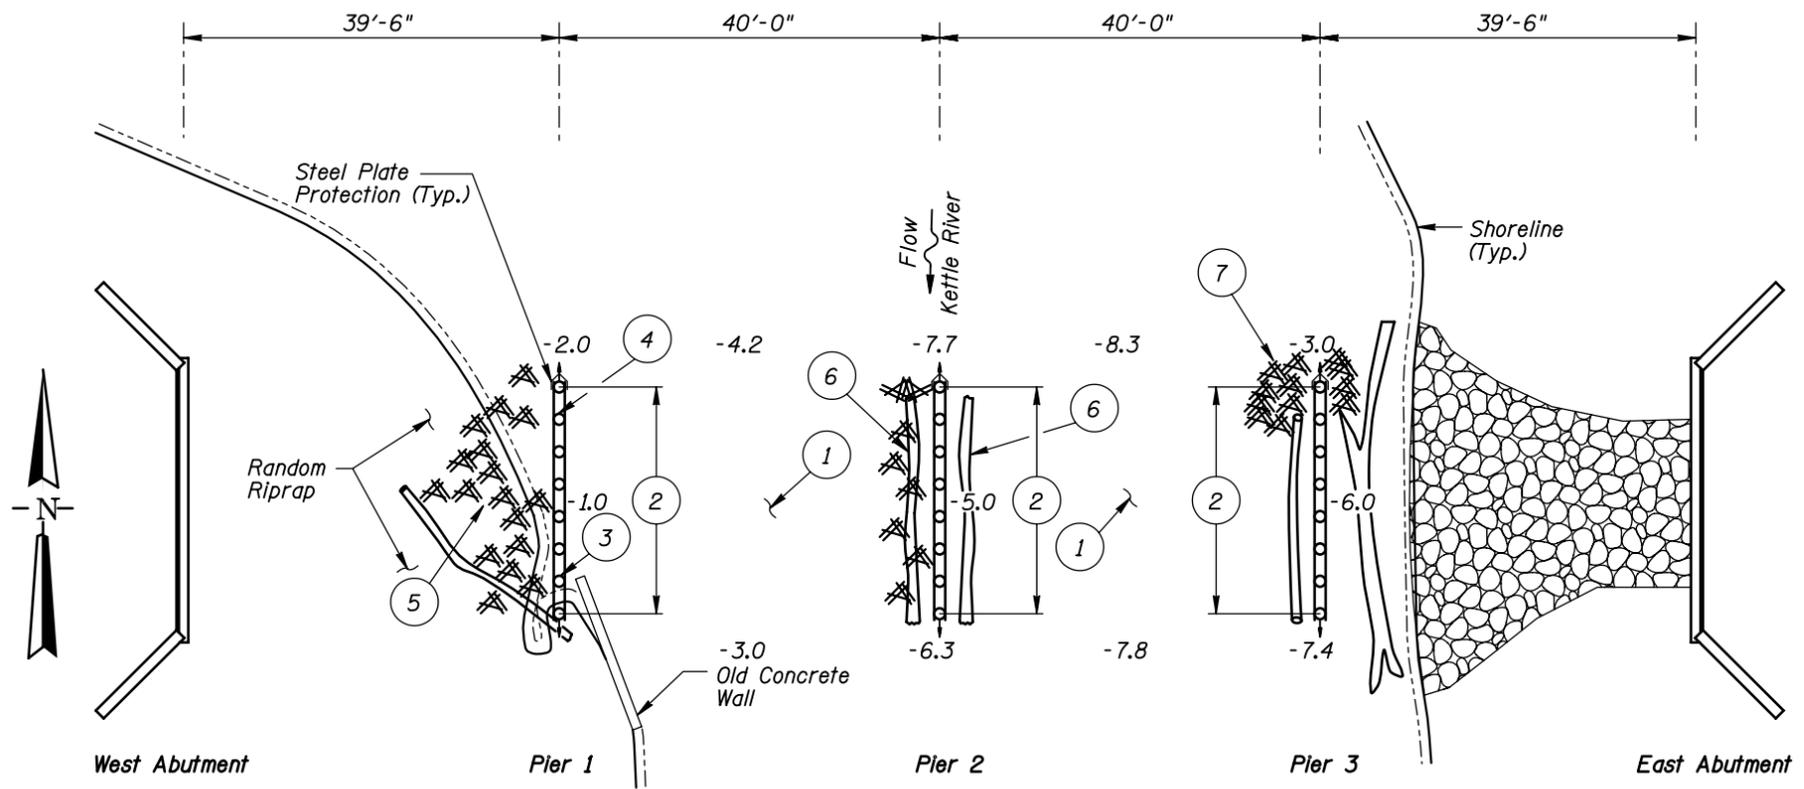
**SOUNDING PLAN**

- 1 The channel bottom consisted of silty sand with up to 1 foot of probe rod penetration.
- 2 The timber piles exhibited minor vertical checking and vertical splits on the outside of the timber shell. Also, the horizontal planking exhibited minor splits and some checking.

- 3 The bottom of the horizontal planking was 2 feet above the waterline at Pier 1.
- 4 The diagonal cross bracing at the upstream end of Pier 1 was split through the connection and exhibited partial section loss along the upstream half of the pier.

- 5 A minor accumulation of 6-inch-diameter and smaller timber debris was observed along the west face of Pier 1.
- 6 A 12-inch-diameter tree trunk with branchy debris was observed along the west face of the pier, and a timber log on the channel bottom was observed along the east face.

- 7 A moderate accumulation of timber debris was observed at the upstream end of Pier 3 with 3-foot-diameter logs that extended along each face of the pier.

- (A) At this point, the timber drift accumulations at the bridge are not excessive; however, they should be monitored, and if found to be progressing to an extent where excessive lateral loads may be exerted on the piers or scour may be influenced, the drift may need to be removed at that time.

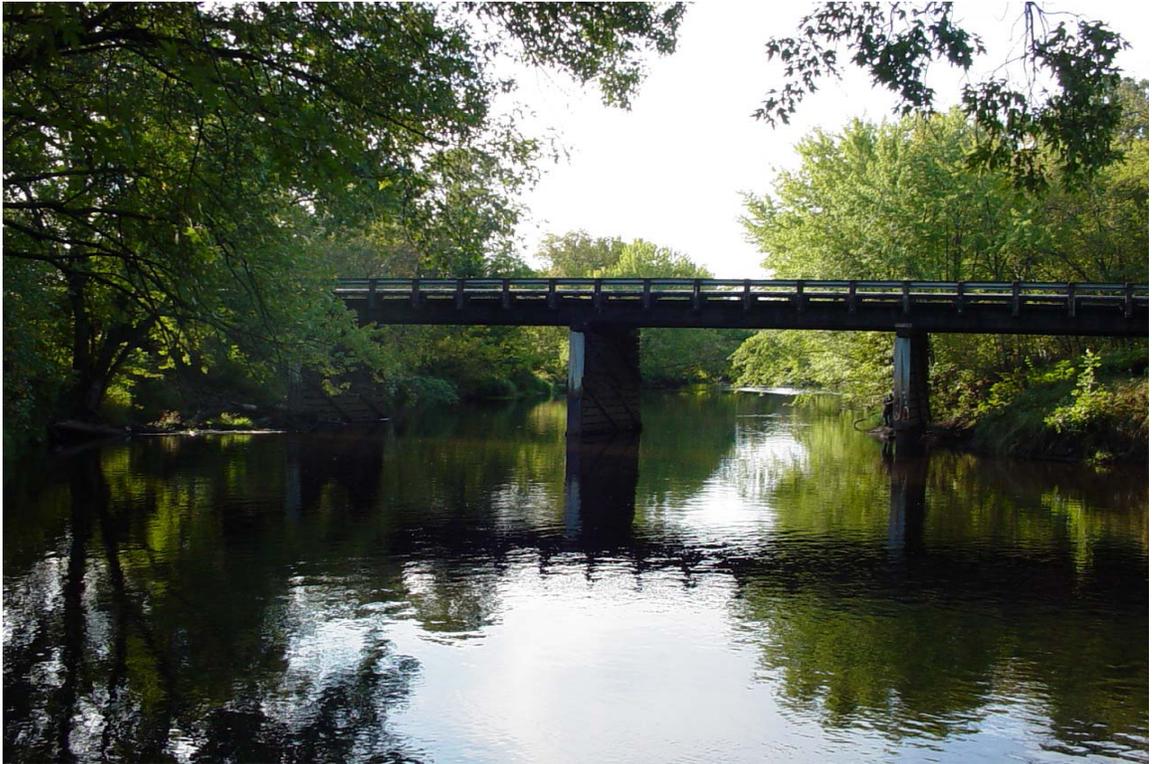
Photograph 1. Overall View of Structure, Looking South.

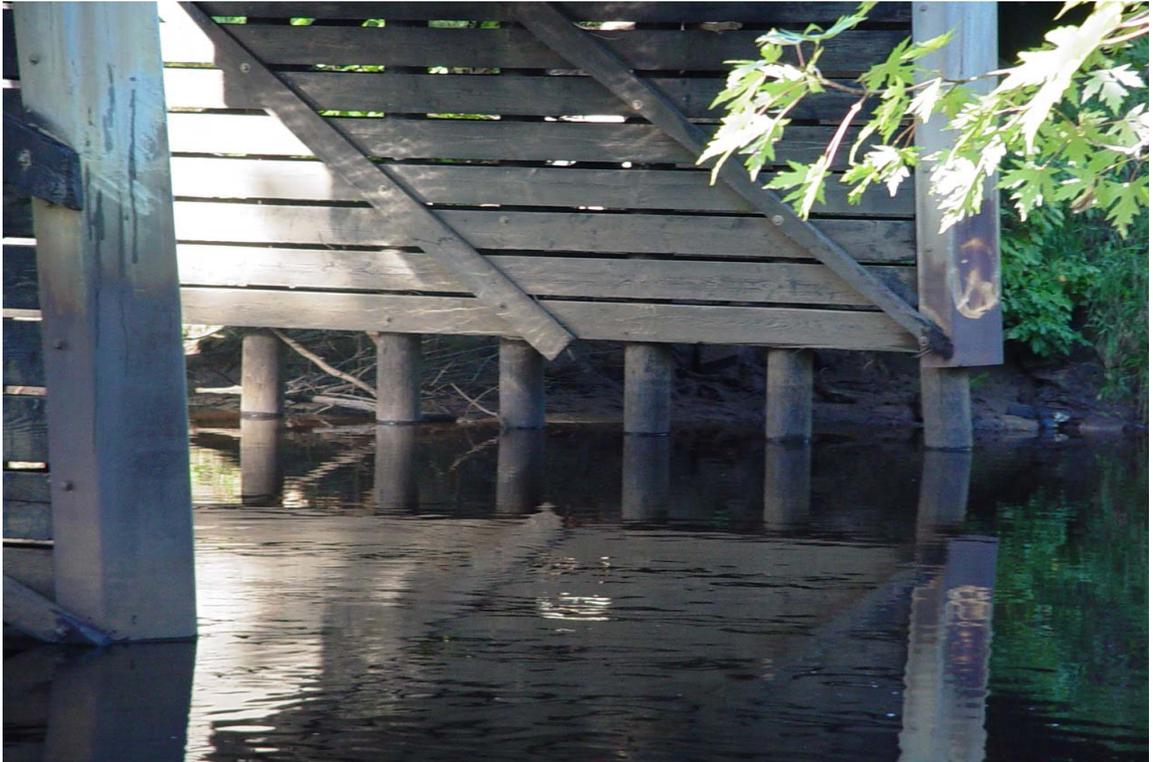
Photograph 2. View of Pier 1, Looking Southwest.

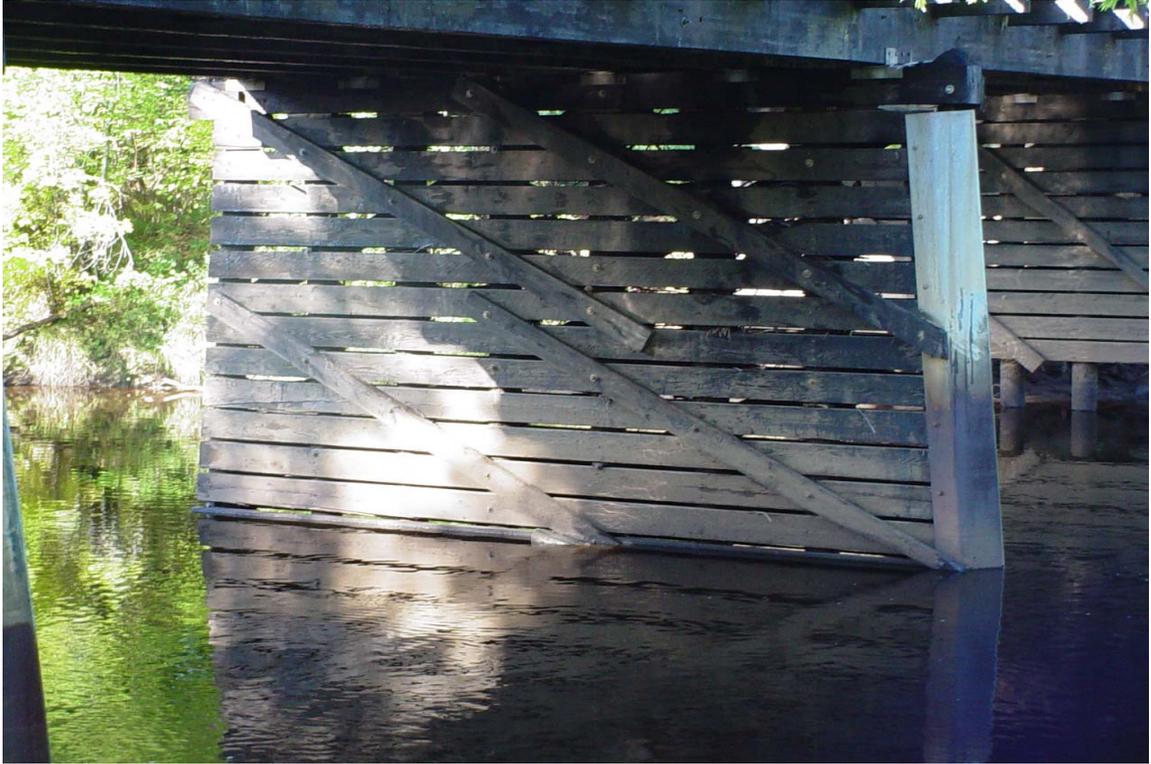
Photograph 3. View of Pier 2, Looking Southwest.

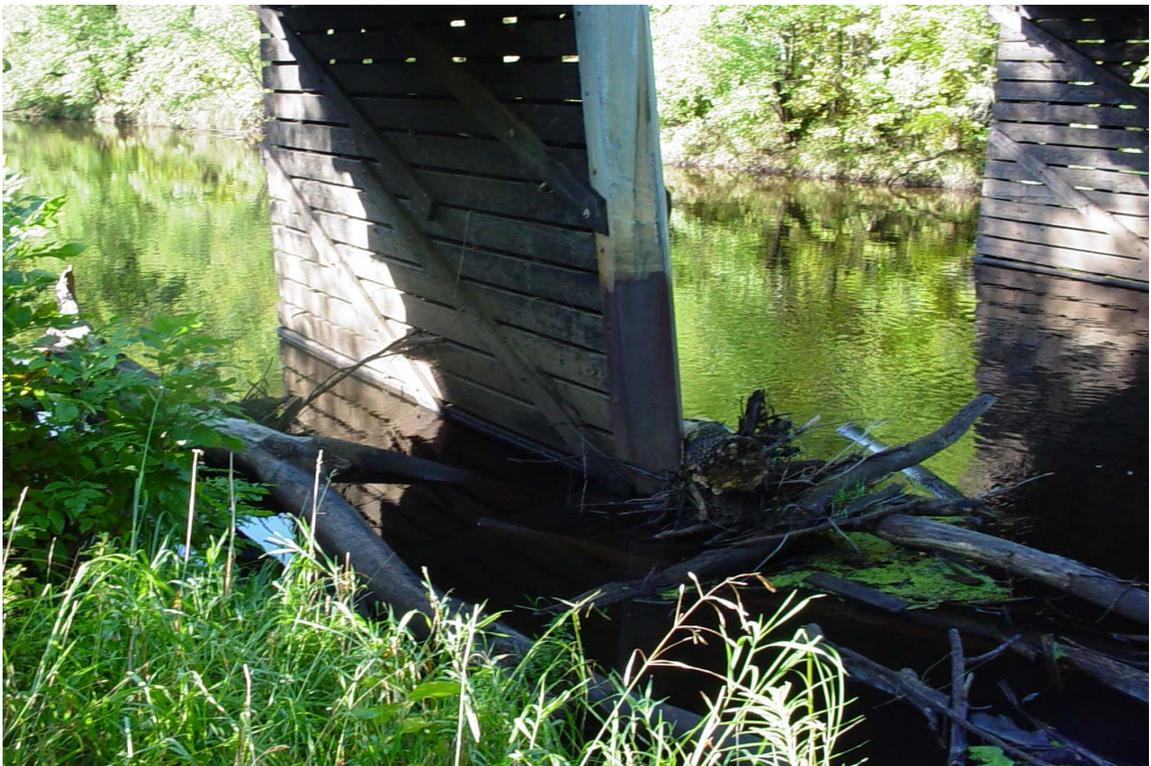
Photograph 4. View of Pier 3, Looking Southwest.
