UNDERWATER BRIDGE INSPECTION REPORT

STRUCTURE NO. 88845

HAY CREEK

DISTRICT 1 - KOOCHICHING COUNTY

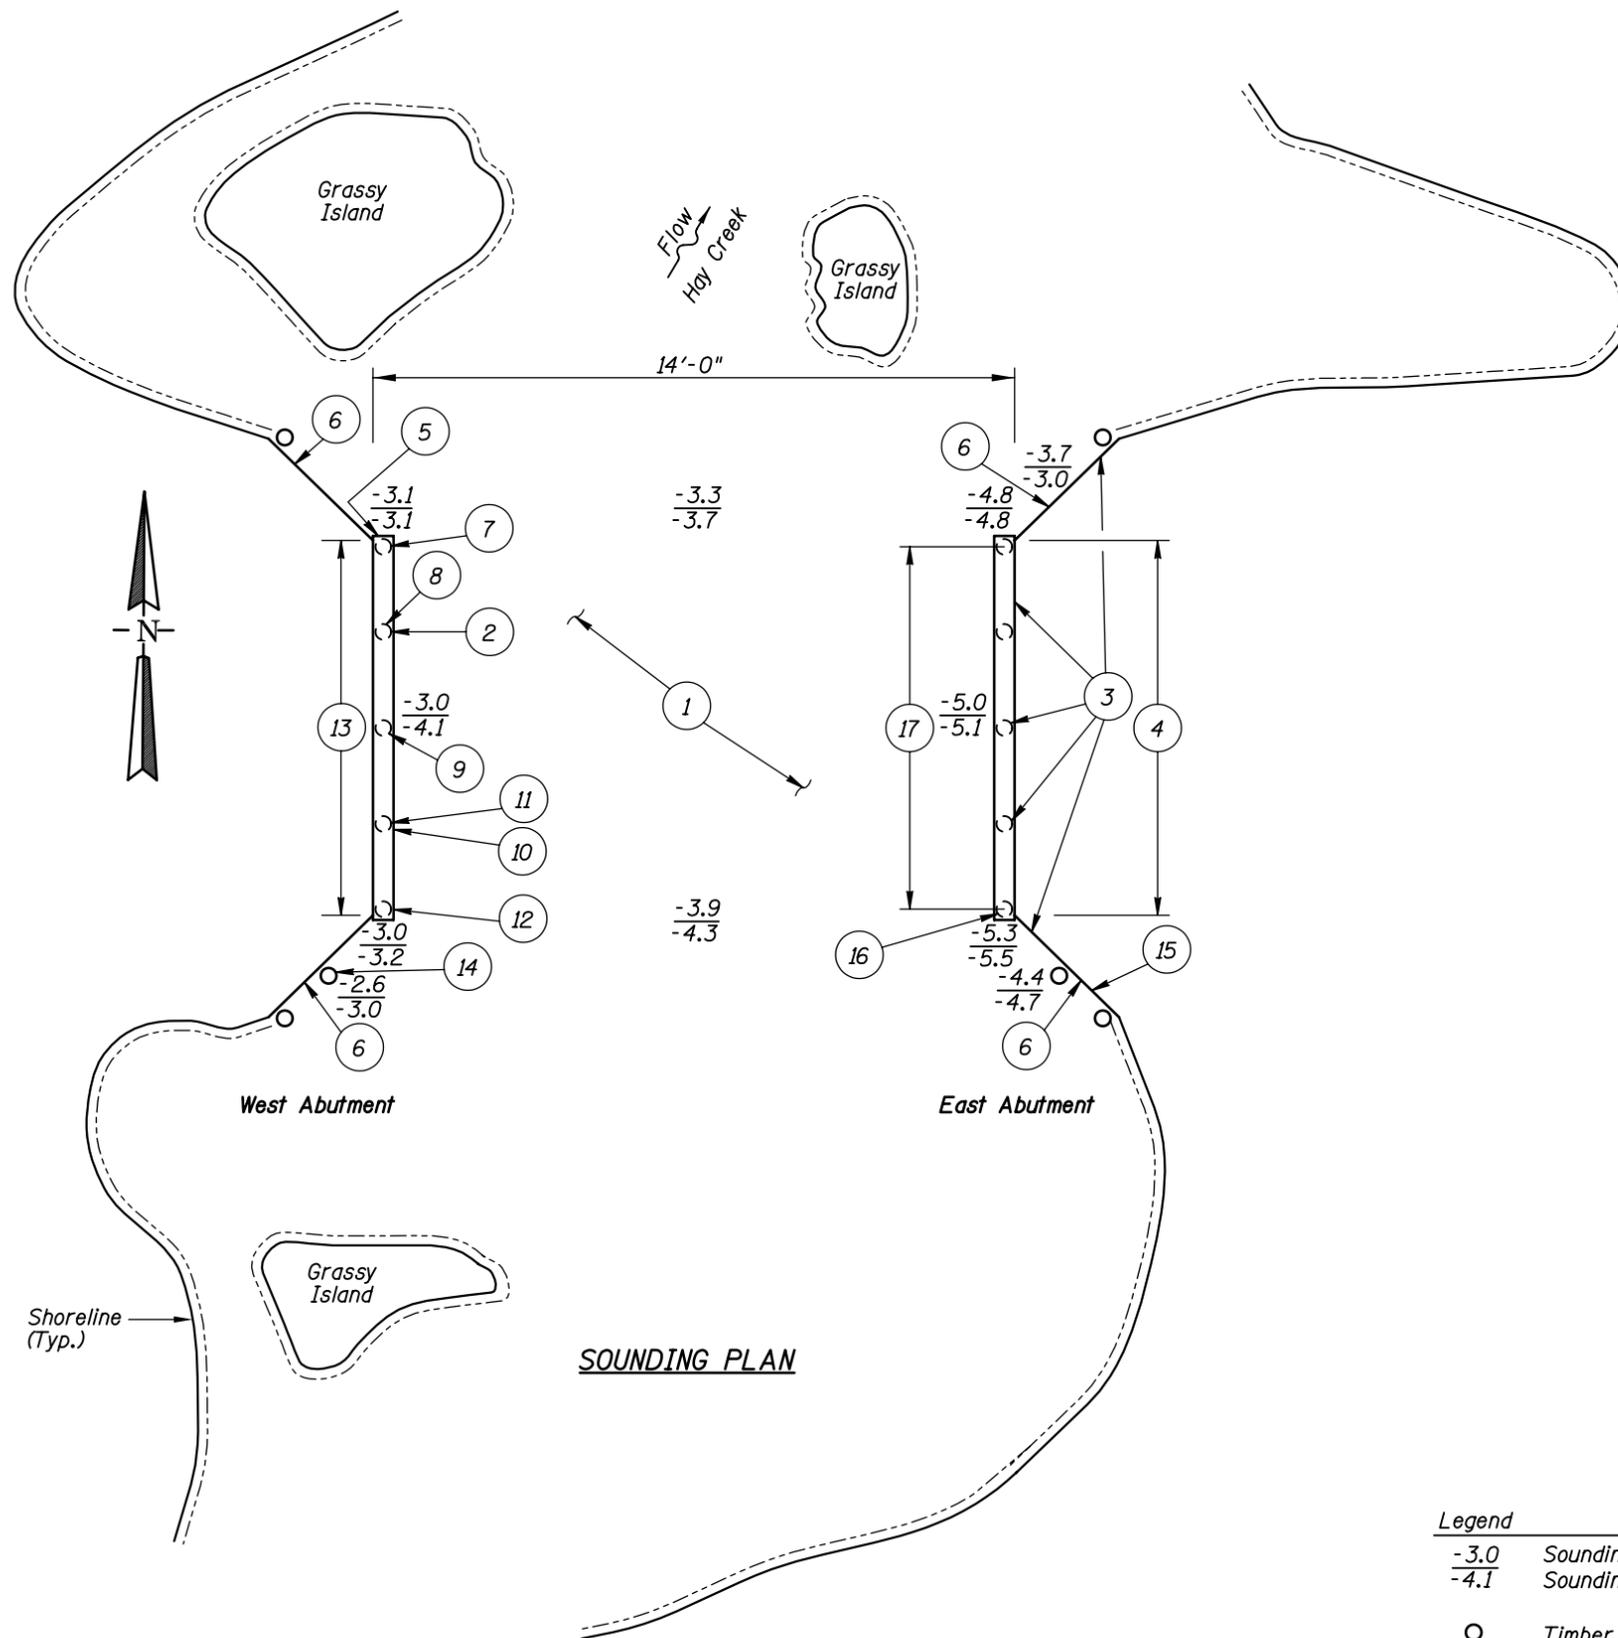
- 1 Channel bottom consisted of primarily a very soft organic/silty material with up to 1 foot of probe rod penetration.
- 2 Checking on east face from 1 foot above to 2 feet below the waterline with a maximum width of 1/4 inch.

- 3 Undermining at abutment wall behind all 5 piles and the northeast wingwall, up to 3 inches in maximum height and 4 foot in maximum width with 6 inches to 1 foot maximum penetration. Undermining is the result of minor scour around each pile.

- 4 A 1/2 inch gap between the backwall planks was observed along the full length of the East Abutment and had up to 2 to 6 inches of penetration with no fill escaping.

- 5 Pile cap warped to north end resulting in loss of bearing at pile top with a maximum gap dimension of 2 inches. (except for note 7)
- 6 Movement at the ends of the wingwalls up to 1 foot at the Northeast and Northwest ends and 6 inches at the southeast and southwest.

- 7 A 4 inch gap between the pile and pile cap.
- 8 The timber pile was displaced to the east approximately 2 inches from center with a 1-1/2 to 2 inch gap between the pile and pile cap. The drift pin connecting the pile and pile cap was inclined to the west.

- 9 A 1 inch gap between the pile and pile cap was observed with no cap bearing on the pile.
- 10 A 1 inch gap between the pile and pile cap was observed with 25 percent of the cap bearing on the pile.

- 11 A 1/2 inch wide split from the top of the pile to 1 foot below the waterline was observed, and exhibited heavy decay with insect infestation (sawdust) present.

- 12 Approximately 33 percent of the pile cap was bearing pile.
- 13 1/2 inch wide gaps between the backwall planks were observed along the West Abutment. The gaps were most probably caused by differential movement resulting from a loss of lateral pile support.

- 14 The pile exhibited a 1/2 inch wide split to the center of the pile that extended from the pile cap to the waterline.
- 15 The top cord timber was missing at the south wingwall of the East Abutment.

- 16 A 1/4 inch wide vertical split was observed in the south end of the East Abutment pile cap.
- 17 The East Abutment timber piles were in good condition with occasional 1/8 inch wide checking.

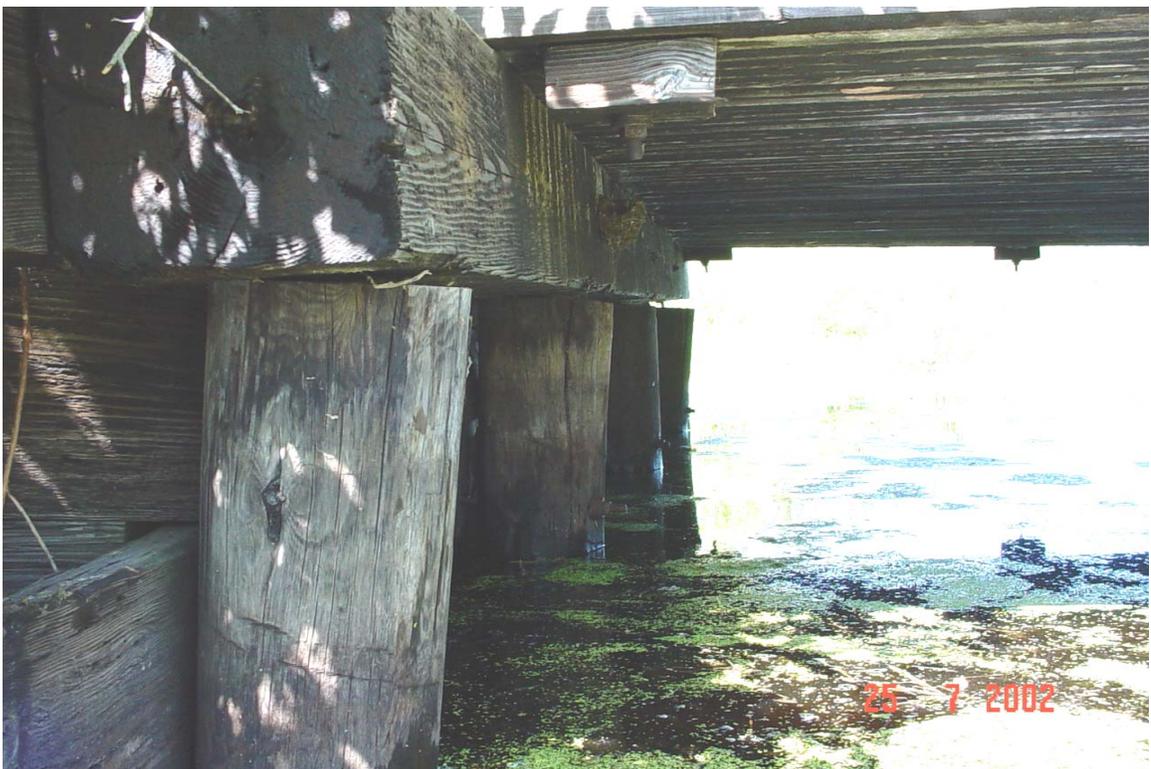
Photograph 2. West Abutment, Looking North.

- (A) At the minimum, full bearing at the pile cap should be restored for all of the piles at the West Abutment. Other repairs to stabilize and/or fortify the (2nd pile from upstream at the West Abutment) and especially all of the wingwalls can also be considered

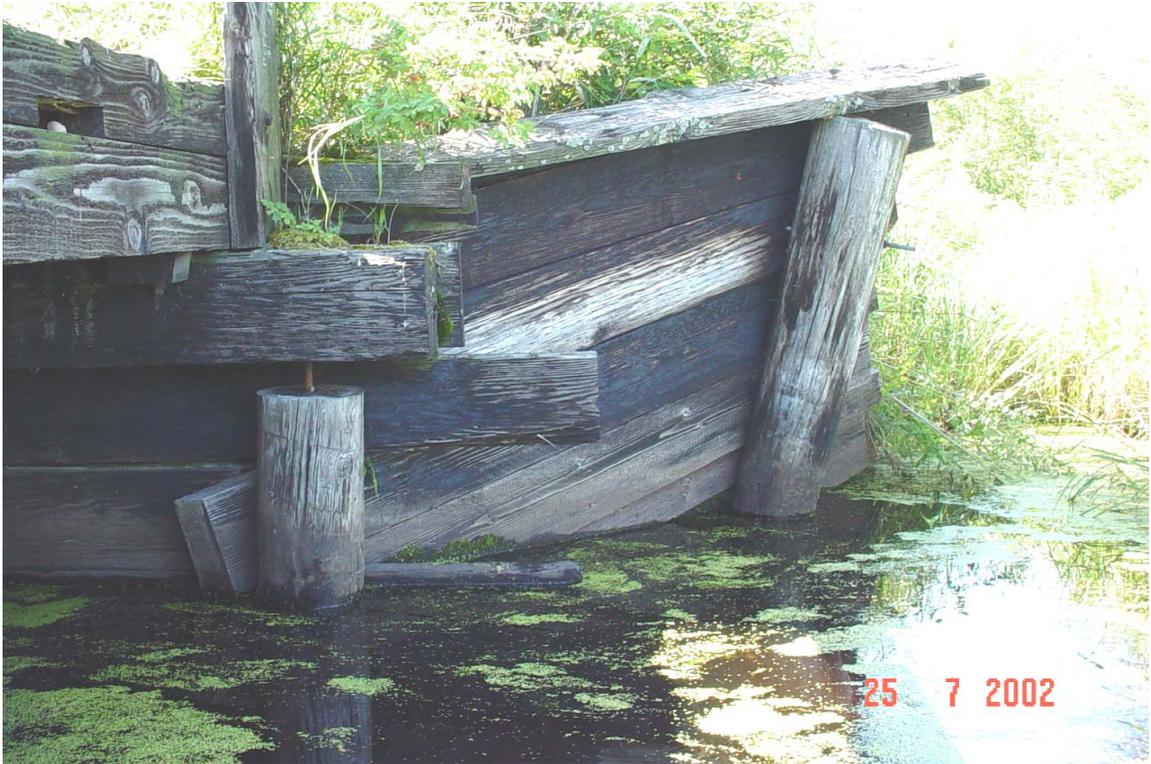
Photograph 3. View of the North Wingwall of the West Abutment, Looking West.

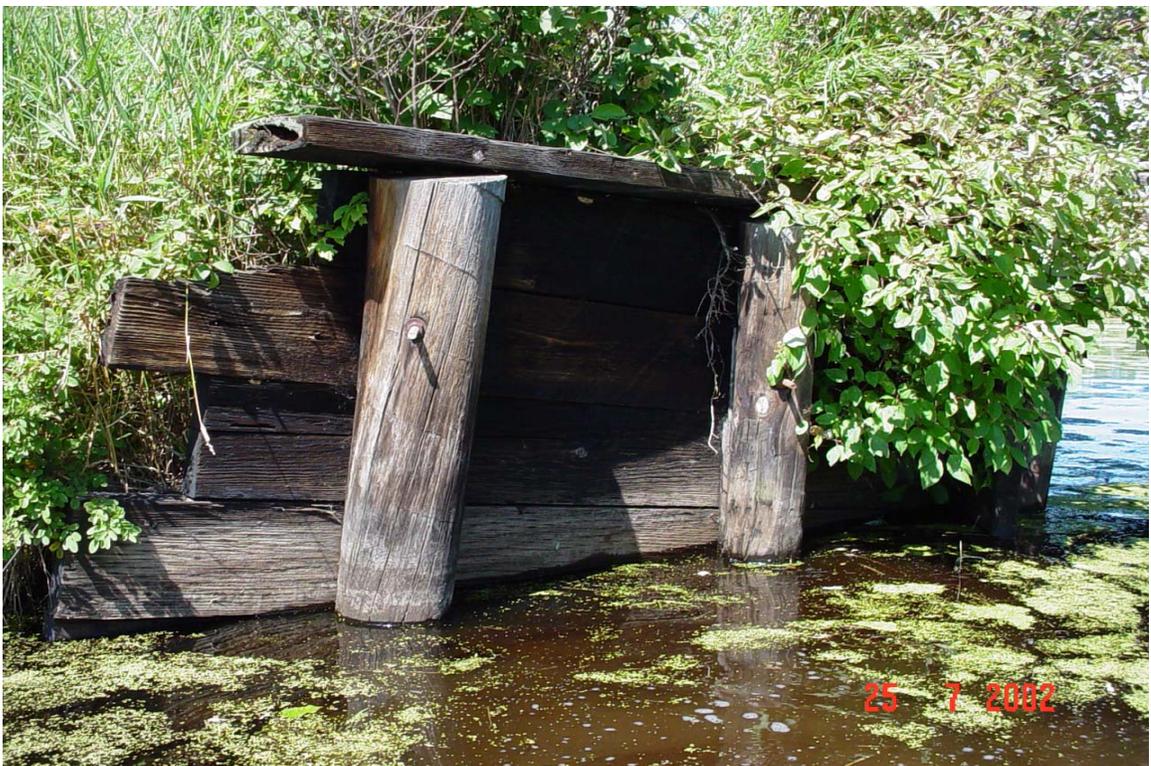
Photograph 4. View of the South Wingwall of the West Abutment, Looking North.

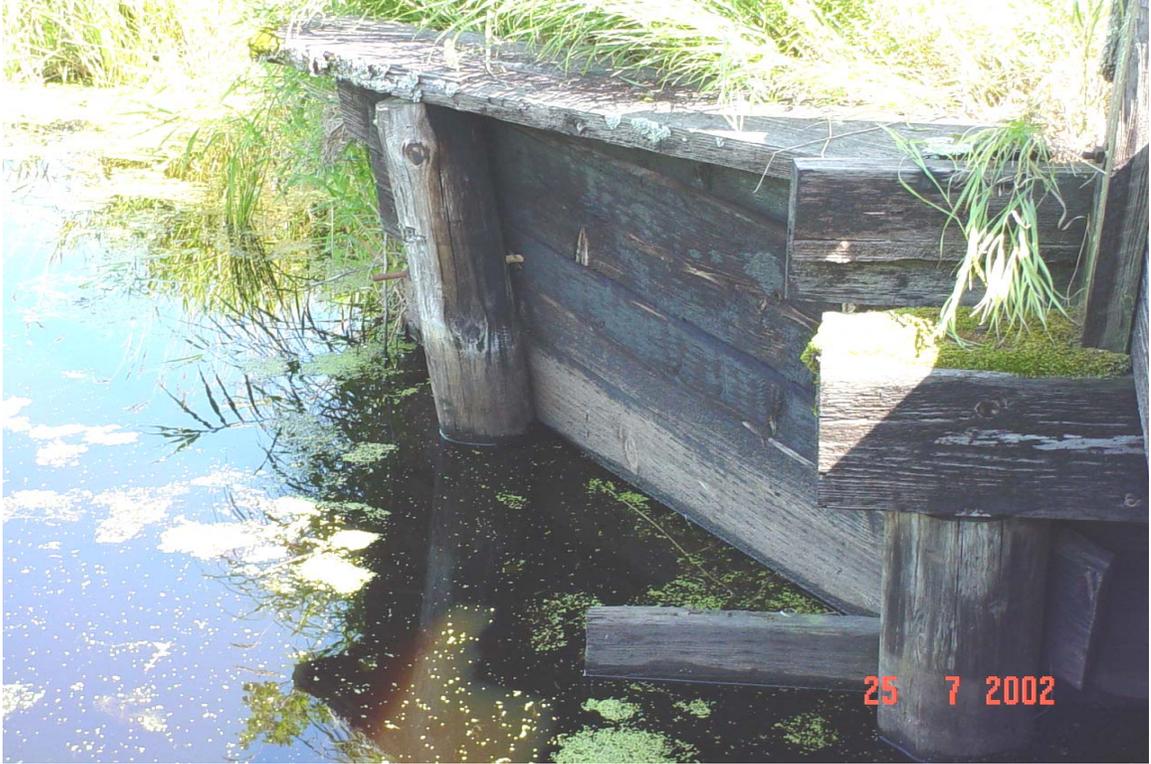
Photograph 5. View of the North Wingwall of the East Abutment, Looking East.

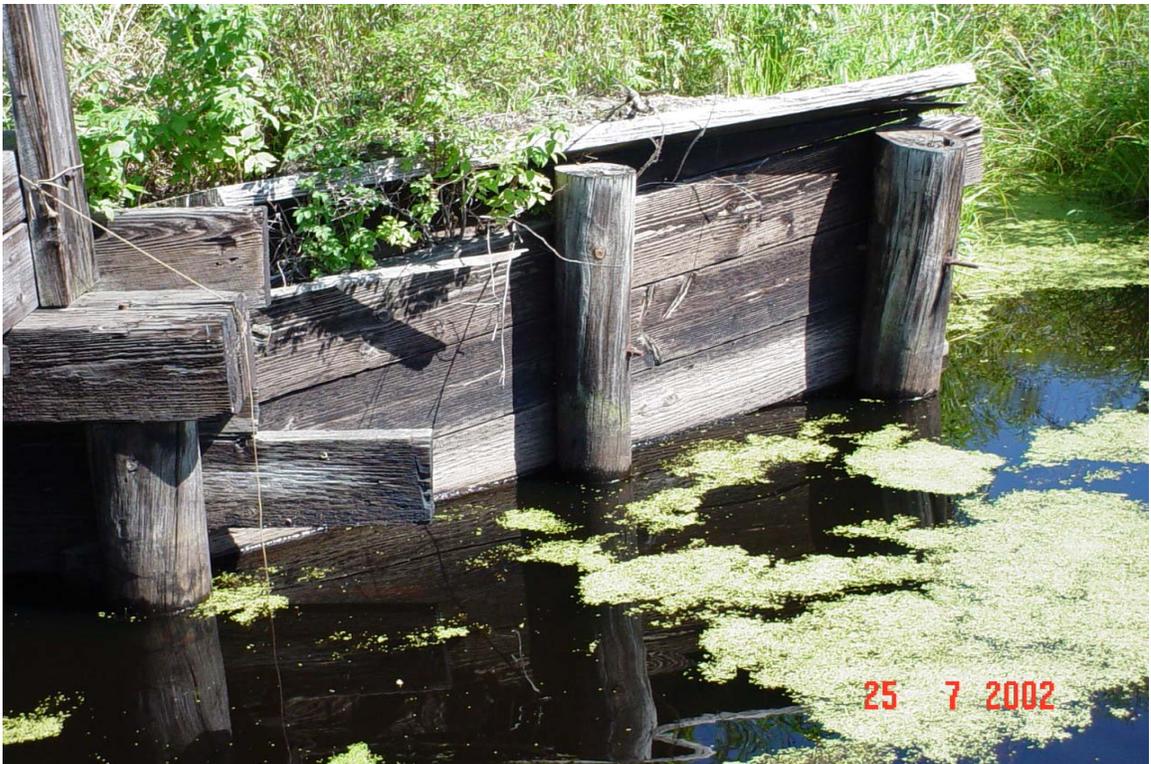
Photograph 6. View of the South Wingwall of the East Abutment, Looking East.

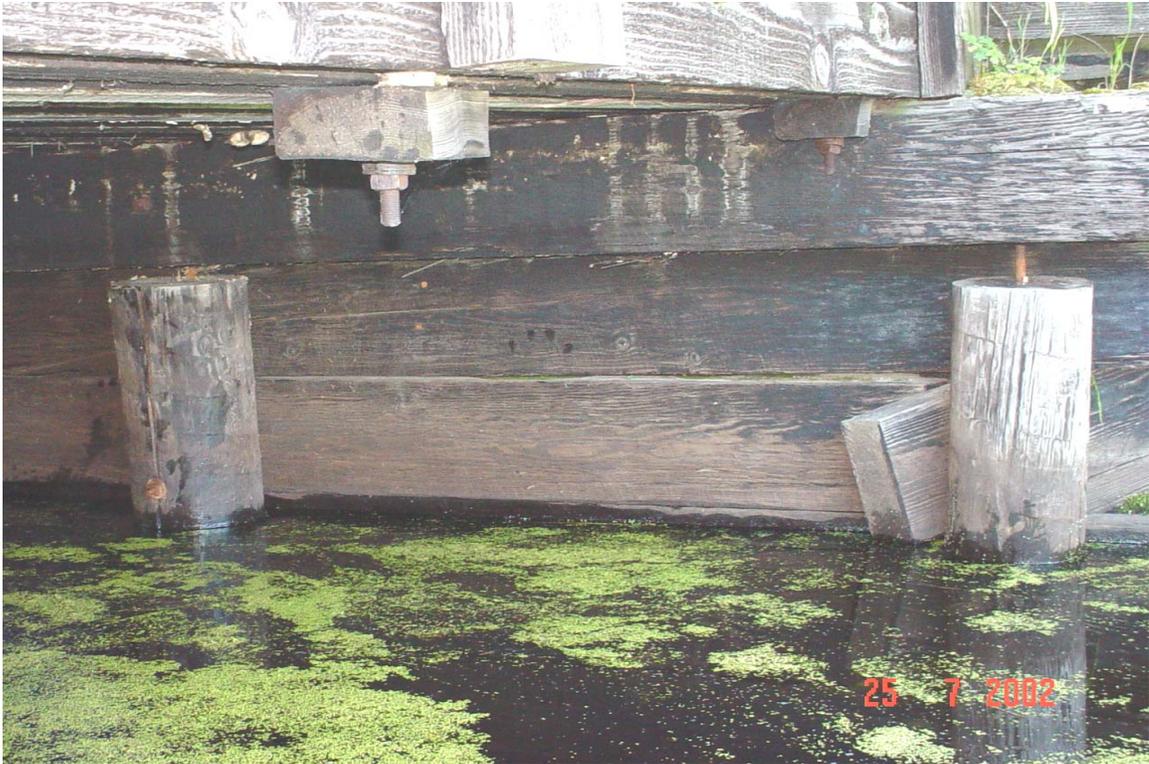
Photograph 7. View of the Downstream End of the West Abutment, Looking West.

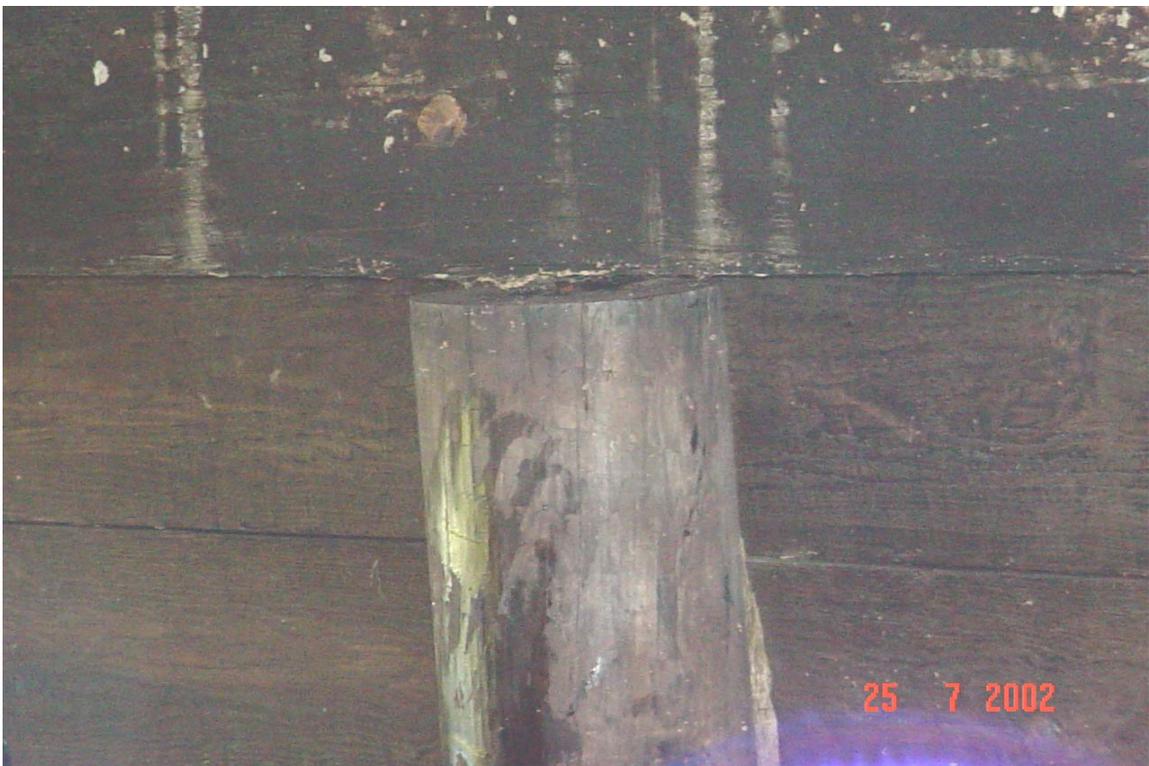
Photograph 8. View of the 3rd Pile in From the Downstream End of the West Abutment, Looking Southwest.

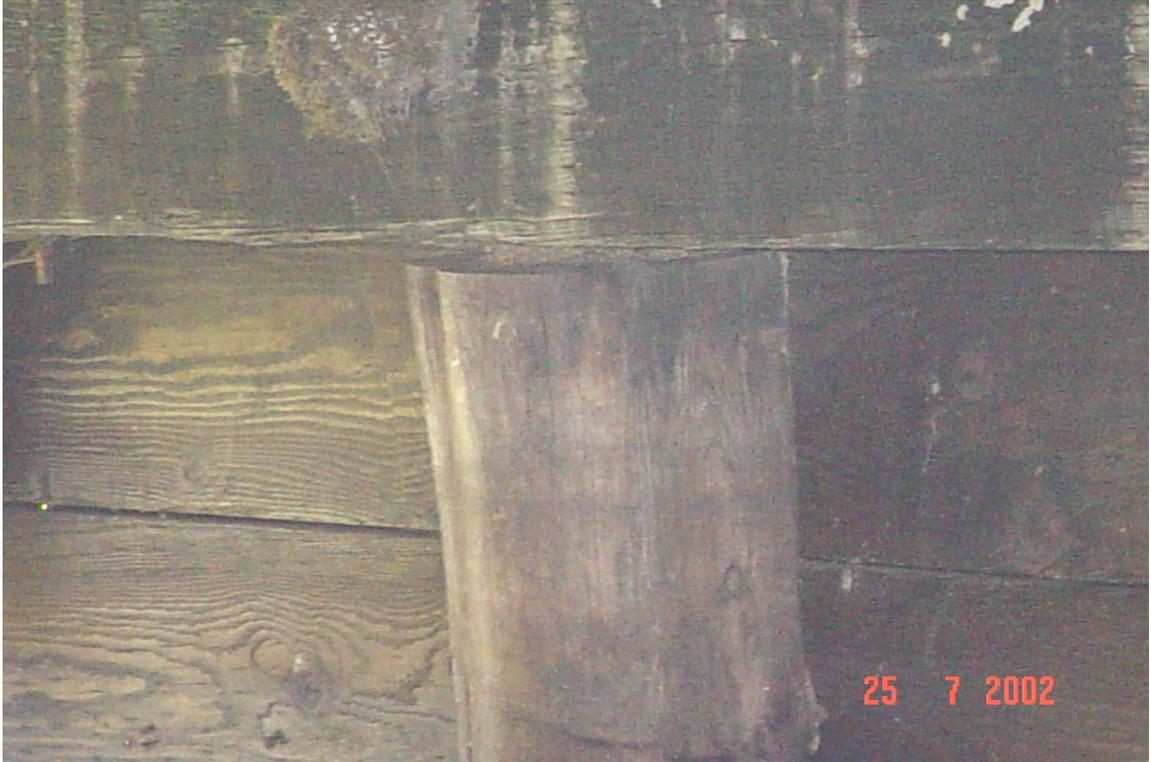
Photograph 9. View of the 4th Pile in From the Downstream End of the West Abutment, Looking Southwest.

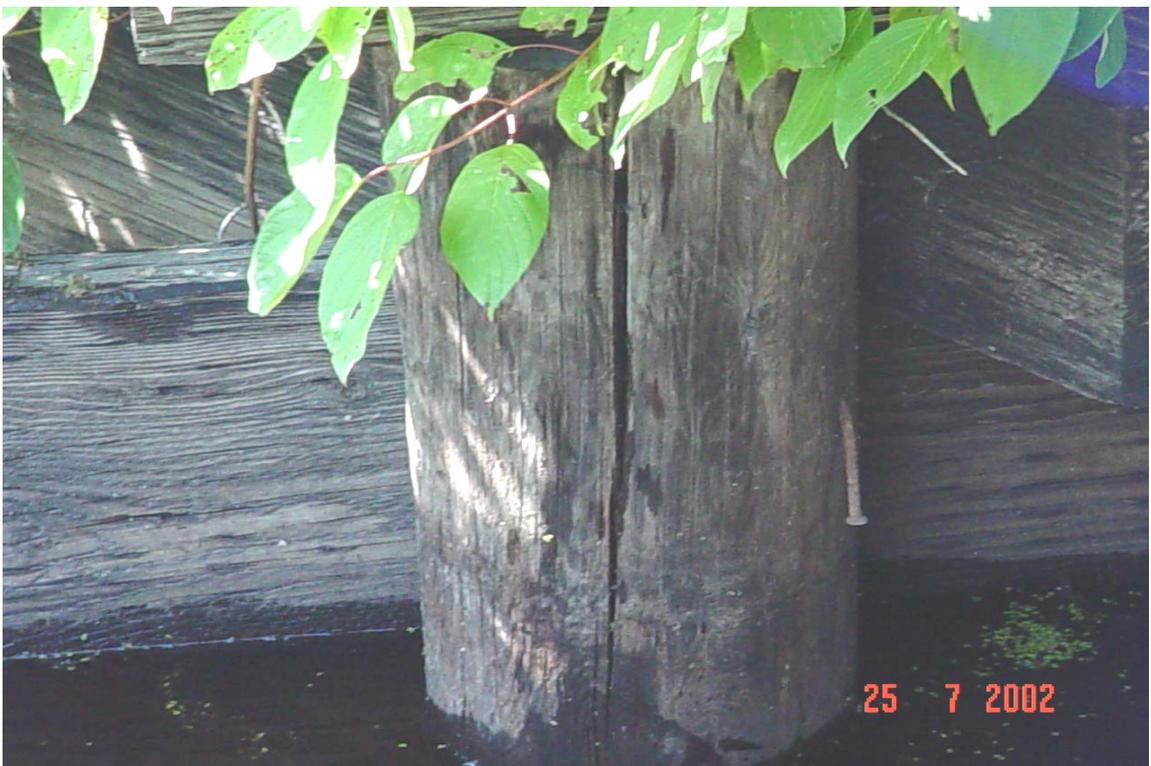
Photograph 10. View of Split in the Upstream Pile of the West Abutment, Looking West.

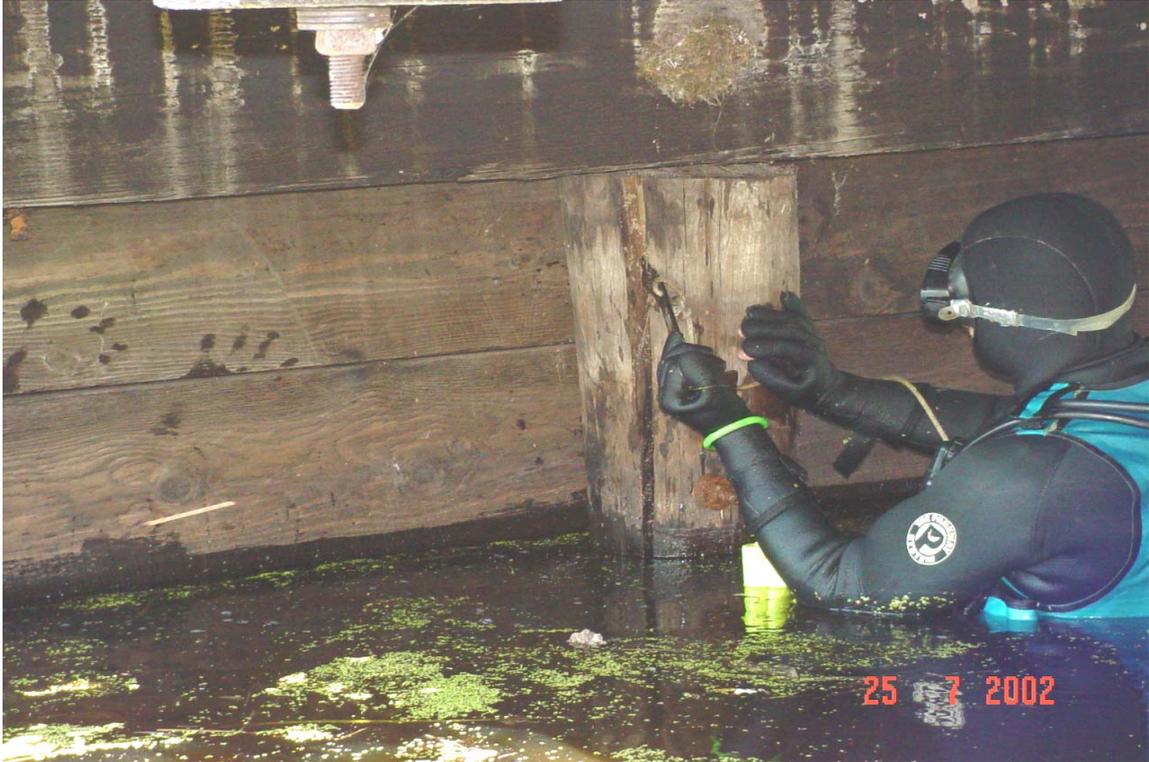
Photograph 11. View of Split in the 2nd Pile in From the Upstream Pile of the West Abutment, Looking Northwest.

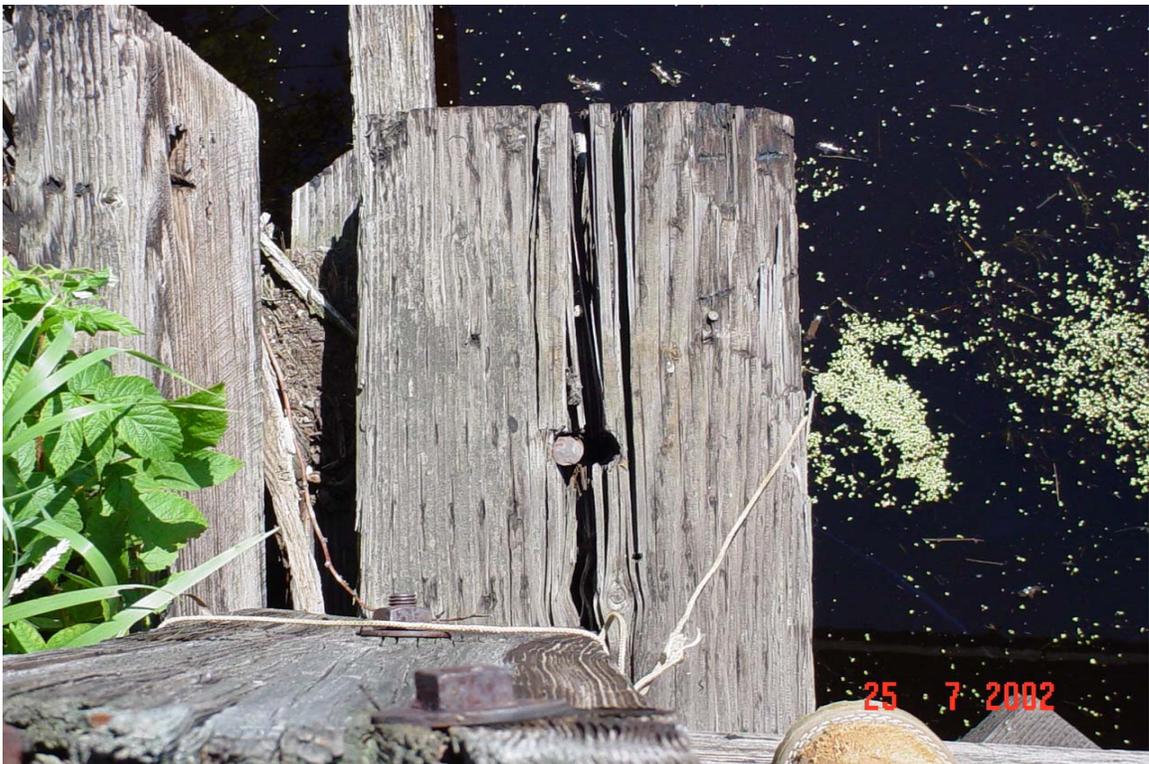
Photograph 12. View of Vertical Split in the Pile Cap of the East Abutment, Looking South.
