UNDERWATER BRIDGE INSPECTION REPORT

STRUCTURE NO. 31510
CSAH NO. 62
OVER THE
MISSISSIPPI RIVER
DISTRICT 1 - ITASCA COUNTY

PREPARED FOR THE
MINNESOTA DEPARTMENT OF TRANSPORTATION
BY
COLLINS ENGINEERS, INC.
JOB NO. 5221 (CEI 29)

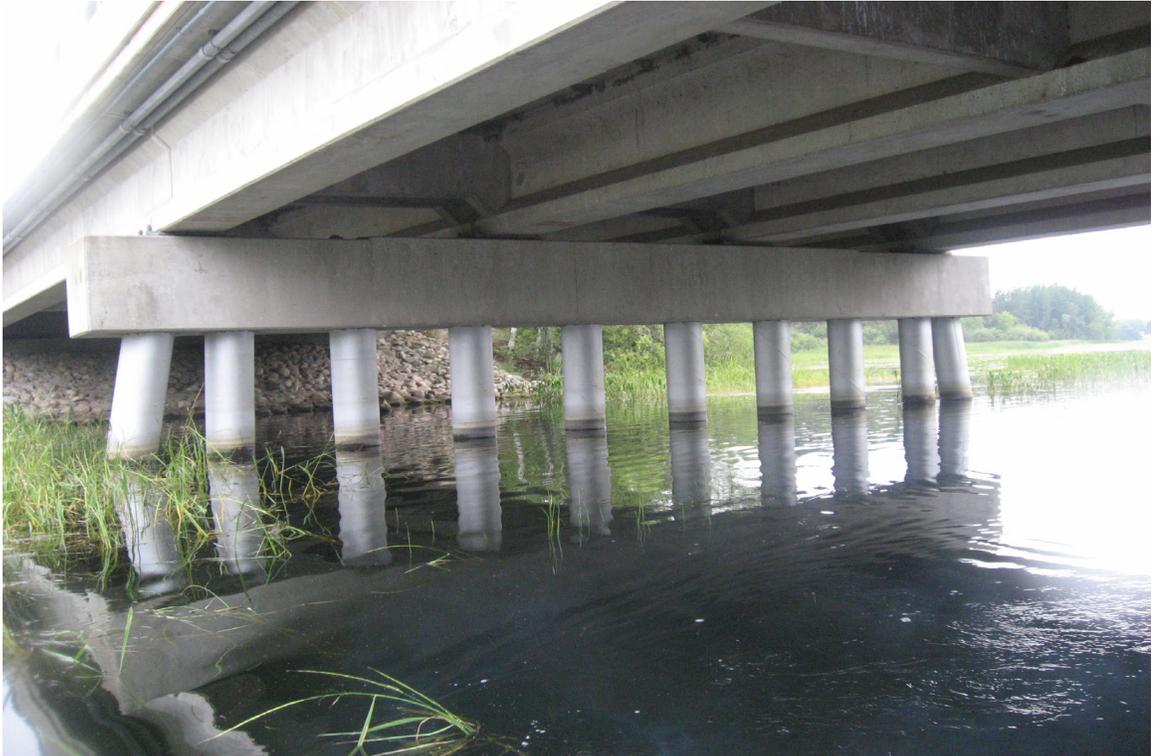
Photograph 2. View of Pier 1, Looking Southwest.

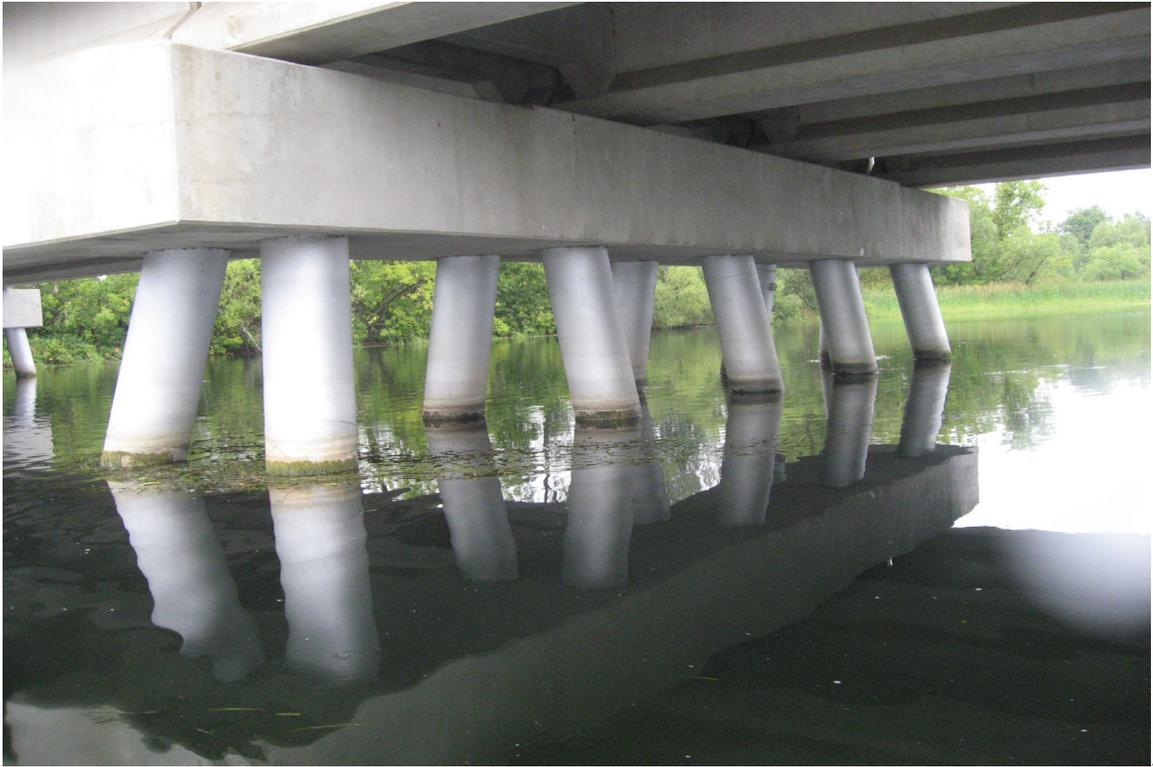
- (C) Minor scour depressions, 1 to 2 feet deep with a 1 to 2 foot radius, have developed around the two upstream piles of Pier 2 since the previous inspection.

Photograph 3. View of Pier 2, Looking Northeast.

- 6 Minor scour depressions, 1 to 2 foot deep with 1 to 2 foot radius, were observed around the upstream piles of Pier 2.
- 7 Heavy accumulation of organics/vegetation was observed at the upstream nose and along the entire bank side of Pier 3 with occasional 1 foot diameter timber debris extending from the mudline up 3 to 4 feet above the channel bottom.

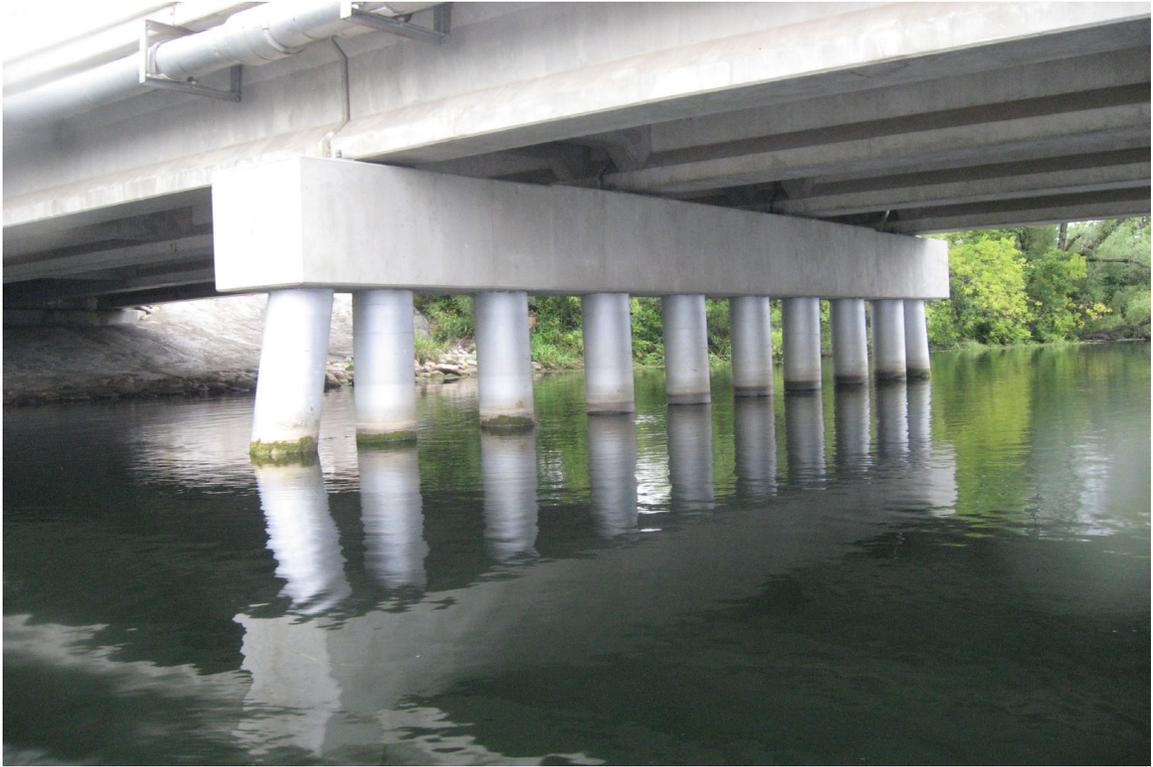
- (D) A heavy accumulation of organics/vegetation with occasional timber debris was observed at the upstream nose and along the entire bank side of Pier 3 extending from the channel bottom to 4 feet above the channel bottom. Scattered steel and timber debris was also observed on the channel bottom at Pier 2 along with a 55 gallon drum at both Piers 1 and 2.

Photograph 4. View of Pier 3, Looking Northeast.

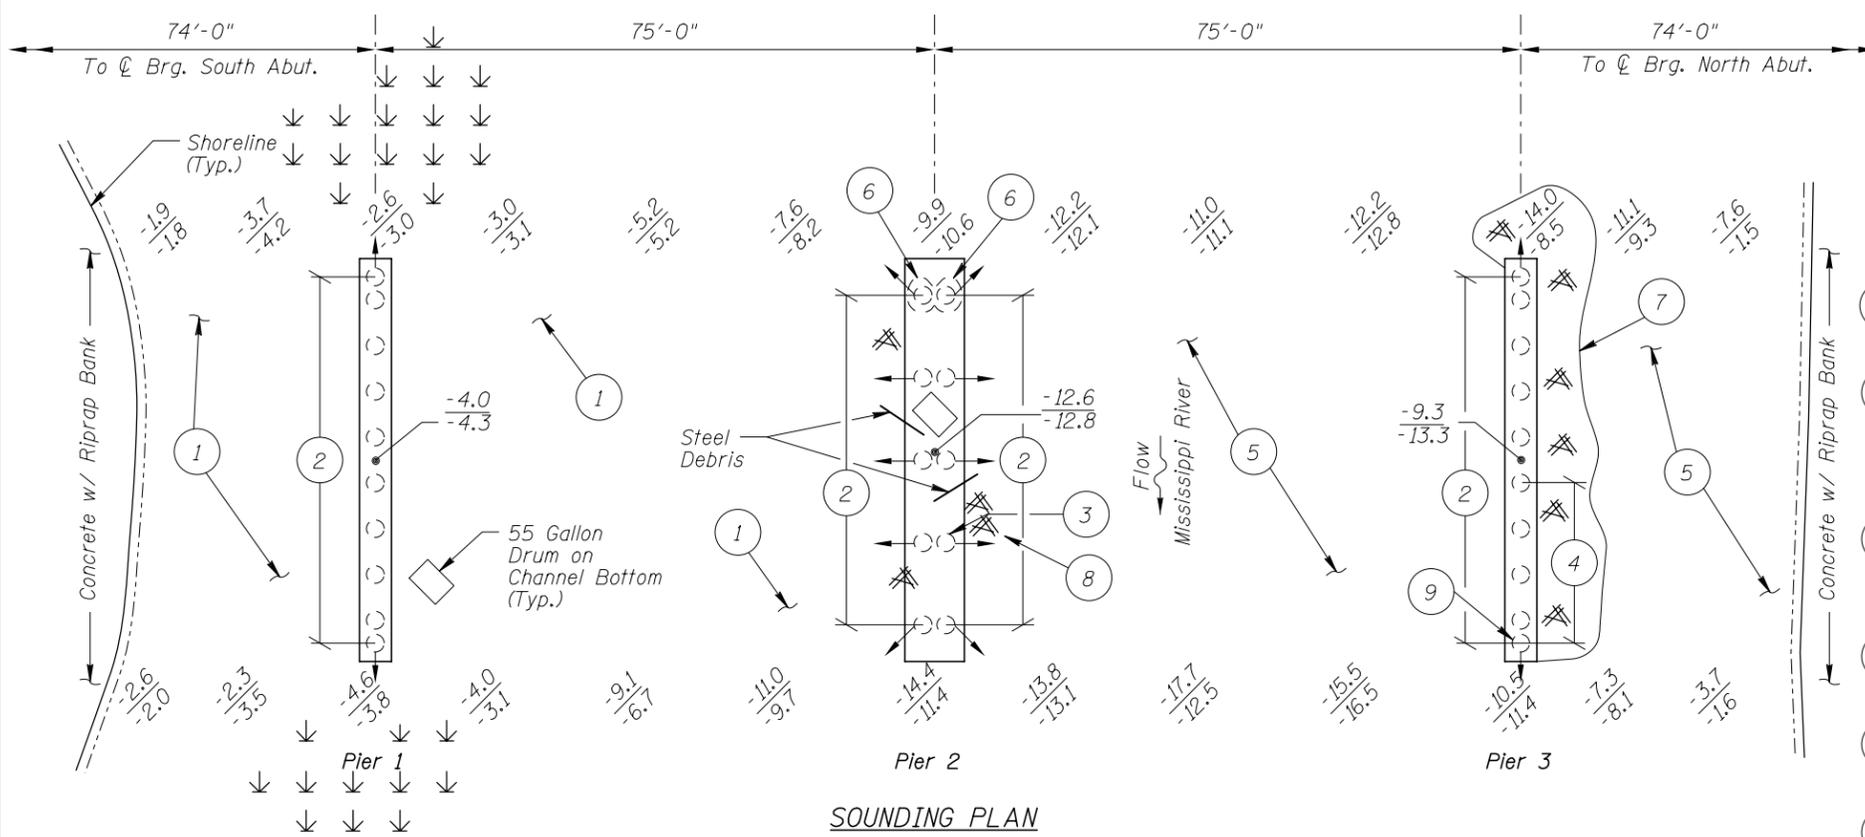
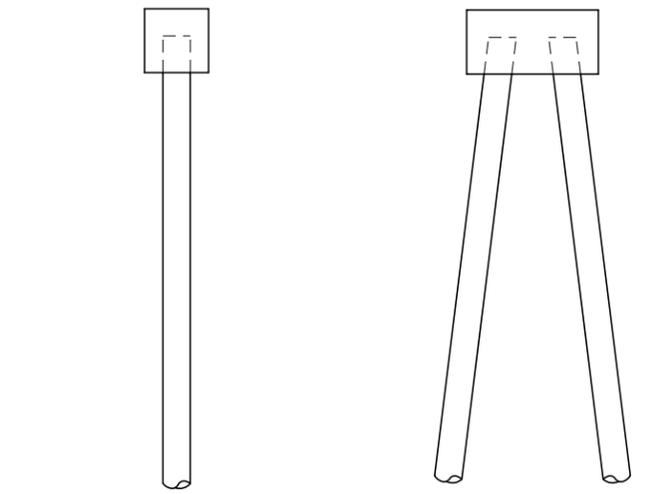
SOUNDING PLAN

- 1 The channel bottom material consisted of soft silty sand with maximum probe rod penetrations of 1 foot.
- 2 Moderate corrosion covered 75 to 100 percent of the pile surfaces from the waterline to the channel bottom. Minimal section loss was observed with typical pitting up to 1/32 inches deep and maximum pitting up to 1/16 inches deep near the waterline.

- 3 Vertical crack along welded joint noted in previous inspection, August 27, 1997, has been repaired with a bolted steel collar extending from the underside of the pile cap to 3 feet below the waterline.

- 4 Random heavy rust nodules extending from 3 feet below the waterline to the mudline.
- 5 The channel bottom material consisted of firm sandy gravel with 6 inch to 2 foot diameter rocks and probe rod penetrations of 2 to 4 inches.

- 8 Minor accumulation of 1 foot diameter timber debris was scattered on the channel bottom along the pier.
- 9 The downstream battered pile at Pier 3 exhibited a 15 degree bend 5 feet below the waterline where the pile then extends vertically into the channel bottom.

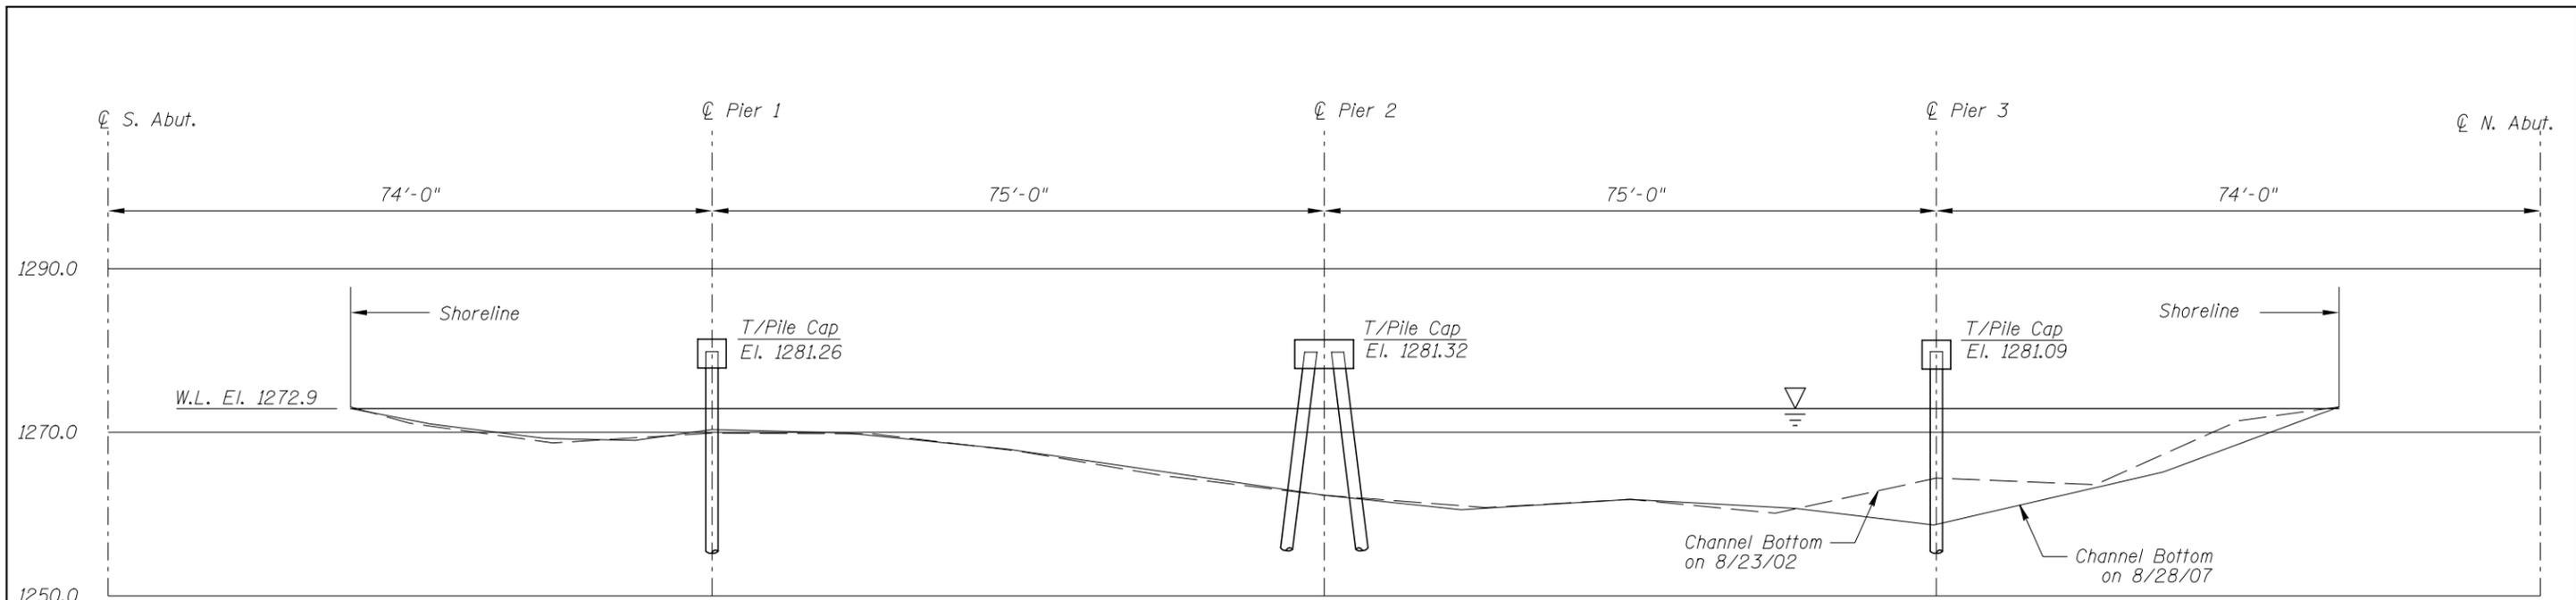
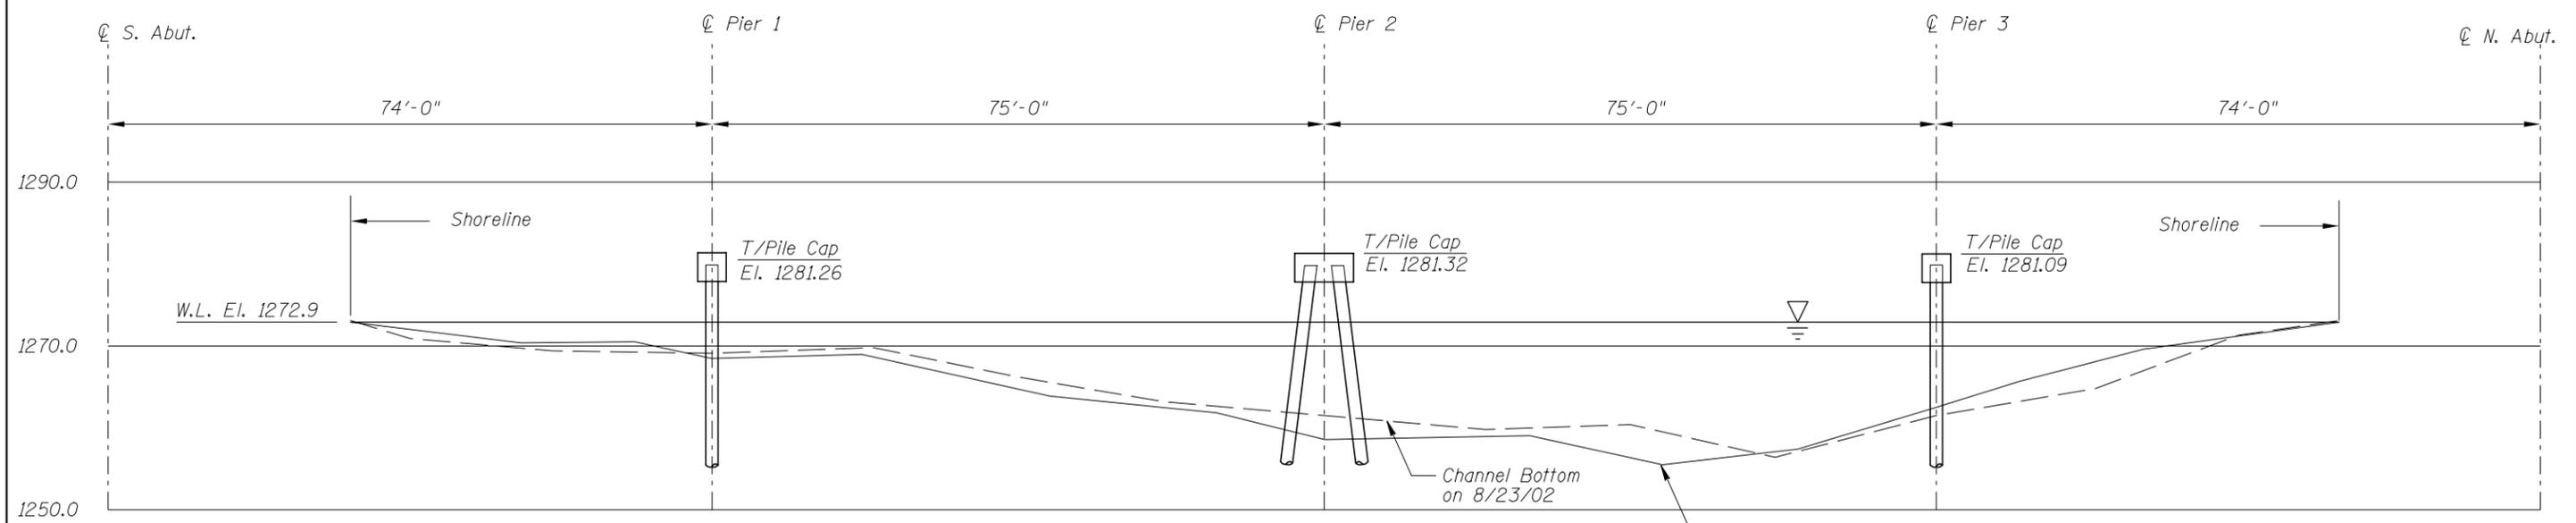
UPSTREAM FASCIA PROFILE

DOWNSTREAM FASCIA PROFILE
