Underwater Inspection Report
Structure No. 31512
CSAH No. 18 over Mississippi River
District 1 – Itasca County
June 15, 2010

UNDERWATER INSPECTION CONDITION RATING FORM

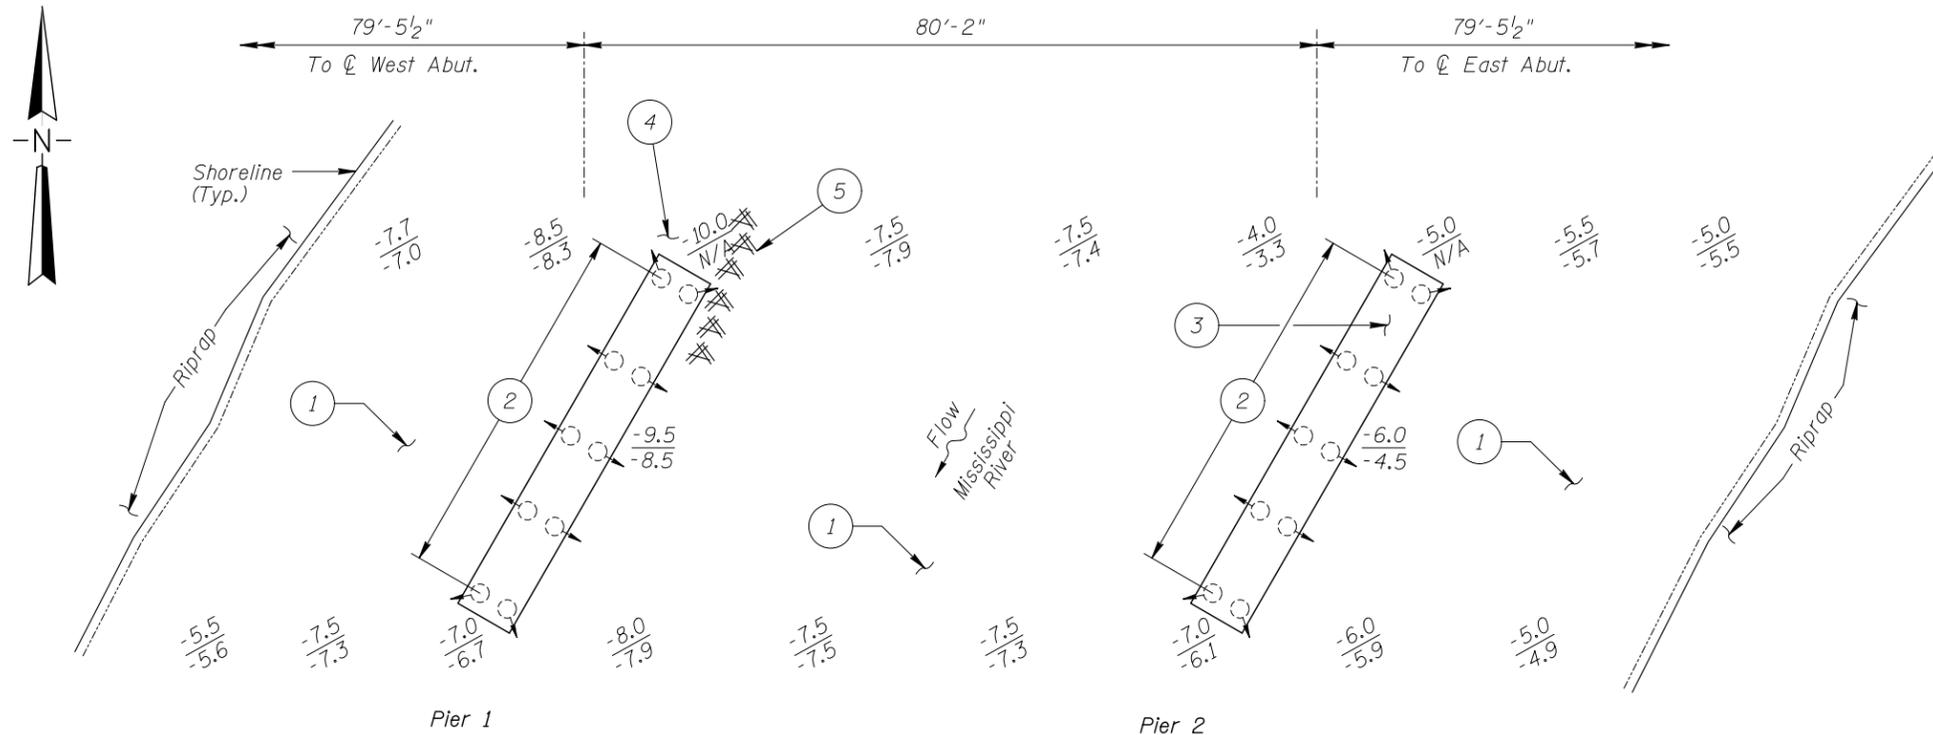
SOUNDING PLAN

- ① The channel bottom material consisted of firm sandy gravel with scattered 6 inch cobbles and a probe rod penetration of approximately 1 inch.
- ② All piles exhibited paint coating deterioration, corrosion, and rust nodules on 50 to 100 percent of the surface area, from 1 foot above the waterline to the channel bottom. Heaviest corrosion (up to 100 percent of surface area) was present between 2.5 feet above and 3 feet below the waterline. Random pitting with a maximum of 1/32 inch penetration was observed on the steel pipe piles.

- ③ There was a moderate accumulation of weeds and organics around the upstream six piles of Pier 2 extending from the channel bottom up 3 feet.
- ④ A 6 foot diameter by 6 foot high pile of organic accumulation and vegetation, consisting of dense roots and organic material, was observed at the channel bottom near the upstream end of Pier 1.

- ⑤ Timber debris, consisting primarily of 1 foot diameter tree, was present on the channel bottom at the upstream end of Pier 1.

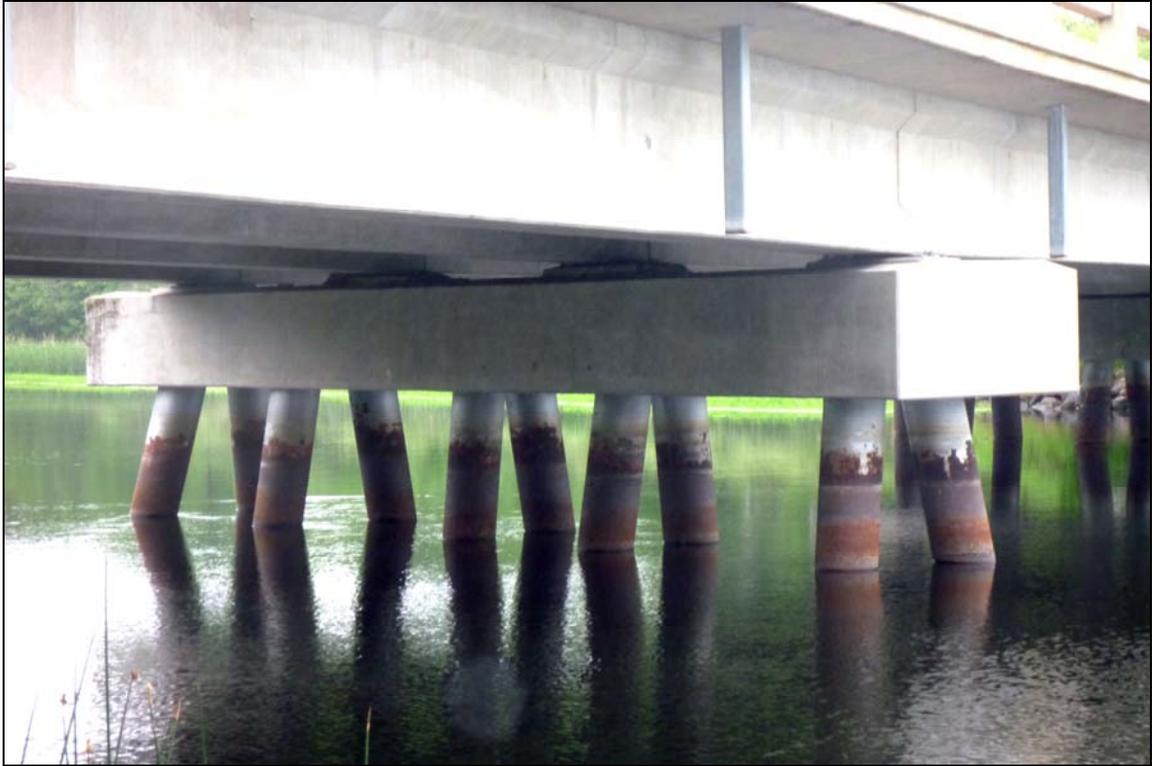
Photograph 3. View of Pier 1, Looking Northeast.

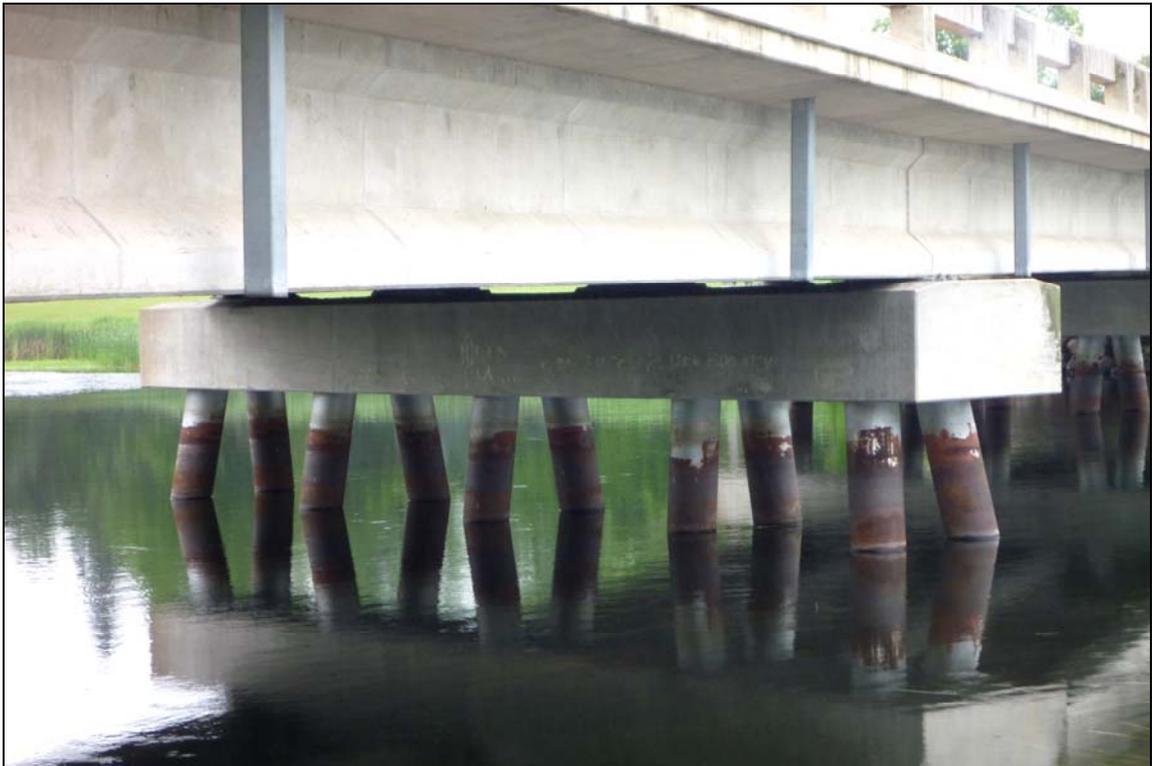
Photograph 4. View of Pier 2, Looking Southwest.
