UNDERWATER BRIDGE INSPECTION REPORT

STRUCTURE NO. 36503

RAT ROOT RIVER

MINNESOTA DEPARTMENT OF TRANSPORTATION
UNDERWATER BRIDGE INSPECTION

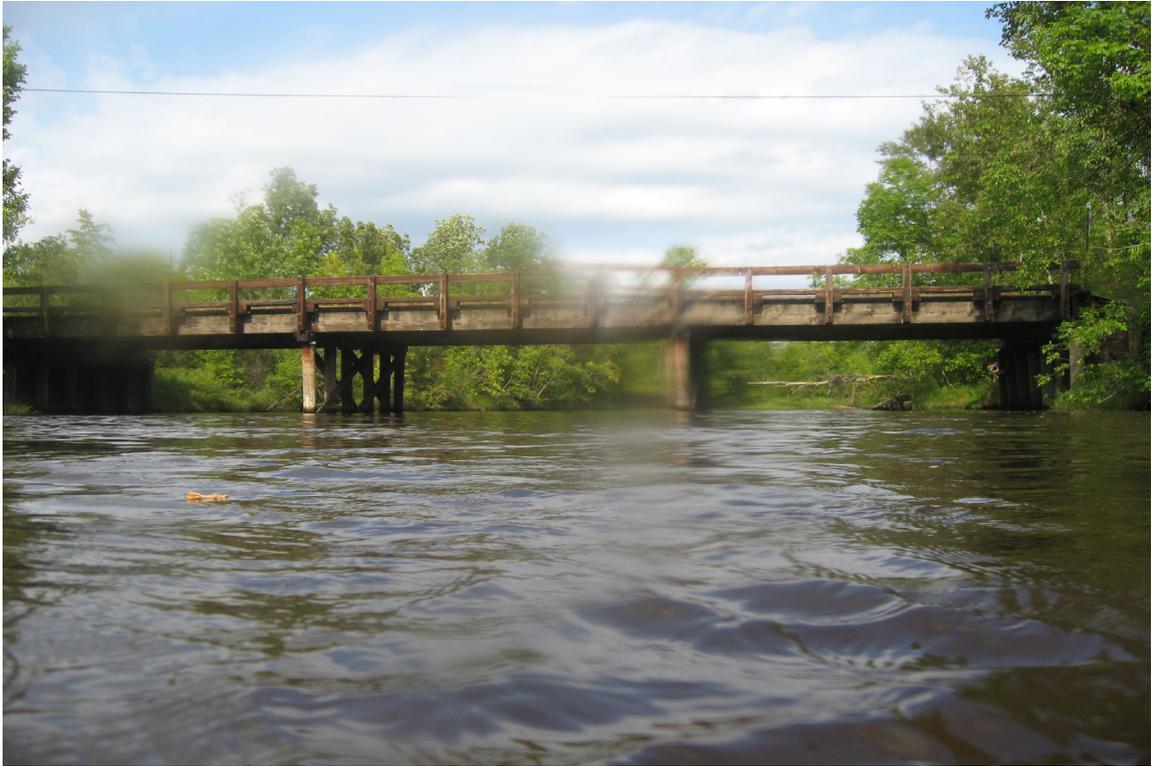
Photograph 1. Overall View of the Structure, Looking West.

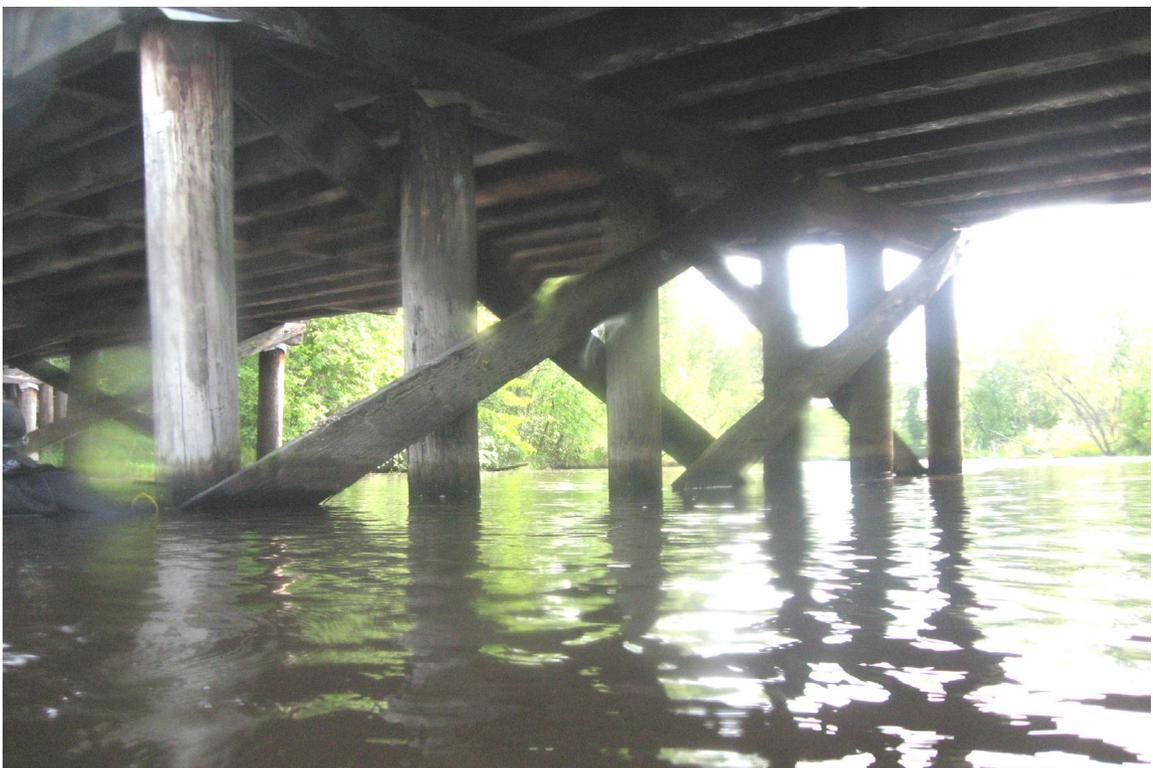
Photograph 2. View of Pier 1, Looking Southeast.

- (A) The timber cross bracing members that exhibited cracking or loss of section should be repaired or replaced during routine maintenance.

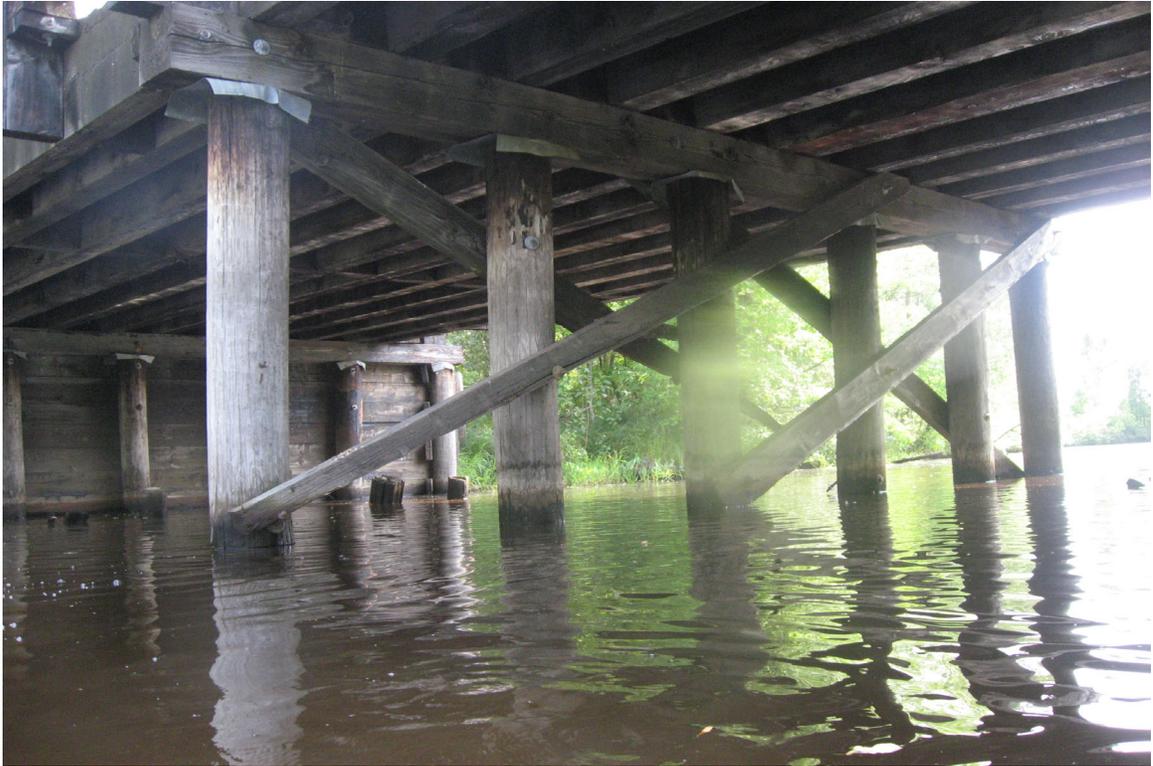
Photograph 3. View of Pier 2, Looking Southeast.

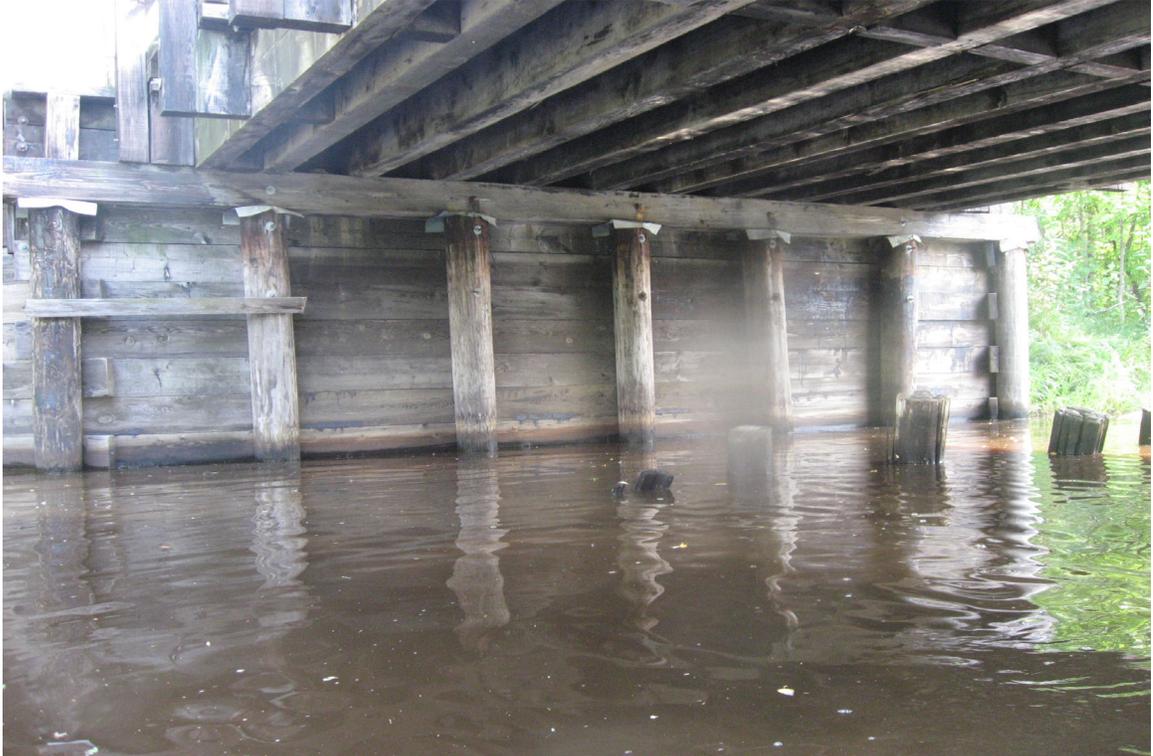
Photograph 4. View of East Abutment, Looking Southeast.

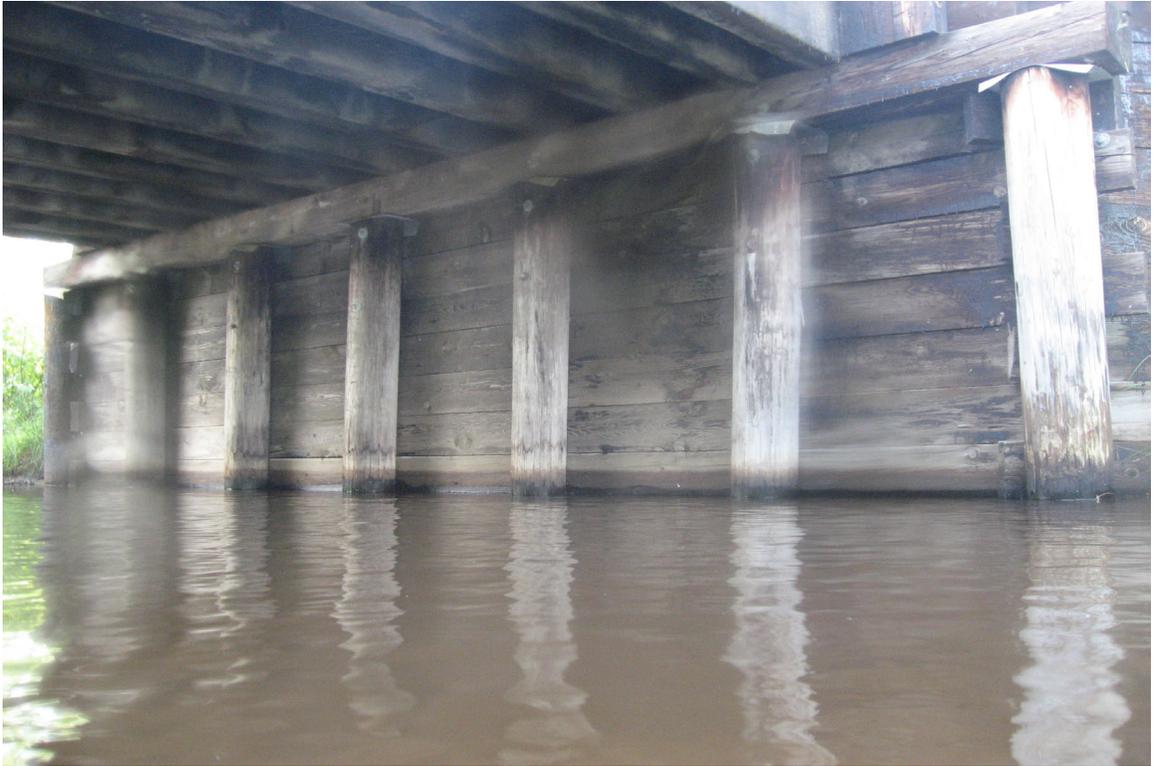
Photograph 5. View of West Abutment, Looking Southwest.

- (B) Monitor the extent of the pile cap rotation at the West Abutment during future inspections and repair if bearing loss becomes excessive.
- (C) Monitor the extent of drift accumulation at the bridge during future inspections, and if found to be progressing, removal may be warranted at that time.
- (D) Reinspect the submerged substructure units at the normal maximum recommended (NBIS) interval of five (5) years.

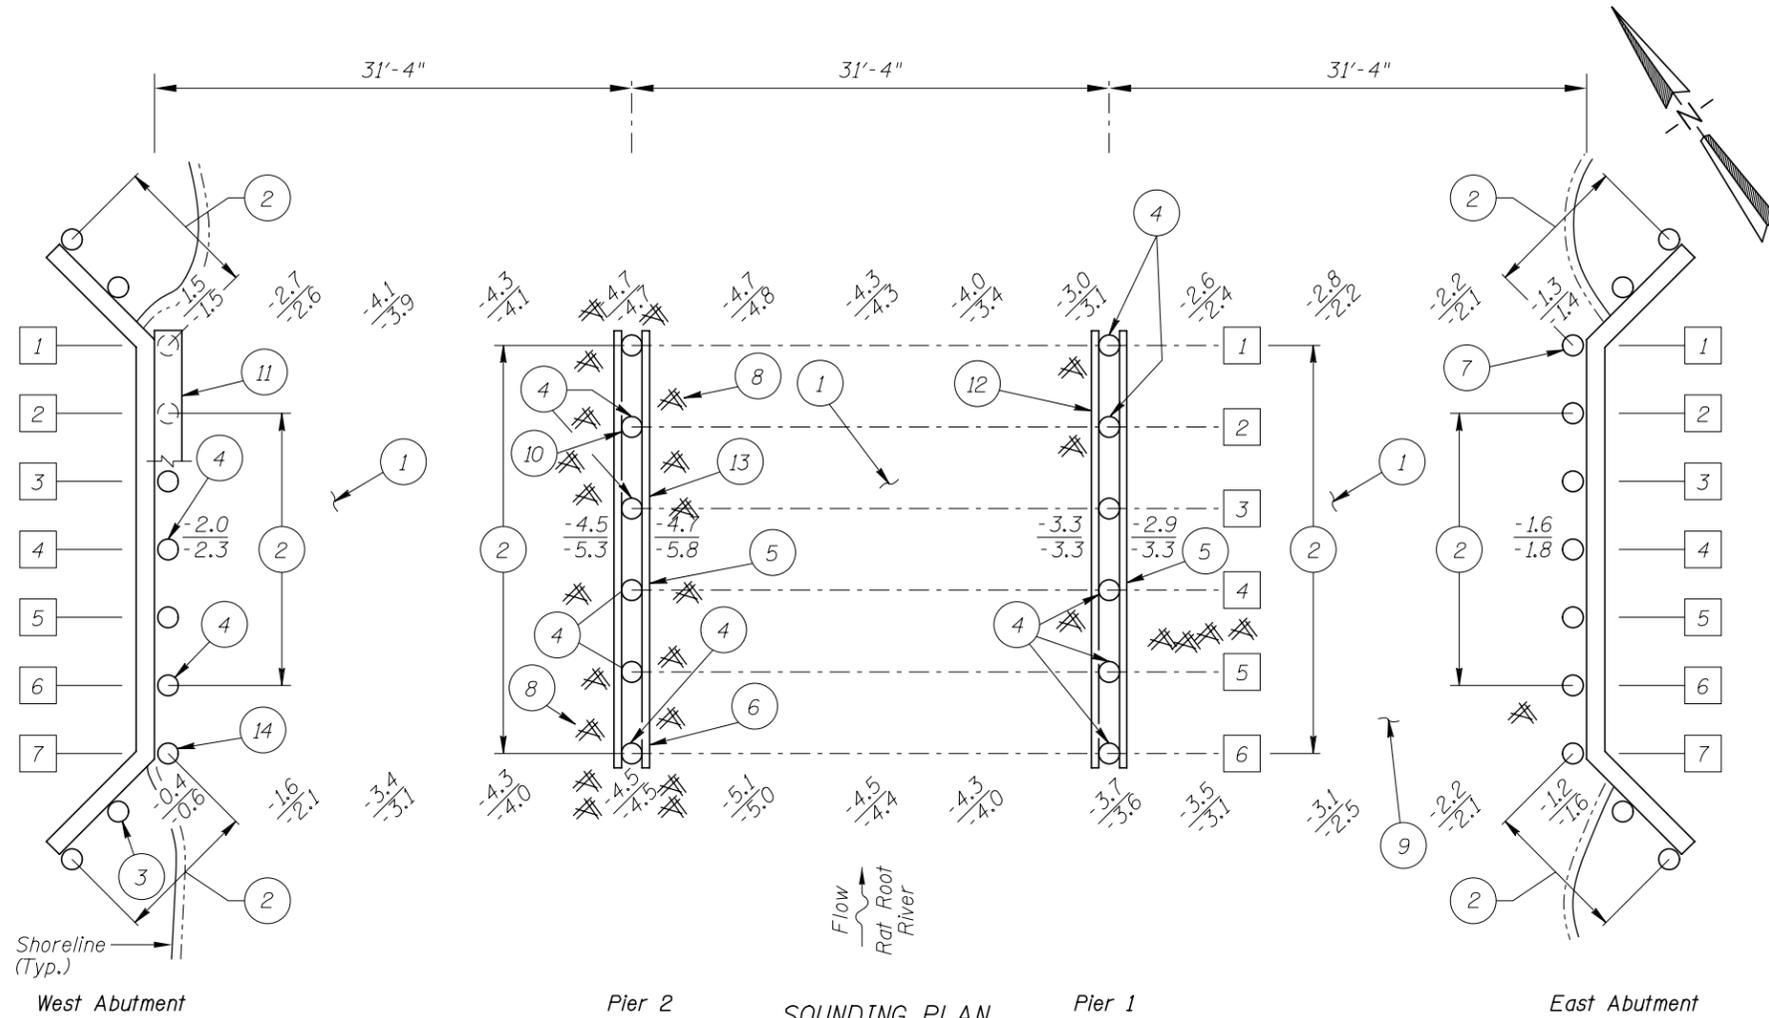
TYPICAL END VIEW OF PIERS

| <p>① The channel bottom material consisted of soft silty clay with random rock, 1 foot in diameter and smaller, with 1 foot of probe rod penetration.</p> <p>② All piles exhibited random checking 1/8 inch wide typical and 1/4 inch wide maximum unless otherwise noted.</p> <p>③ Timber pile with 1/2 inch wide crack from the top down 6 feet with 4 inches penetration.</p> <p>④ Timber pile from approximately 4 feet below the waterline or the channel bottom to 2 feet above the waterline exhibited a 10 inch wide to half the pile circumference wide area of splintering and delaminating with up to 1.5 inch penetration. (ice abrasion damage)</p> <p>⑤ Timber cross bracing missing section near waterline, up to 3 feet long, 3 inches deep, and 1 inch remaining timber to fastener, due to ice abrasion damage.</p> <p>⑥ Timber cross bracing exhibited up to 3 foot long split below fastener.</p> <p>⑦ Timber pile with 1 inch wide split from the top down 6 feet with penetration through 1/2 of the pile.</p> | <p>⑧ A moderate accumulation of timber debris consisting of 6-inch-diameter and smaller branches was observed along the west side of Pier 2 and extended from the channel bottom up to 2 feet.</p> <p>⑨ Light timber drift accumulation between East Abutment and Pier 1 hung up on cut off piles. In addition, light timber debris up to 6 inches in diameter was scattered around Pier 1.</p> <p>⑩ Timber cross bracing is no longer attached to Pile 2 on the west side of Pier 2.</p> <p>⑪ The pile cap over Piles 1 and 2 was rotated slightly to the west, with some minor diagonal torsional cracking along the south side, and as a result cap was not bearing directly on up to 50 percent of the top of the piles.</p> <p>⑫ Half of the timber cross bracing was broken away and was missing. The section that was remaining and still attached was split and was no longer engaged to the fasteners of Piles 1 and 2.</p> <p>⑬ Timber cross bracing had a 3 inch by 1-1/2 foot area of timber missing and the fastener from the pile was no longer engaged to the cross bracing.</p> <p>⑭ A 1/2 inch wide split with 4 inches of penetration, extending 3 feet down from the top of the pile.</p> |
