UNDERWATER BRIDGE INSPECTION REPORT

STRUCTURE NO. 36504

CR NO. 98

RAT ROOT RIVER

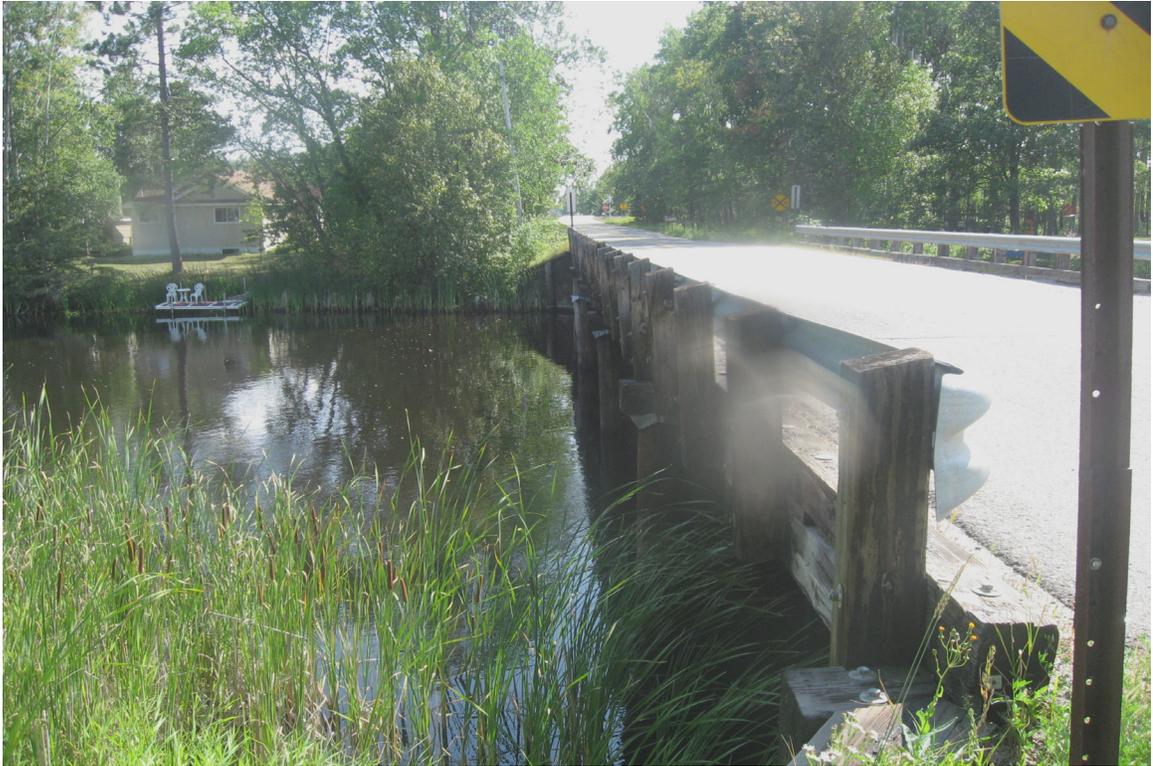
Photograph 1. Overall View of Structure, Looking Southwest.

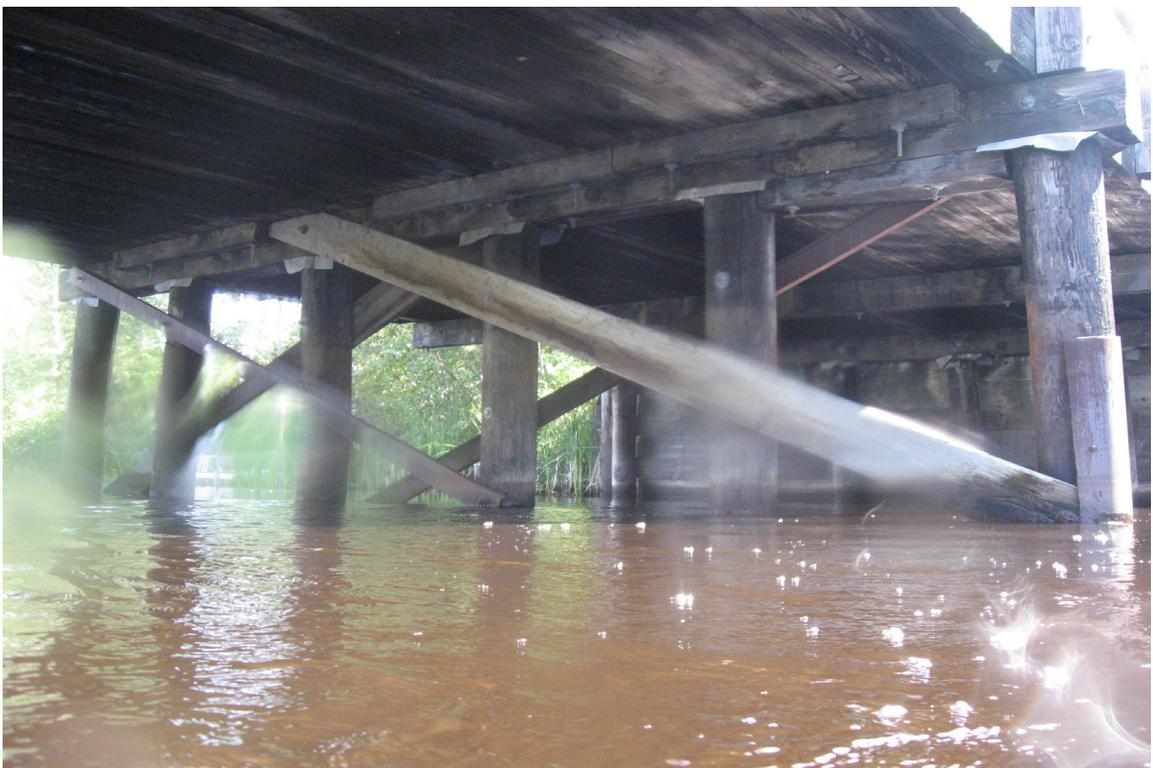
Photograph 2. View of Pier 1, Looking Southeast.

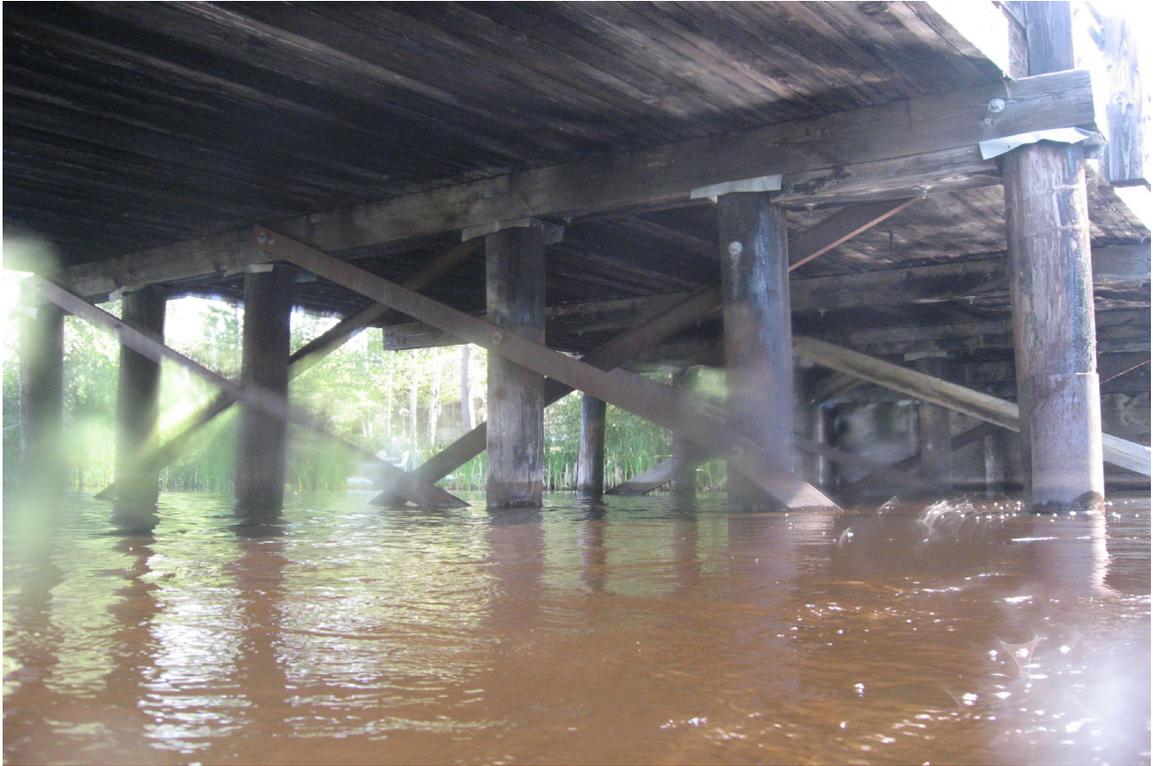
Photograph 3. View of Pier 2, Looking Southeast.

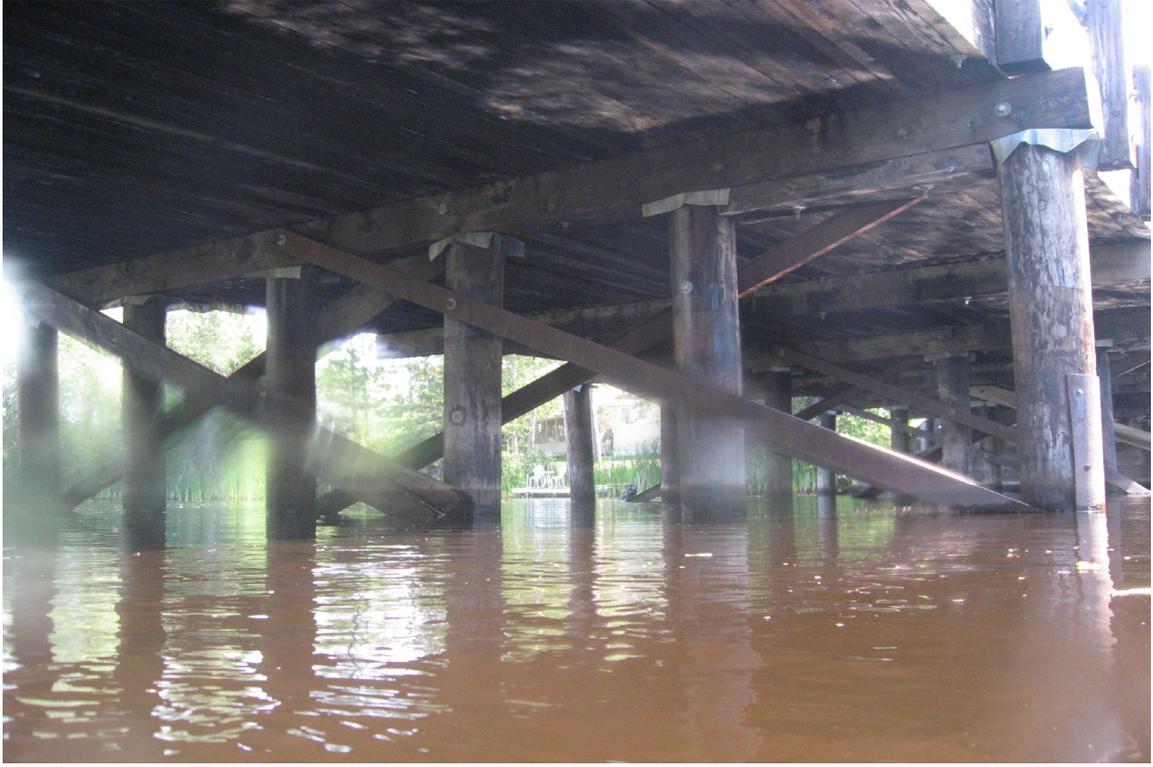
Photograph 4. View of Pier 3, Looking Southeast.

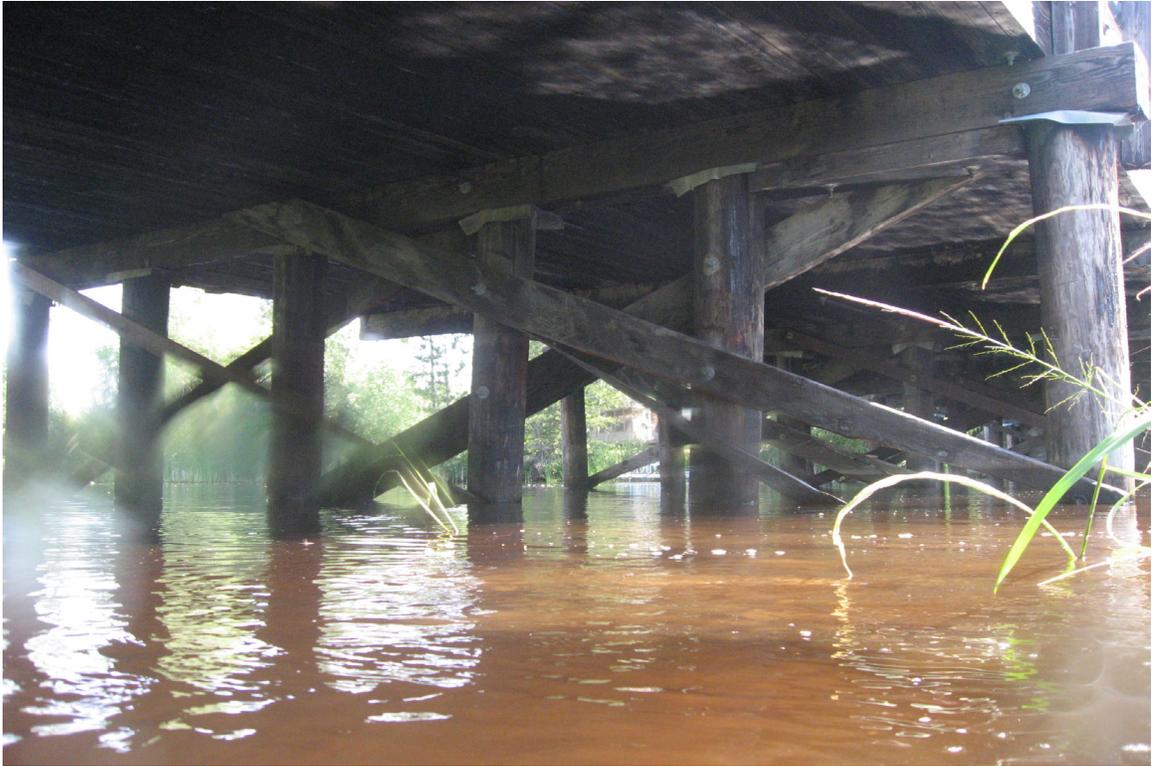
Photograph 5. View of Pier 4, Looking Southeast.

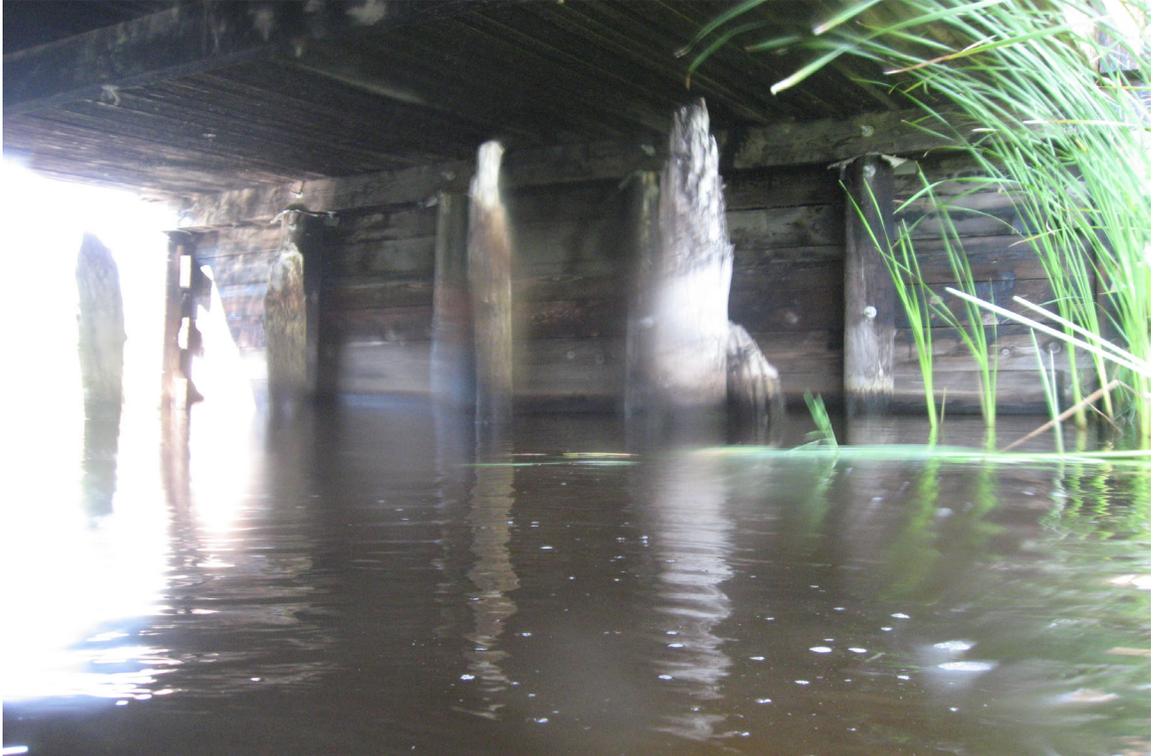
Photograph 6. View of the North Abutment, Looking Northwest.

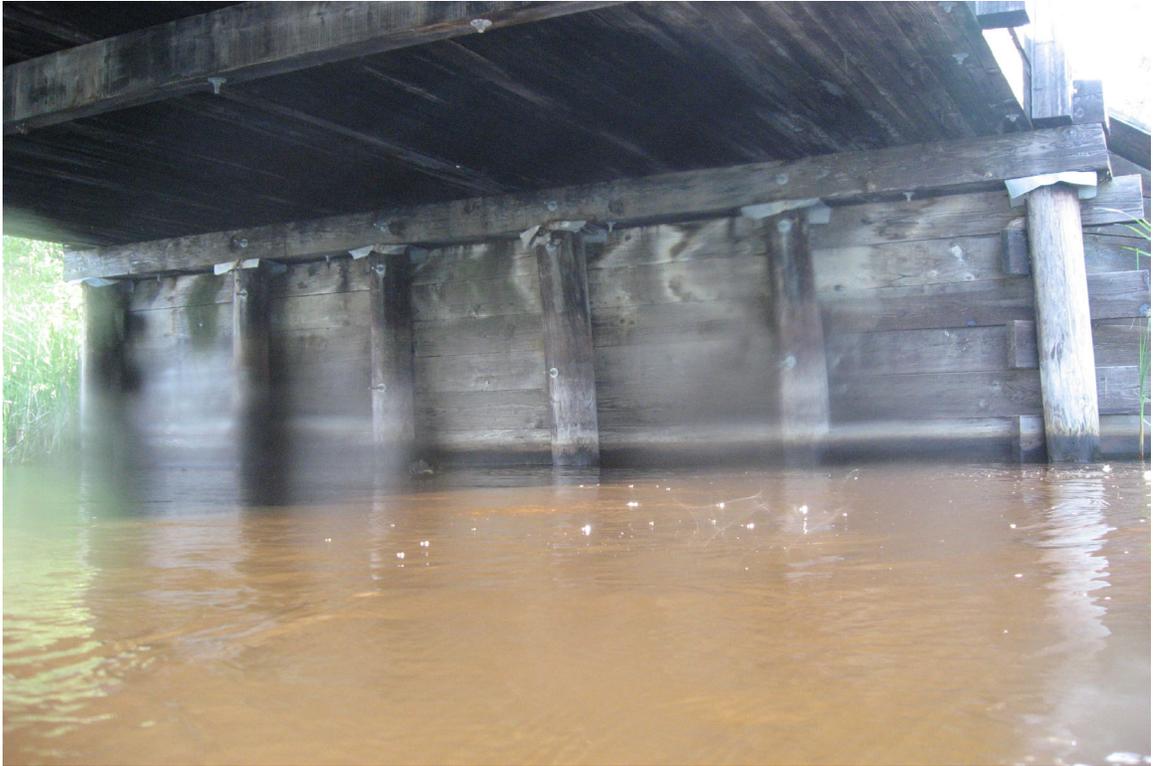
Photograph 7. View of the South Abutment, Looking Southeast.

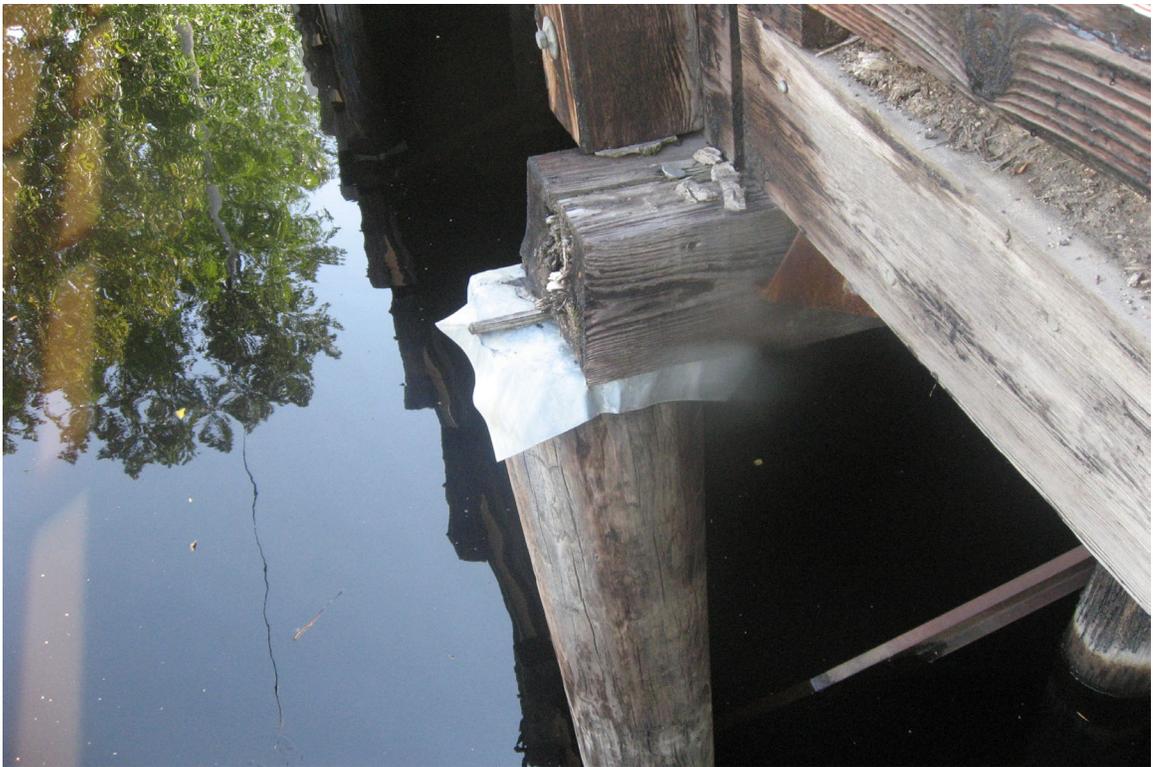
Photograph 8. View of Pile Cap not Bearing Fully on the Downstream Pile of Pier 2, Looking South.

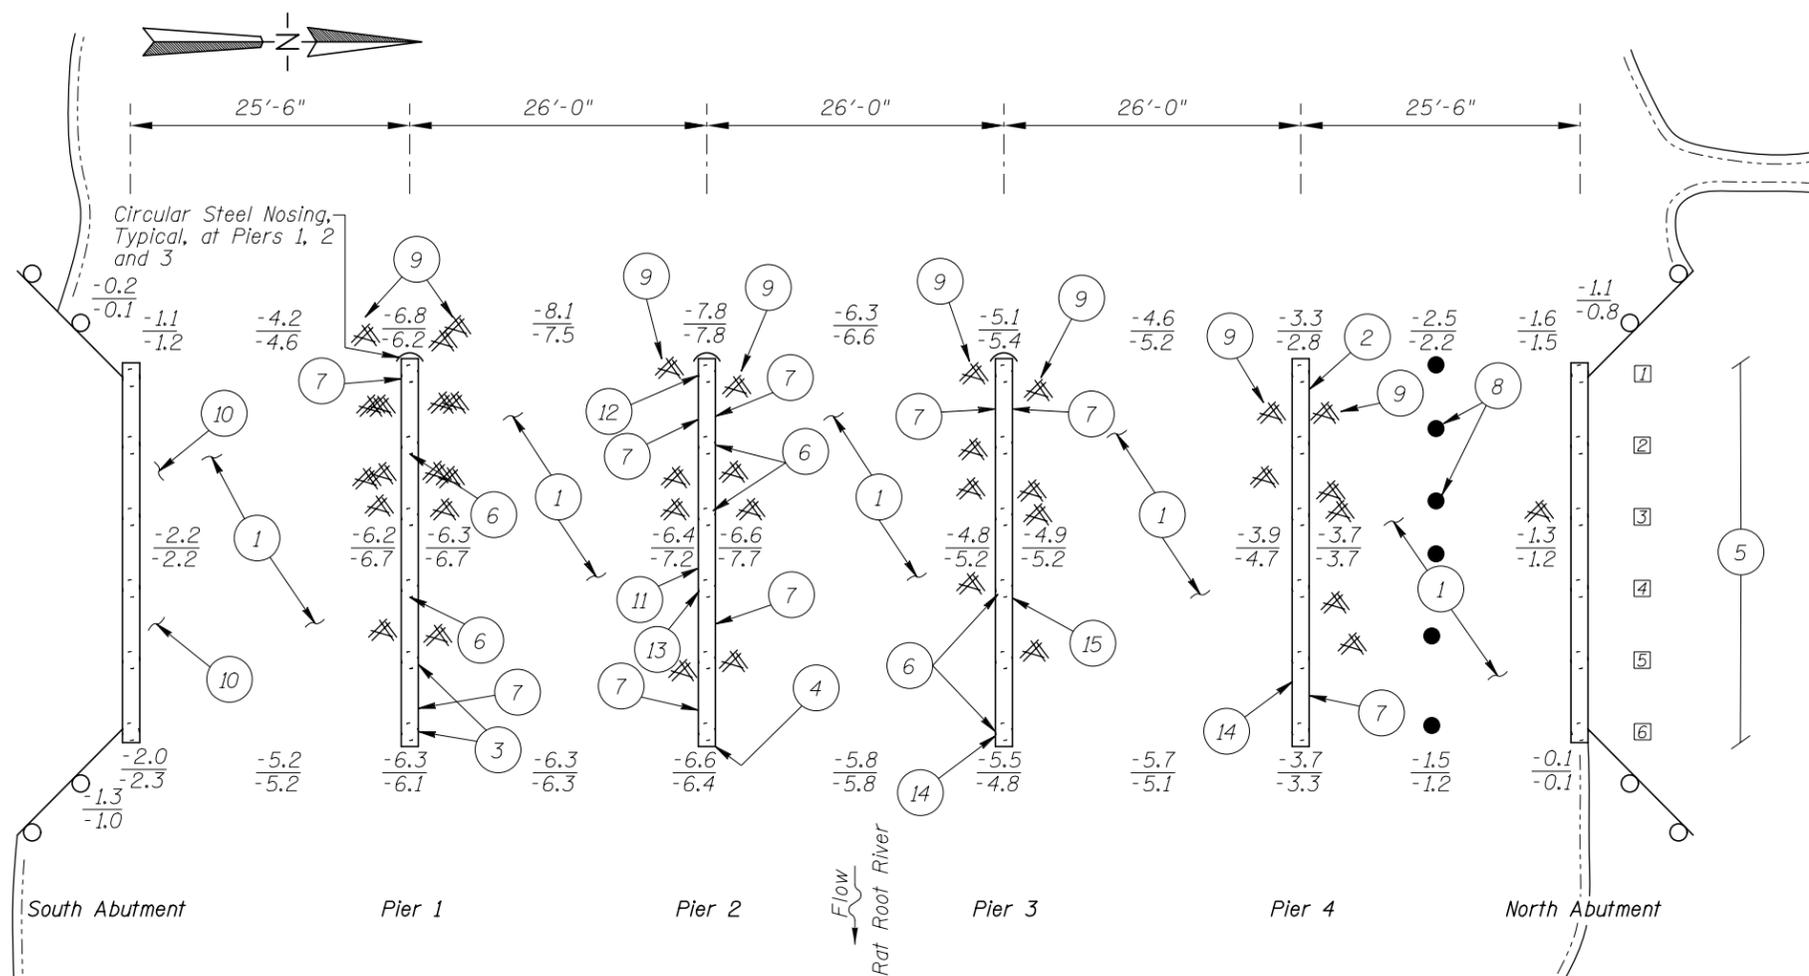
| <p>1 The channel bottom material around all of the piers typically consisted of silty clay with a maximum probe rod penetrations of 1 foot.</p> <p>2 Bracing split over length of 10 feet and separated through pile fastener.</p> <p>3 Outer layer of pile softer than typical with approximately 1 inch surface delamination from 3 feet above the waterline to the channel bottom. (ice related damage)</p> <p>4 End of cap at above the easternmost pile has a 50 percent loss of section, that has reduced the cap's bearing capacity on the pile by 50%. The pile seems to have shifted downstream.</p> <p>5 All of the timber piles around the waterline and below exhibited random 1/4 inch soft outer layer with checking and delamination due to normal weathering, age, and ice damage. Random 1/4 inch wide checking was also present at most piles.</p> <p>6 Heavier surface splintering and delamination, as noted in Note 5, typically extending between 1 foot below and 4 feet below the waterline with penetration/depth of 1/2 inch.</p> <p>7 Steel channel replacement cross bracing was used to replace the old timber cross bracing on the upstream south side and downstream north side of Pier 1, all of the timber cross bracing at Pier 2, and on the upstream north and south sides of Pier 3.</p> <p>8 Old abandoned timber piles that were protruding 2 to 4 feet above the mudline.</p> | <p>9 Light timber debris consisting of branches up to 6 inches in diameter. Most of the debris extended from the channel bottom to 1 to 3 feet above the channel bottom.</p> <p>10 The channel bottom at the South Abutment consisted of gravel and 1 foot diameter riprap.</p> <p>11 The steel channel was deformed between the 3rd and 4th pile in from the upstream fascia, and was not engaged to the 4th pile in from the upstream fascia.</p> <p>12 The steel channel was no longer engaged to the upstream pile and had been deformed by ice flow and drift.</p> <p>13 The timber pile exhibited a 3 inch diameter, with 1 inch penetration, area of abrasion that was caused by rubbing contact with the unconnected steel channel, and was located 1-1/2 feet below the waterline.</p> <p>14 Timber cross bracing was no longer in place.</p> <p>15 A 6 feet long by 2 inch wide split in timber bracing through the pile fastener.</p> |
