UNDERWATER BRIDGE INSPECTION REPORT

STRUCTURE NO. 36514

RAPID RIVER

DISTRICT 1 - KOOCHICHING COUNTY

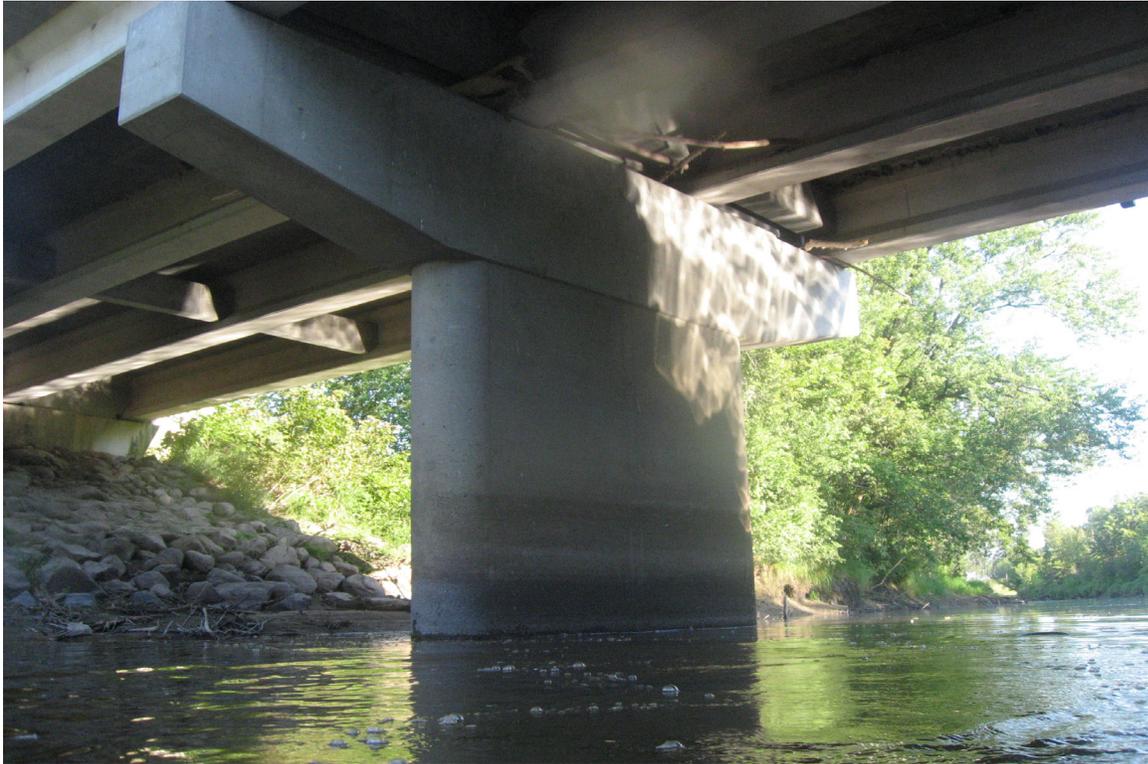
- (A) The concrete of Piers 1 and 2 was smooth and sound with no significant deterioration.
- (B) Light scaling was observed from 3 feet above the waterline to 2 feet below the waterline with maximum penetrations of ¼ inch on Piers 1 and 2.
- (C) A minor accumulation of timber debris was observed at Pier 1 consisting of a few branches measuring up to 2 inches in diameter. A moderate accumulation of debris measuring up to 1 foot in diameter was observed across the upstream nose of Pier 2 and extending towards the easterly shoreline.

Photograph 1. View of Pier 1, Looking Northwest.

- (A) Monitor the accumulations of timber debris at the upstream nose of Piers 1 and 2, and if found to be increasing, removal may be warranted as part of future maintenance to alleviate scour influence at the pier and any further accumulation.

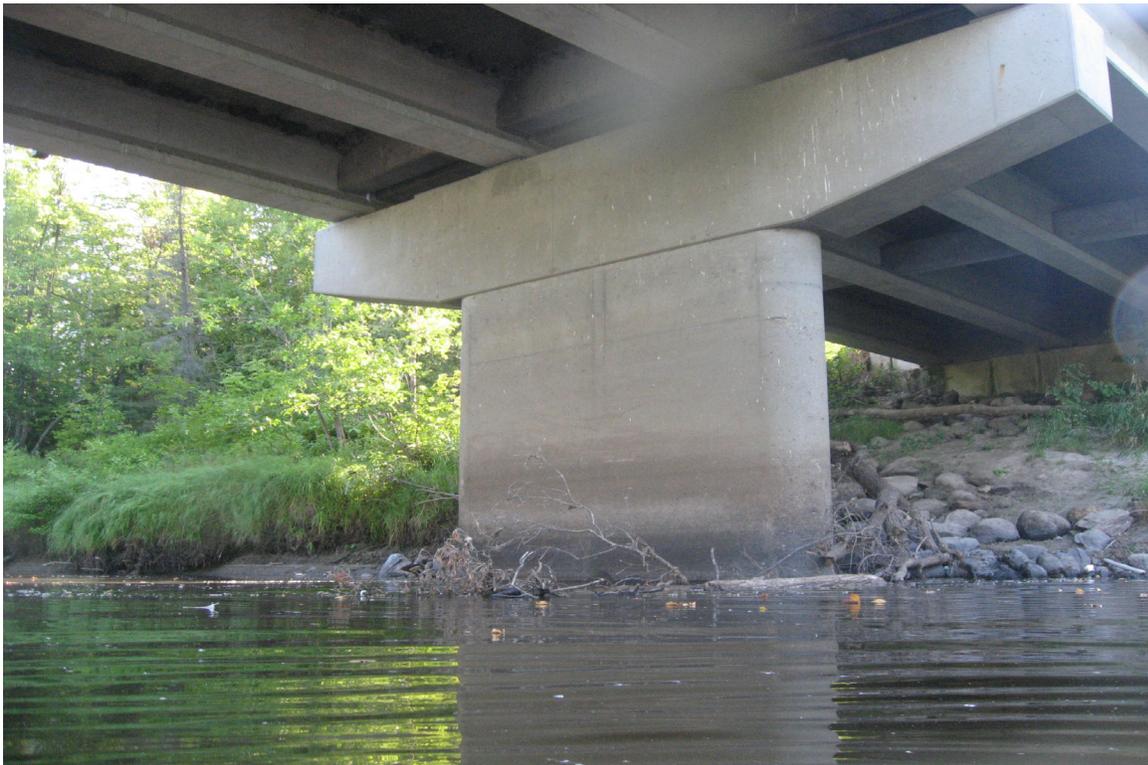
Photograph 2. View of Pier 2, Looking Northeast.

- 3 A moderate accumulation of timber debris was observed, consisting of numerous logs and tree trunks measuring up to 1 foot in diameter lying across the upstream nose and extending to the easterly shoreline. Debris extended from channel bottom to waterline at Pier 2.

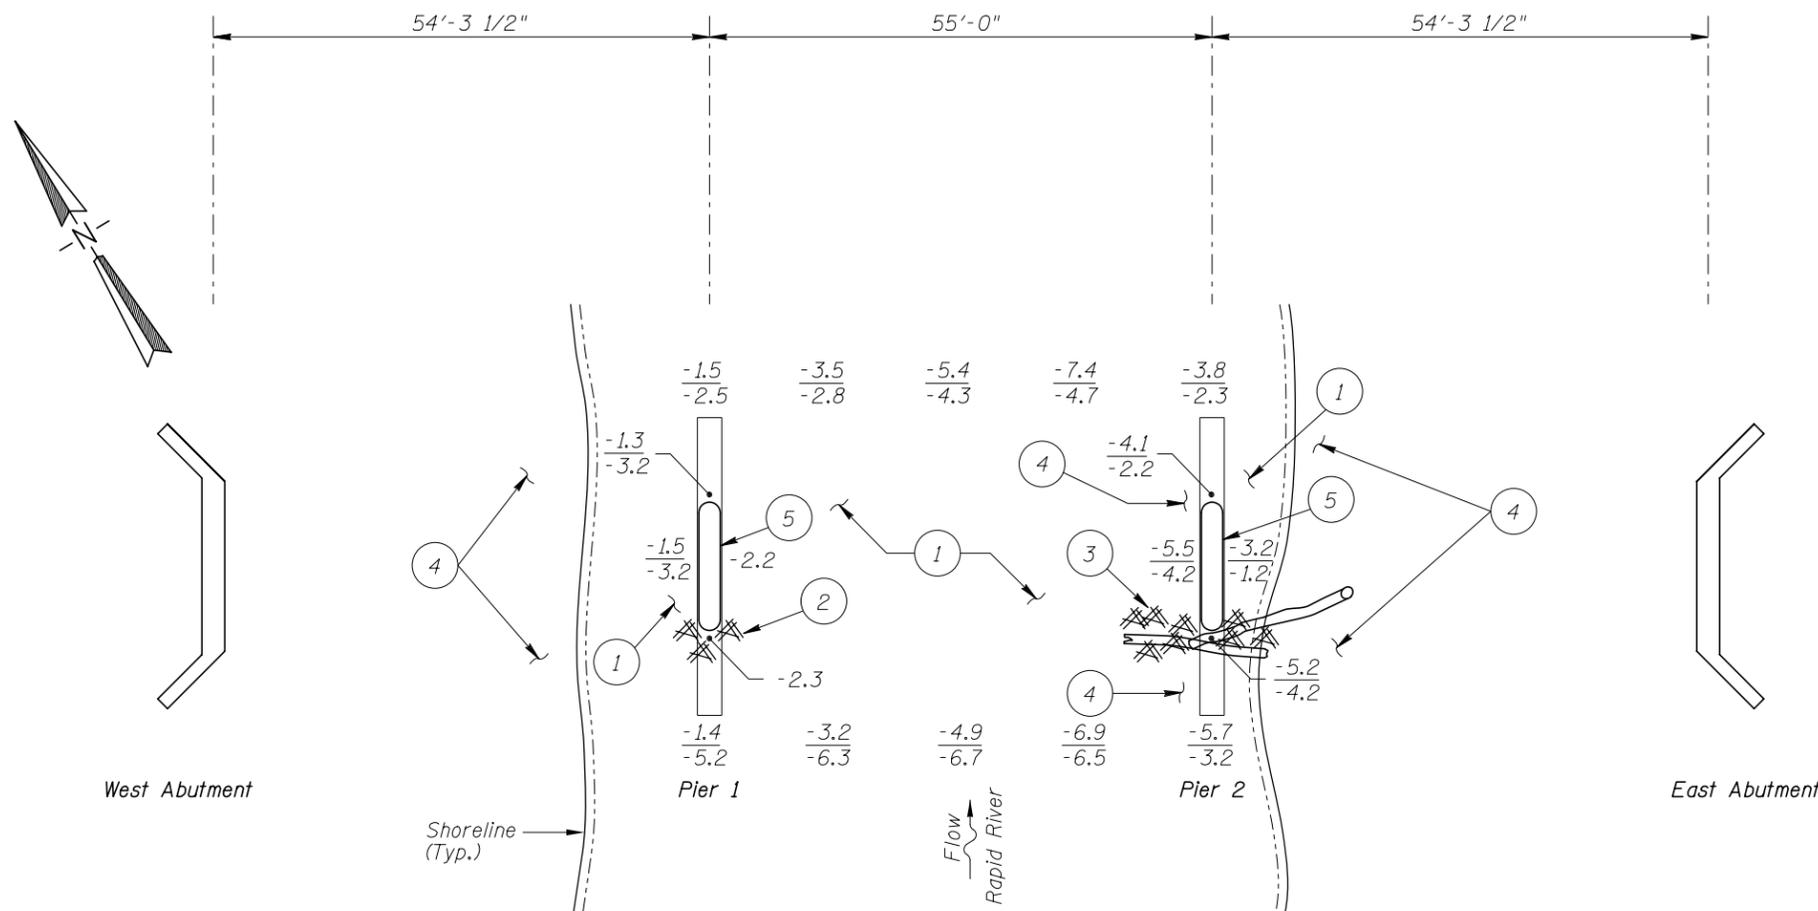
INSPECTION AND SOUNDING PLAN

- 1 The channel material consisted of sand and gravel with some silt and up to 6 inches of probe rod penetration.
- 2 A minor accumulation of timber debris was observed at Pier 1, consisting of a few branches, each measuring up to 2 inches in diameter. The debris extended 1 foot up from channel bottom.

- 4 The shoreline consisted of up to 2 feet diameter riprap, which was also present around the upstream and downstream noses of Pier 2.
- 5 Light scaling from 3 feet above the waterline to 2 feet below water level with 1/8 inch typical to 1/4 inch maximum penetrations was observed along the entire perimeter of Pier 1 and Pier 2.
