UNDERWATER BRIDGE INSPECTION REPORT

STRUCTURE NO. 36517

LITTLE FORK RIVER

COLLINS ENGINEERS, INC.

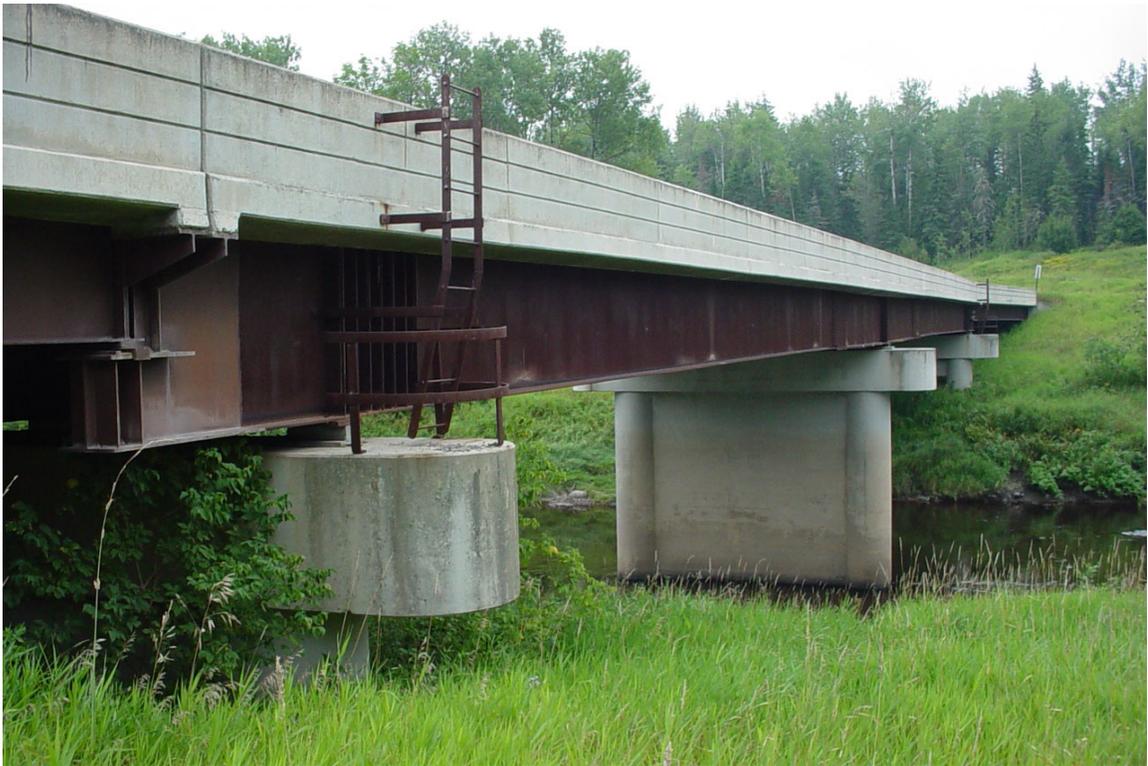
Photograph 1. Overall View, Looking Southeast.

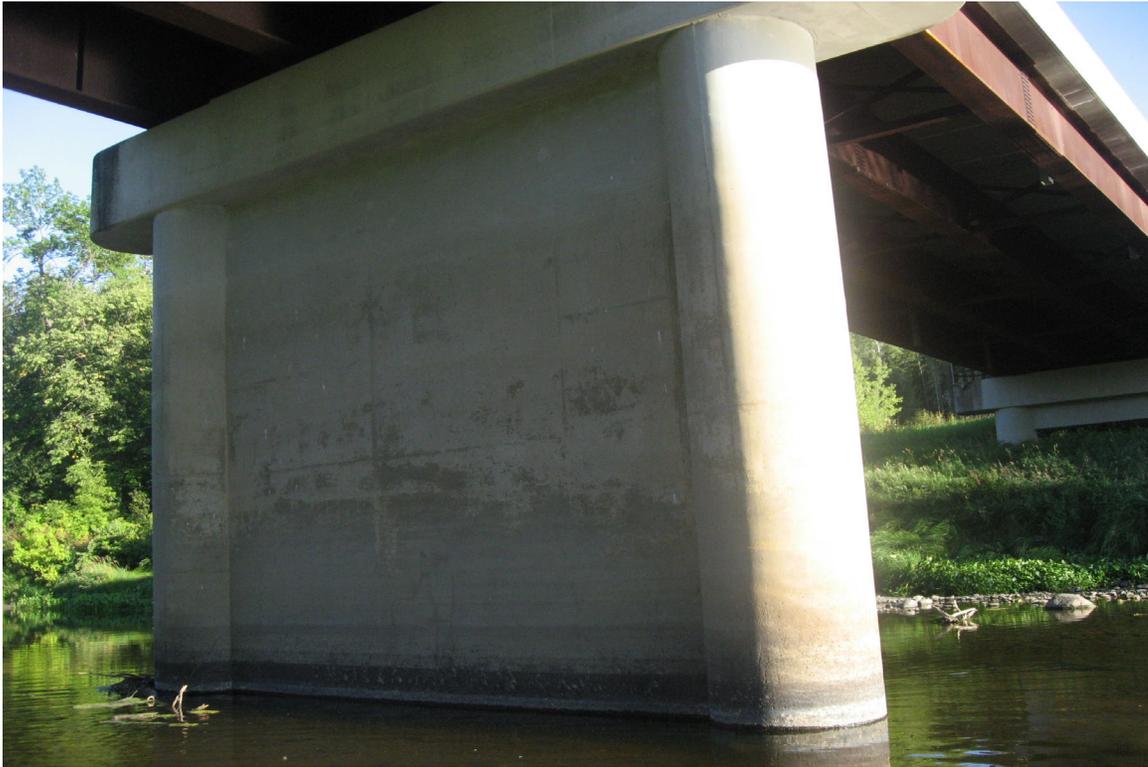
The substructure unit inspected at Bridge No. 36517, Pier 2, was found to be in good condition below water with no defects of structural significance. The channel bottom around Pier 2 was presently firm and appeared stable with minor scour and no significant changes since the last inspection. The footing was exposed at both the upstream and downstream noses of the pier.

Photograph 2. Pier 2, Looking Southeast.

- (A) Footing exposures should be monitored during future inspections.
- (B) Reinspect the submerged substructure units at the normal maximum recommended (NBIS) interval of five (5) years.

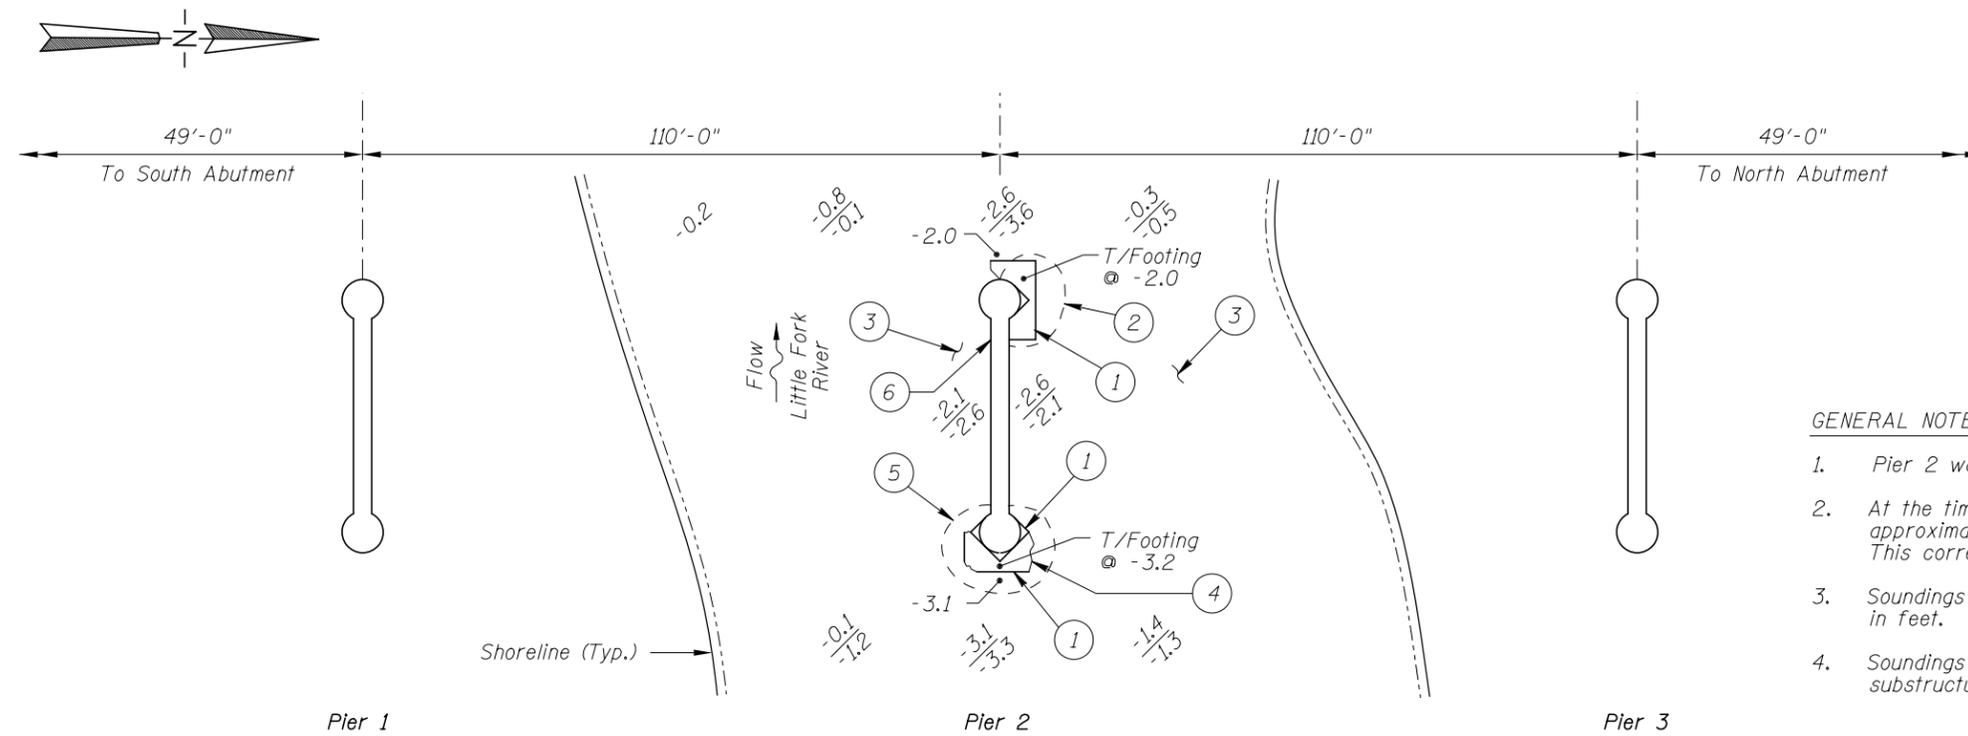
**INSPECTION AND SOUNDING PLAN**

- ① The footing was exposed at both noses of the pier approximately as shown. The exposure was primarily only the top of the footing with no vertical exposure.
- ② Minor scour depression, 3 feet in radius and 0.5 foot deep, was observed at the downstream column of the pier.
- ③ The channel bottom material consisted of a firm, sandy gravel and scattered riprap with up to 1 inch probe rod penetration.
- ④ A light accumulation of timber debris consisting of 8 inches diameter and smaller branches was observed at the upstream nose of Pier 2, extending from waterline to channel bottom.
- ⑤ Minor scour depression, 5 feet in radius and 1.5 feet deep was observed at the upstream column of Pier 2.
- ⑥ A band of scaling 1 foot high was located at waterline with 1/4 inch max penetration.
