UNDERWATER BRIDGE INSPECTION REPORT

STRUCTURE NO. 36523
CSAH NO. 18
OVER THE
EAST FORK OF THE RAPID RIVER
DISTRICT 1 - KOOCHICHING COUNTY

PREPARED FOR THE
MINNESOTA DEPARTMENT OF TRANSPORTATION
BY
COLLINS ENGINEERS, INC.

JOB NO. 5221

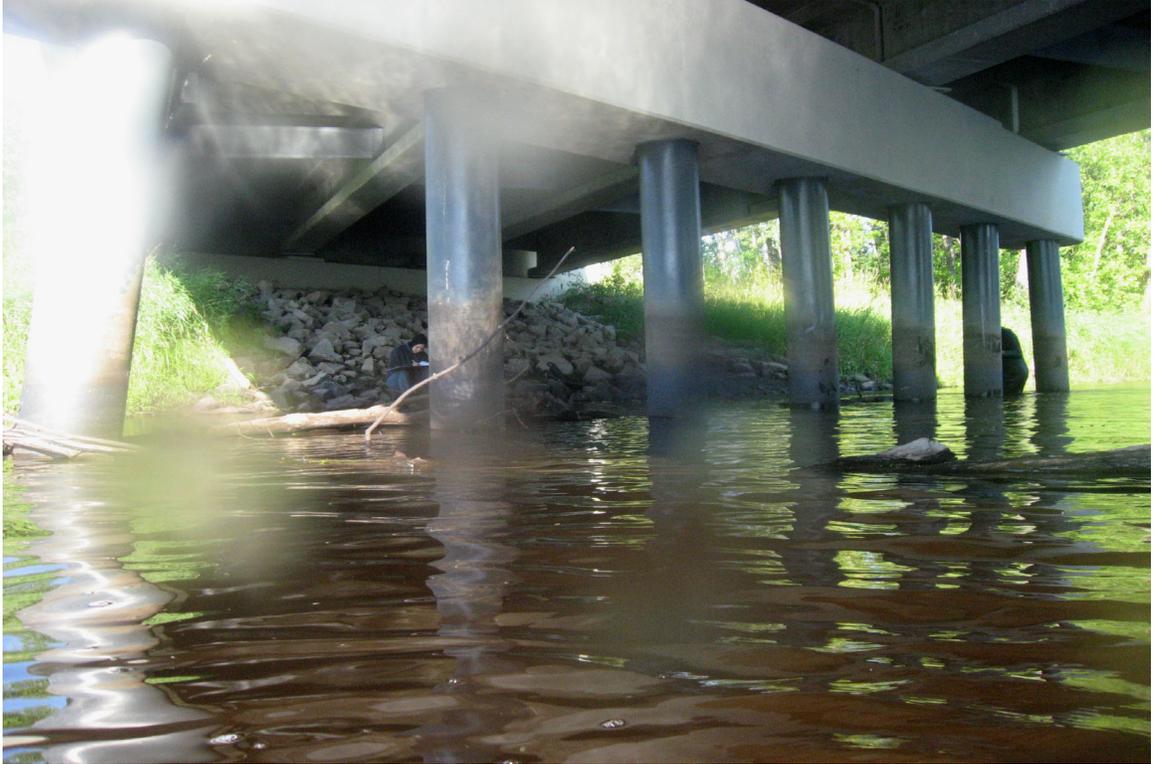
- (A) The protective coating on the piles exhibited signs of breakdown and surface corrosion from 6 inches above the waterline to the channel bottom. Also, nodules were observed ¼ inch maximum size. No appreciable section loss was observed and the corrosion coverage was 10 to 20 percent.

- (B) Two 1.5-foot-diameter tree trunks were observed along the west side of Pier 1 and a light accumulation of 6-inch-diameter timber debris was observed scattered throughout the piles of both Piers 1 and 2 extending from the channel bottom to the waterline.

Photograph 1. View of Pier 1, Looking Northwest.

- (A) Reinspect all substructure units underwater within the normal maximum (NBIS) interval of five (5) years. Monitor the drift accumulations and if found to be increasing in future, removal may be warranted at that time.

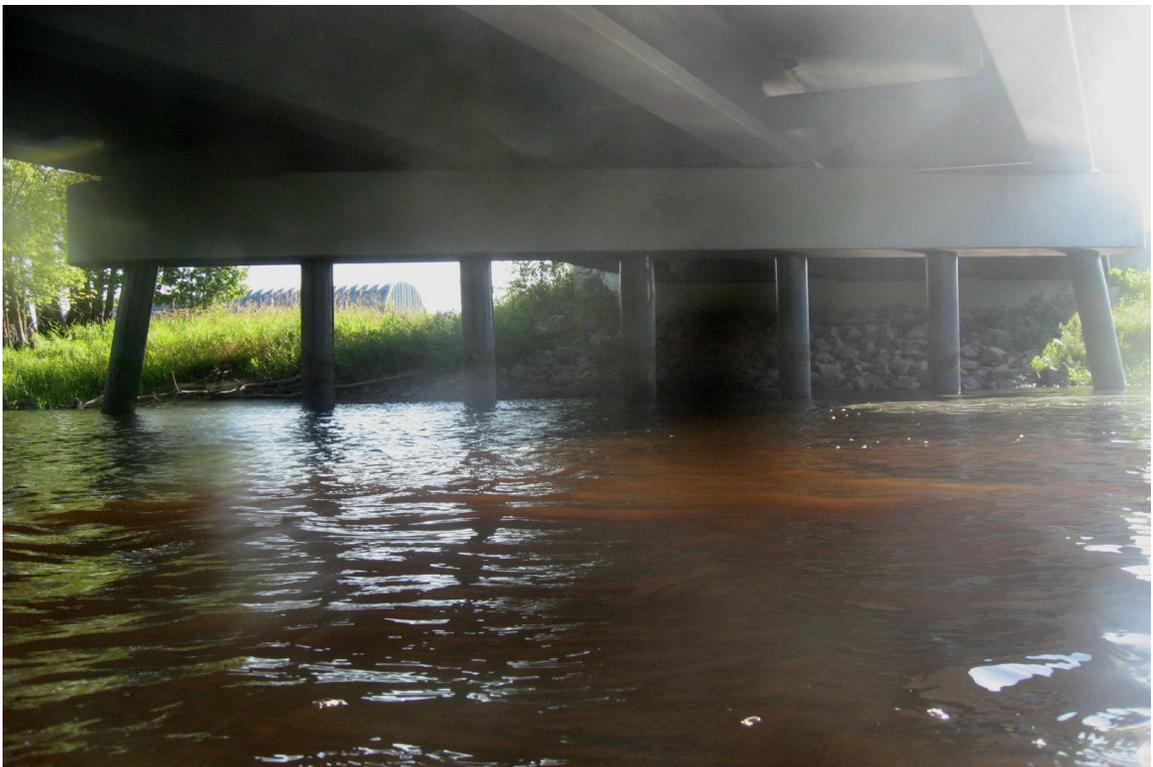
Photograph 2. View of Pier 2, Looking Northeast.

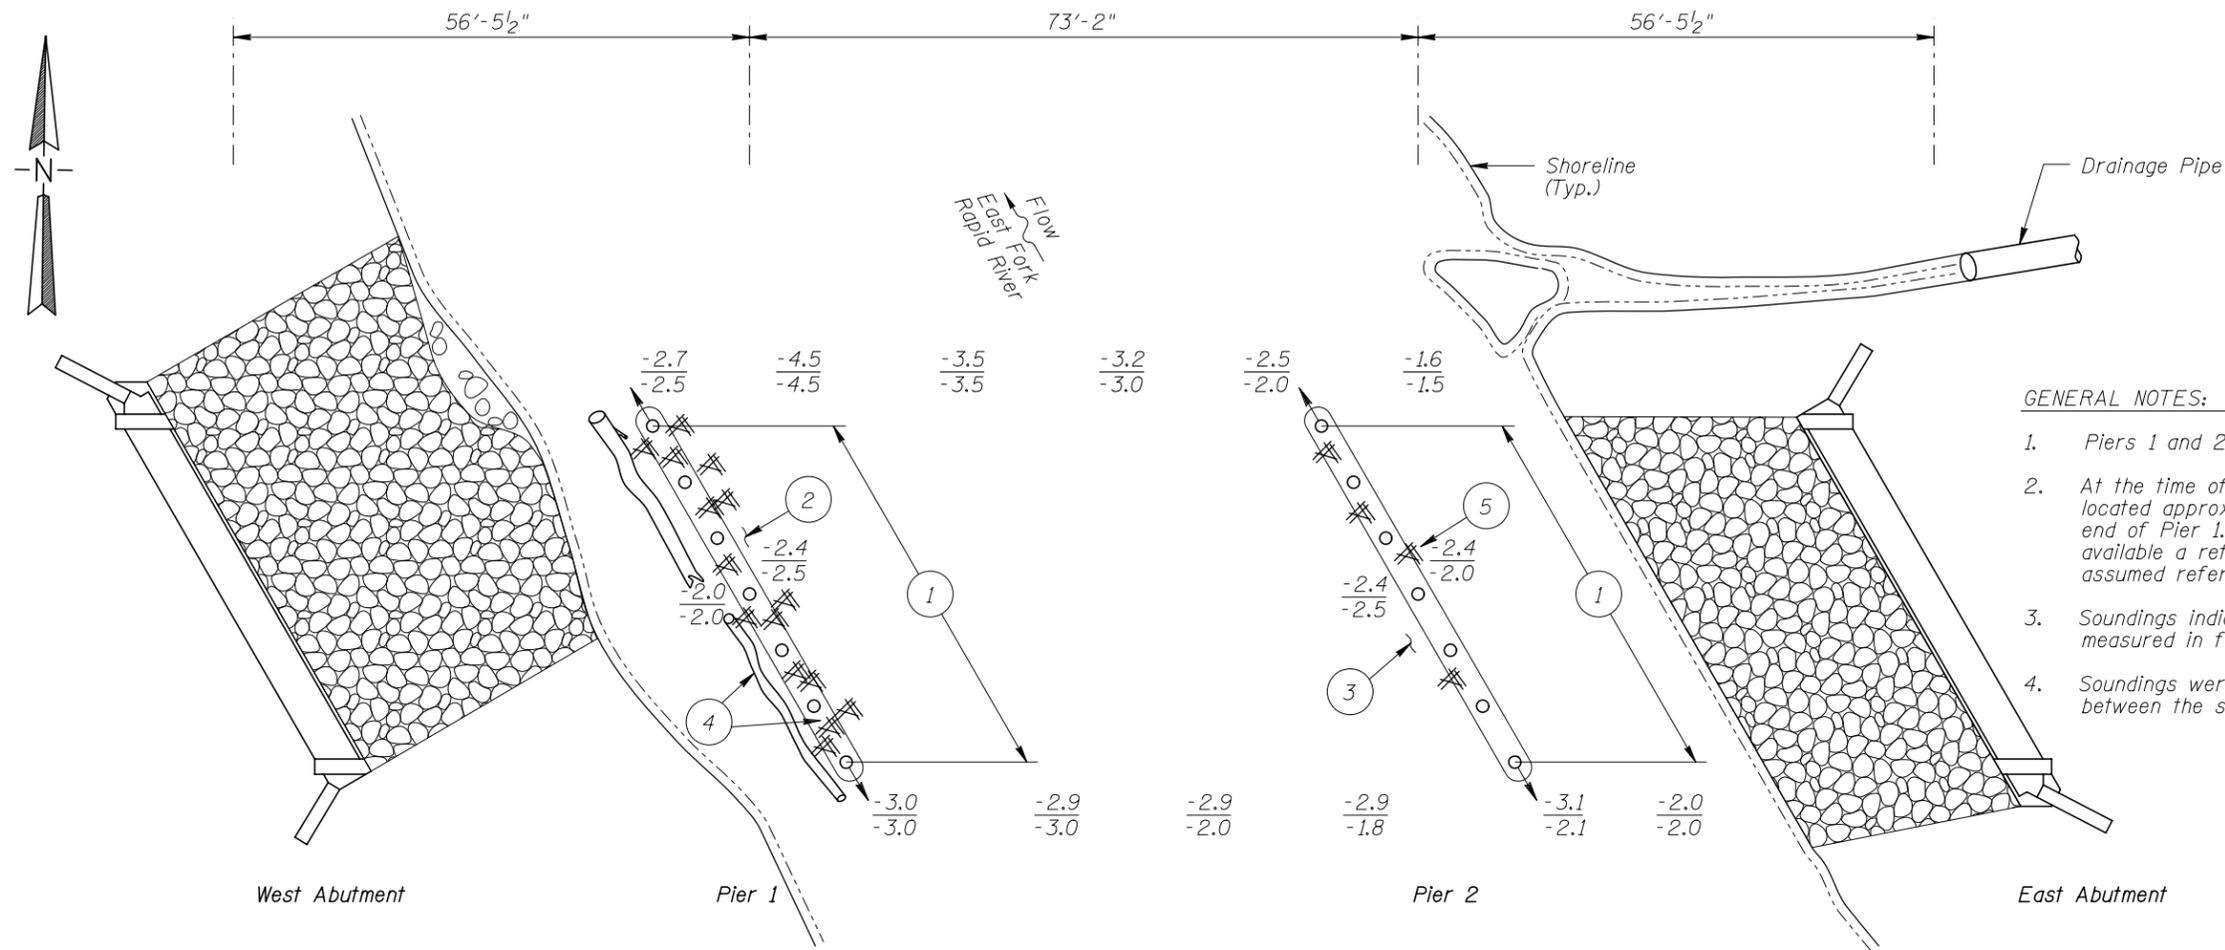
SOUNDING PLAN

- 1 The coating on the steel encased concrete piles (concrete filled pipe piles) exhibited signs of breakdown and surface corrosion 6 inches above waterline to channel bottom. Nodules were observed 1/4 inch maximum size. No appreciable section loss was observed and the coverage was 10-20%.
- 2 The channel bottom at Pier 1 consisted of soft silt with a maximum probe rod penetration of 1 foot and occasional riprap.
- 3 The channel bottom at Pier 2 consisted of soft silt with a maximum probe rod penetration of 6 inches.
- 4 Two 1.5-foot-diameter tree trunks were observed along the west side of Pier 1 and a moderate accumulation of 6-inch-diameter timber debris was observed scattered throughout the piles from the channel bottom to the waterline.
- 5 A light accumulation of 6-inch-diameter timber debris was observed scattered throughout the piles.
