UNDERWATER BRIDGE INSPECTION REPORT

STRUCTURE NO. 38505
CSAH NO. 16
OVER
SILVER RAPIDS
DISTRICT 1 - LAKE COUNTY

PREPARED FOR THE
MINNESOTA DEPARTMENT OF TRANSPORTATION
BY
COLLINS ENGINEERS, INC.
JOB NO. 5221 (CEI 13)

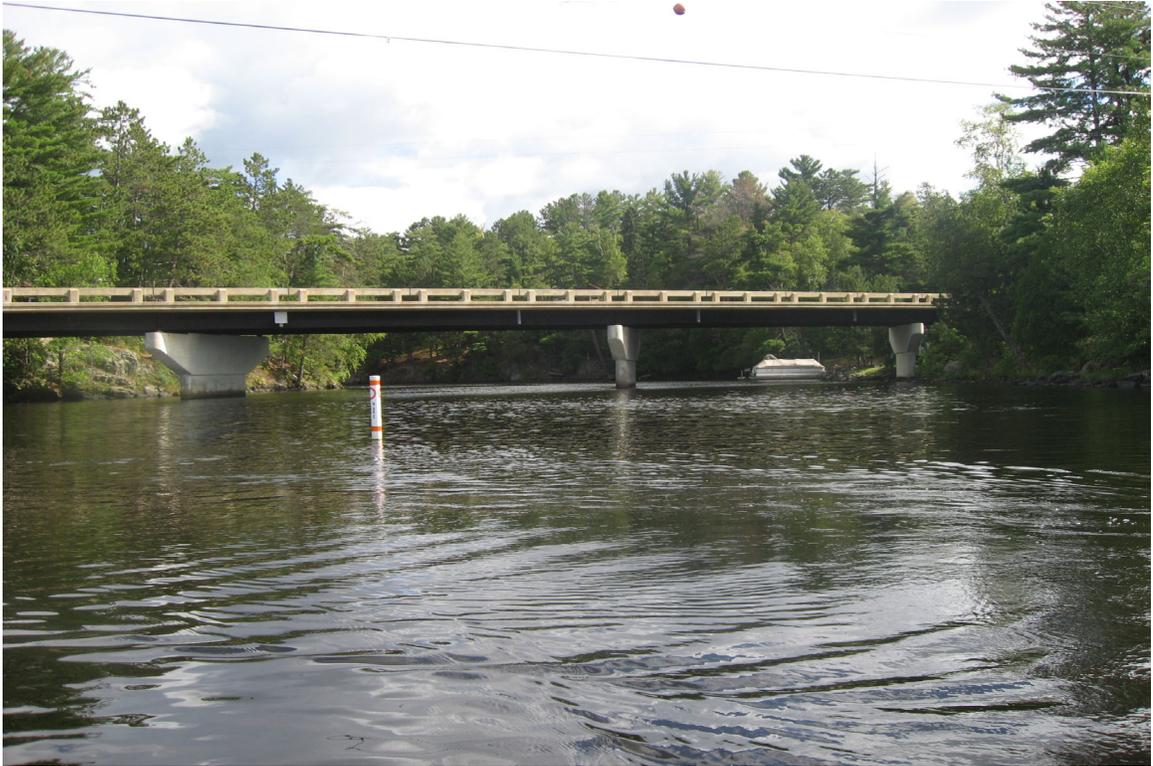
Photograph 1. Overall View of the Structure, Looking South.

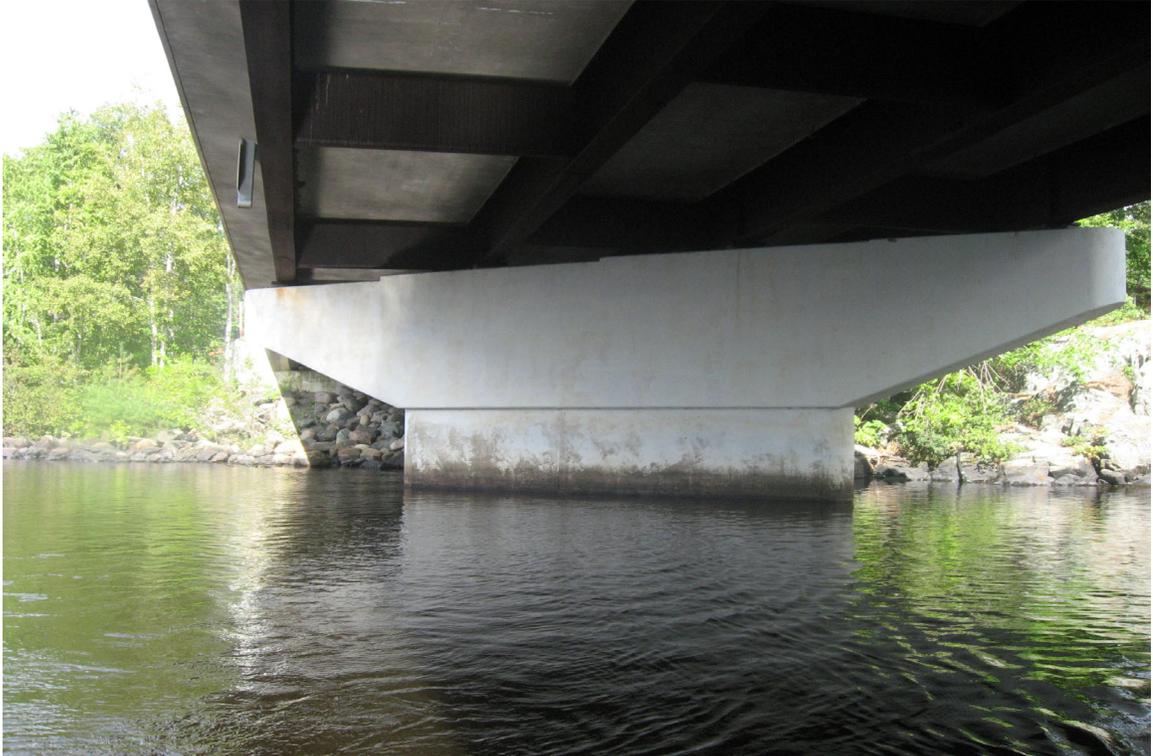
Photograph 2. View of Pier 1, Looking West.

REMARKS: Overall, the submerged concrete of the piers was in good condition with random light scaling and exposed aggregate, especially around the noses. A minor scour depression, 4 feet in radius and 6 inches deep, was observed on the channel side of Pier 1. The scour depression exposed the top of the footing but no vertical exposure was observed.

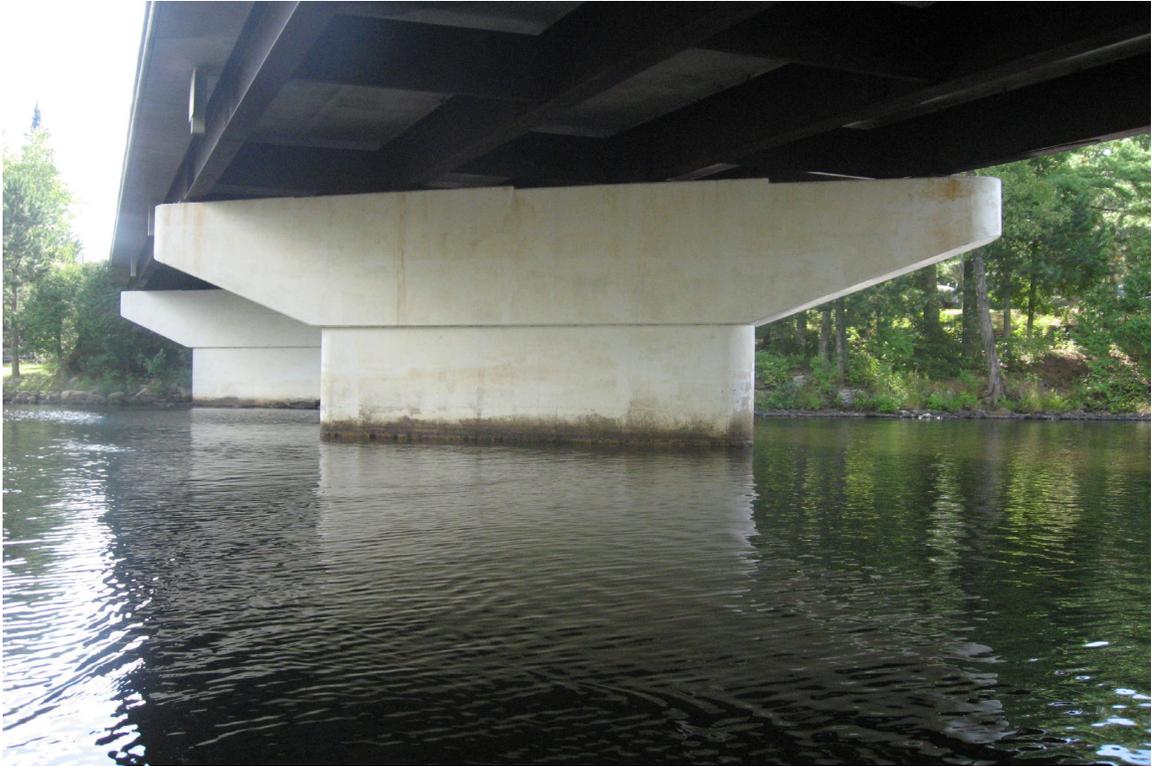
Photograph 3. View of Pier 2, Looking East.

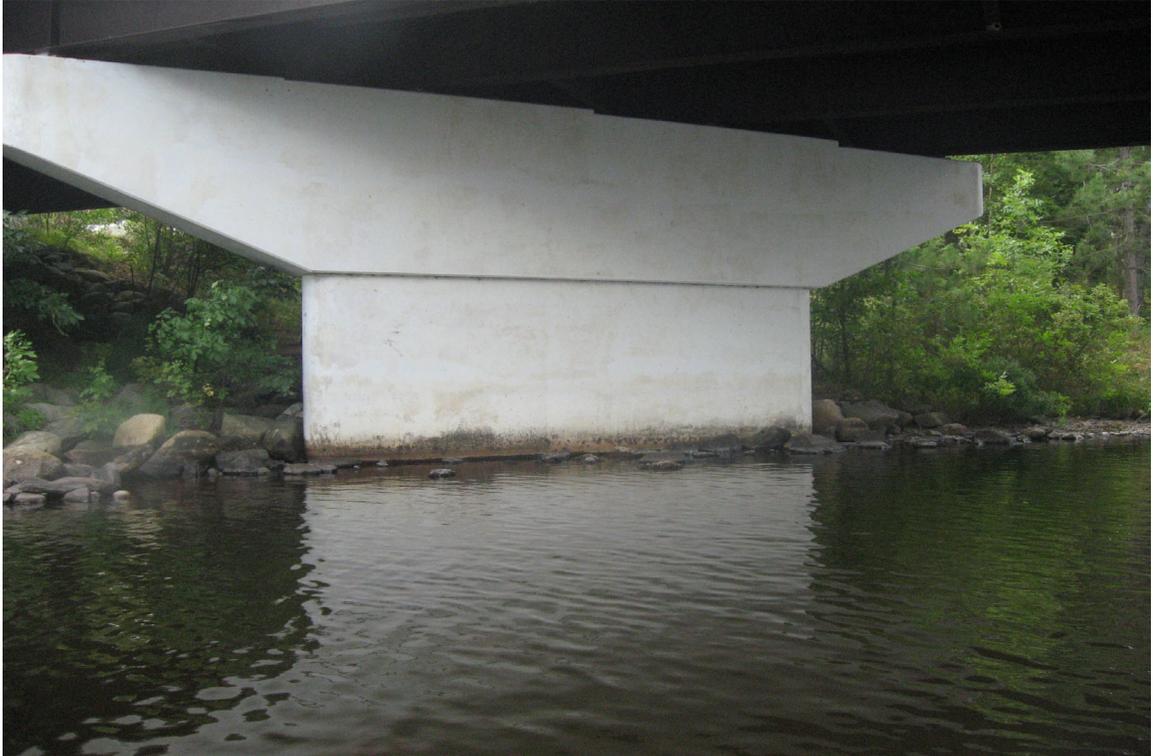
Photograph 4. View of Pier 3, Looking Southeast.

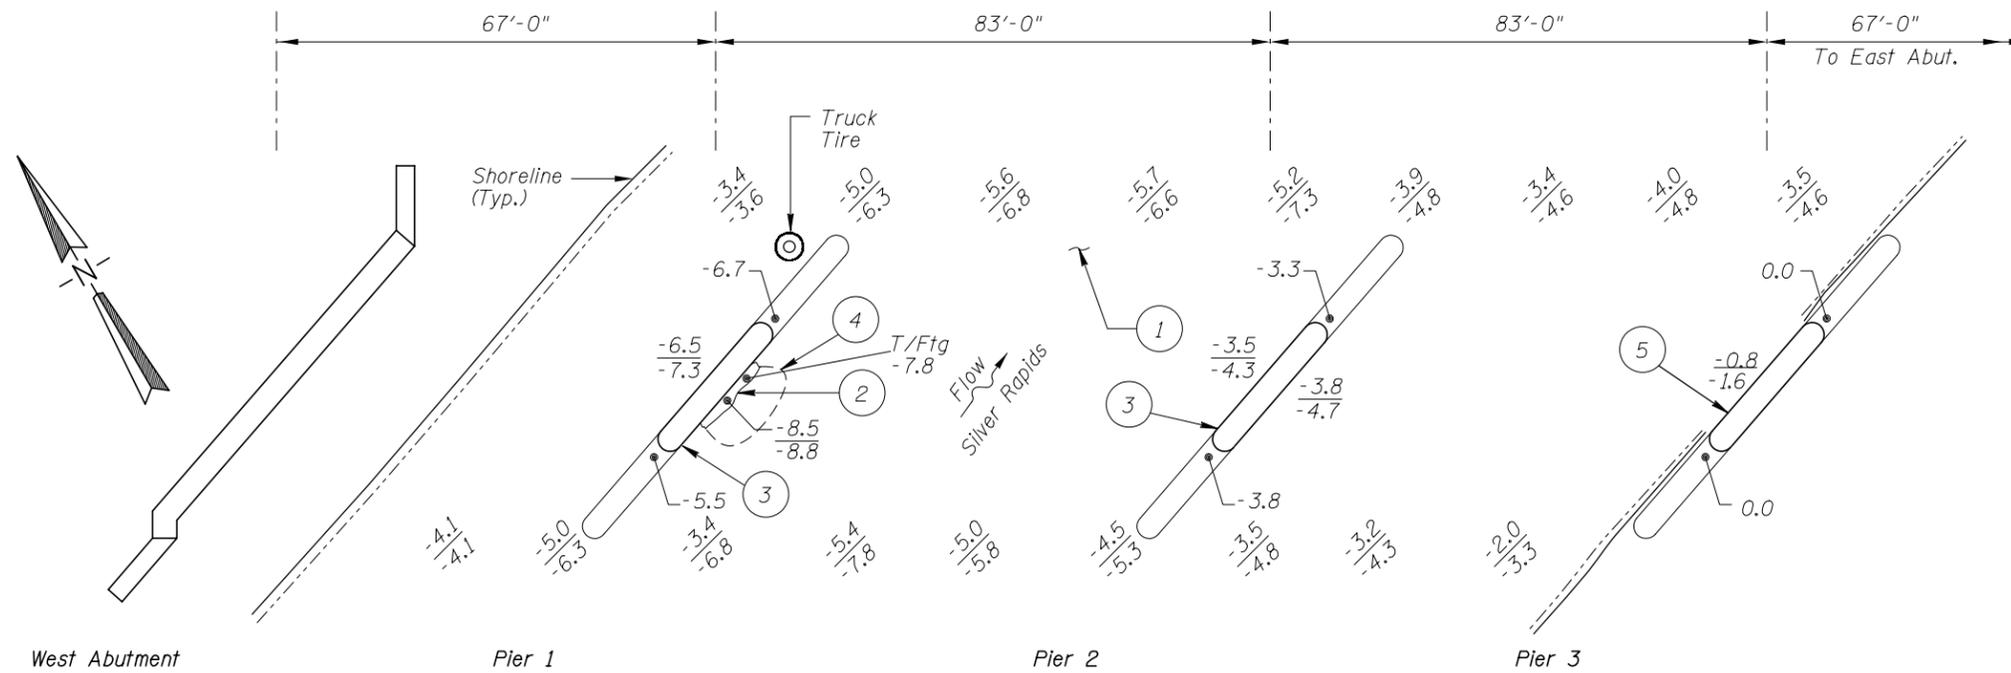
SOUNDING PLAN

- ① The channel bottom material consisted of large riprap with firm sandy gravel and no appreciable probe rod penetration. Riprap sizes typically ranged from approximately 6 inch to 1 foot in diameter.
- ② The top of the Pier 1 footing was exposed along most of the east side of the pier. The footing was level with the channel bottom, with a maximum width of 2 feet exposed and no edge or vertical face exposure.
- ③ A band of scaling was observed around Piers 1 and 2, extending from 1 foot above the waterline to 3 feet below the waterline, with typical penetrations of 1/16 to 1/8 inch and maximum penetrations of 1/4 inch at the upstream ends of the piers.
- ④ A minor scour depression with a radius of 4 feet and a depth of 6 inches was observed along the south side of Pier 1.
- ⑤ Random light scaling and exposed aggregate was observed at Pier 3.
