UNDERWATER BRIDGE INSPECTION REPORT

STRUCTURE NO. 58510
CSAH NO. 61
OVER THE
SNAKE RIVER
DISTRICT 1 - PINE COUNTY

PREPARED FOR THE
MINNESOTA DEPARTMENT OF TRANSPORTATION
BY
COLLINS ENGINEERS, INC.
JOB NO. 5221 (CEI 72)

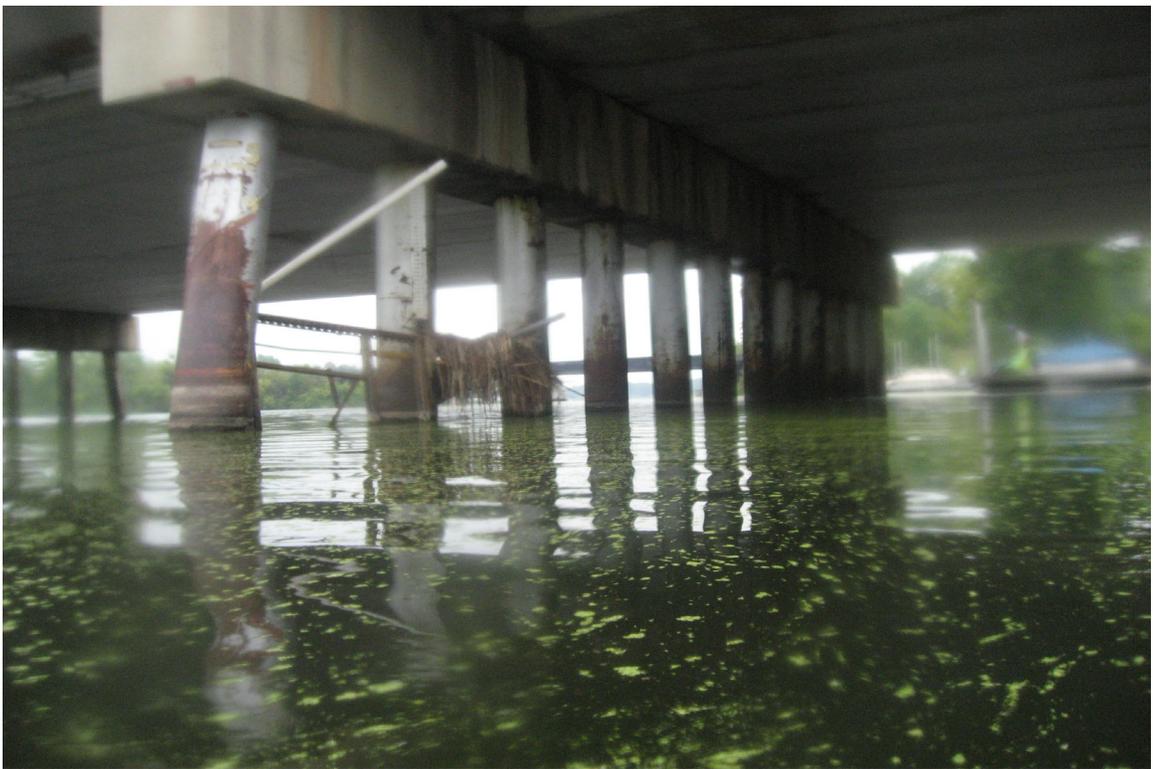
Photograph 2. View of Pier 1, Looking Northeast.

- ⑥ Metal dock framing debris was observed around the two upstream piles of Pier 1.
- ⑦ A light accumulation of grassy vegetation was observed around all of the piers.

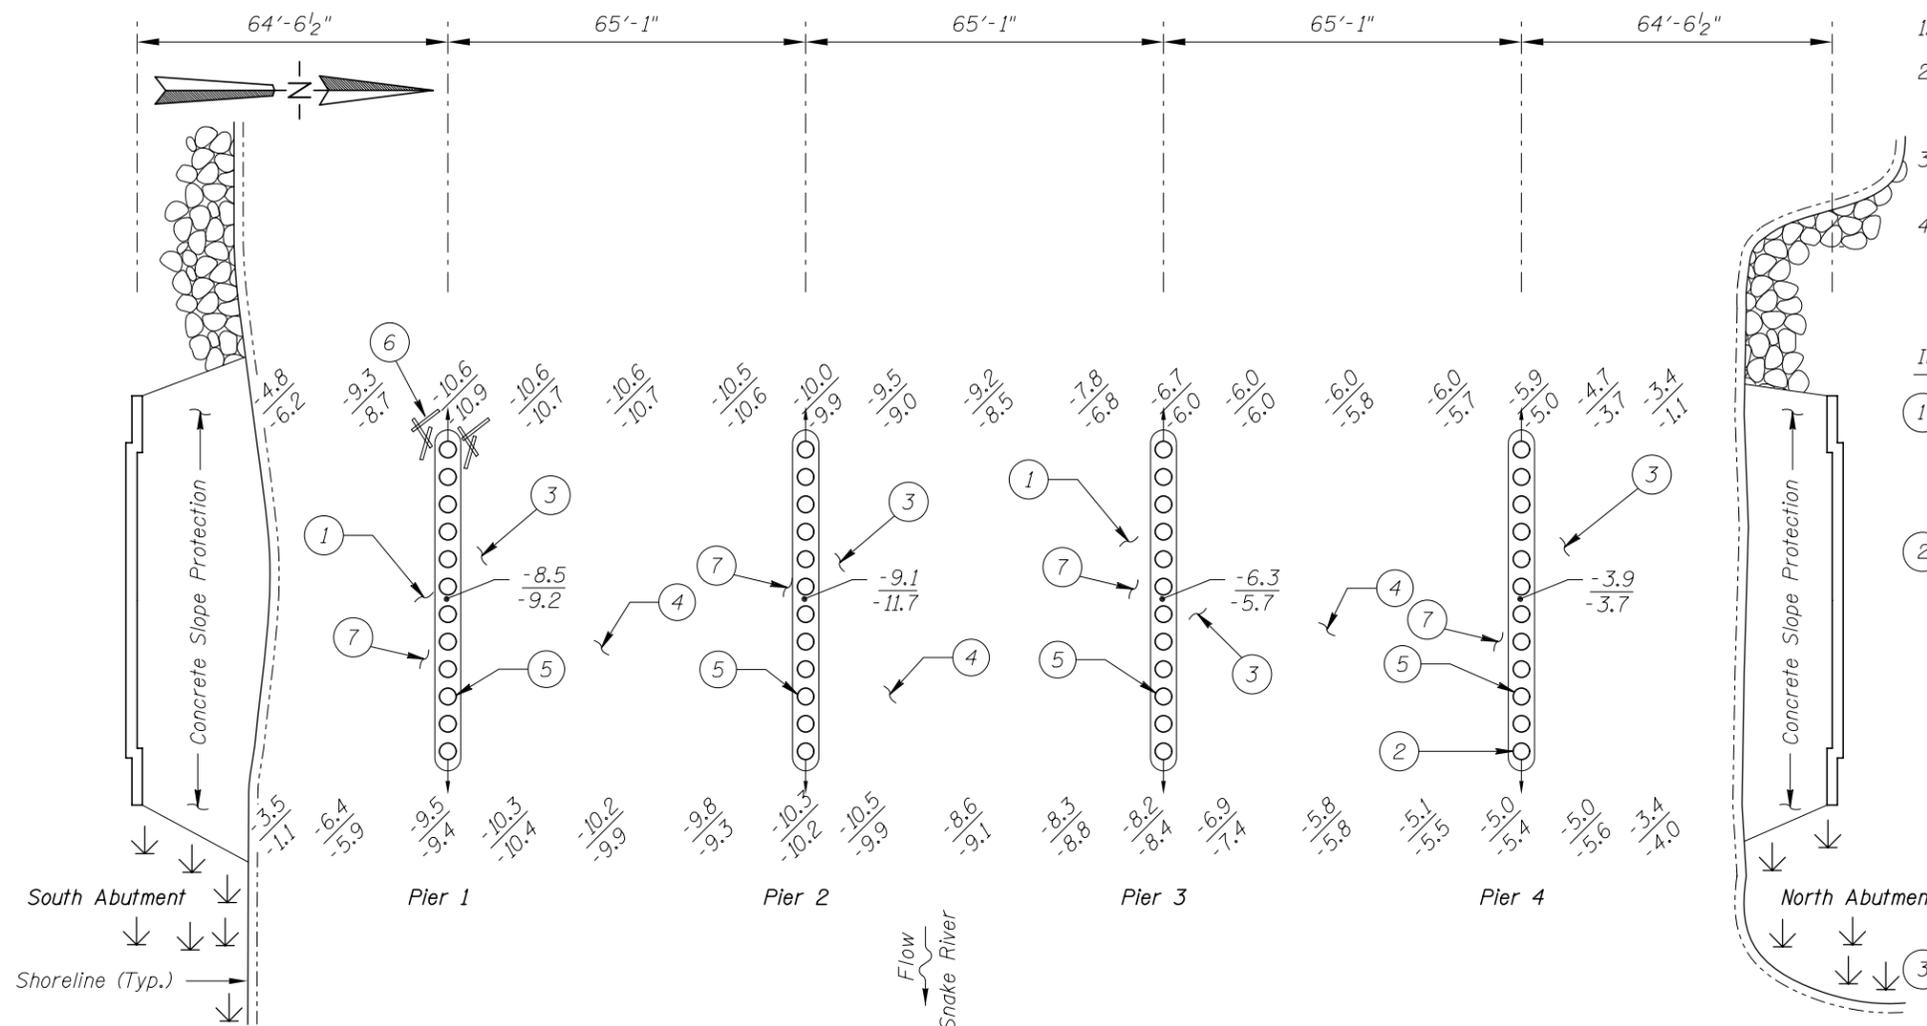
- ① A light amount of scattered timber debris 3 inch diameter and smaller was observed on the south side of Piers 1 and 2 along the channel bottom and upstream half of Pier 3 had light to moderate 6 inch diameter and smaller debris from channel bottom to 3 feet below the waterline.

- ② Four deformations were present on the east and south side of the easternmost pile:
 - A. A 6 inch wide by 3 inch high by 2 inch deep dent was located 4 feet below water on the south face.

- B. A 6 inch by 3 inch high by 1 inch deep dent located at 3 feet below the waterline.
 - C. A 6 inch diameter by 2 inch deep dent located at the waterline. This dent was accompanied by 1/8 inch deep corrosion pitting.

- D. An 8 inch diameter by 1 inch deep dent located at 1.5 foot below the waterline.
- ③ Timber piles from an earlier structure were located along the north side of each pier. The tops of the piles were located at 2 feet above channel bottom.

- ④ Channel bottom material consisted of gravelly sand with scattered riprap and cobbles, and 2 inch maximum probe rod penetration.
- ⑤ Light to moderate corrosion (10% min to 75% max) on all piles from 2 feet above the waterline to the channel bottom with up to 1/2 inch diameter rust nodules covering approximately 50% to 100% of the surface area of the piles, with a maximum of 1/8 inch deep pitting from 6 inches above water to 1.5 inches below water.
