UNDERWATER BRIDGE INSPECTION REPORT

STRUCTURE NO. 69505
CSAH NO. 8
OVER THE
ST. LOUIS RIVER
DISTRICT 1 – ST. LOUIS COUNTY

PREPARED FOR THE
MINNESOTA DEPARTMENT OF TRANSPORTATION
BY
COLLINS ENGINEERS, INC.
JOB NO. 5221 (CEI 2)

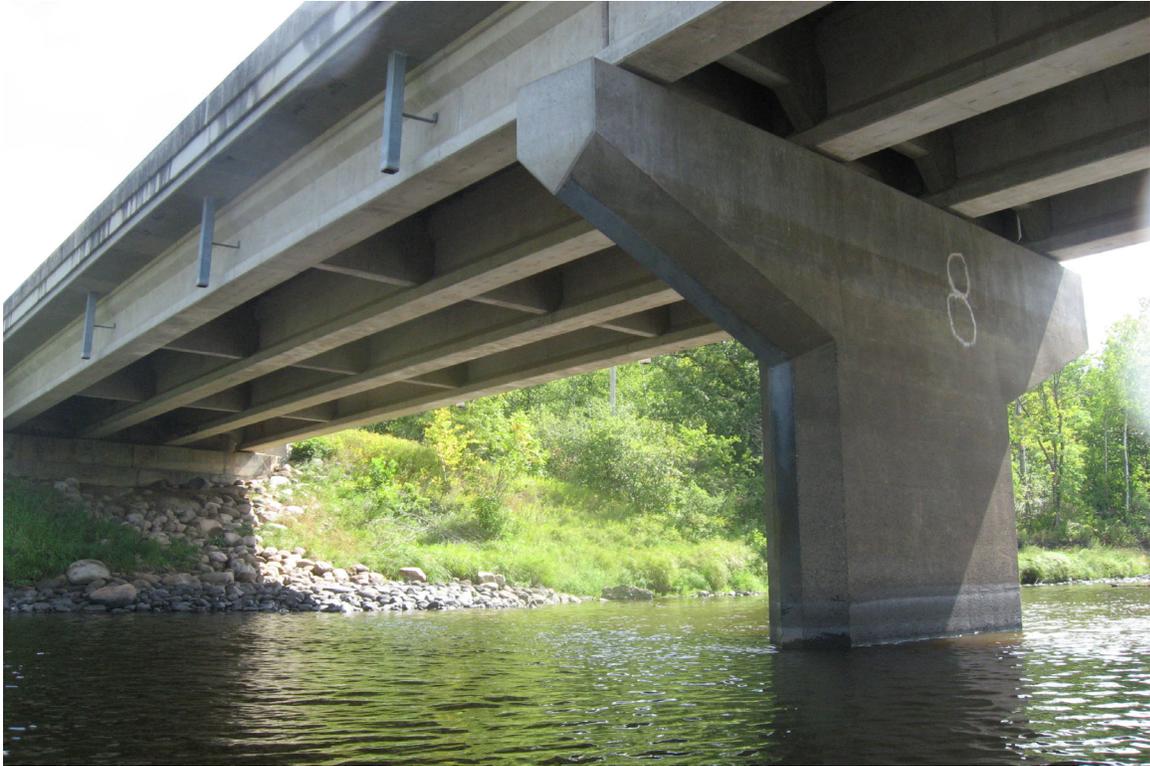
Photograph 1. View of East Pier and East Embankment, Looking Southeast.

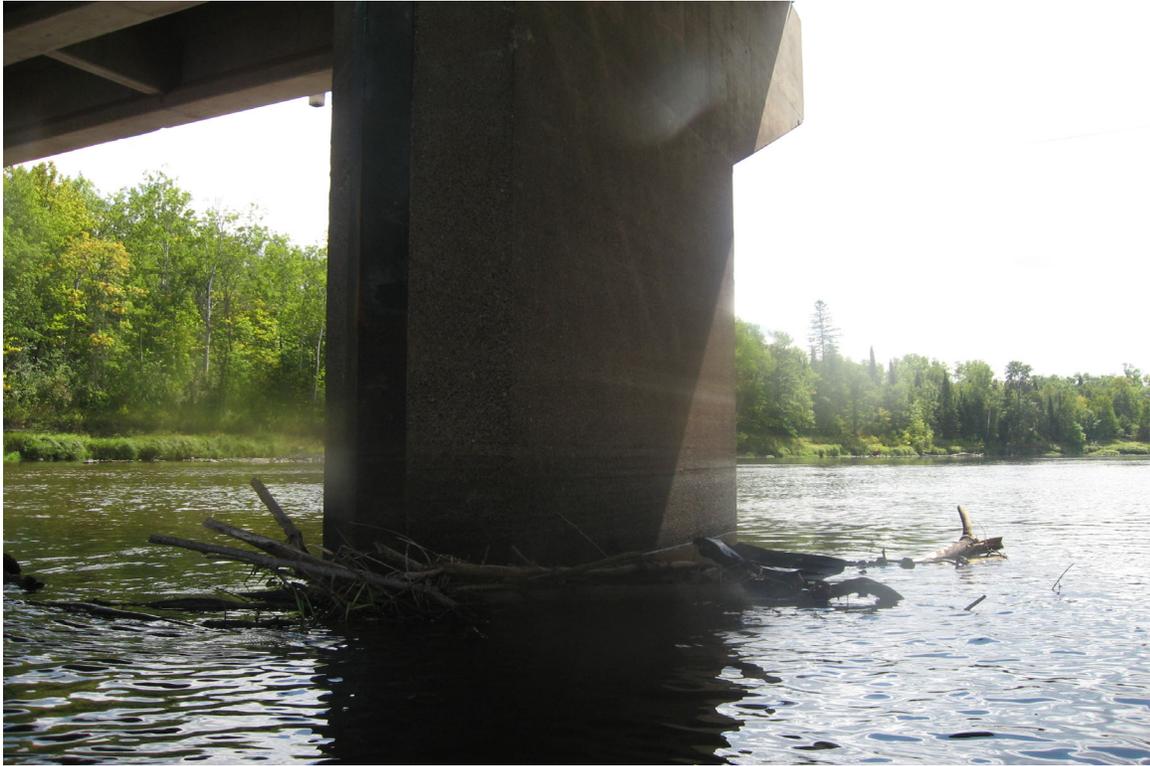
The substructure units inspected at Bridge 69505, the West and East Piers, were in good condition with no defects of structural significance observed. A moderate accumulation of timber debris was observed at the upstream end of the West Pier. The channel bottom appeared to be in stable condition with no evidence of significant scour.

Photograph 2. View of West Pier and Timber Debris, Looking Southeast.

- (A) Monitor timber drift accumulation at West Pier, and if found to be increasing in the future, removal operations may be required at that time.
- (B) Reinspect the submerged substructure units at the normal maximum recommended (NBIS) interval of five (5) years.

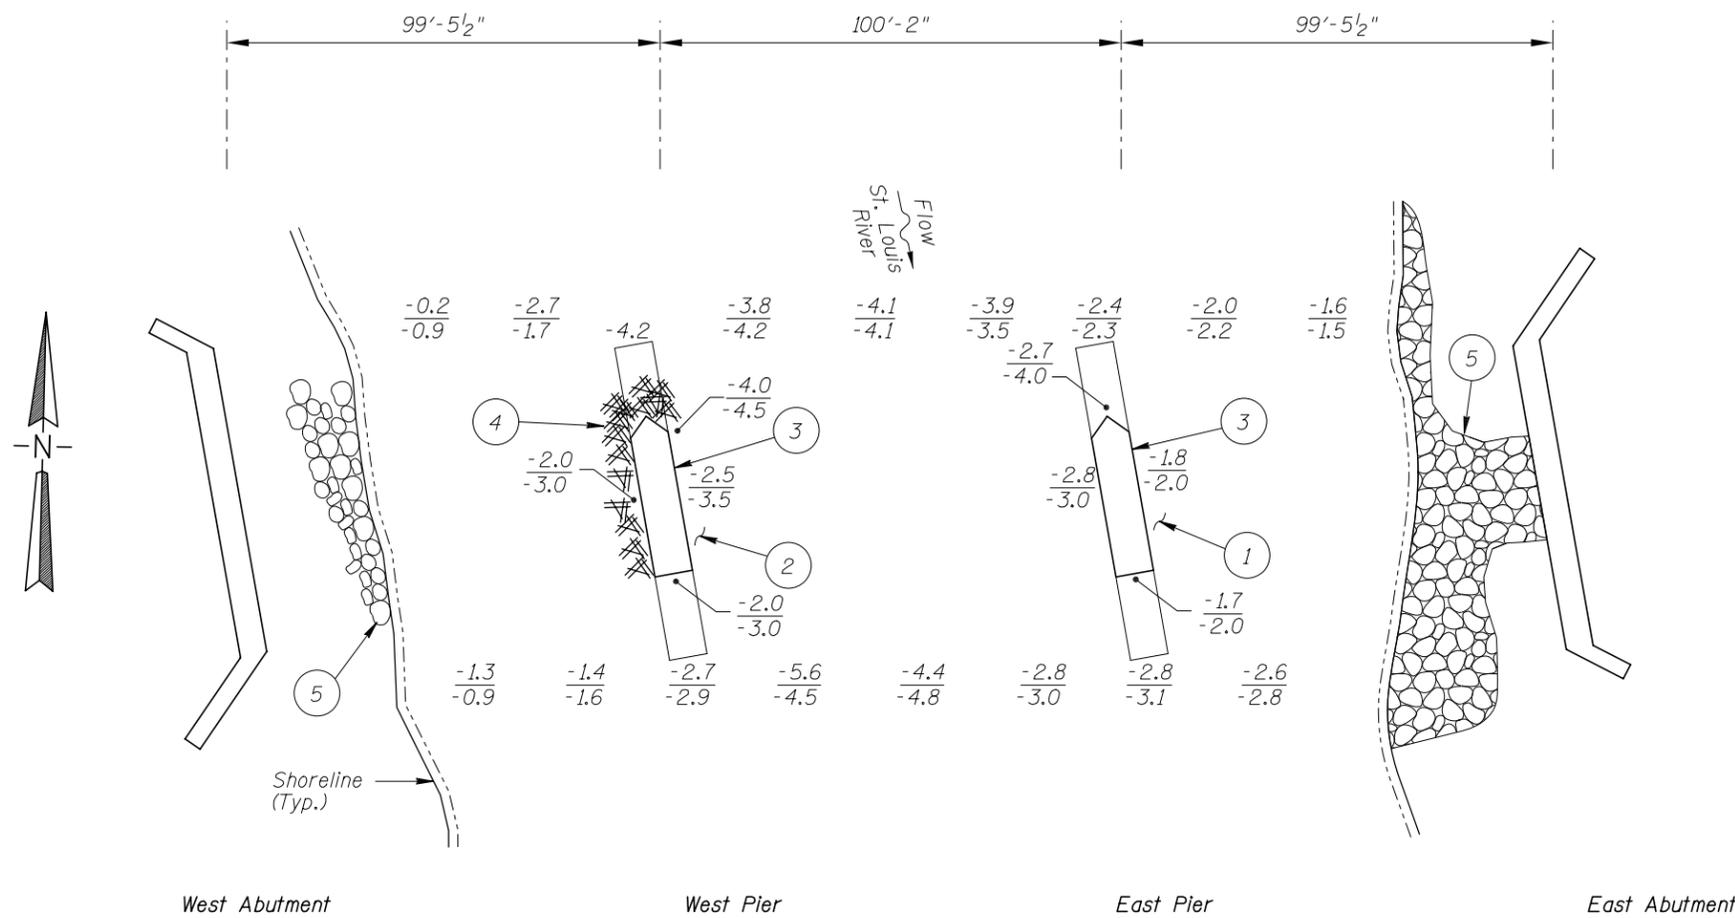
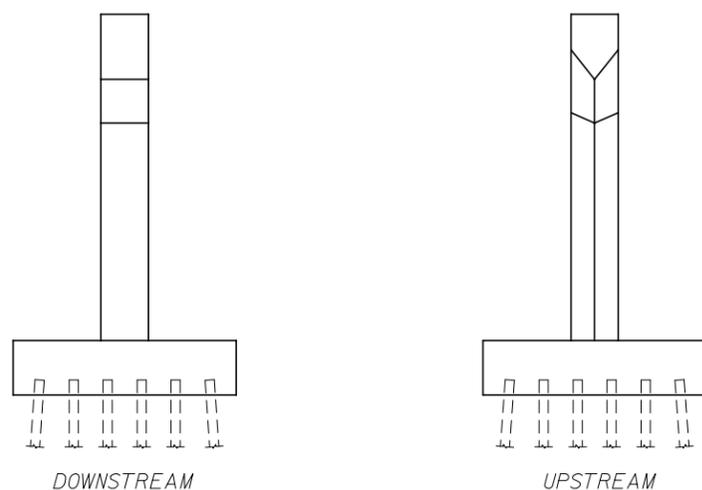
INSPECTION AND SOUNDING PLAN

1. The channel bottom consisted of 1- to 2-foot-diameter riprap and cobbles.
2. The channel bottom consisted of 1 to 2 inches of soft silt over a firm mix of 1-to 2-foot-diameter riprap and cobbles.
3. The concrete exhibited light scaling from 4 feet above the waterline to the channel bottom with exposed aggregate and typical penetrations of 1/8 inch and maximum penetrations ranging from 1/4 inch to 1/2 inch.
4. A moderate accumulation of 1-foot-diameter and smaller timber debris was observed at the upstream end and along the shore side of the West Pier extending from the channel bottom to 1 foot above the waterline. The drift extended 5 feet upstream of the pier and 4 feet into the adjoining spans.
5. 1- to 2-foot-diameter riprap and cobbles were observed at the embankments.
