UNDERWATER BRIDGE INSPECTION REPORT

STRUCTURE NO. 69530
CSAH NO. 139
OVER THE
LITTLE FORK RIVER
DISTRICT 1 - ST. LOUIS COUNTY

PREPARED FOR THE
MINNESOTA DEPARTMENT OF TRANSPORTATION
BY
COLLINS ENGINEERS, INC.
JOB NO. 5221 (CEI 11)

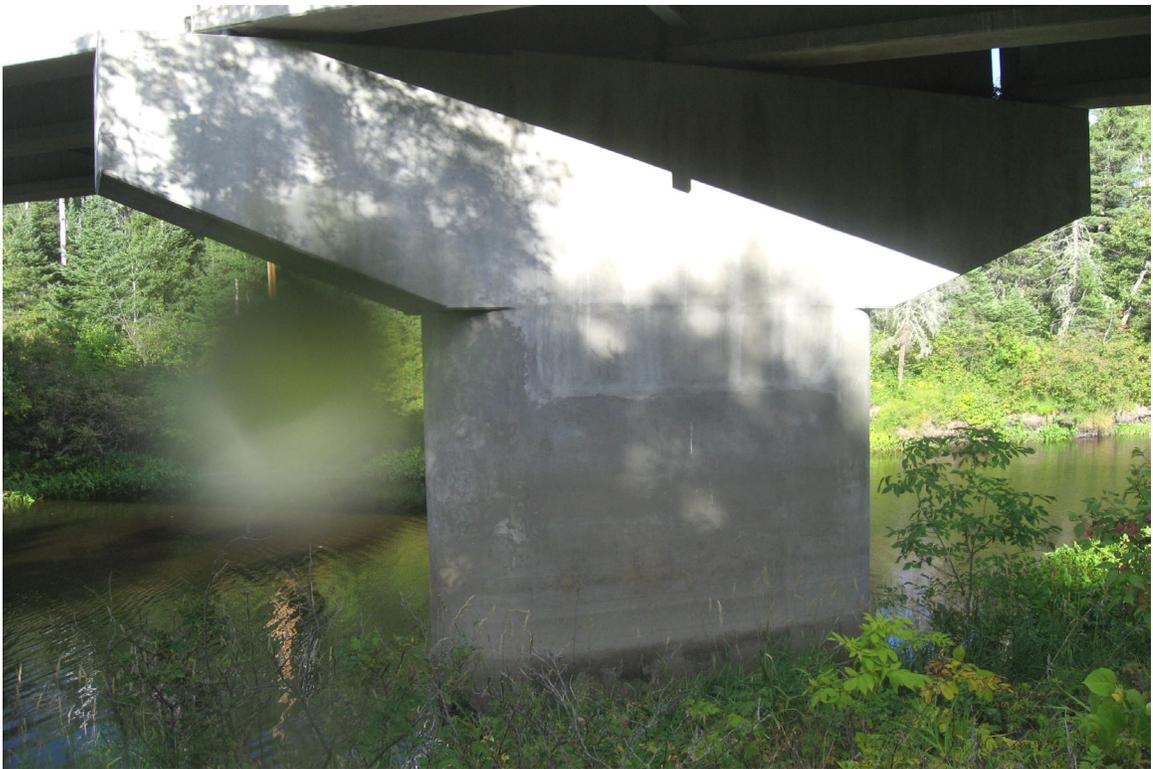
Photograph 2. View of Pier 1, Looking Northeast.

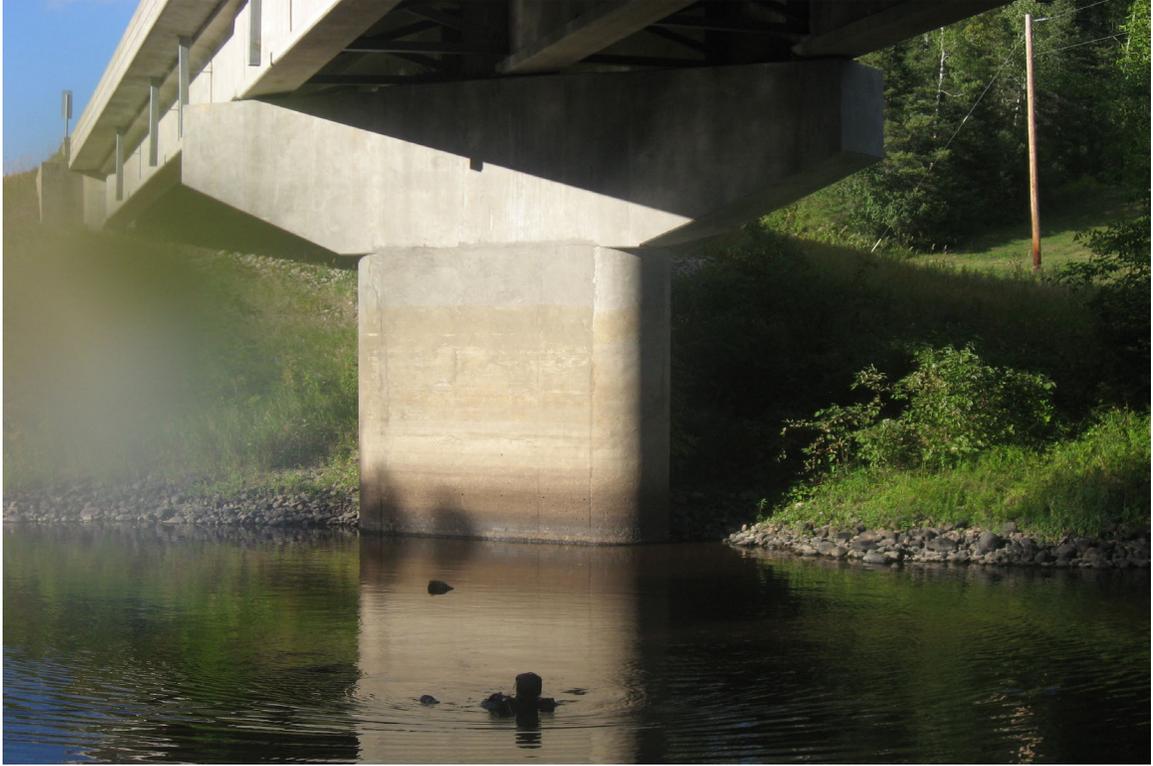
Photograph 3. View of Pier 2, Looking Northeast.

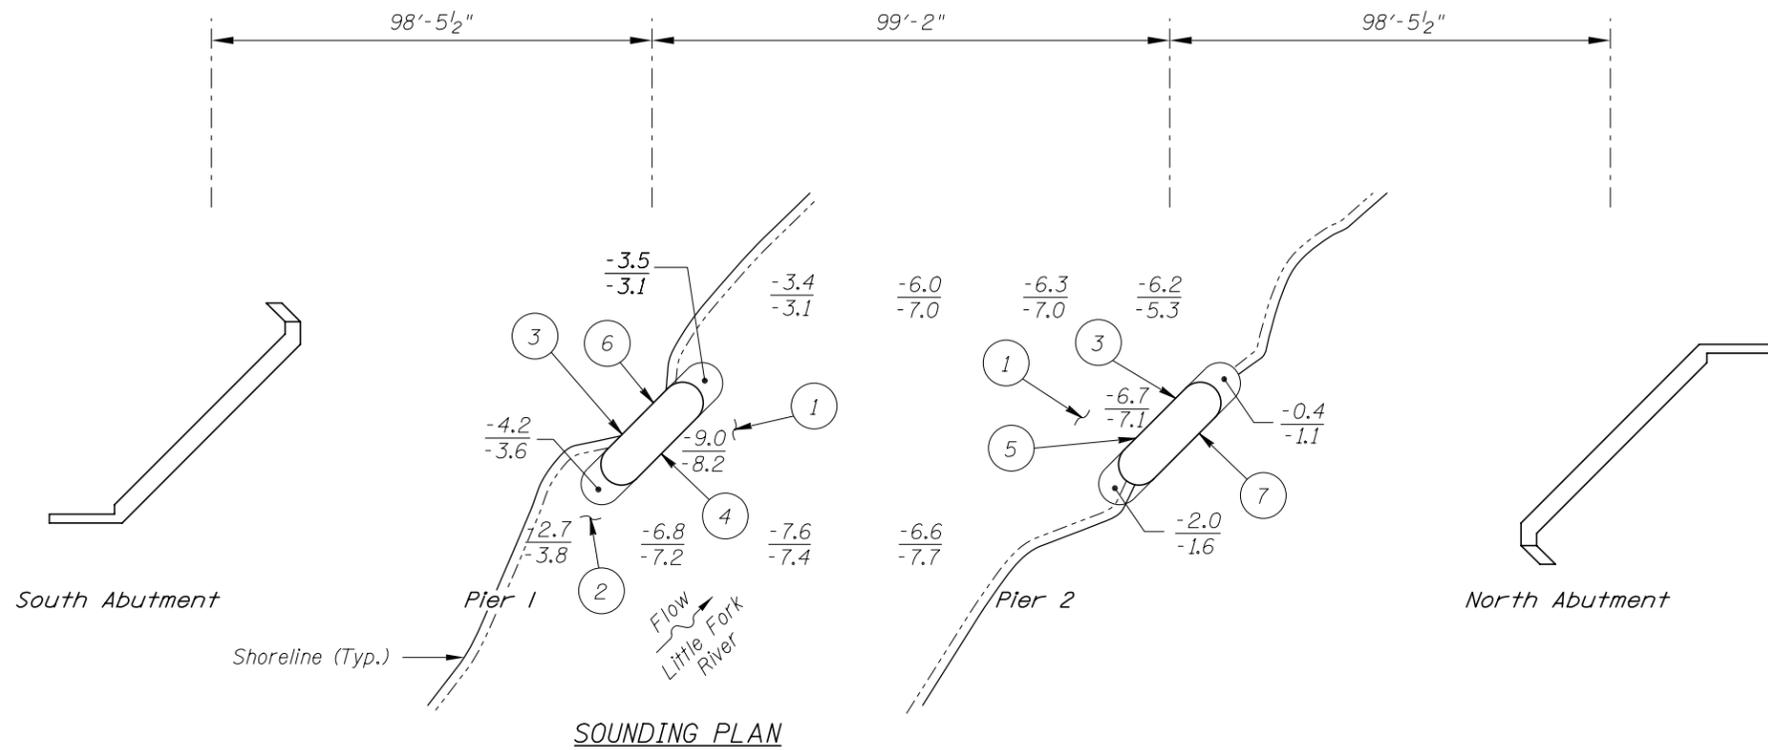
INSPECTION AND SOUNDING PLAN

- The channel bottom material consisted of soft silt and scattered riprap with probe rod penetrations up to 1 foot at Pier 2 and up to 1.5 feet at Pier 1.
- The channel bottom material consisted of 6-inch to 1-foot-diameter riprap at the upstream nose of Pier 1 and along the north face of Pier 2.
- The concrete at both piers was smooth and sound.
- The top of the footing along the north face of Pier 1 was located with a probe rod below 1.5 feet of soft silt.
- The top of the footing along the south face of Pier 2 was located with a probe rod below 1.5 foot of soft silt.
- Scaling was observed 6 inches above the waterline to 1 foot below the waterline, with 1/4 inch maximum penetration along the entire perimeter of Pier 1.
- Scaling was observed 1 foot above the waterline to 2 feet below the waterline, with 1/2 inch maximum penetration along the entire perimeter of Pier 2.

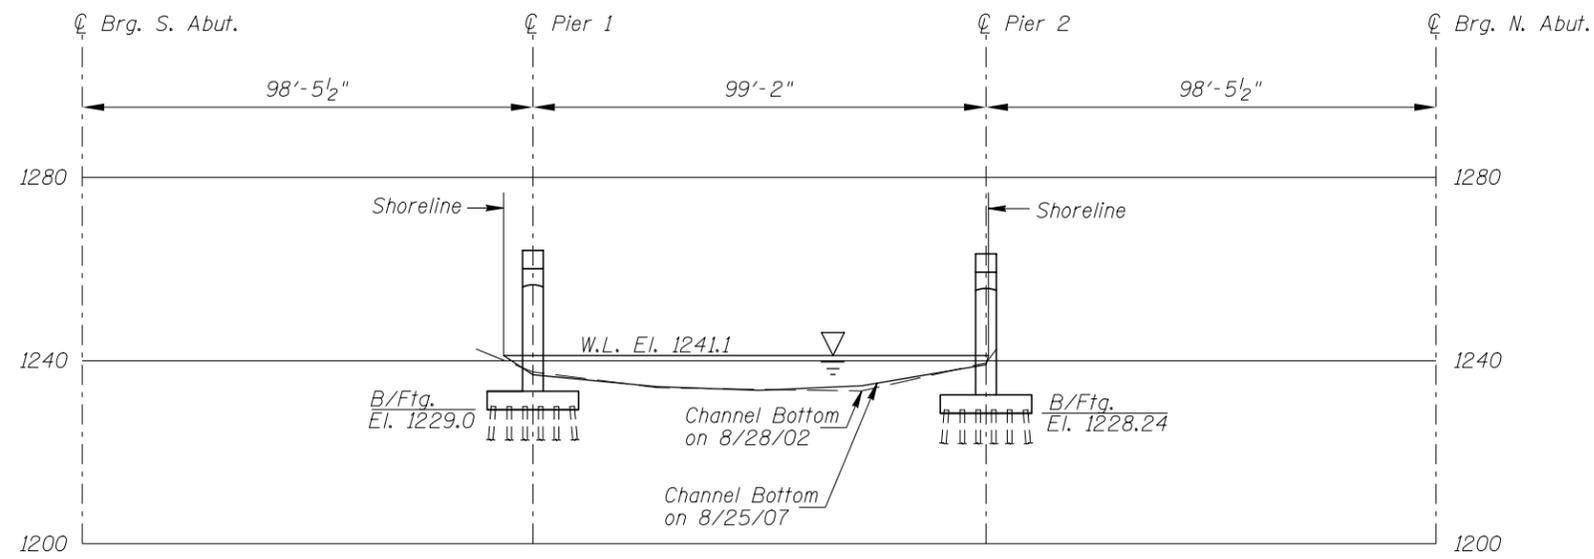
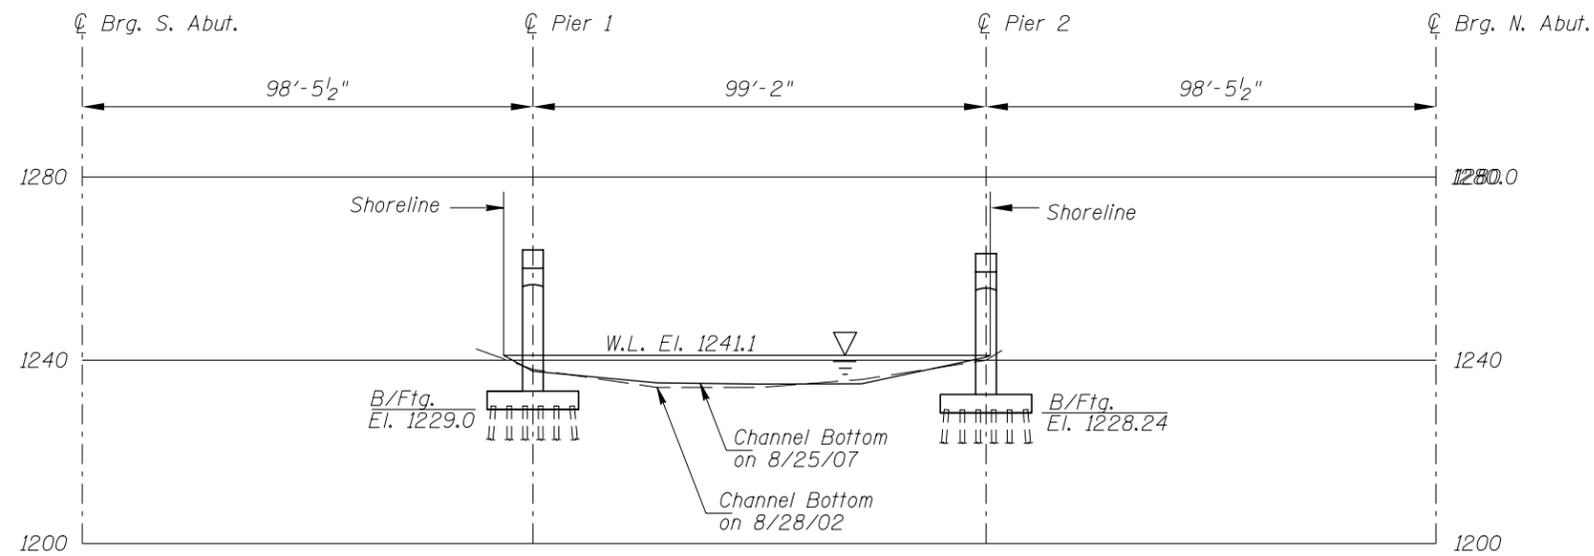
UPSTREAM FASCIA PROFILE

DOWNSTREAM FASCIA PROFILE
