UNDERWATER BRIDGE INSPECTION REPORT

STRUCTURE NO. 69J13

RAILROAD STREET

COLLINS ENGINEERS, INC.

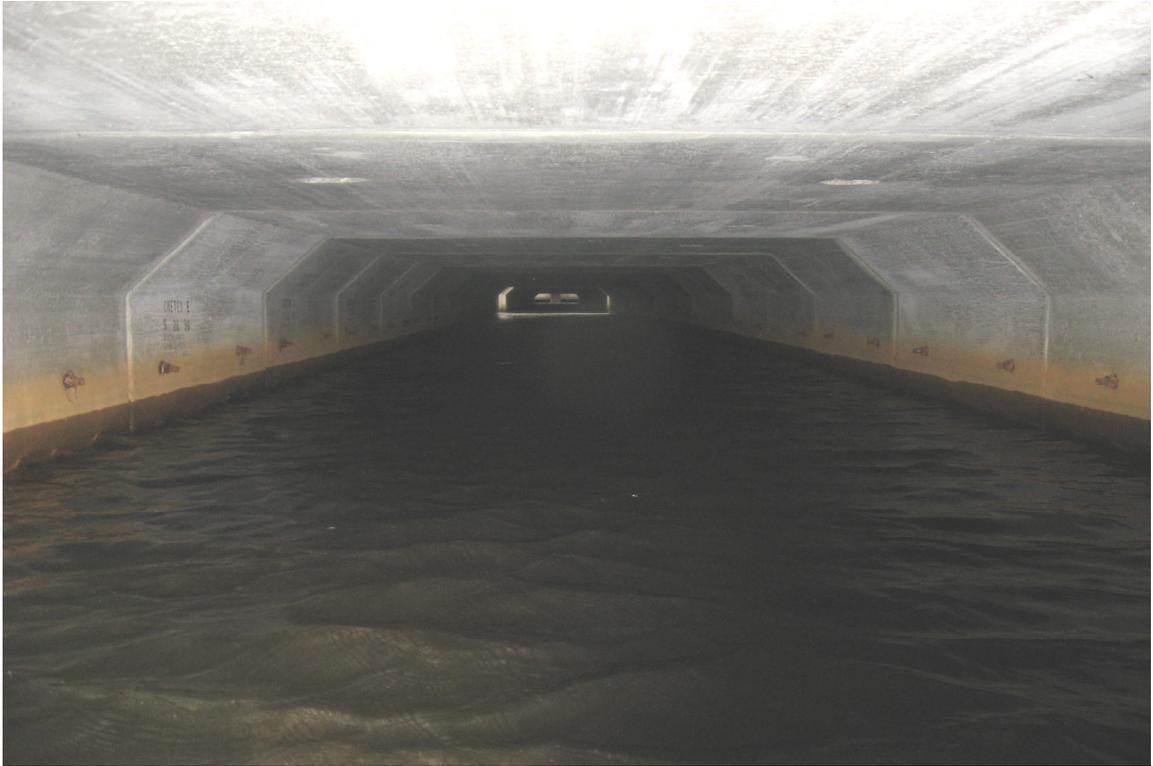
Photograph 1. View of Inside of Culvert Box, Looking Southeast.

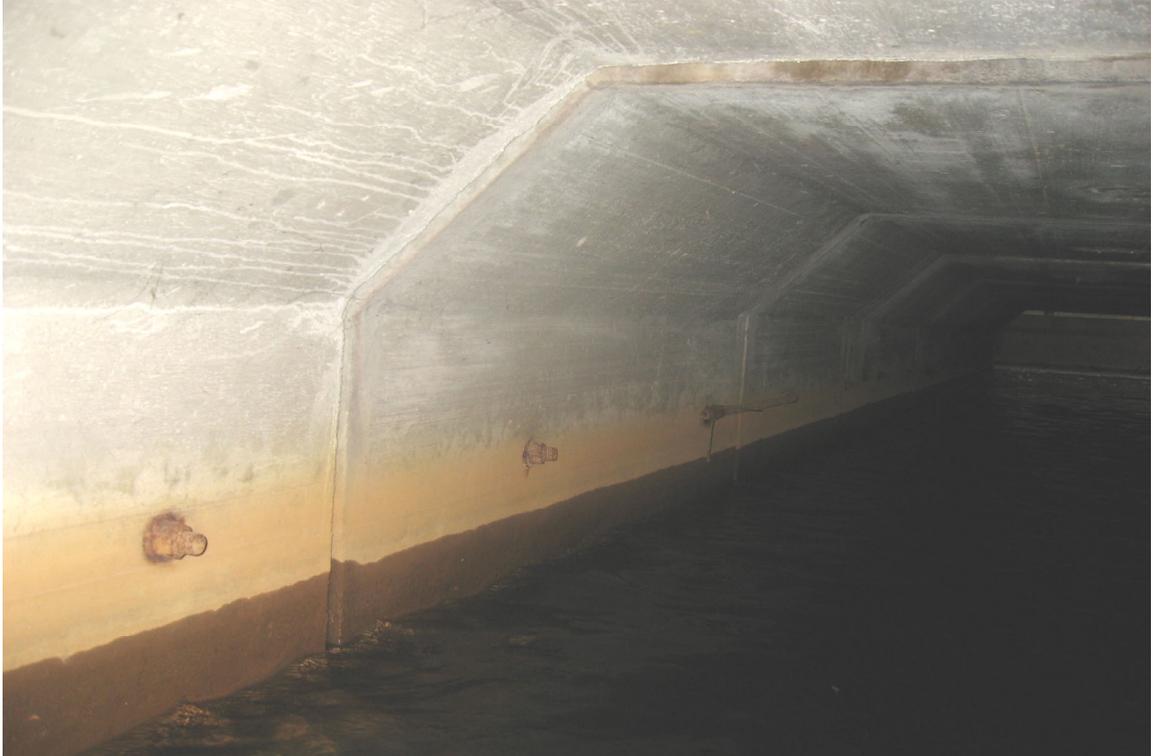
Photograph 2. View of Southwest Wall beneath the West Side of the Road, Looking Northwest.

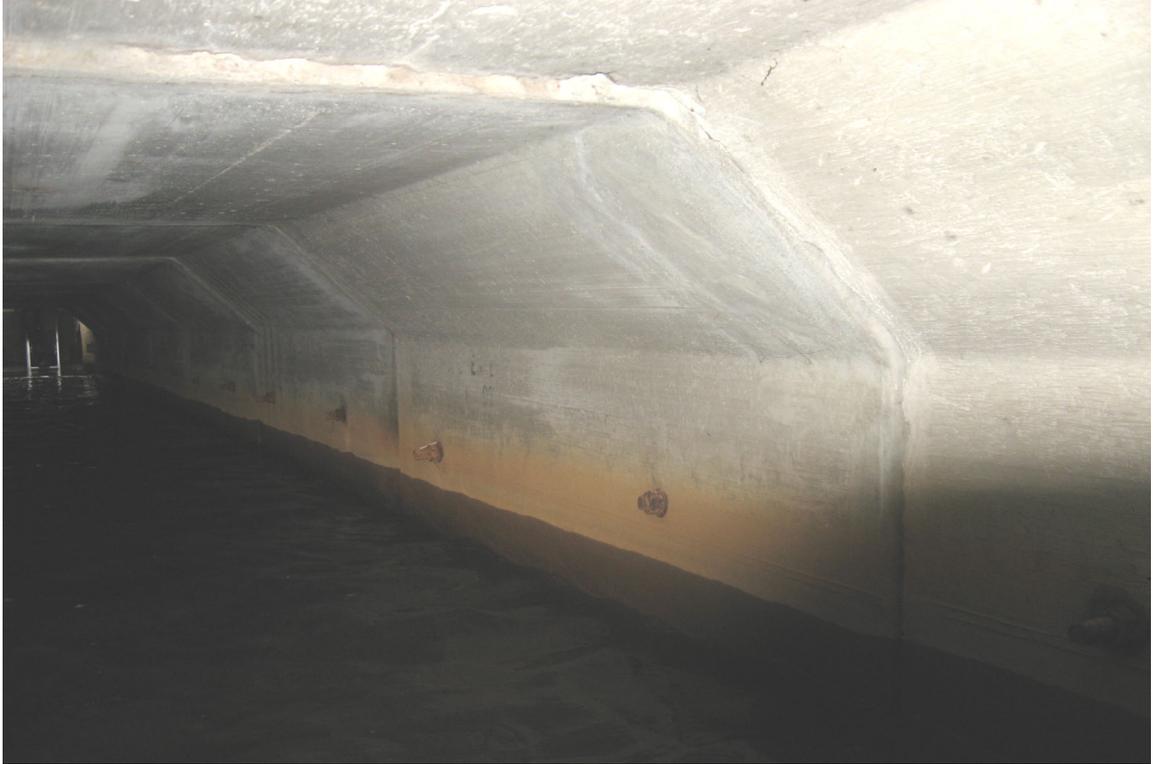
Photograph 3. View of Northeast Wall beneath the East Side of the Road, Looking Northeast.

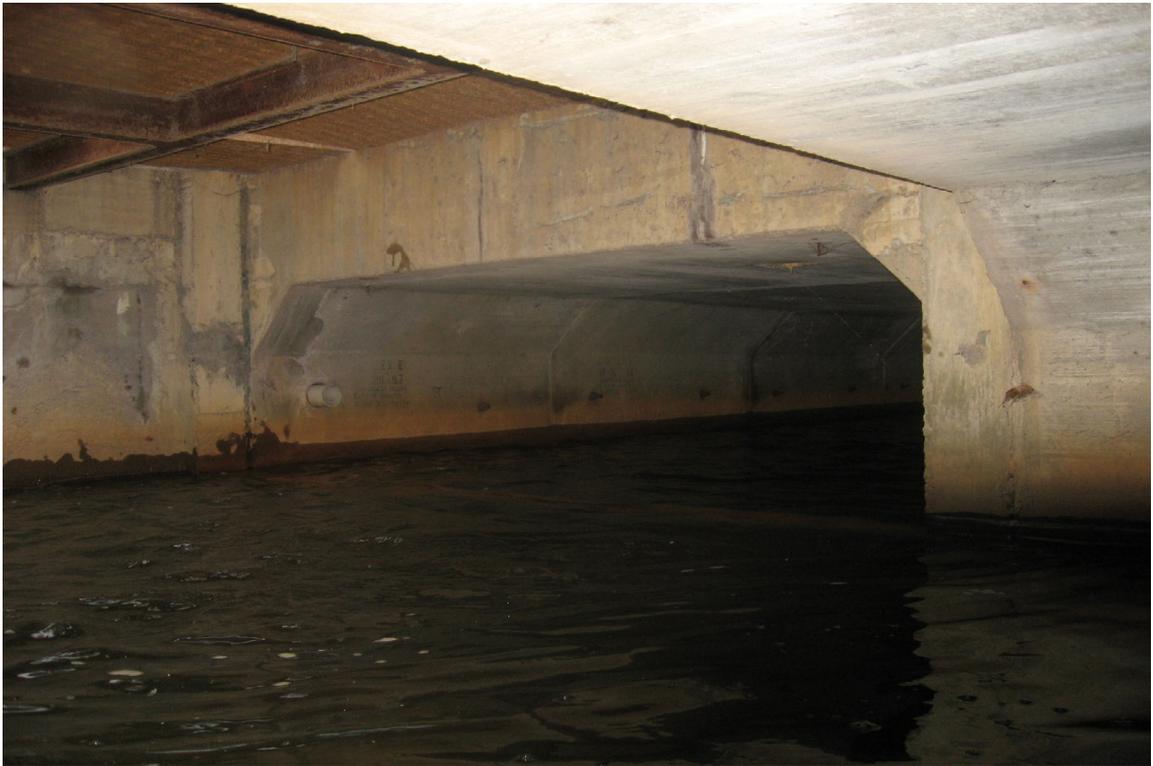
Photograph 4. View of Northwest Culvert Opening, Looking East.

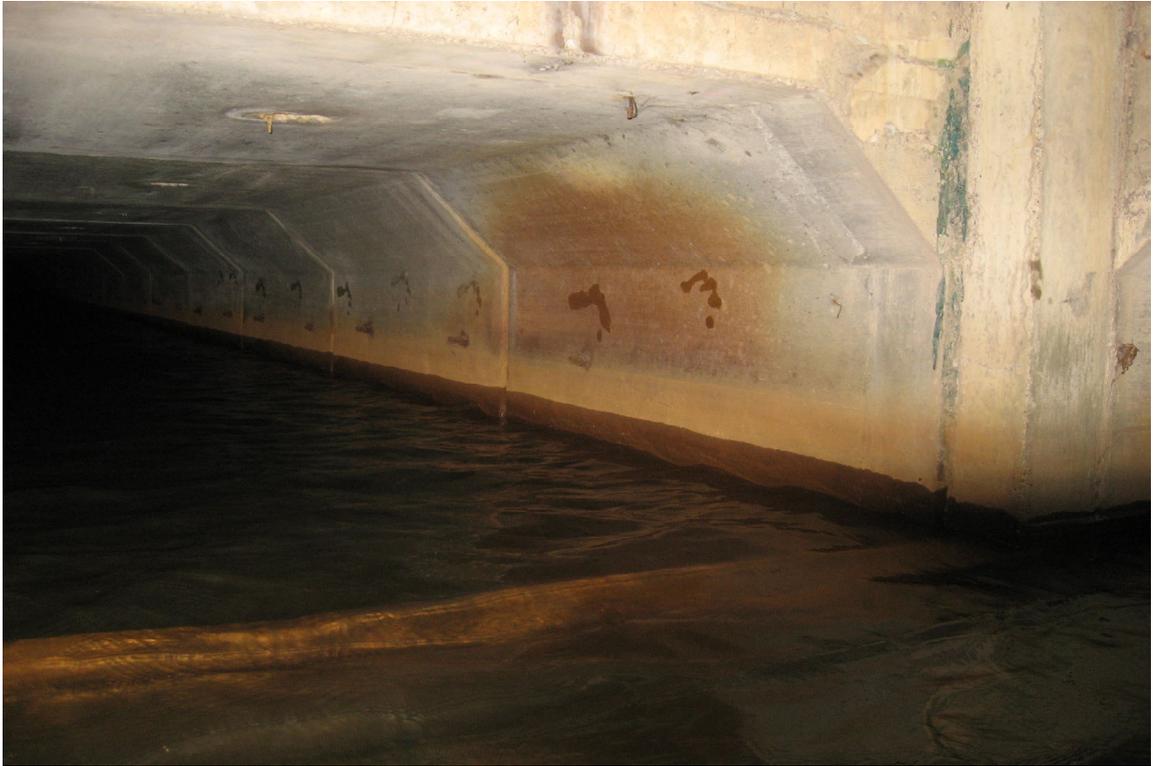
Photograph 5. View of West Side of Opening, Looking Southwest.

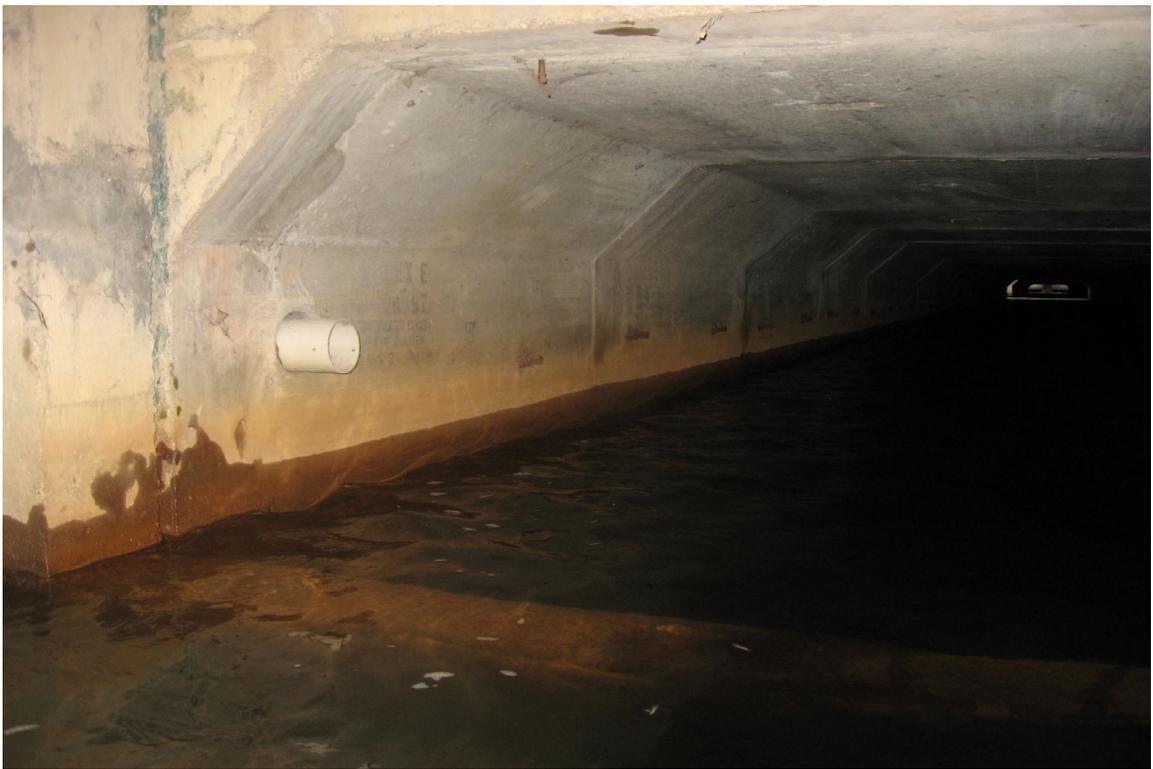
Photograph 6. View of East Side of Opening, Looking Southeast.

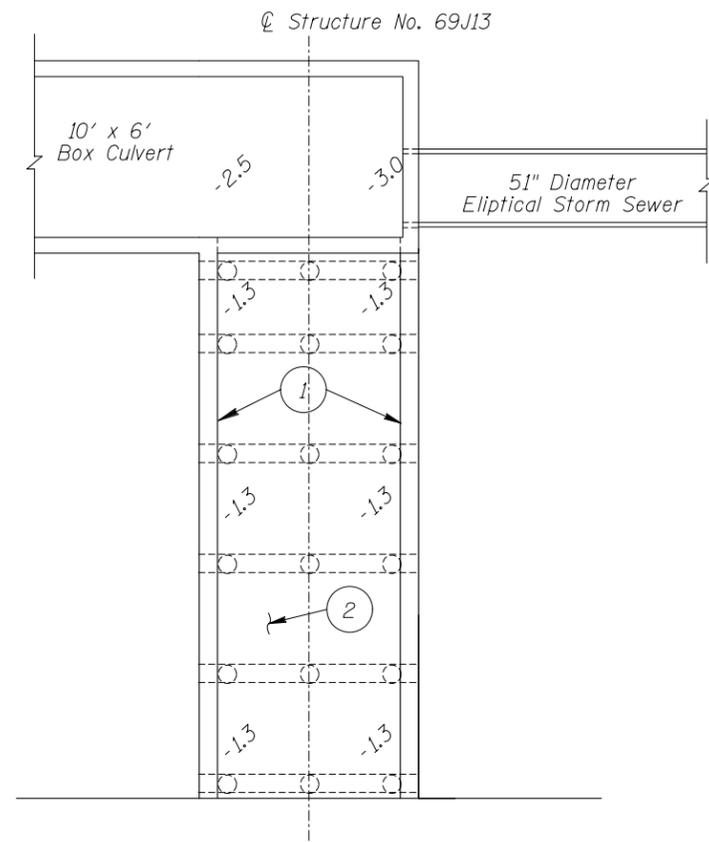
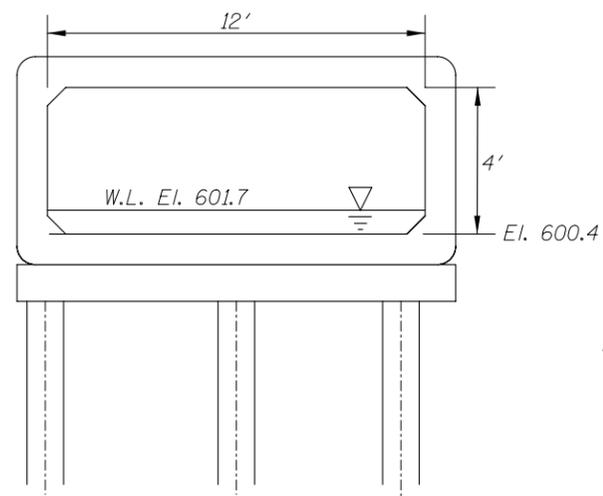
TYPICAL END VIEW OF CULVERT

- ① The concrete was in smooth and sound condition with no notable deterioration. The joints between culvert segments exhibited 1/4- to 1-inch-wide gaps (at tongue and groove arrangement with no complete separations of joints) and up to 1/2 inch differentials between faces across joints.
- ② A 6-inch-thick layer of soft silt covered most of the concrete floor of the culvert.
