UNDERWATER BRIDGE INSPECTION REPORT

STRUCTURE NO. 7065

GARDEN LAKE

DISTRICT 1 - LAKE COUNTY

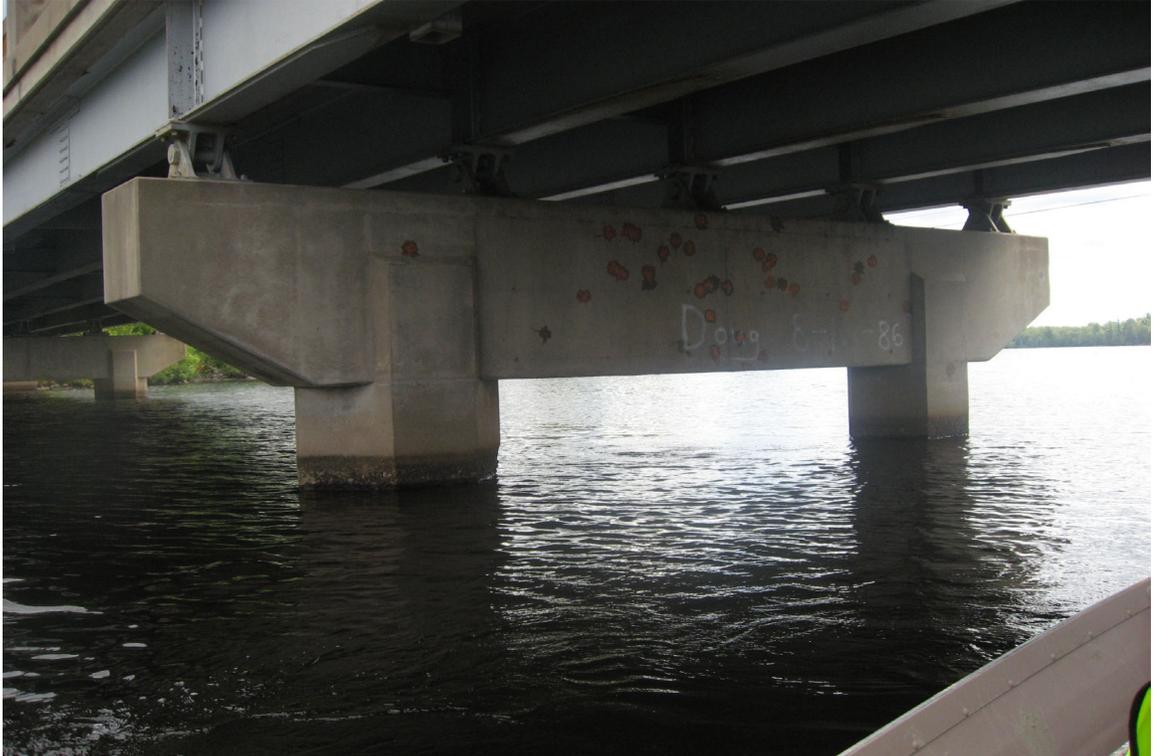
Photograph 2. View of Pier 1, Looking Southeast.

- (A) An area of minor section loss, 12 inches high by 6 inches wide with 2 inches of penetration, was located on the upstream nose of the north (downstream) shaft of Pier 1 with no exposed reinforcing steel.

- (C) Minor accumulations of timber debris were observed around the upstream column of Pier 1.
- (D) The top of the horizontal strut was observed at approximately 5.5 feet below the waterline at Pier 1. The channel bottom was flush with the bottom of horizontal strut on the west side of the pier, and on the east side of the pier there was a 6-inch cavity below the bottom of the horizontal strut.

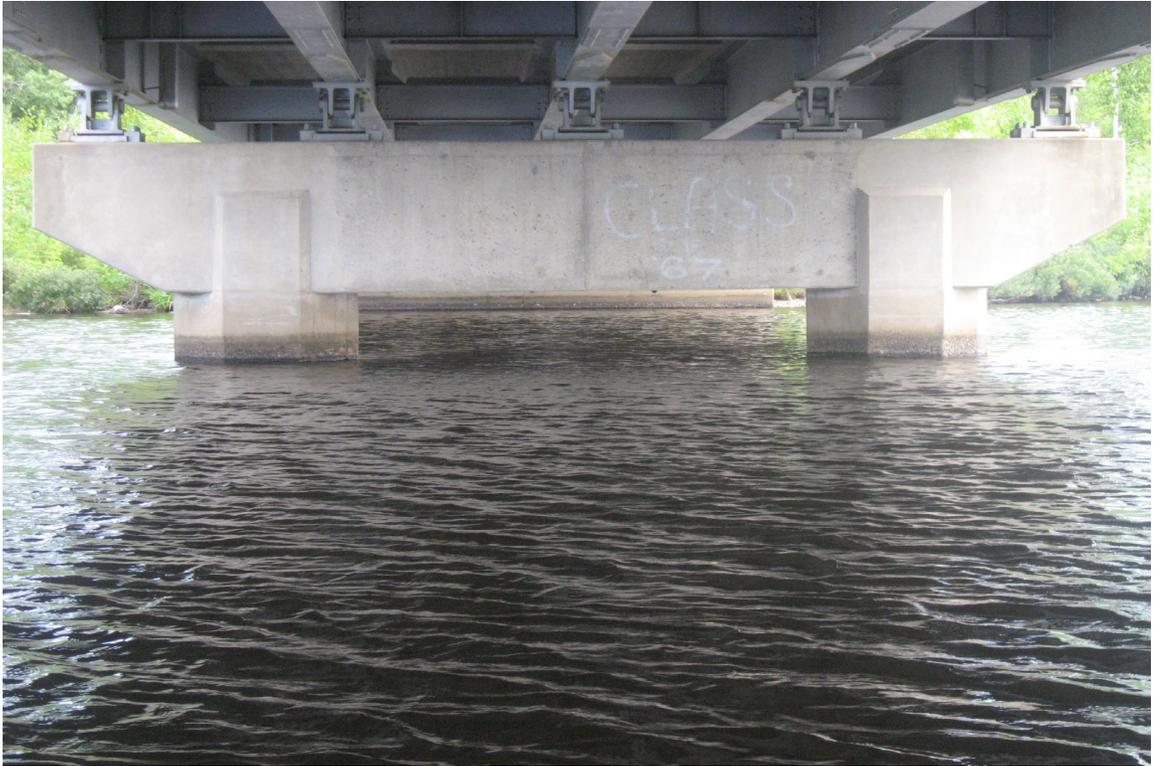
Photograph 3. Overall of Pier 1, Looking North.

- (B) The concrete surfaces on both piers from 6 inches above the waterline to 3 feet below the waterline exhibited up to a 1/4 inch deep scaling, and somewhat soft surface concrete with random areas of minor poor consolidation and up to 1/2 inch deep penetration.

- (E) A minor scour depression, 5 foot in radius by 1 foot deep, was observed at the upstream nose of Pier 1.

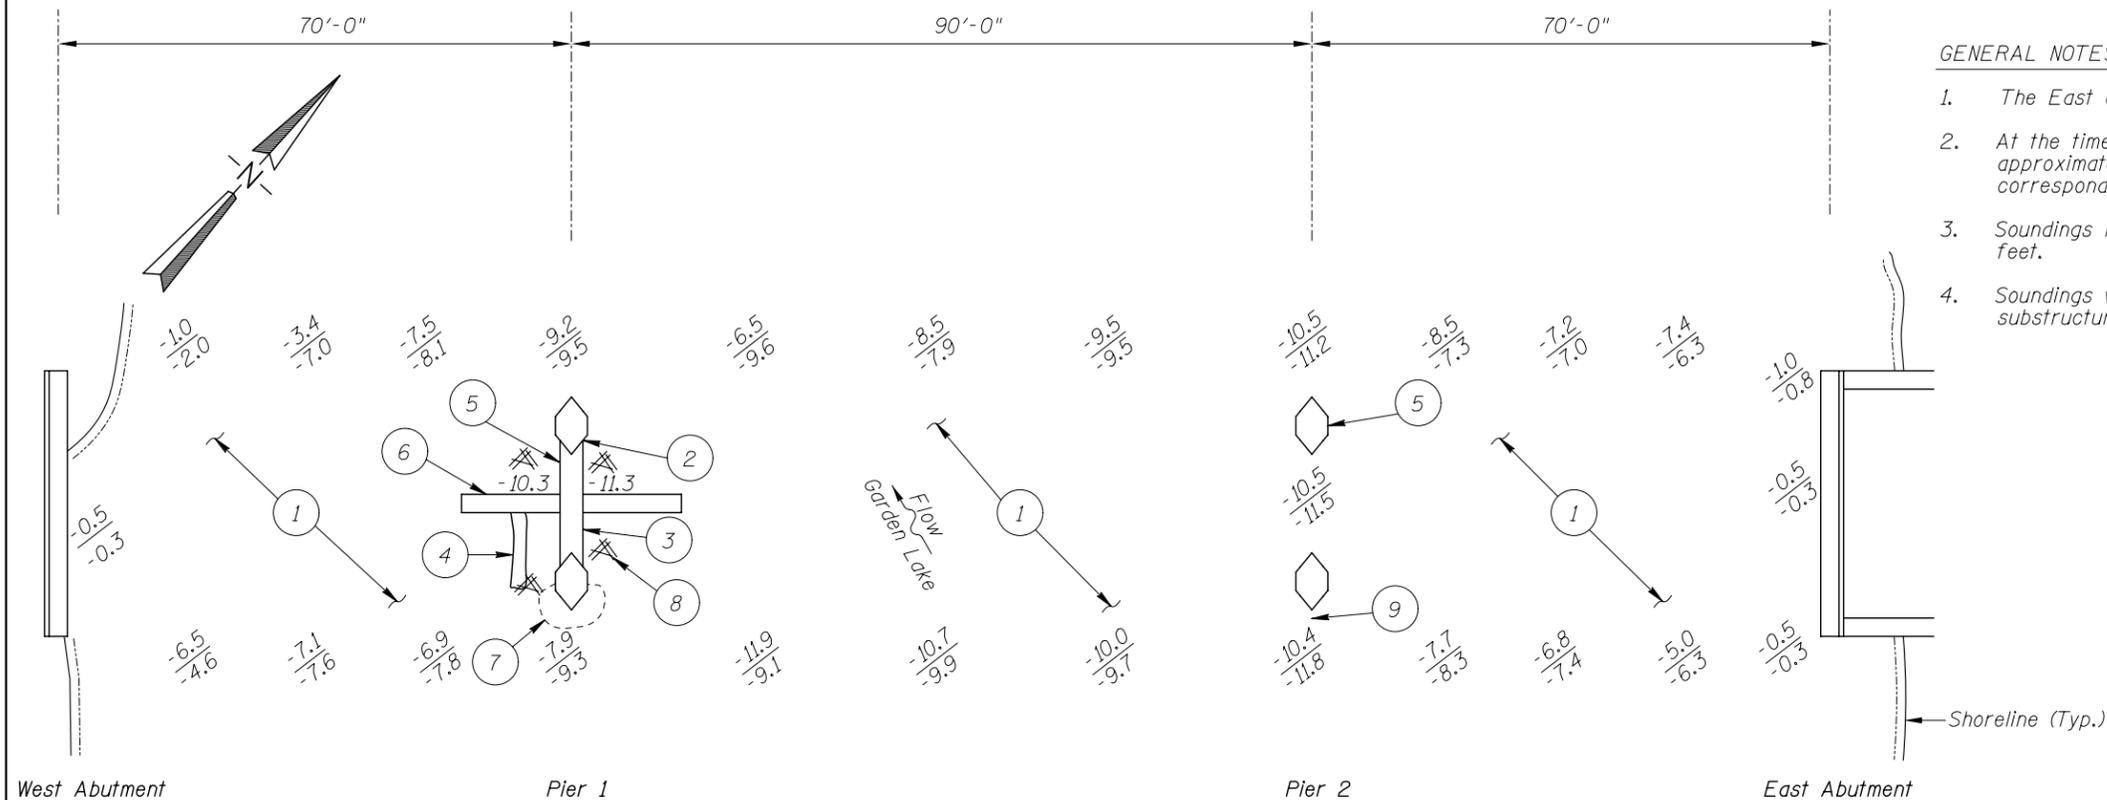
SOUNDING PLAN

| <p>① The channel bottom material consisted of sandy gravel with 2 inches of probe rod penetration and scattered 1- to 3-foot-diameter riprap and 6-inch-diameter cobbles.</p> <p>② Section loss, approximately 12 inches high by 6 inches wide, with 2 inches maximum penetration was observed at the upstream nose of the downstream shaft of Pier 1. No exposed reinforcing steel.</p> <p>③ The top of a horizontal strut was observed approximately 5.5 feet below the waterline. The channel bottom was flush with the bottom of horizontal strut on the west side of the pier, and on the east side of the pier there was a 6 inch cavity below the bottom of the horizontal strut.</p> <p>④ 1-foot-diameter log was observed on the channel bottom extending along the upstream half of the pier.</p> <p>⑤ The concrete surfaces on both piers from 6 inches above the waterline to 3 feet below the waterline exhibited up to a 1/4 inch deep scaling, and somewhat soft surface concrete with random minor areas of poor consolidation. Up to 1/2 inch deep total penetration</p> <p>⑥ At approximately 8.0 feet below the waterline at the center of the horizontal strut of Pier 1 a steel I-beam was observed extending out 5 feet on each side of the strut.</p> | <p>⑦ A minor scour depression, 5 feet in radius by 1 foot deep, was observed at the upstream nose of Pier 1.</p> <p>⑧ A minor accumulation of timber debris consisting of 6-inch-diameter and smaller logs and branches was observed scattered around the upstream column of Pier 1.</p> <p>⑨ Heavy concentration of riprap was observed at the upstream nose of Pier 2.</p> |
