UNDERWATER BRIDGE INSPECTION REPORT

STRUCTURE NO. 7254

KETTLE RIVER

DISTRICT 1 – PINE COUNTY

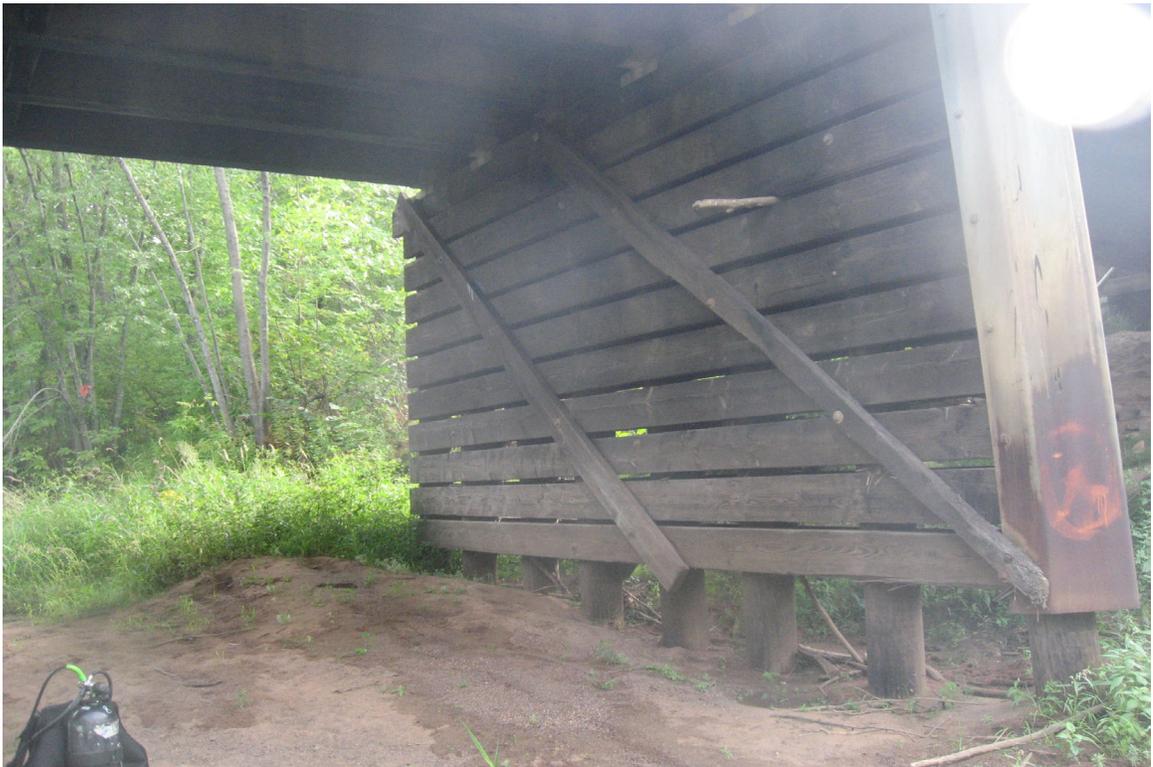
Photograph 2. View of Pier 1, Looking Southwest.

- 3 The diagonal cross bracing at the upstream end of Pier 1 was split through the connection and exhibited partial section loss along the upstream half of the pier.

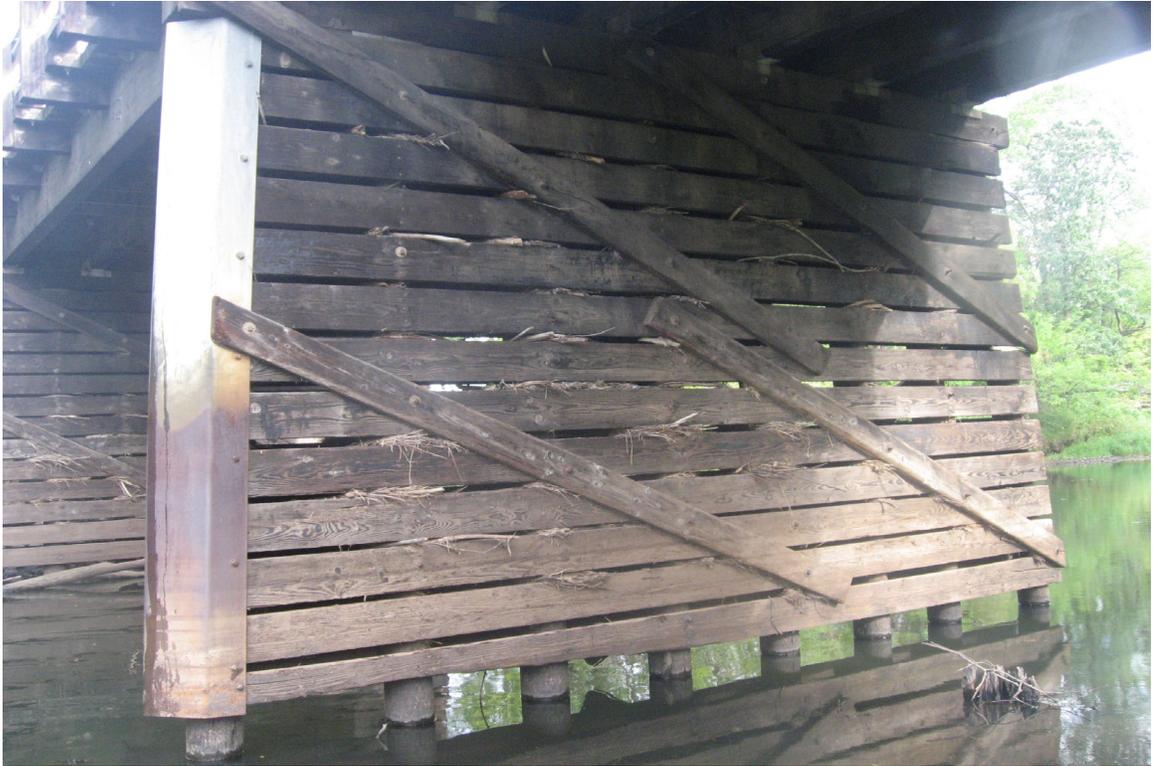
Photograph 3. View of Pier 2, Looking Southeast.

- 4 A 12-inch-diameter tree trunk with branchy debris was observed along the west face of Pier 2, and a light accumulation of debris 6 inches in diameter and smaller was observed along the east face from channel bottom to waterline.

- 6 The diagonal cross bracing at the east side of Pier 2 exhibited 50% section loss at the upstream connection.

At this point, the timber drift accumulations at the bridge are not excessive; however, they should be monitored, and if found to be progressing to an extent where excessive lateral loads may be exerted on the pier or scour is influenced, the drift may need to be removed at that time.

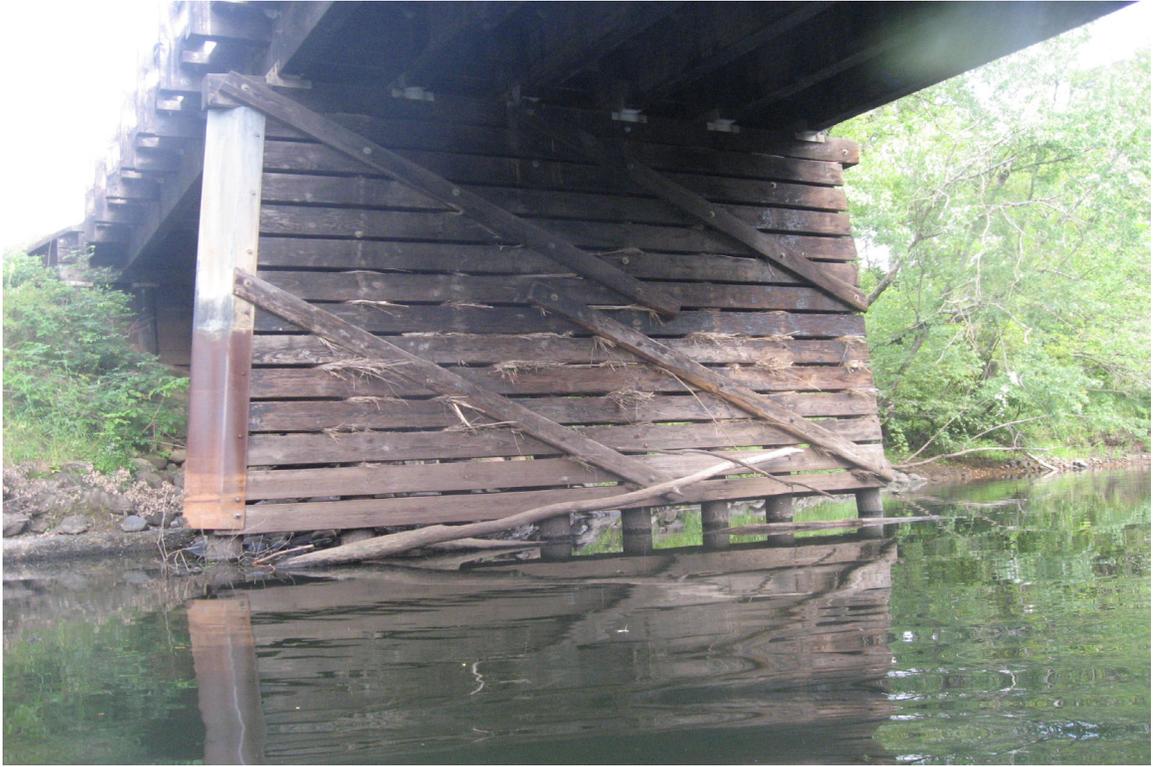
Photograph 4. View of Pier 3, Looking Southeast.

- 5 A moderate accumulation of timber debris was observed at the upstream half of Pier 3 with 1.5-foot-diameter logs that extended along the west face of the pier from channel bottom to waterline.

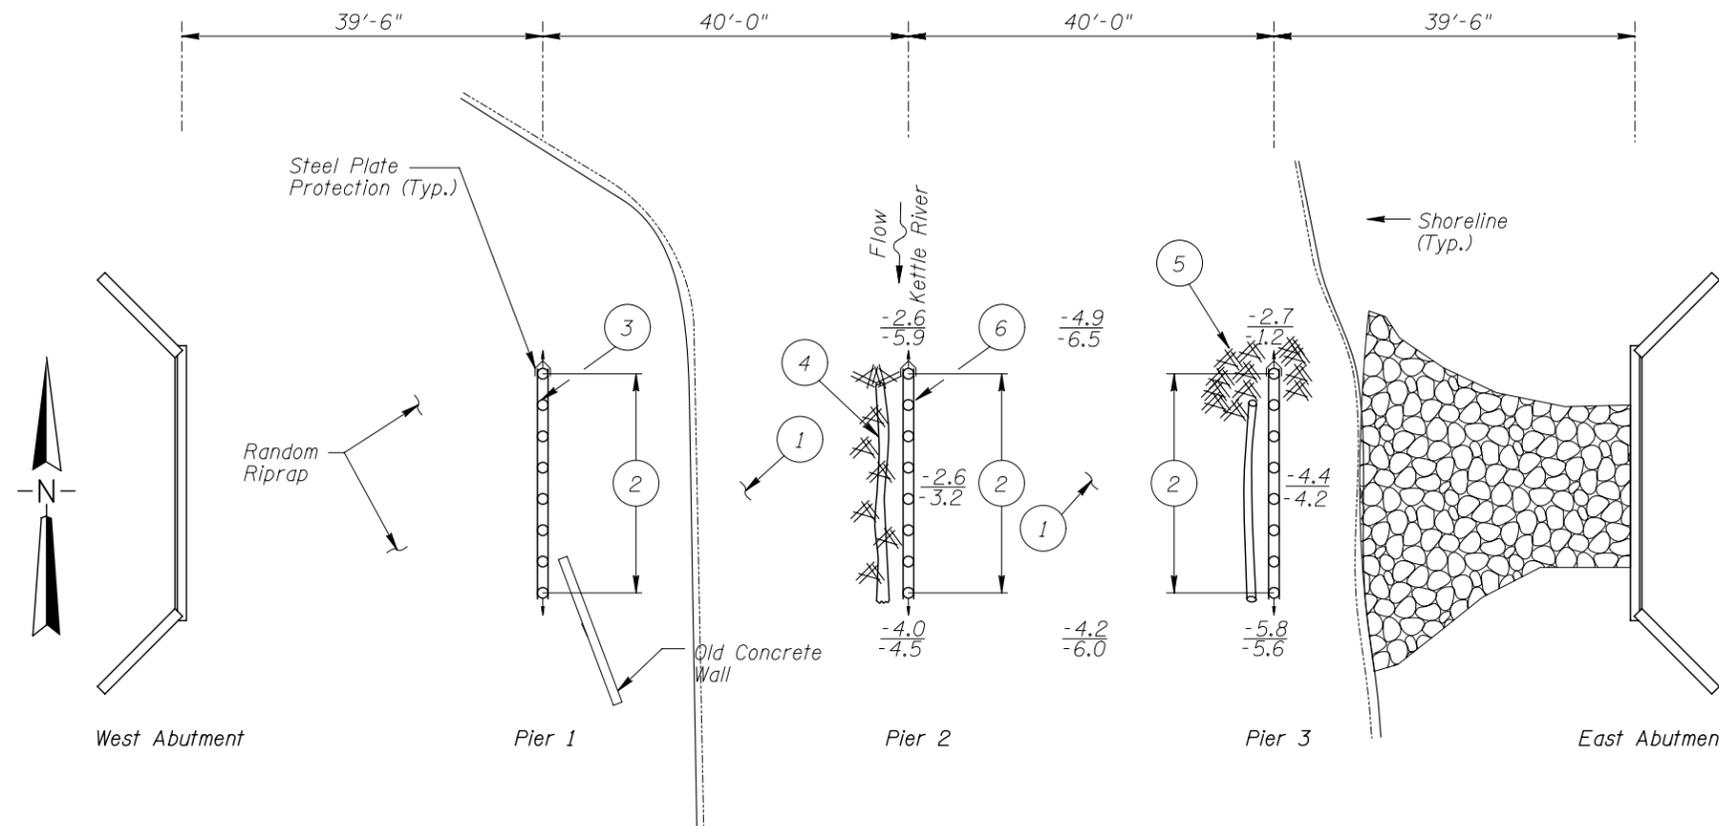
SOUNDING PLAN

- 1 The channel bottom consisted of silty sand with up to 1 foot of probe rod penetration.
- 2 The timber piles exhibited minor vertical checking and vertical splits on the outside of the timber shell. Also, the horizontal planking exhibited minor splits and some checking.
