UNDERWATER BRIDGE INSPECTION REPORT

STRUCTURE NO. 7771

CSAH NO. 110

CHANNEL AT WHITEWATER AND COLBY LAKES

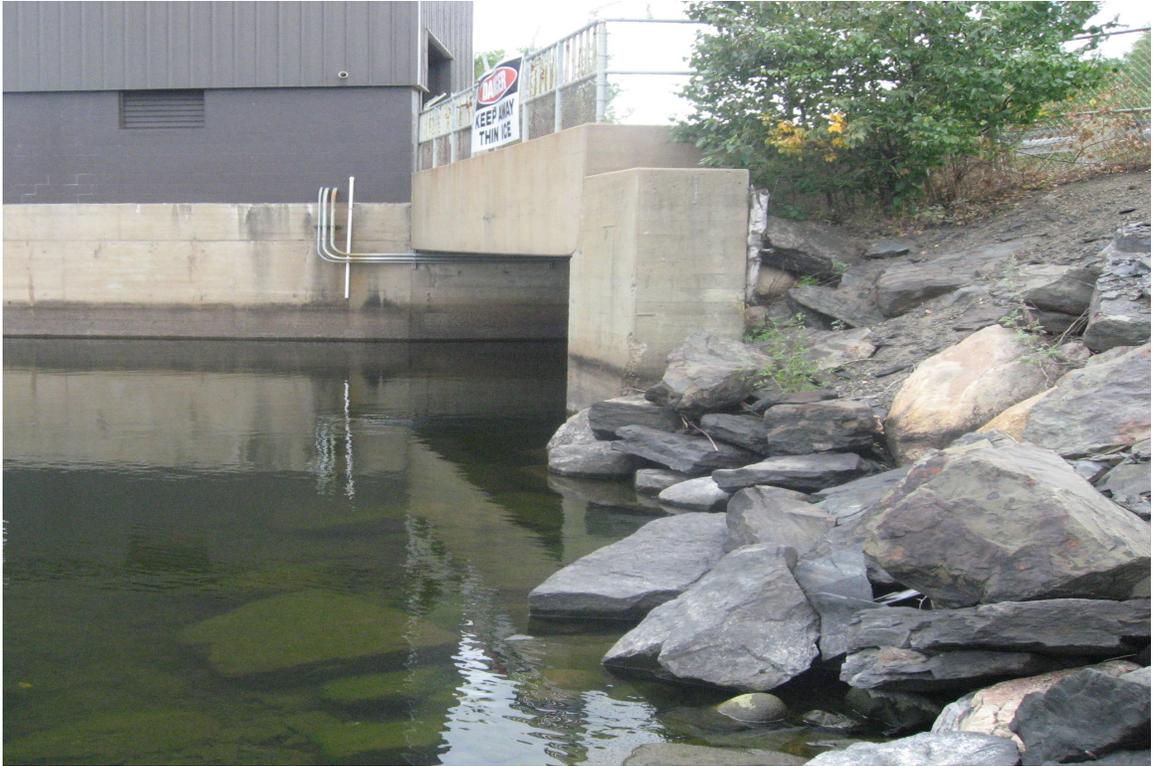
- (A) There was a vertical crack at the south end of the West Abutment, extending from under the fascia beam to 1 foot below the waterline with a maximum width of 1/8 inch. Minor section losses, up to 1 inch wide, were observed at various locations along the crack. At the bottom of the crack, a larger area of section loss with up to 1.5 inches of penetration was present.

Photograph 1. View of the West Abutment and South Bridge Fascia, Looking Northwest.

- (A) Monitor the cracks in both abutment walls for any progression, which could result due to freeze and thaw action, and if found to be worsening, repairs may become warranted at a later date.

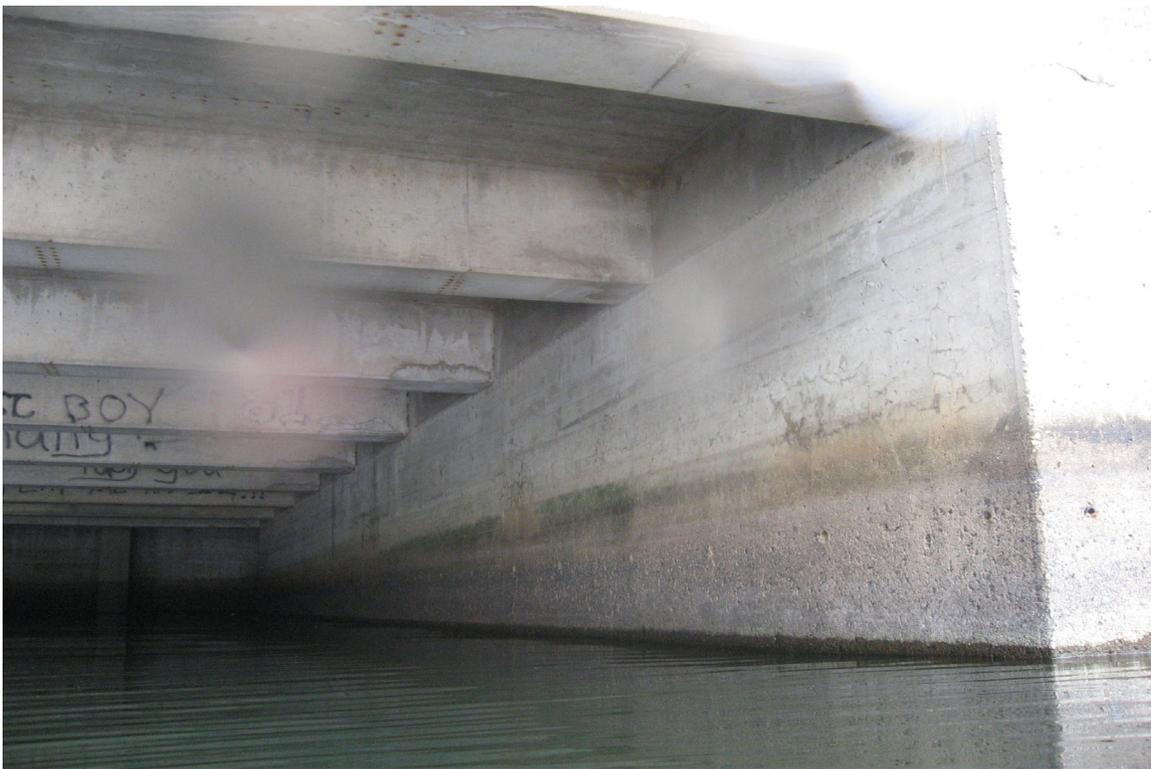
Photograph 2. View of East Abutment, Looking Northeast.

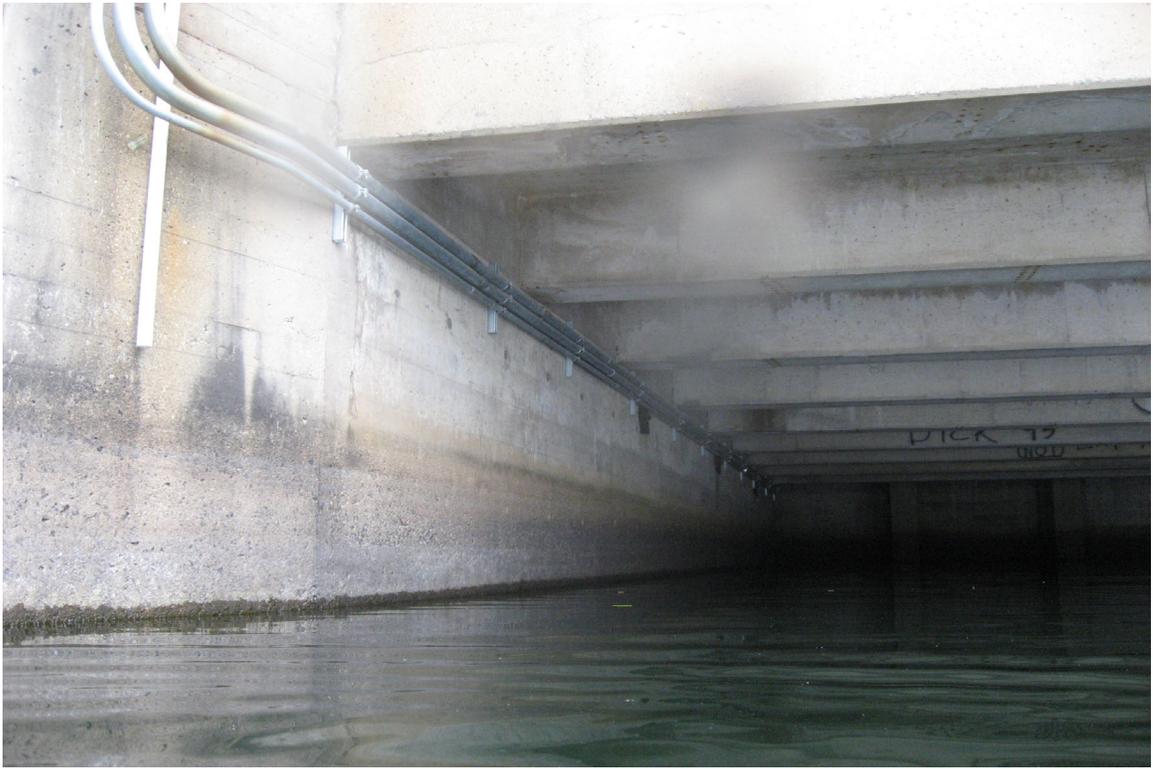
Photograph 3. View of West Abutment, Looking Northwest.

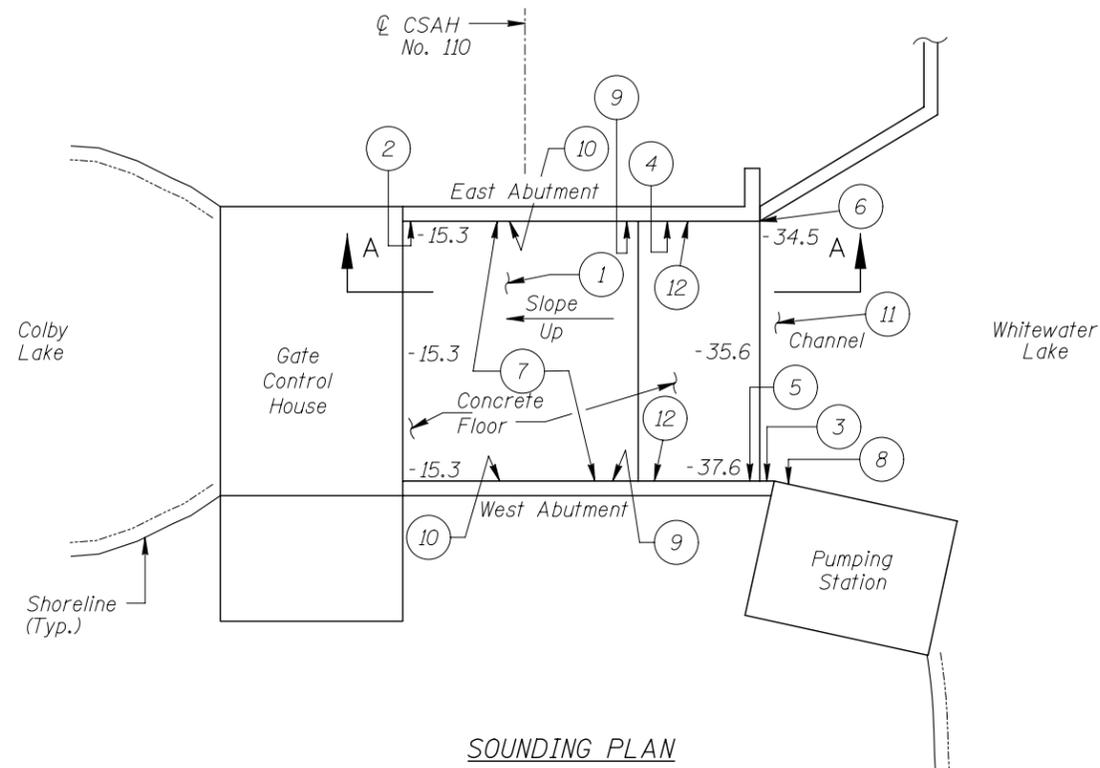
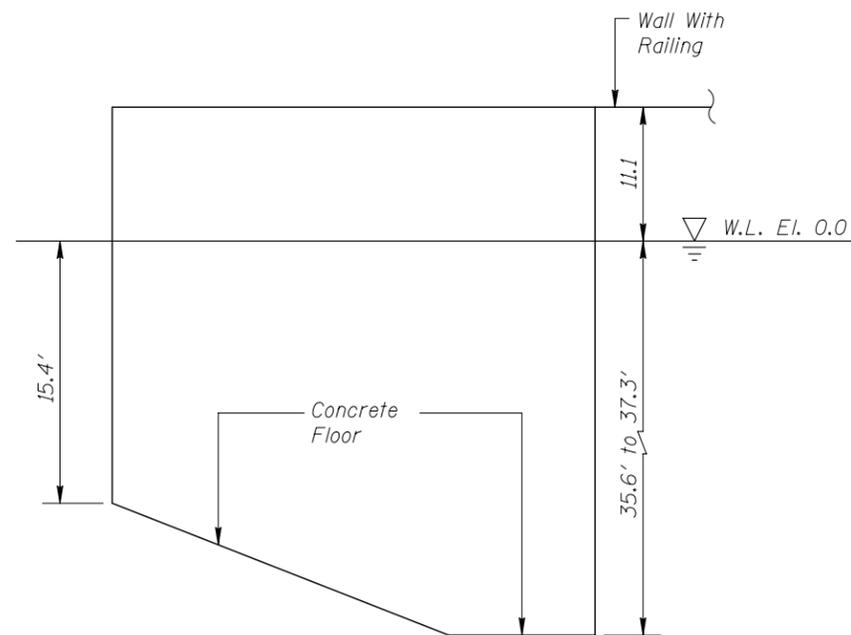
| INSPECTION AND SOUNDING PLAN | | |

- 1 The channel bottom consisted of a formed concrete slab with a light layer of silt.
- 2 At 9 feet below the water level, the bottom of the vertical joint exhibited a 6-inch-high by 3-inch-wide area of section loss with a penetration of 1 inch.

- 3 Vertical crack, extending from under the fascia beam to 1 foot below the waterline with a maximum width of 1/8 inch and minor loss of section with surface openings of up to 1 inch wide along crack.

- 4 Vertical hairline crack with efflorescence from 7 feet below the waterline to 16 feet below the waterline.
- 5 Area of horizontal section loss at 3 foot below the waterline, measuring 2.5 feet long by 3 inches high with a maximum penetration of 1.5 inches.

- 6 Section loss on corner at 2 feet above the waterline, measuring 9 inches wide by 2 feet high with 2 inches of penetration.
- 7 The concrete on all faces was generally smooth and sound with random small pockets of poorly consolidated concrete. On walls, up to 1/2 inch section loss along various horizontal cold construction joints below water.

- 8 An area of horizontal section loss, 3 feet long by 2 inches high, with 3 inches of penetration, was observed on the pump station wall.
- 9 Random hairline map cracking with light efflorescence was observed from the waterline to 3 feet above the waterline.

- 10 A 1/16 inch wide vertical crack with light efflorescence was observed on both abutment walls beginning at the bottom of the bridge deck, between the center and next to the north beams, and extended to 1 foot below the waterline.

- 11 Scattered riprap was observed along the south fascia.
- 12 Light scaling with from 1/8 inch to 1/4 inch penetration was observed from 2.5 feet above the waterline to 10 feet below the waterline on both abutment walls.
