UNDERWATER BRIDGE INSPECTION REPORT

STRUCTURE NO. 7799

WOLF CREEK

MINNESOTA DEPARTMENT OF TRANSPORTATION  
UNDERWATER BRIDGE INSPECTION

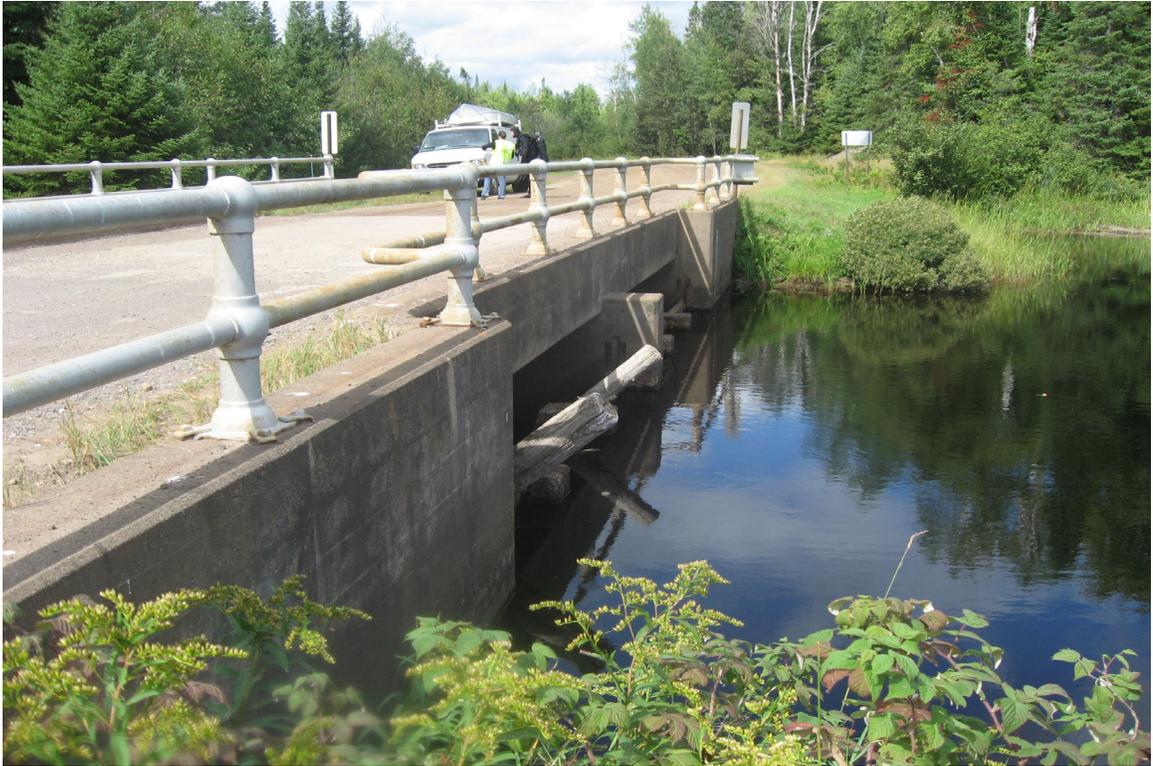
Photograph 1. Overall View of the Upstream Fascia of Structure, Looking Southwest.

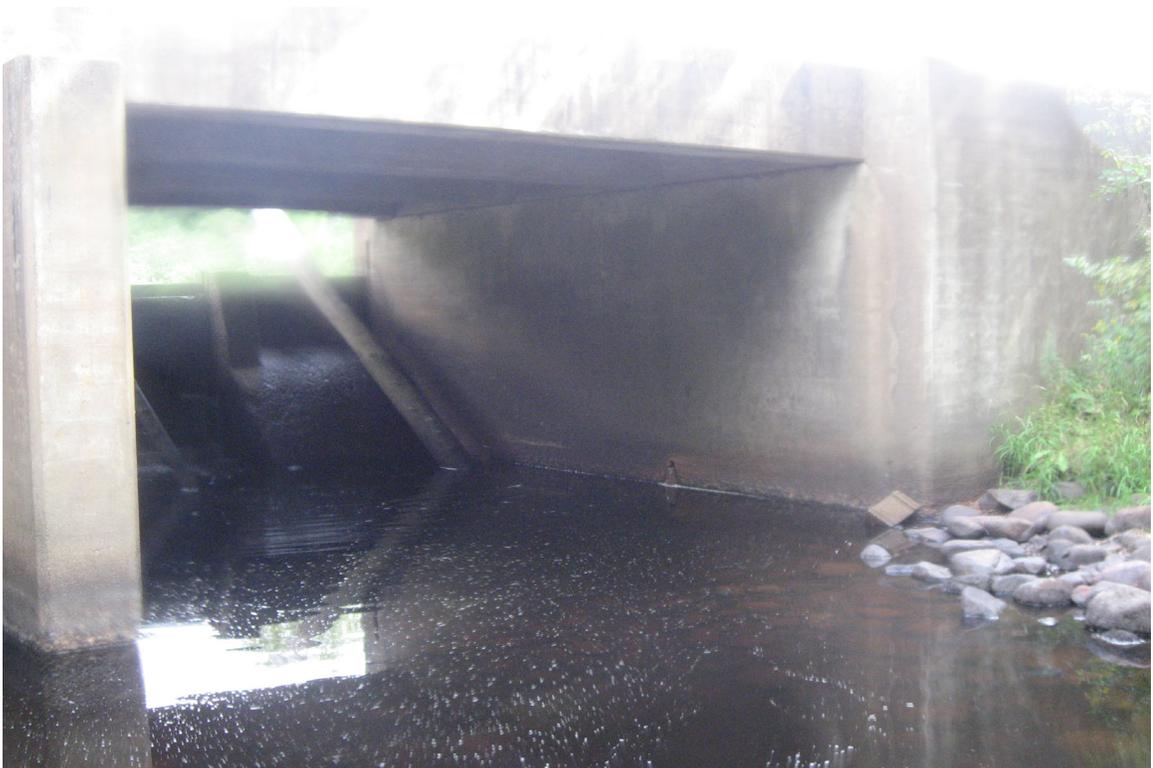
Photograph 2. View of the East Abutment, Looking Northeast.

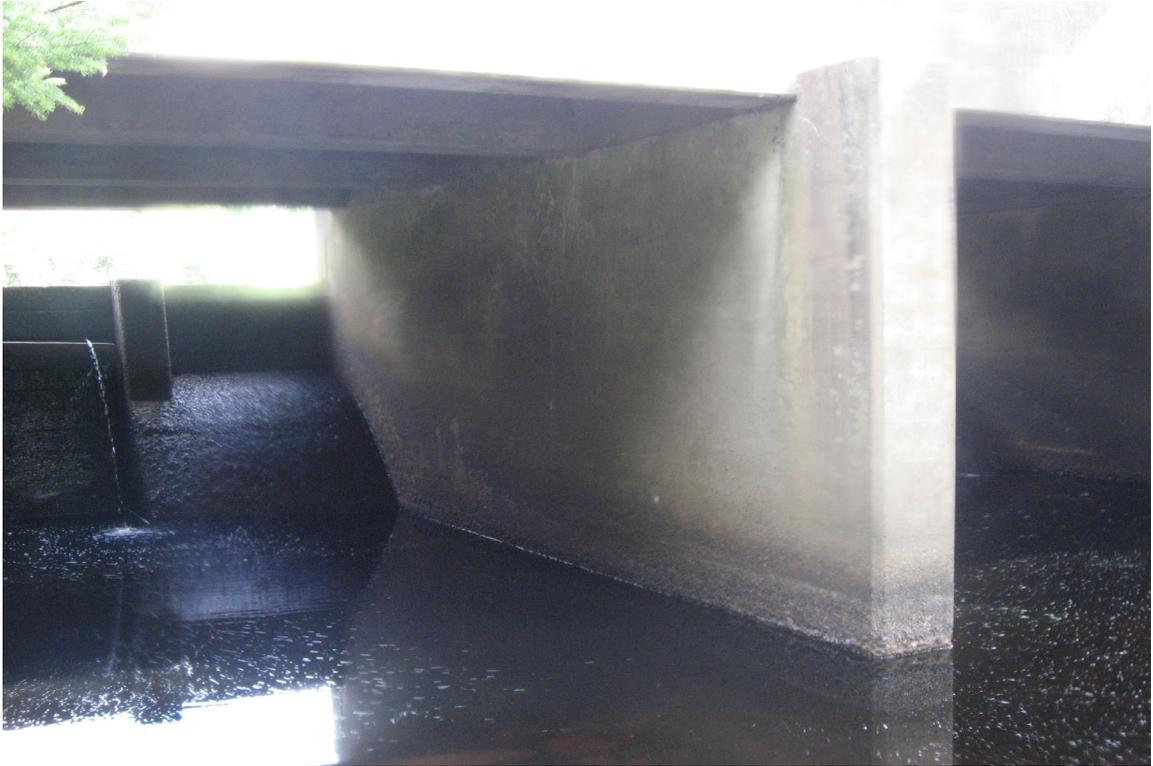
Photograph 3. View of the Center Pier, Looking Northeast.

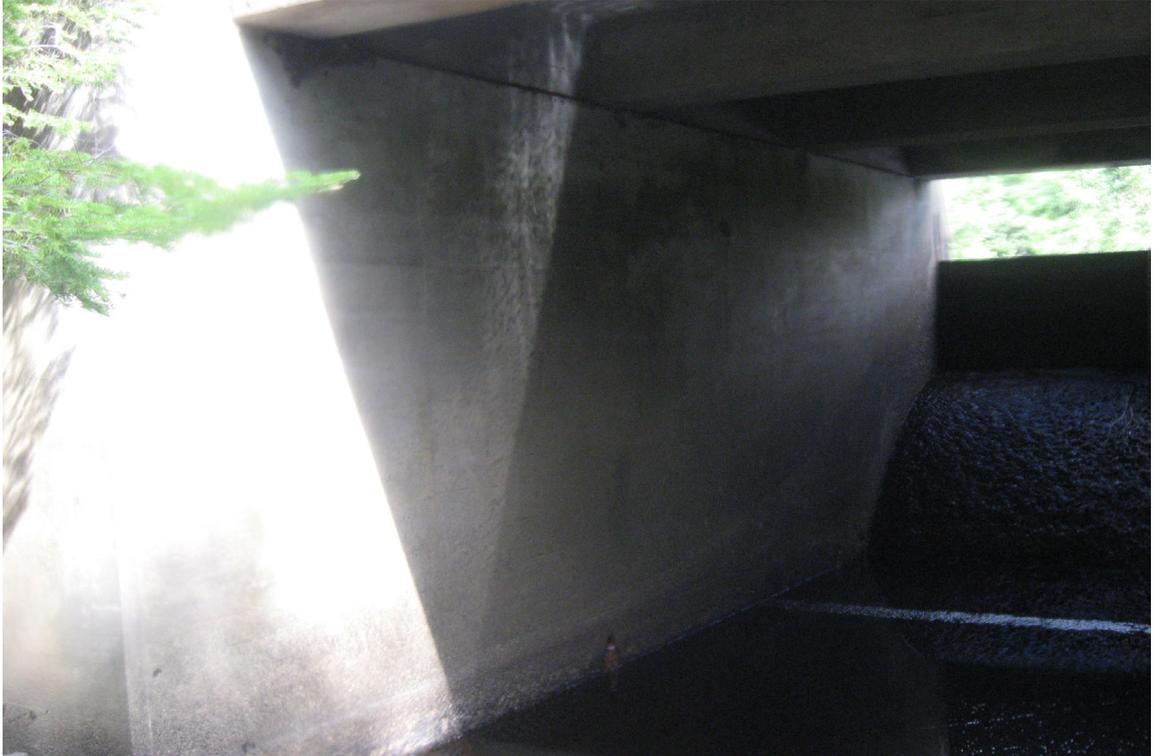
Photograph 4. View of the West Abutment, Looking Northwest.

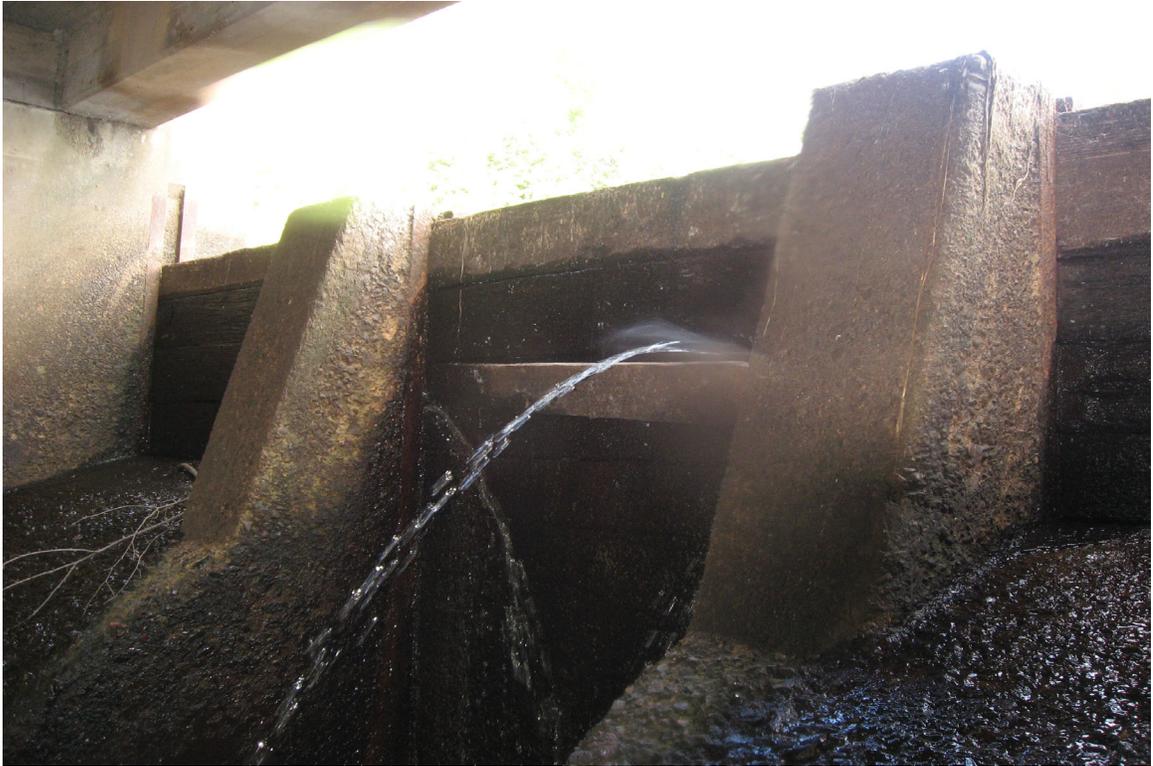
Photograph 5. View of the Third from top (failed) Timber Flash Board at West Wall of Dam, Looking Northwest.

- 10 A 1-foot-diameter log and an 8-inch-diameter log were observed laying across the dam.
- 11 The third flash board from top of the west dam wall has failed.

- (A) Notify proper authorities of the impending failure of top two flash boards at the middle span between the Center Pier and the East Abutment and third from top flash board at the middle span between the Center Pier and the West Abutment, whose failure could disrupt water levels and hydraulics upstream and downstream of the bridge.
- (B) Reinspect the submerged substructure units at the normal maximum recommended (NBIS) interval of five (5) years.

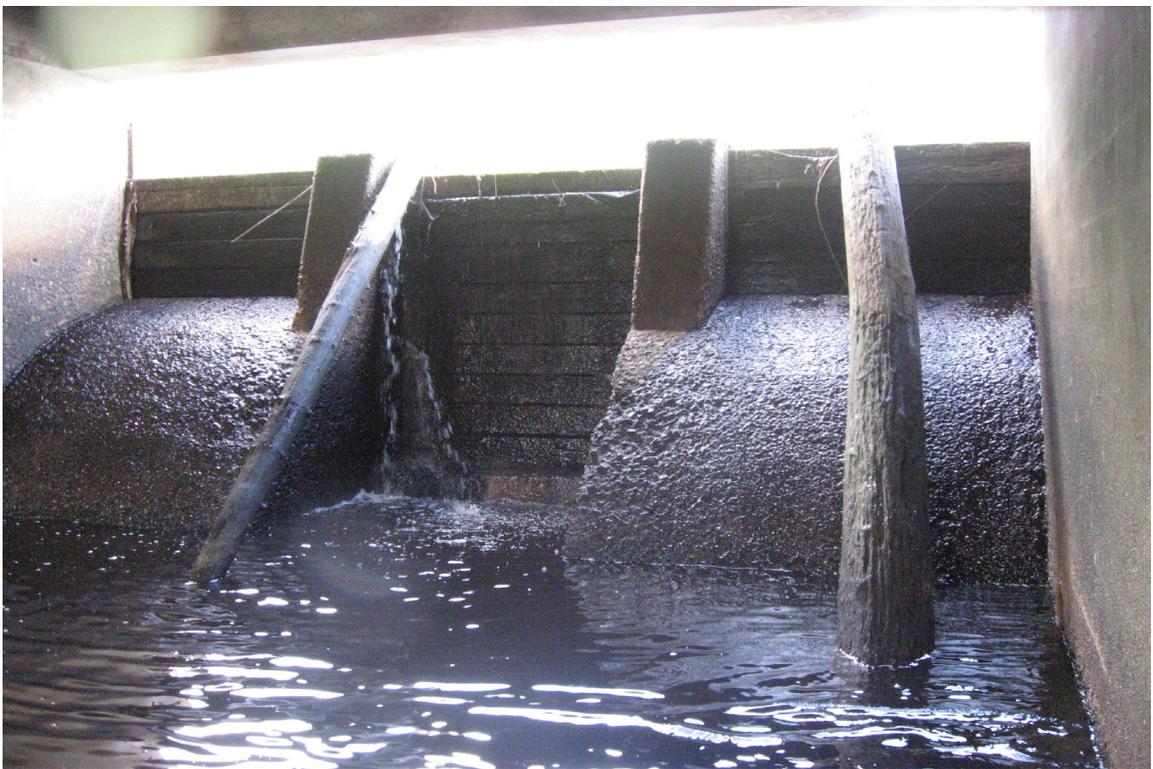
Photograph 6. View of the Timber Flash Boards and Debris at East Wall of Dam, Looking Northwest. Note top two center boards bowed and failing.

- 8 A vertical crack up to 1/32 inch wide with efflorescence extended from the bottom of the bridge deck to 3 feet above the waterline.
- 9 The top two flash boards of the east dam wall exhibited up to 5 inches of deflection towards the downstream fascia, and appeared to be approaching failure.

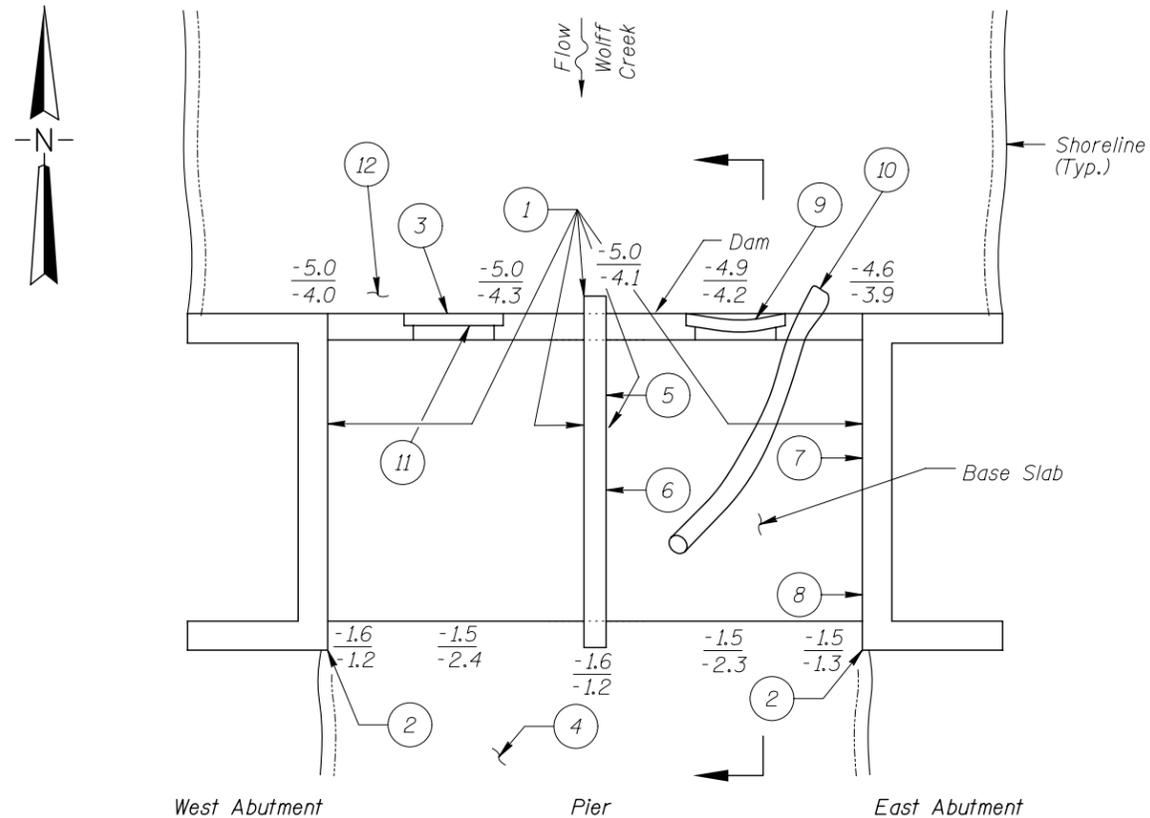
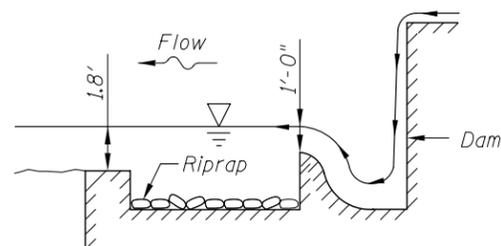
INSPECTION AND SOUNDING PLAN

- 1 Moderate to heavy scaling was observed on all substructure units from 1.5 foot above the waterline to 1 foot below the waterline with up to 1 inch of penetration.

- 2 Hairline vertical crack, extending from the top corner of the wingwall down full height of wall, with associated minor spalling up to 1/2 inch wide.

- 3 The concrete sill at the base of the upstream dam was observed 4.5 feet below the waterline that had a maximum of 1 foot of vertical exposure with a light accumulation of 6-inch-diameter timber debris against the face of the base slab.

- 4 Channel bottom consisted of sandy gravel and 0.5- to 1-foot-diameter riprap with less than 1 inch of probe rod penetration.
- 5 A hairline vertical crack with efflorescence extended from the bottom of the bridge deck to the lip of the spillway.

- 6 A hairline vertical crack extended from the bottom of the bridge deck to the base slab.
- 7 A vertical crack up to 1/16 inch wide extended from the bottom of the bridge deck to the base slab.

- 12 A light accumulation of debris consisting of 6-inch-diameter and smaller branches was located along the North face of the dam.
