UNDERWATER BRIDGE INSPECTION REPORT

STRUCTURE NO. 88594  
CSAH NO. 44  
OVER THE  
INDIAN CREEK  
DISTRICT 1 – ST. LOUIS COUNTY

PREPARED FOR THE  
MINNESOTA DEPARTMENT OF TRANSPORTATION  
BY  
COLLINS ENGINEERS, INC.  
JOB NO. 5221 (CEI 6)

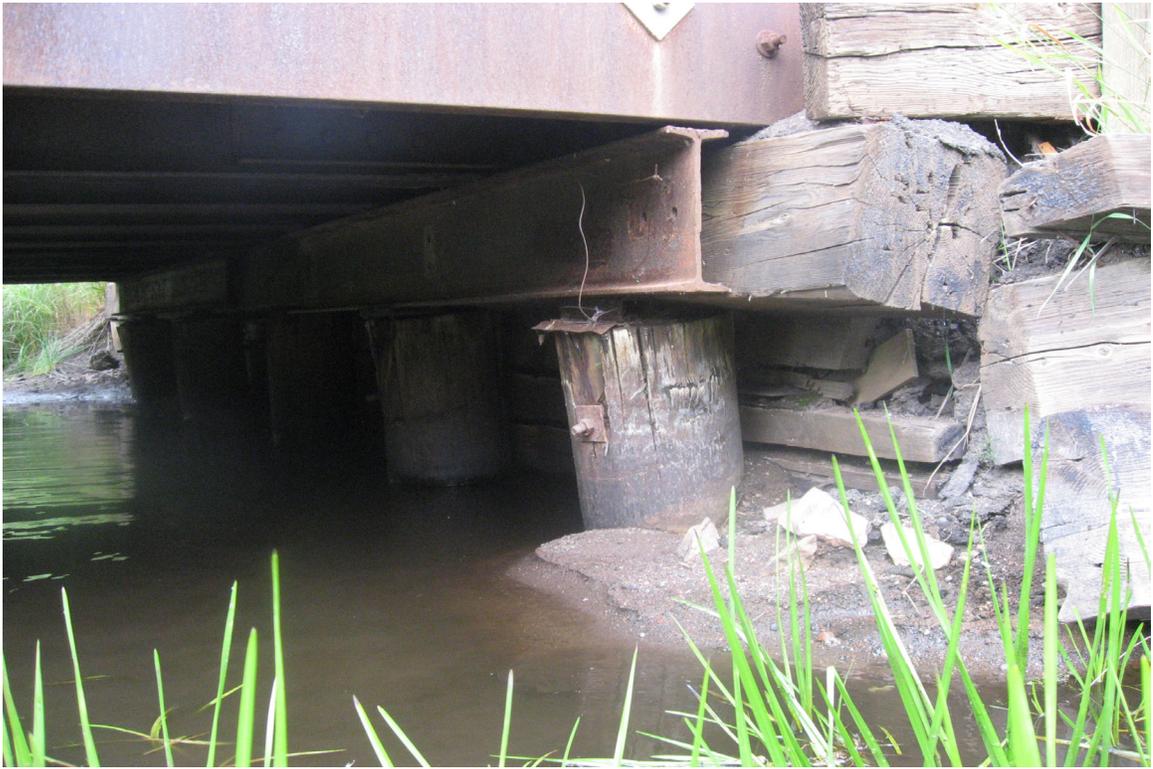
Photograph 1. View of the North Abutment, Looking Northwest.

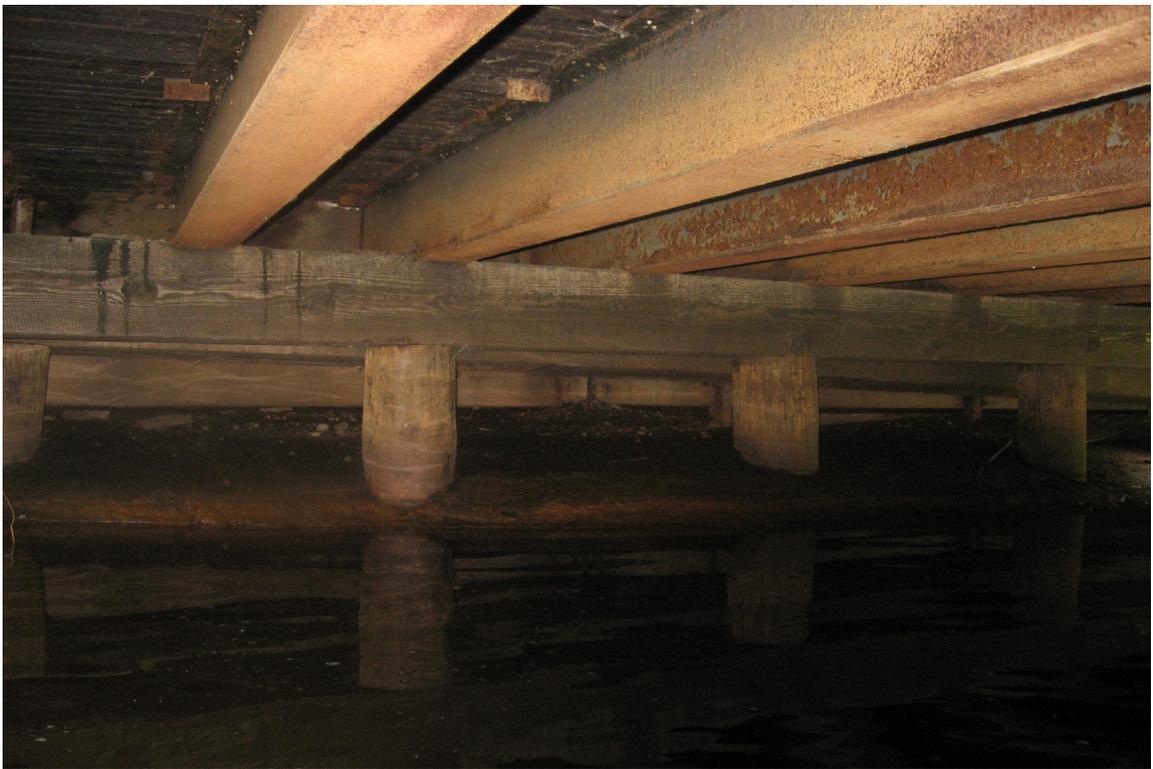
Photograph 2. View of the Backwall at North Abutment, Looking North.

- 9 There is evidence of movement of the backwall planking allowing loss of backfill/embankment on both North and South Abutments.
- 10 The timber pile exhibited splitting and delamination on the South face of the pile with the outer 1 inch thick shell being the most affected.

Ideally, the North Abutment backwall and its northeast wingwall should be rebuilt and/or repaired to prevent further loss of backfill under the approach. Given the overall condition of the bridge, complete replacement of the structure should also be a consideration. Until repairs and/or replacement can be made, above and below water inspection should monitor the failing North Abutment components, especially in light of the current high speed truck traffic being carried by the bridge.

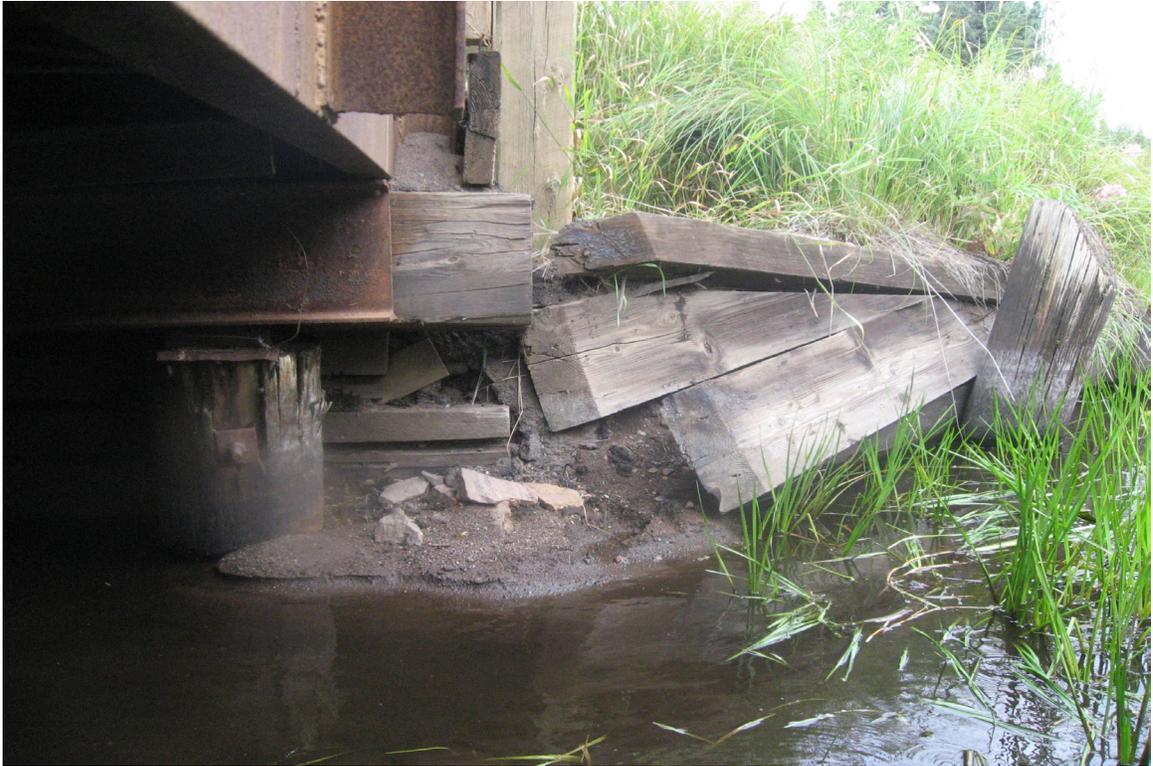
Photograph 3. View of the Failed Wingwall and Pile 1 at the North Abutment, Looking North.

- 5 The timber pile exhibited a 1/2-inch-wide, 1.5-inch-deep split extending from the pile cap to the channel bottom.
- 6 The wingwall has failed and the east end of the backwall exhibited considerable movement with backfill escaping through 1-inch-gaps between the planking.

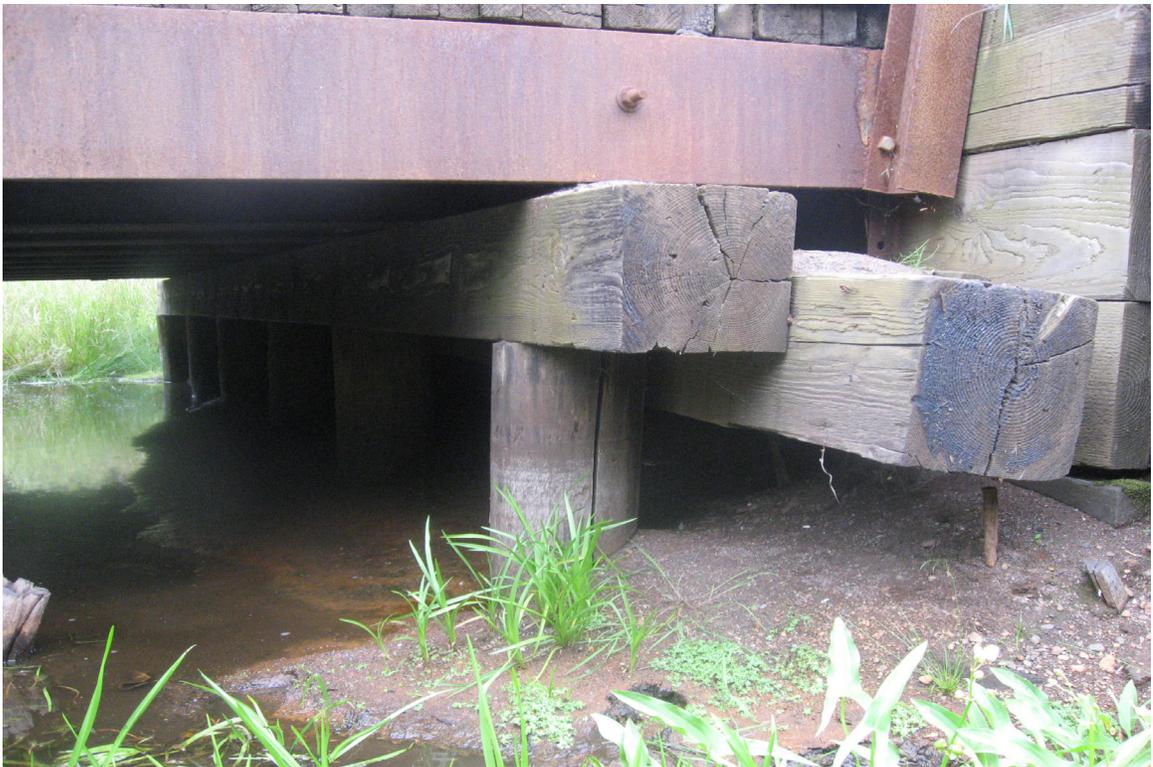
Photograph 4. View of South Abutment, Looking Southeast.

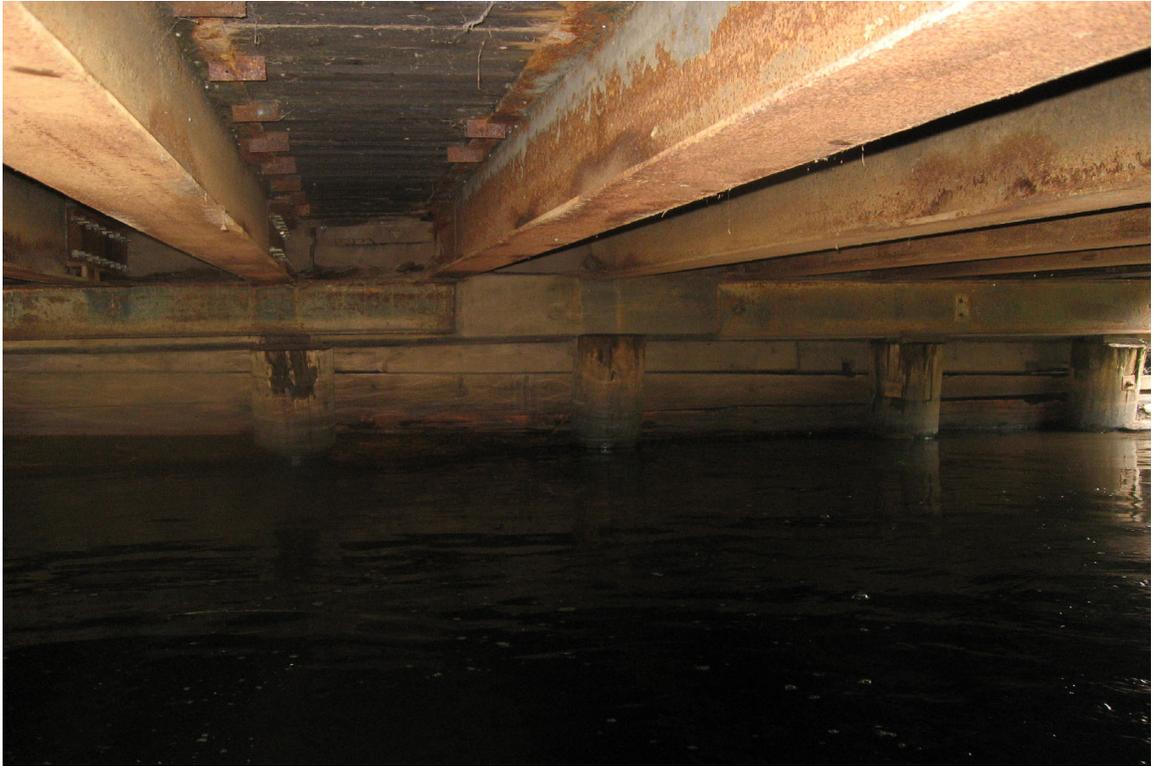
Photograph 5. View of the Backwall at South Abutment, Looking South.

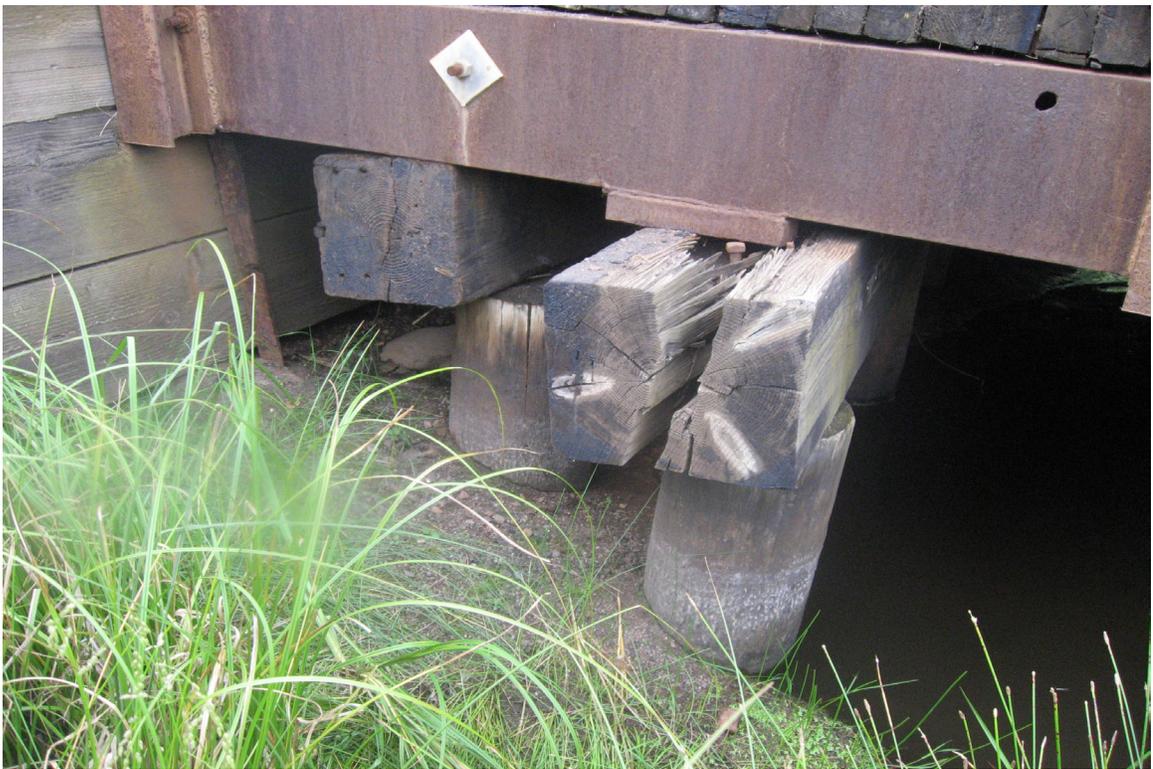
Photograph 6. View of Pile Cap Failure (split), Looking Southwest.

- 1 The channel bottom consisted of silty sand with a maximum probe rod penetration of 1.5 feet.
- 2 The pile cap exhibited a 3-inch-wide vertical split which extended from the end of the pile cap to Pile 2. Also, there is up to 25% loss of section over the first pile related to decay due to the splitting.

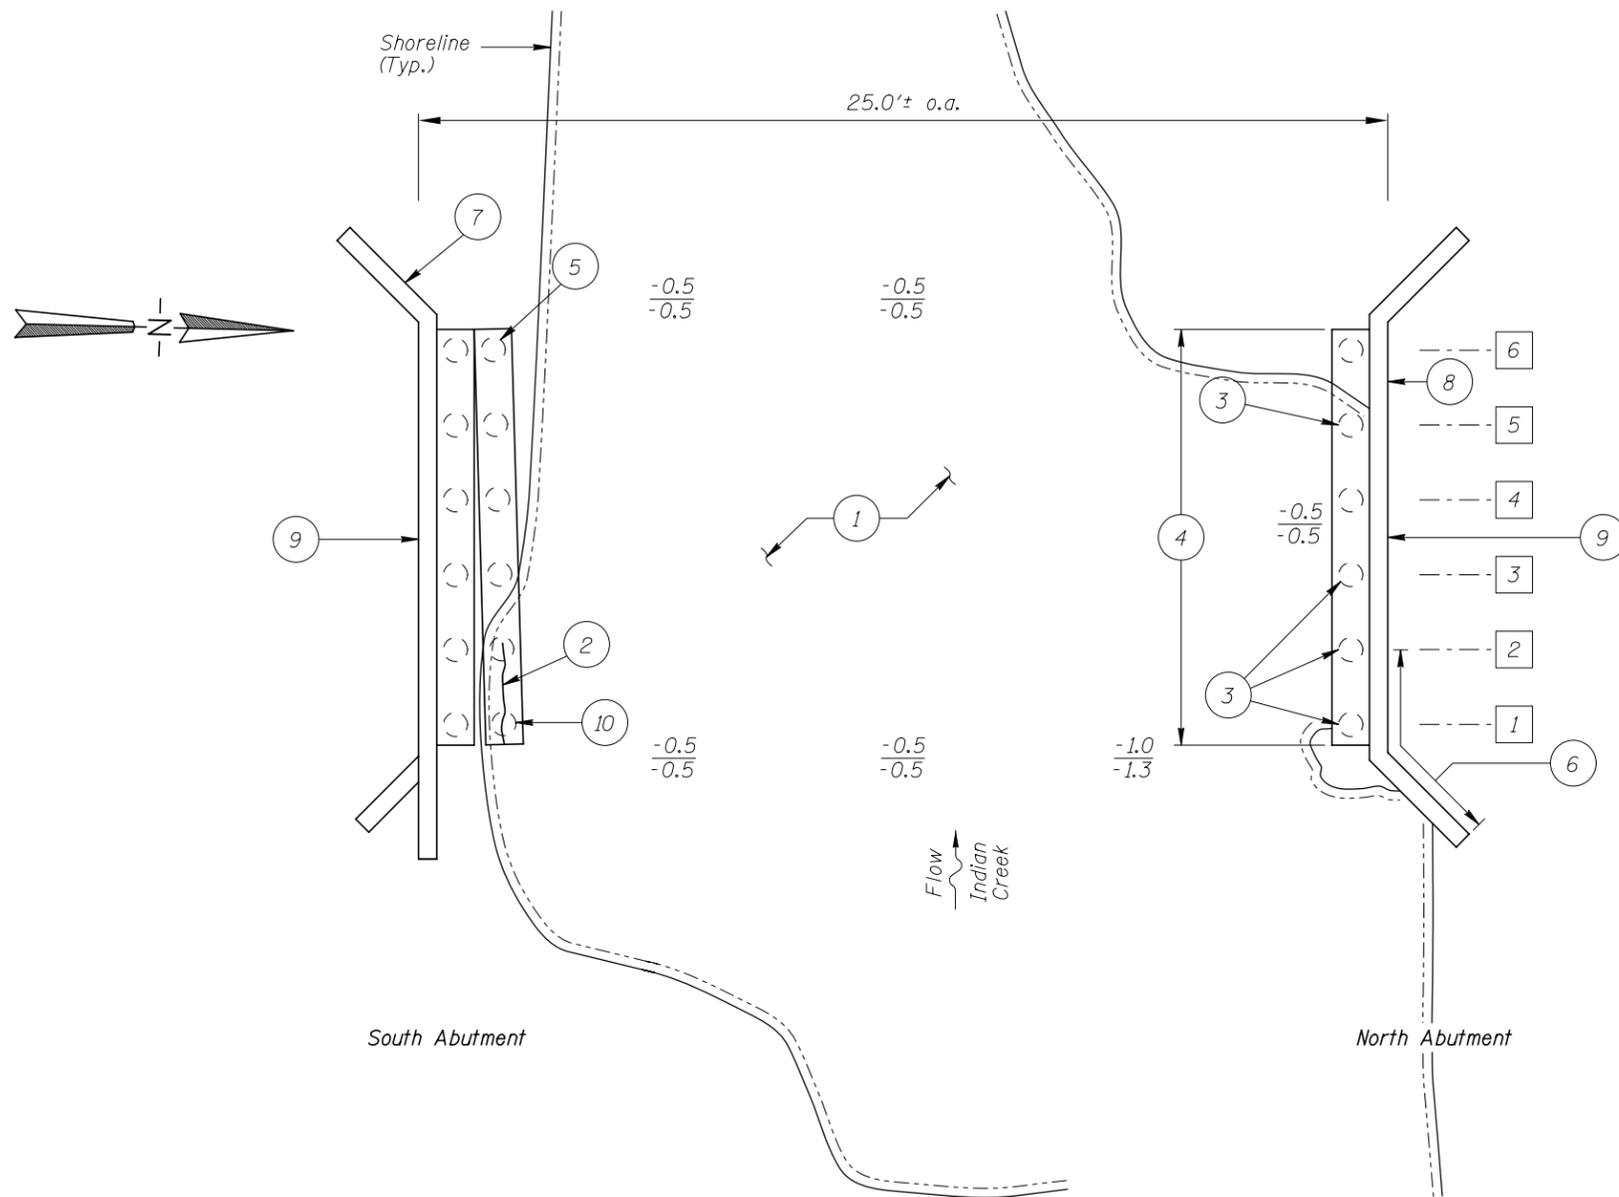
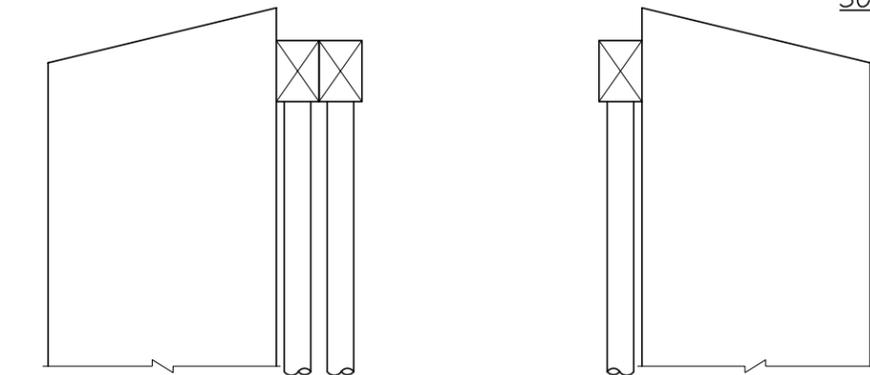
**INSPECTION AND SOUNDING PLAN**

- 3 The timber pile exhibited splitting and delamination around the entire circumference with the outer 1.5 inch thick shell being the most affected.
- 4 The pile cap was rotated towards the embankment and was held in place with steel beams and shims.

- 7 Bottom plank was 6 inches above channel bottom with 1 foot of penetration behind wall. There is loss of backfill between backwall and wingwall.
- 8 Portion of backwall exhibited 1-foot-wide by 6-inch-high gap with 6 inches of penetration and signs of backfill escaping.
