UNDERWATER BRIDGE INSPECTION REPORT

STRUCTURE NO. L9465

EAST FORK OF THE RAPID RIVER

PREPARED FOR THE
MINNESOTA DEPARTMENT OF TRANSPORTATION

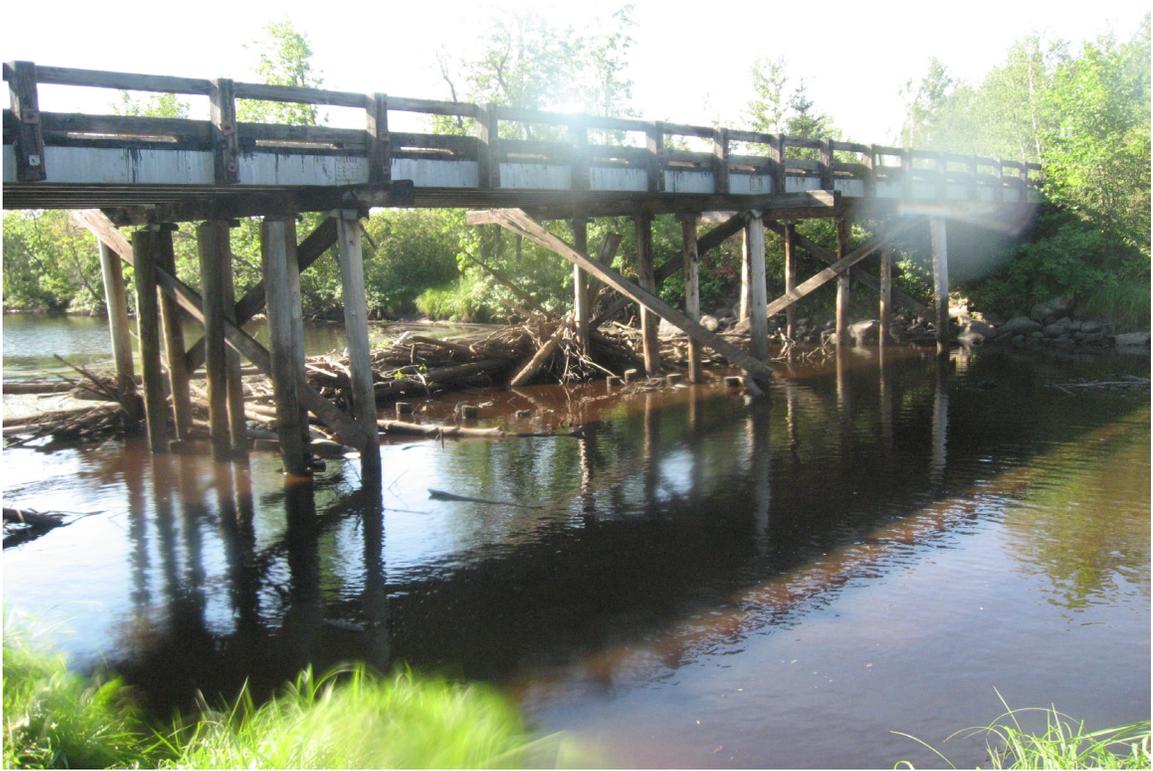
- (A) A very heavy accumulation of timber debris was observed along Piers 1 through 4 and in the channel upstream of the piers extending 40 feet upstream. The debris has restricted the channel flow, causing increased flow and an erosion pocket to form along the west bank. In addition, the drift has the potential to exert considerable lateral load on the bridge during a period of high flow.

Photograph 1. Overall View of the Structure, Looking Southwest.

- (A) Remove the very heavy accumulation of timber debris at Piers 1 through 4 and between the spans to eliminate the potential for continued accumulation, scour influence, and excessive lateral loads on bridge.
- (B) Repair and replace the damaged cross-bracing and connection at upstream pile of Pier 3. Restore or replace the dislodged upstream pile at Pier 3 also.
- (C) Reinspect the submerged substructure units at the normal maximum recommended (NBIS) interval of five (5) years. However, until timber debris can be removed closely monitor structure during and after any significant high flow event.

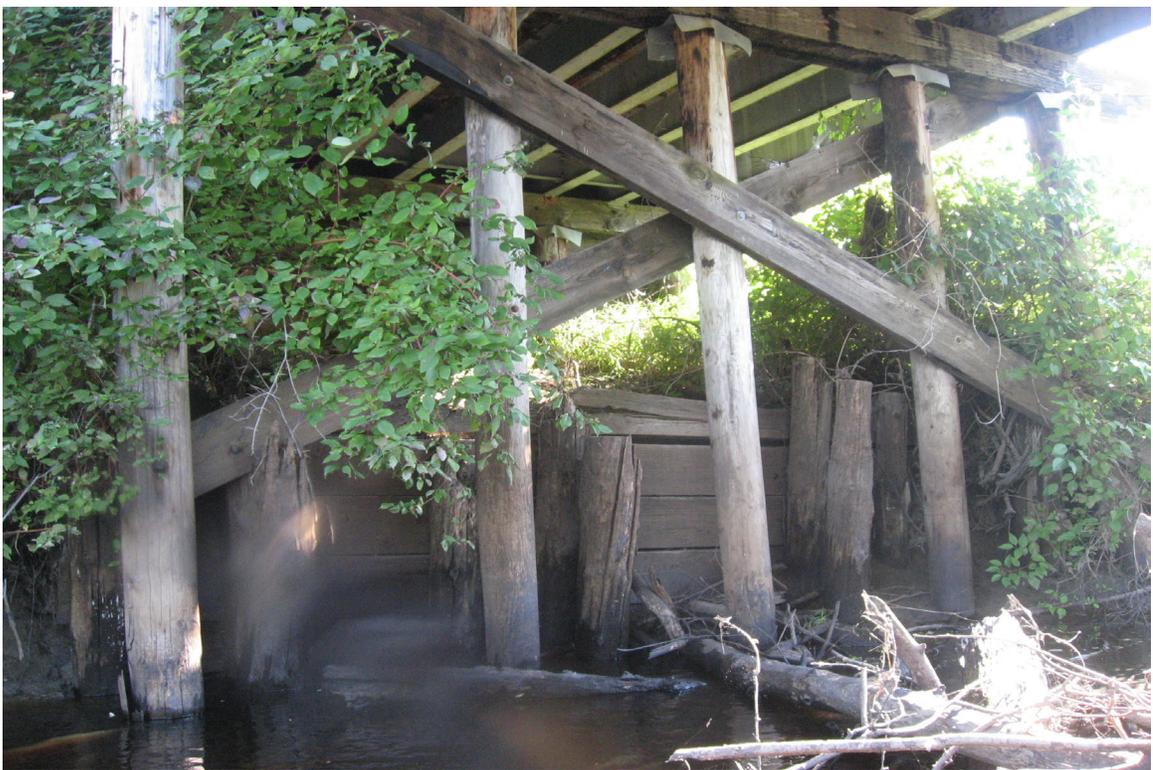
Photograph 2. View of Pier 1 and Embankment, Looking East.

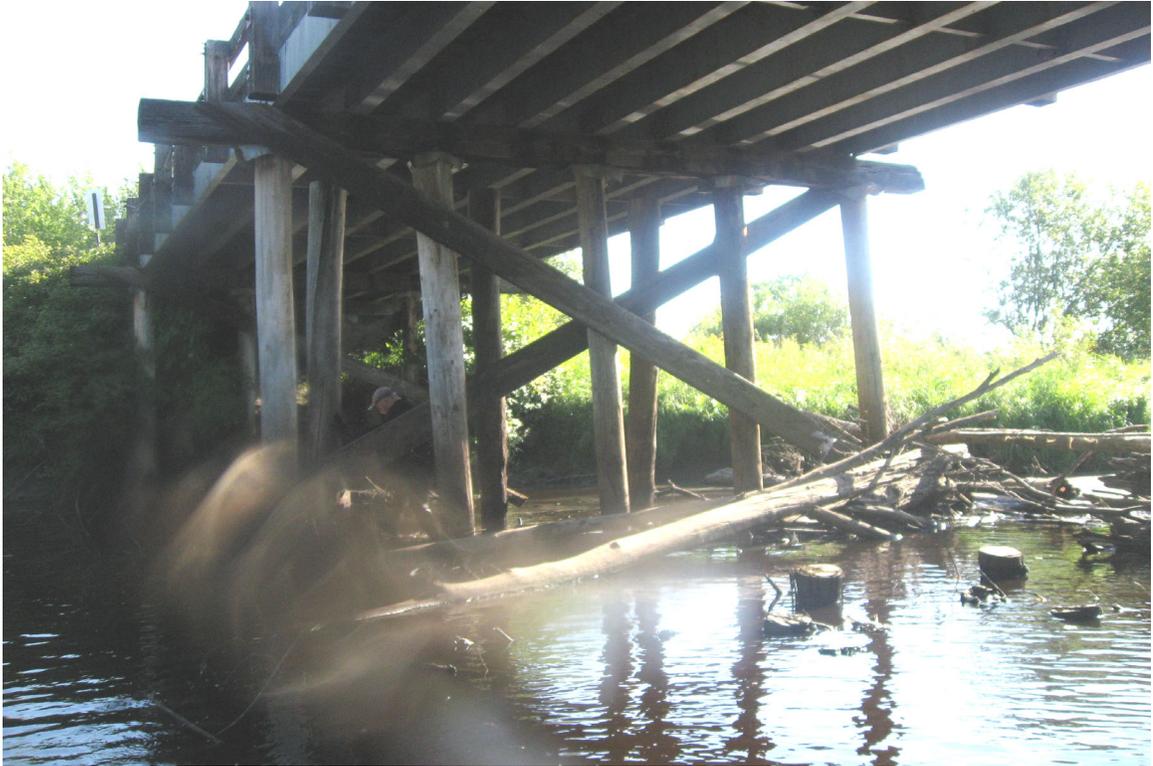
Photograph 3. View of Pier 2, Looking Southeast.

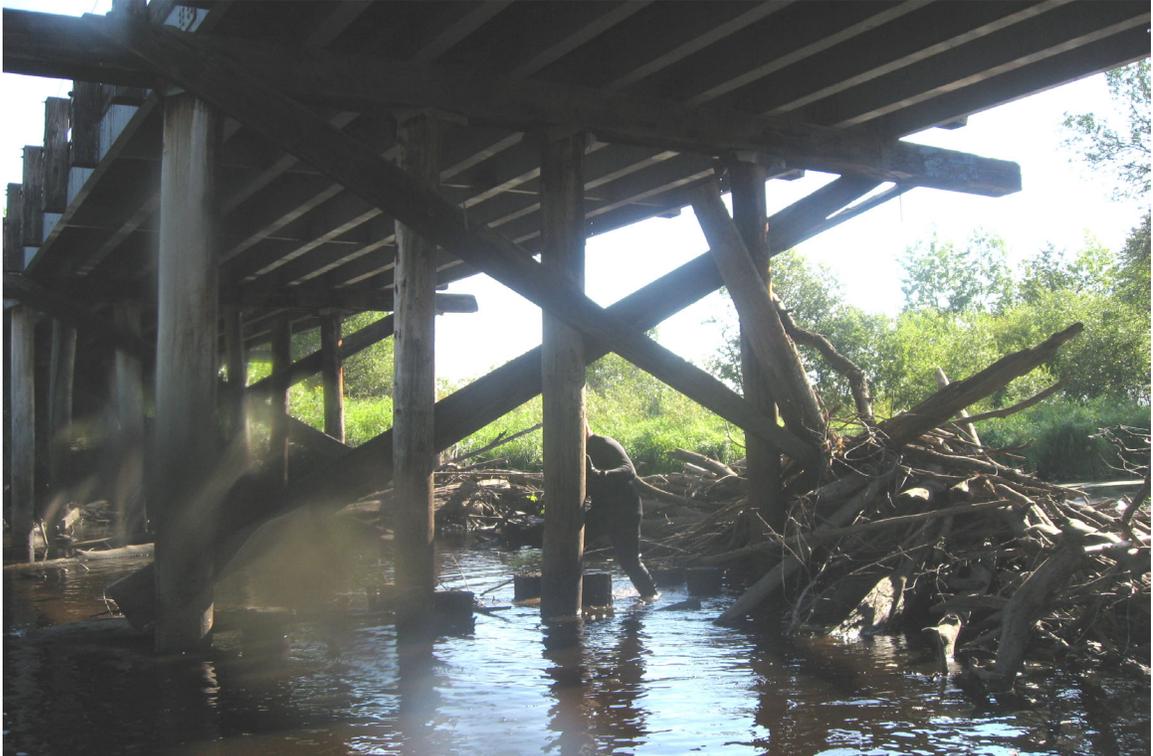
- (D) The cross-bracing at the upstream end of Pier 3 was heavily damaged and split and had no connection to the upstream pile. The first upstream pile of Pier 3 has been dislodged due to lateral loads coming from the timber debris.

Photograph 4. View of Pier 3, Looking Southeast. Note Dislodged Upstream Pile.

- 7 The cross bracing was heavily damaged and split and no longer connected to the upstream pile of Pier 3. The debris has dislodged first upstream pile, and now debris and pile are coming up against the second upstream pile of Pier 3.

Repair and replace the damaged cross-bracing and connection at upstream pile of Pier 3. Restore or replace the dislodged upstream pile at Pier 3 also.

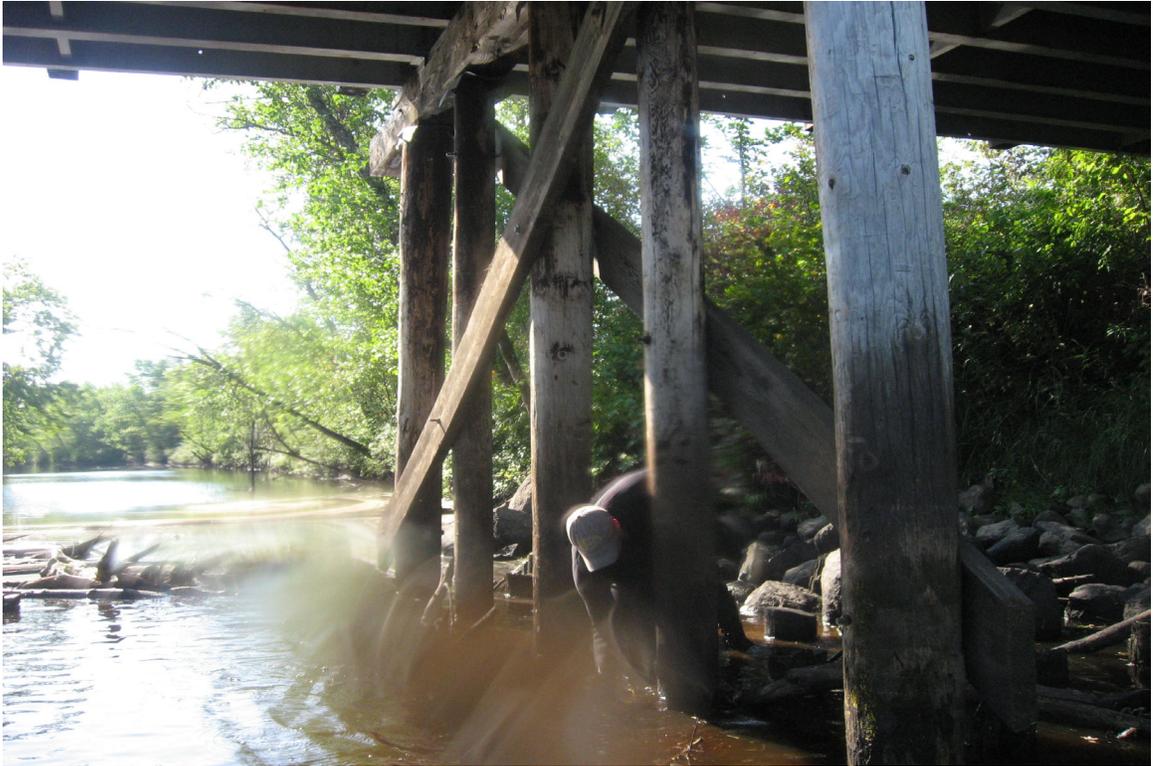
Photograph 5. View of Pier 4, Looking Southeast.

- 9 At Bent 4, the middle pile showed a 1 inch wide check from 2 feet above waterline to the top of the pile.

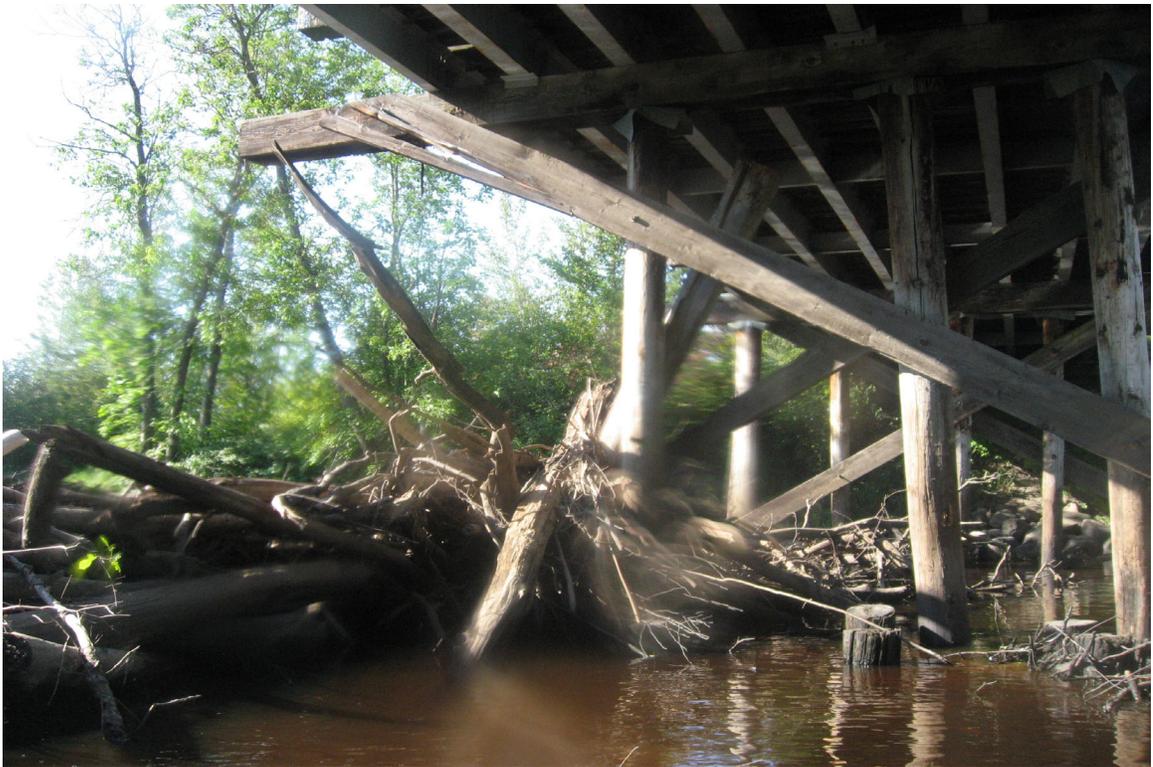
Photograph 6. View of the upstream pile of Pier 3 (dislodged), Looking East.

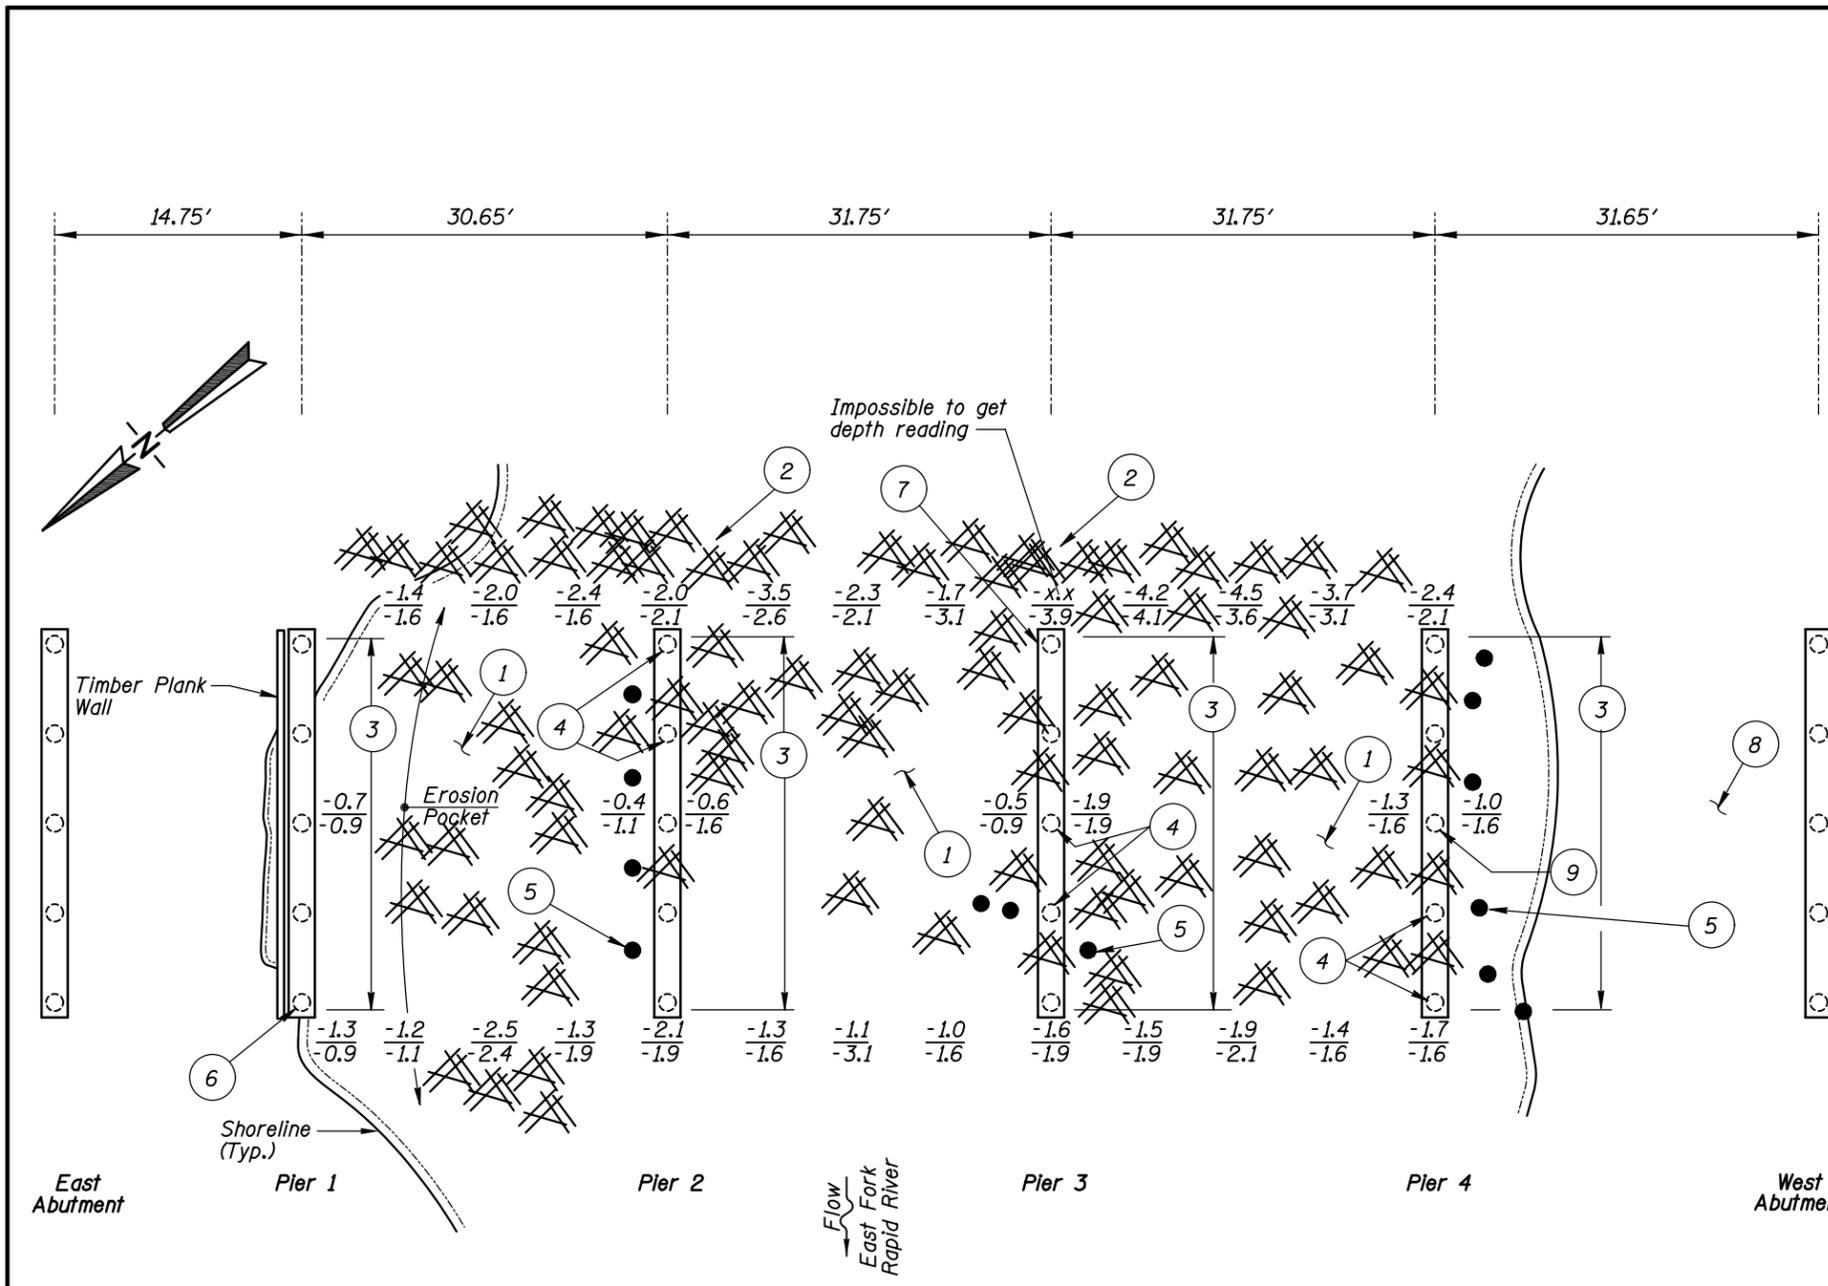
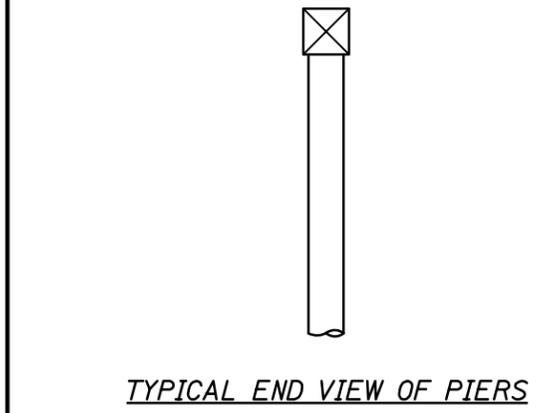
SOUNDING PLAN

- 1 The channel bottom consisted of approximately 1 foot of soft organic material and twigs overlaying a firm silty clay with probe rod penetrations of 6 inches.

- 2 Very heavy accumulation of timber debris was observed along and between Piers 1 through 4, and in the channel upstream of the piers extending 40 feet upstream. The debris has restricted the channel flow causing increased flow and erosion pocket to form in the channel to the west of Pier 1. The debris extends from channel bottom up to 3 to 6 feet above the waterline (heaviest at Bent 3).

- 3 Minor deterioration was randomly observed on all timber piles consisting of weathering and 1/8 to 1/4 inch wide checking.
- 4 Above water, especially near their tops, indicated piles exhibited heavier checking and splitting from 1/2 to 1 inch wide with a maximum penetration of half the pile diameter.

- 5 Piles cut off above the waterline were observed typically extending 1 foot above the waterline with some extending up to the pile cap.
- 6 Moderate deterioration (splintering and delamination) along a 2 inch wide strip from channel bottom to 2 feet above waterline, with 1/2 inch penetration and another 1 inch of soft timber.

- 8 Erosion of shoreline was observed along the west shoreline. However, the shoreline armour consisted of 3 feet diameter riprap was still in place along the shoreline.
