UNDERWATER BRIDGE INSPECTION REPORT

STRUCTURE NO. R0278

DISTRICT 1 - KOOCHICHING COUNTY

MINNESOTA DEPARTMENT OF TRANSPORTATION  
UNDERWATER BRIDGE INSPECTION

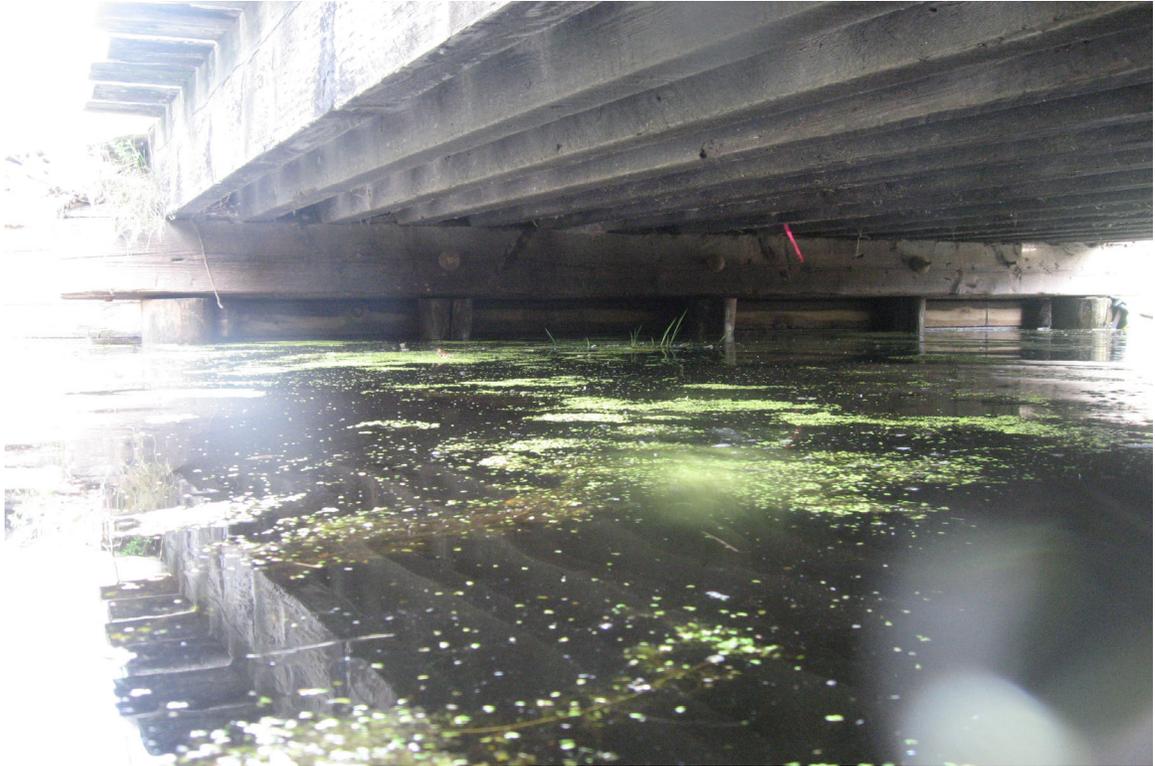
Photograph 1. View of North Abutment, Looking Northeast.

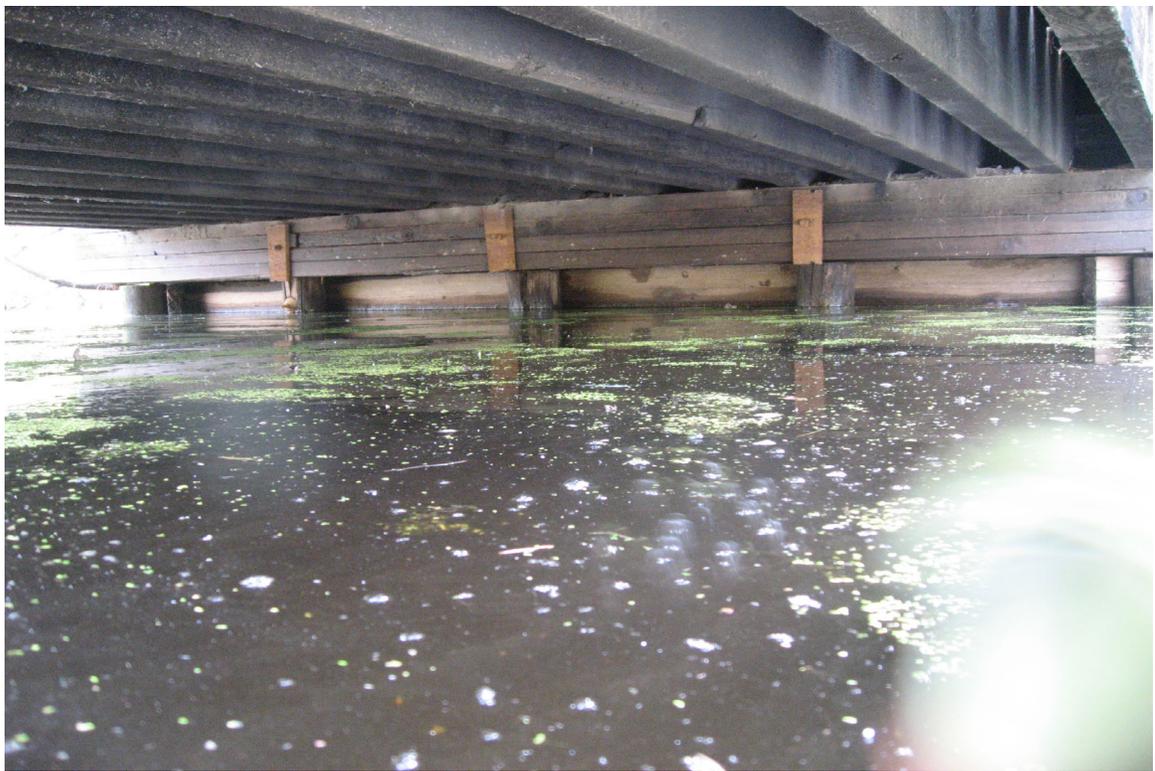
Photograph 2. View of South Abutment, Looking Southeast.

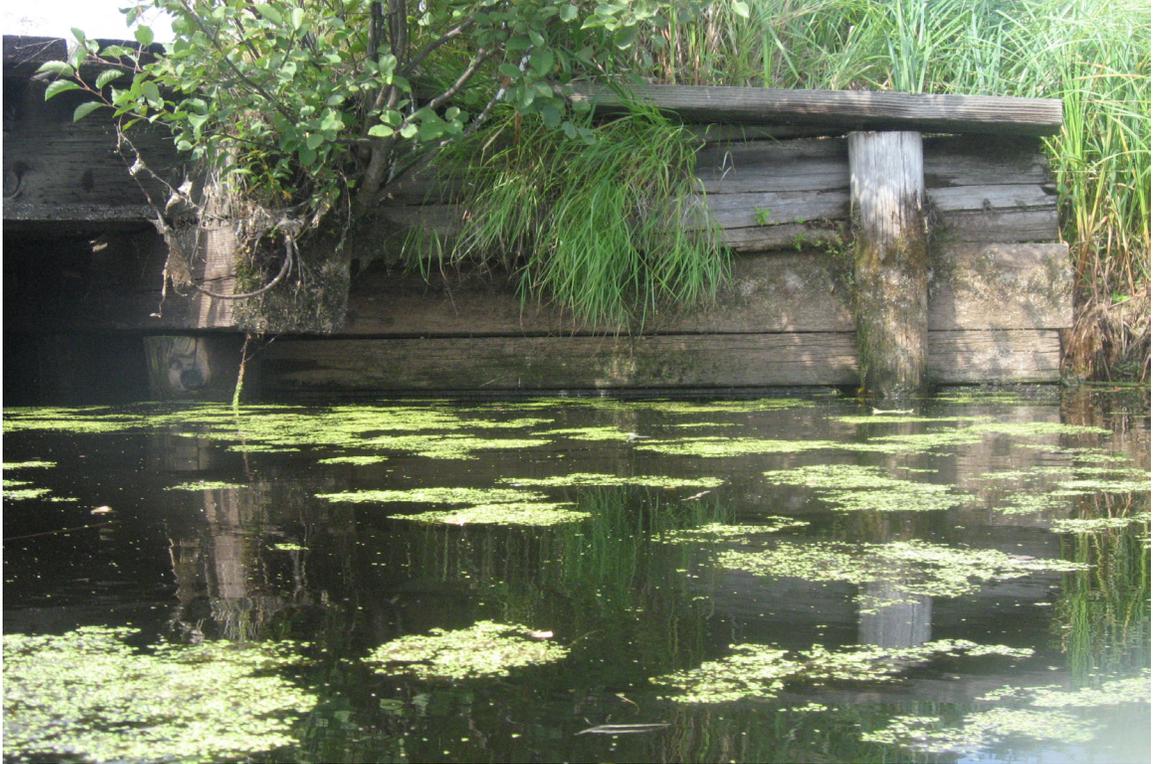
Photograph 3. View of Northeast Wingwall, Looking Northwest.

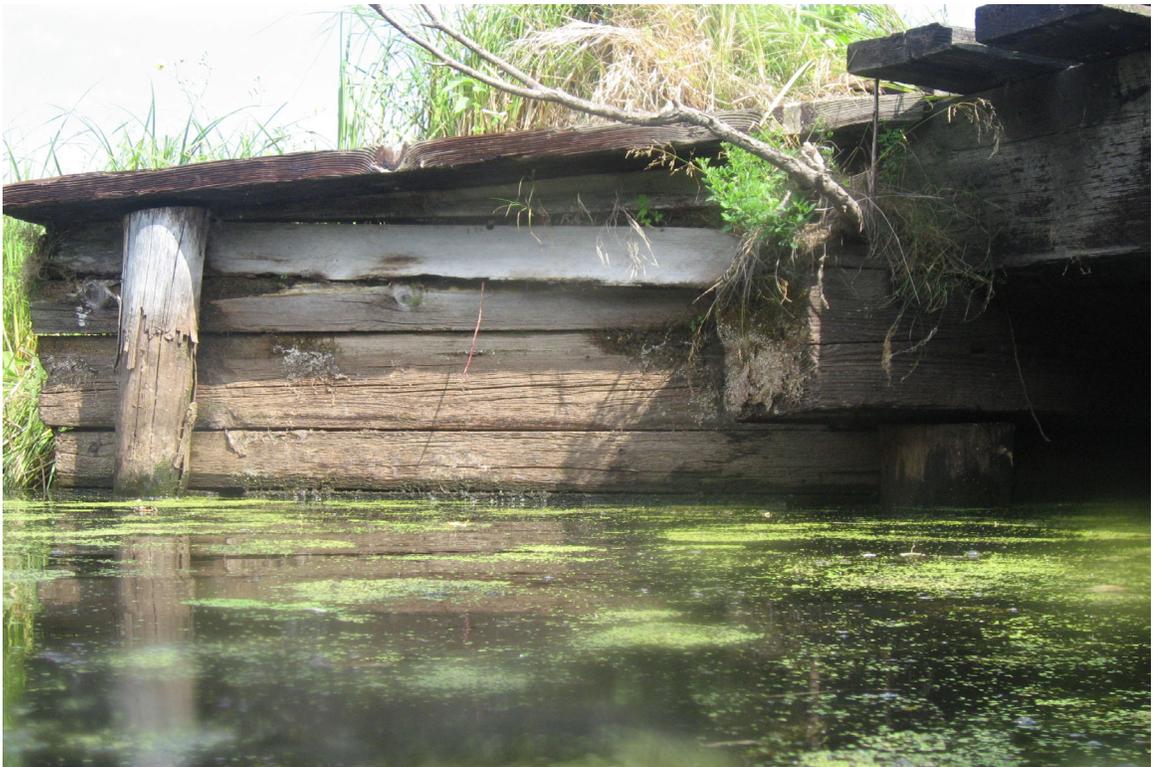
Photograph 4. View of Northwest Wingwall, Looking Northeast.

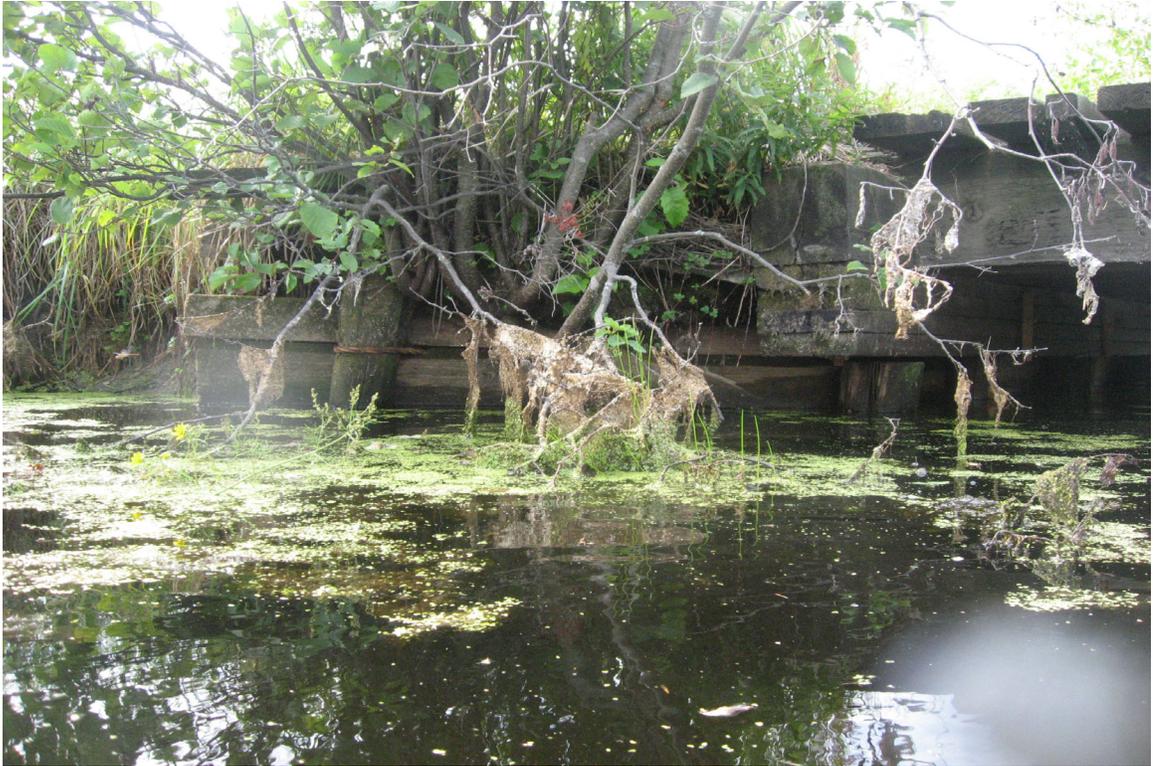
Photograph 5. View of Southeast Wingwall, Looking Southwest.

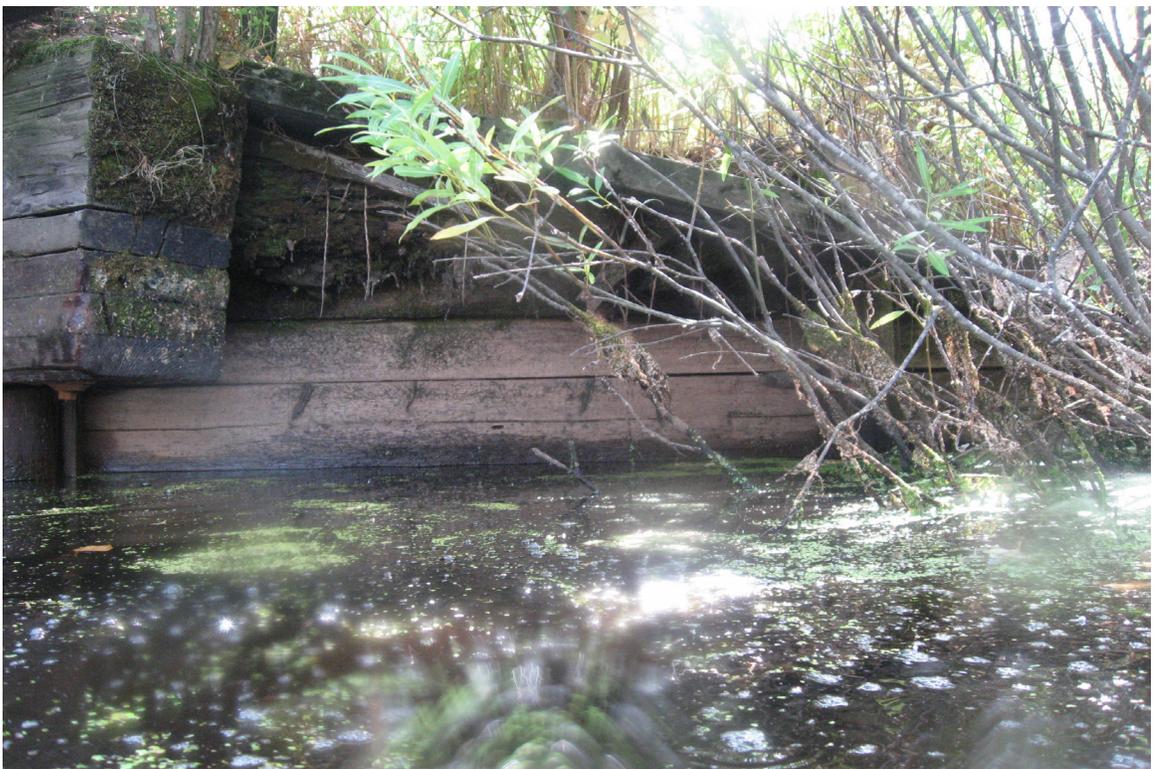
Photograph 6. View of Southwest Wingwall, Looking Southeast.

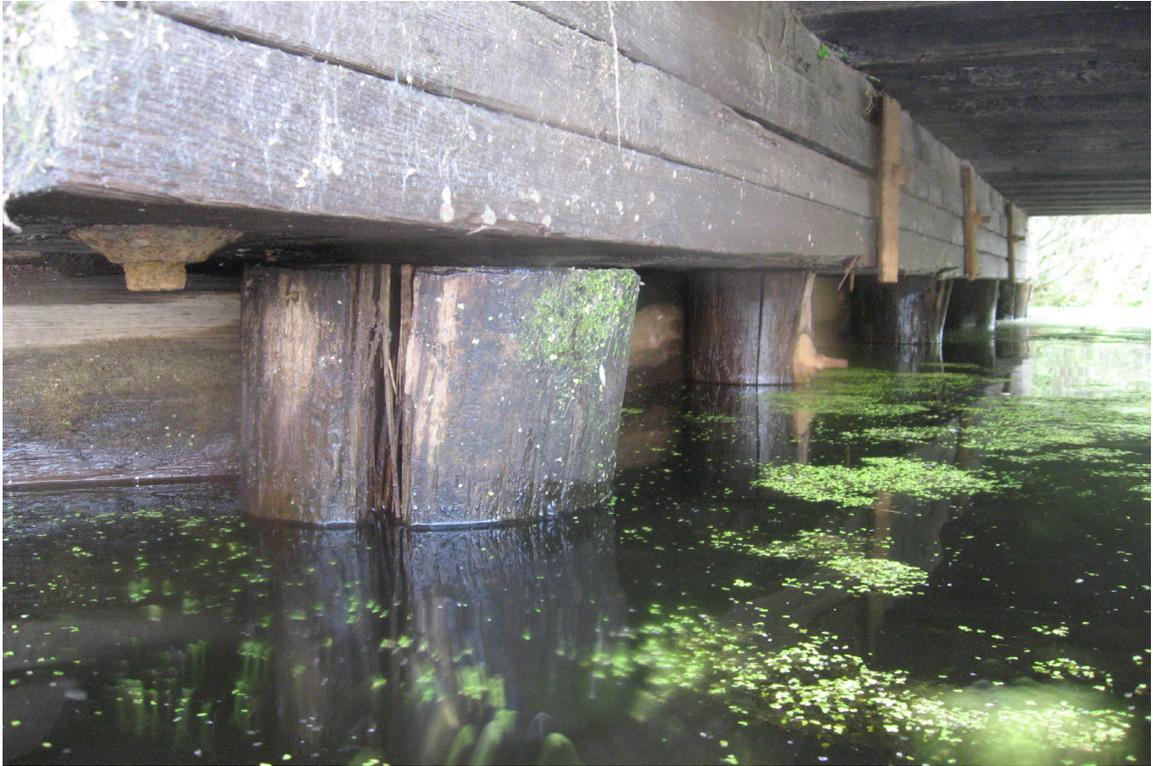
Photograph 7. View of the First Downstream Pile of the South Abutment, Looking Southwest. Note gap between top of pile and pile cap.

- ⑩ There was a 3 inch wide by 6 inch penetration gap (reduced bearing area) between pile caps and all piles on South Abutment.
- ⑪ The channel bottom consisted of soft silt with a maximum probe rod penetration of 1 foot.

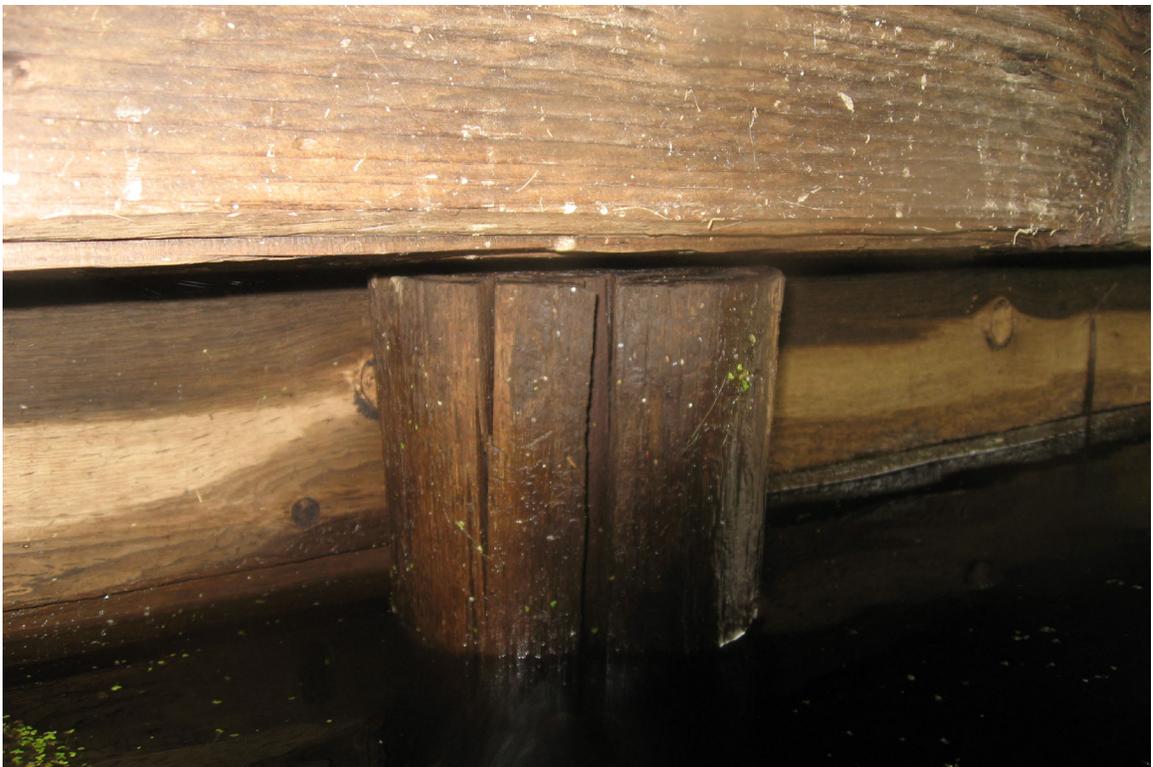
Photograph 8. View of the First Downstream Pile of the South Abutment, Looking Northwest. Note gap between top of pile and pile cap.

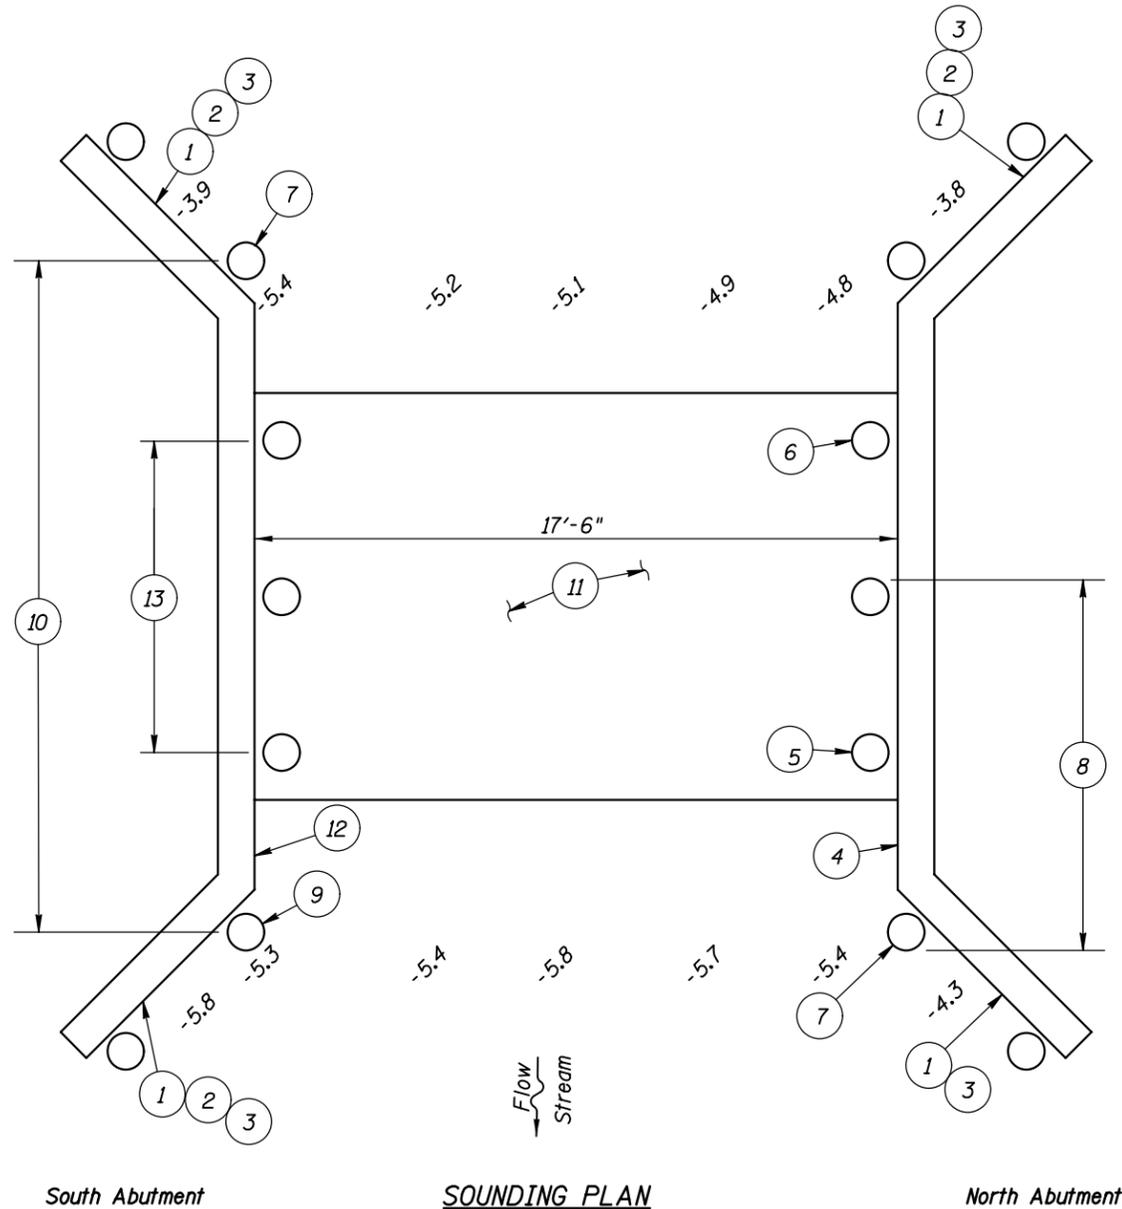
- ① Wingwalls and planking were displaced with evidence of fill material spilling out.
- ② The plank on the west wingwall of the north abutment as well as both wingwalls on South Abutment (first two from the top) have failed at the joint backwall area, exposing some backfill.

- ③ Vegetation has grown at the joints between wingwalls and abutment faces.
- ④ Backwall plank at the downstream end of the north abutment is heavily deteriorated.

- ⑤ There is a 6 inch wide by 3 feet long by 6 inches deep gap along the backwall by the second pile from the downstream end of the north abutment.
- ⑥ There is a 3 inch wide by 3 feet long by 6 inches deep gap along the backwall by the fourth pile from the downstream end of the north abutment.

- ⑦ The outer shell of the downstream pile of the North Abutment and upstream pile of the South Abutment was split and delaminated all around the circumference with a 2 inch depth. This condition extends from the top of the pile to 1 foot below the waterline.

- ⑧ The three piles on the downstream end of the North Abutment exhibited surface cracking and delamination on portions of the perimeter with 0.5 to 1 inch of maximum penetration in outer shell from the top of pile to 1 foot below the waterline.

- ⑨ The first pile on the downstream end of the South Abutment was split and delaminated with a 2 inch penetration. This condition extends from the top of pile to the waterline.

- ⑫ Between first and second pile from downstream end of South Abutment exhibited a gap 5 feet long by 6 inches wide by 6 inches deep between pile cap and backwall.

- ⑬ Middle piles on South Abutment exhibited a 1/2 inch wide split.

Monitor gaps and loss of backfill at all wingwalls, and if found to be affecting the roadway embankment, repair may be necessary.
