UNDERWATER BRIDGE INSPECTION REPORT

STRUCTURE NO. 09501

KETTLE RIVER

MINNESOTA DEPARTMENT OF TRANSPORTATION  
UNDERWATER BRIDGE INSPECTION

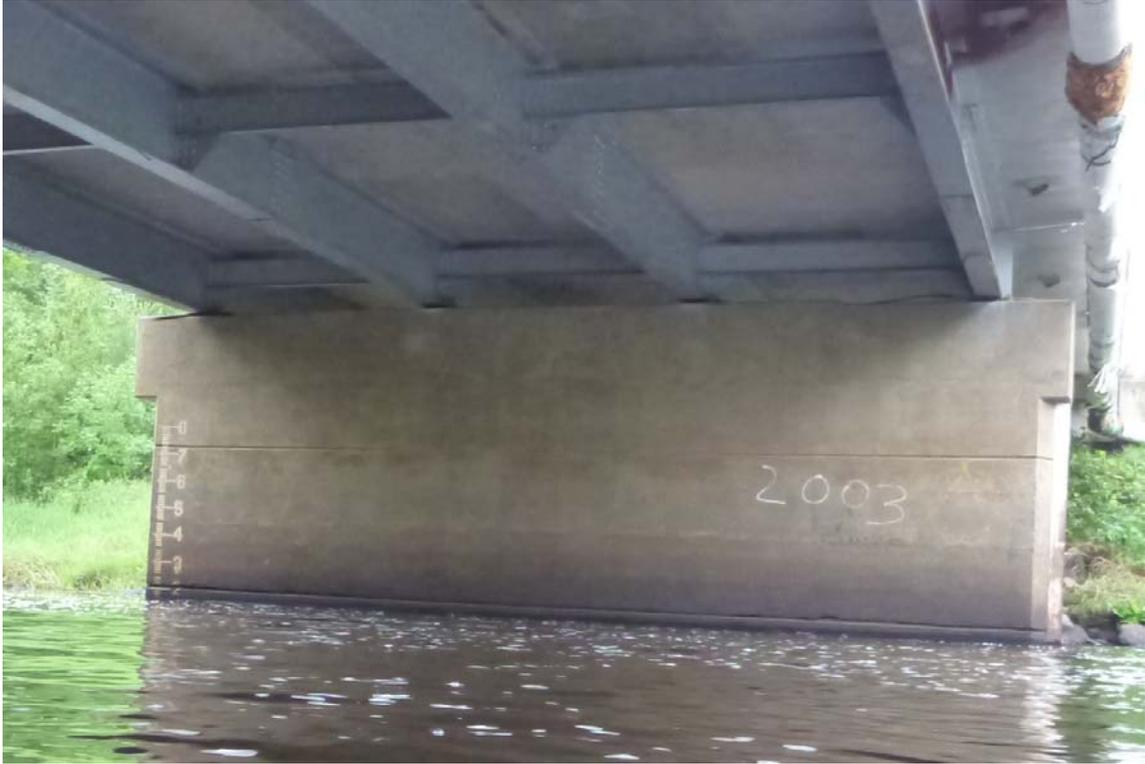
Photograph 1. View of Pier 1, Looking West.

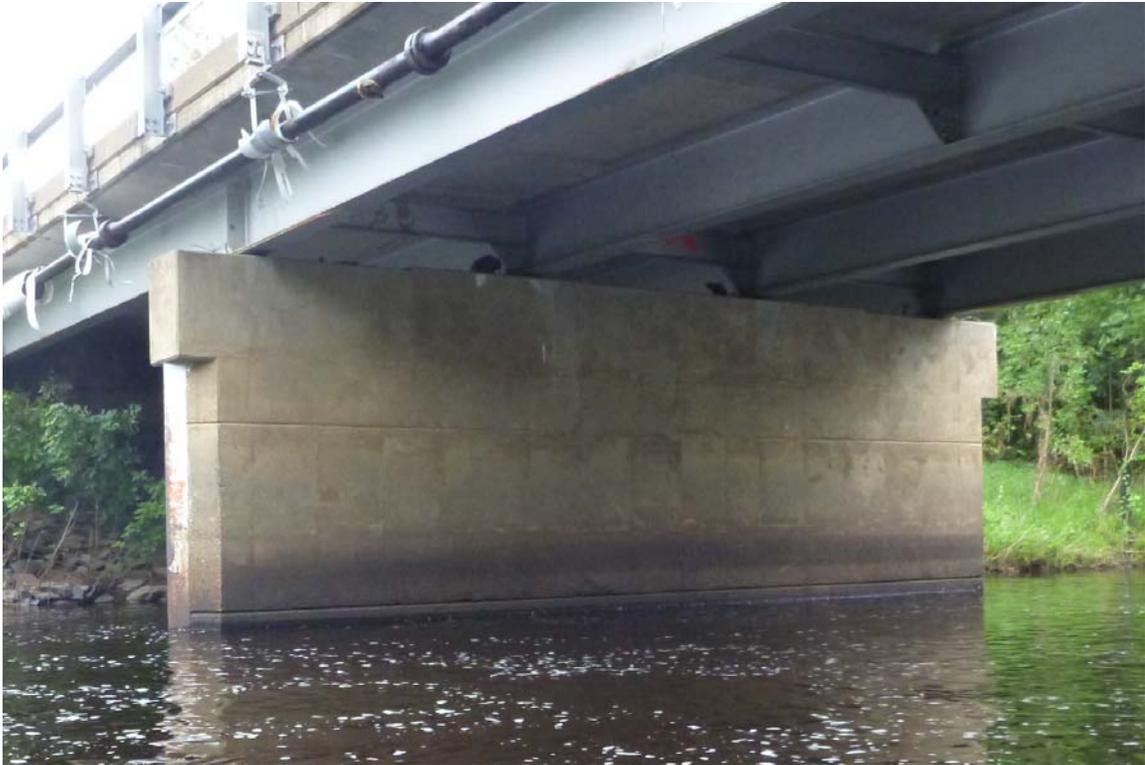
Photograph 2. View of Pier 2, Looking Southeast.

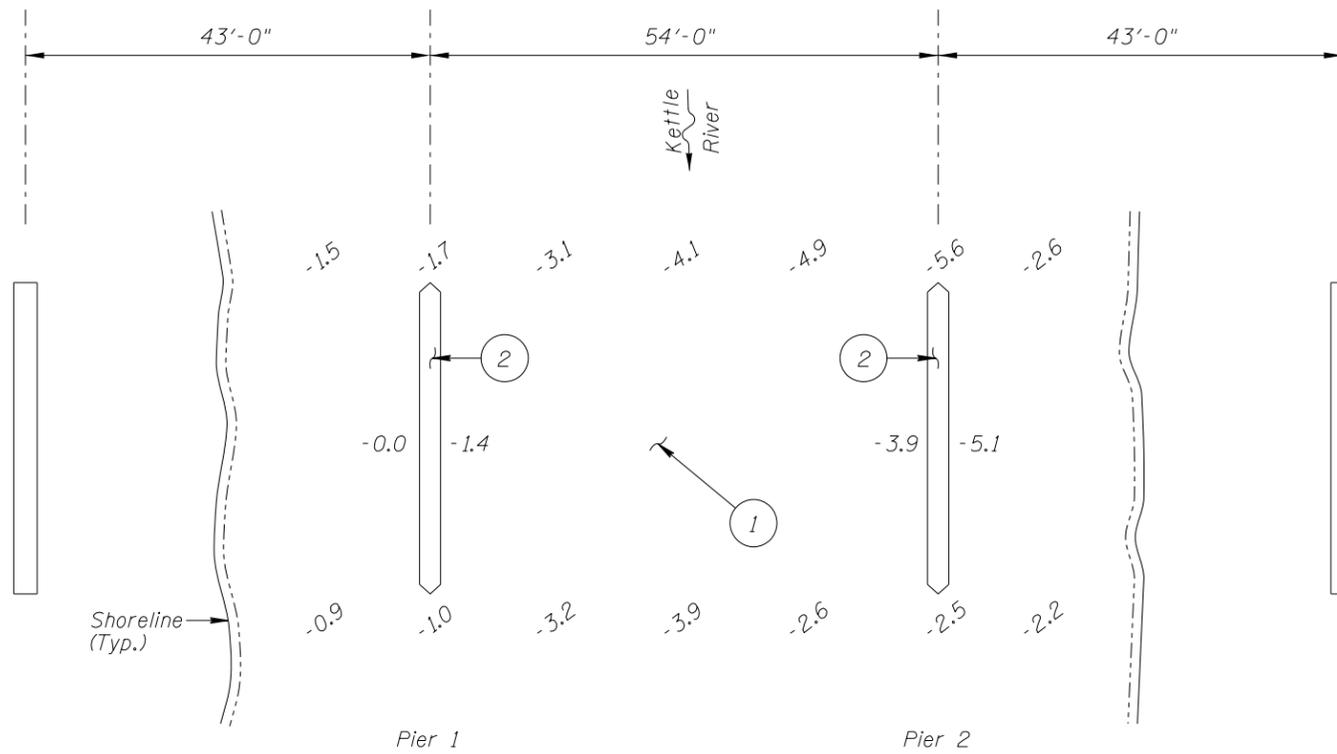
INSPECTION AND SOUNDING PLAN

- (1) The channel bottom consisted of riprap 2 feet diameter and smaller rocks with no rod penetration possible.
- (2) Light concrete scaling, with up to 1/8 inch penetration was observed from 1 foot above waterline to channel bottom on Pier 1 and 2.
