UNDERWATER BRIDGE INSPECTION REPORT

STRUCTURE NO. 09513

CSAH NO. 61

THE ST. LOUIS RIVER

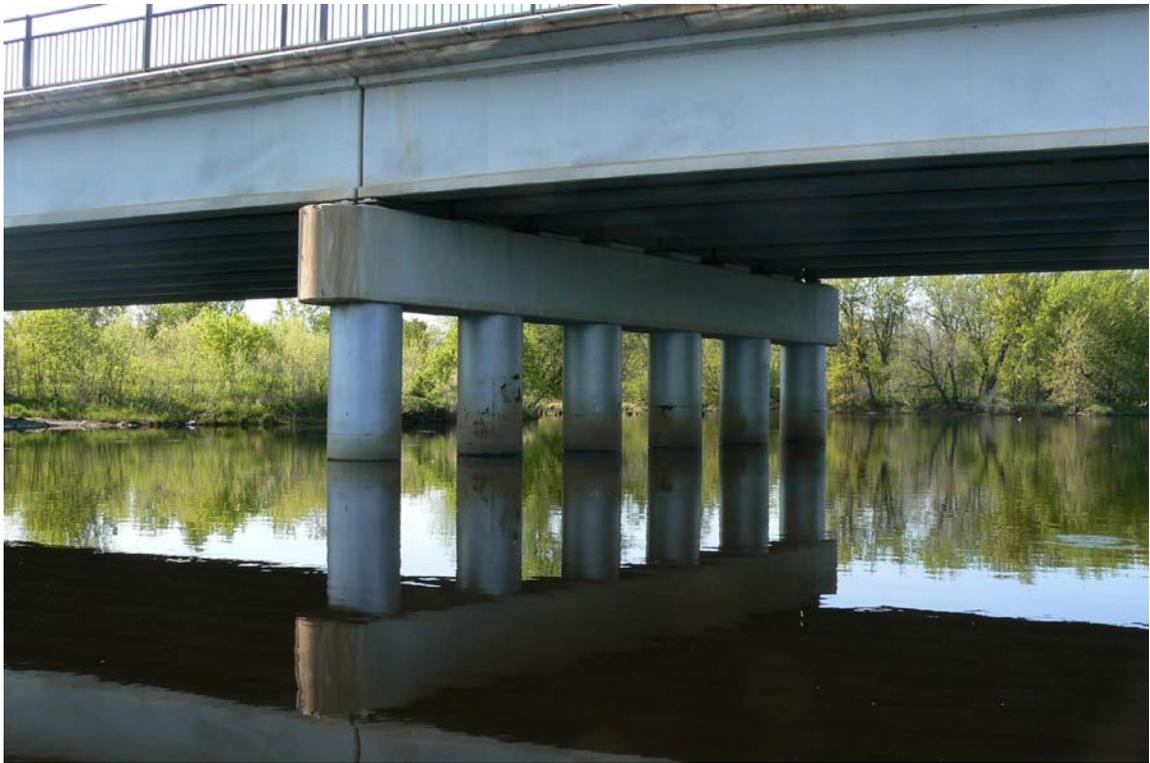
Photograph 1. View of Pier 1, Looking Northwest.

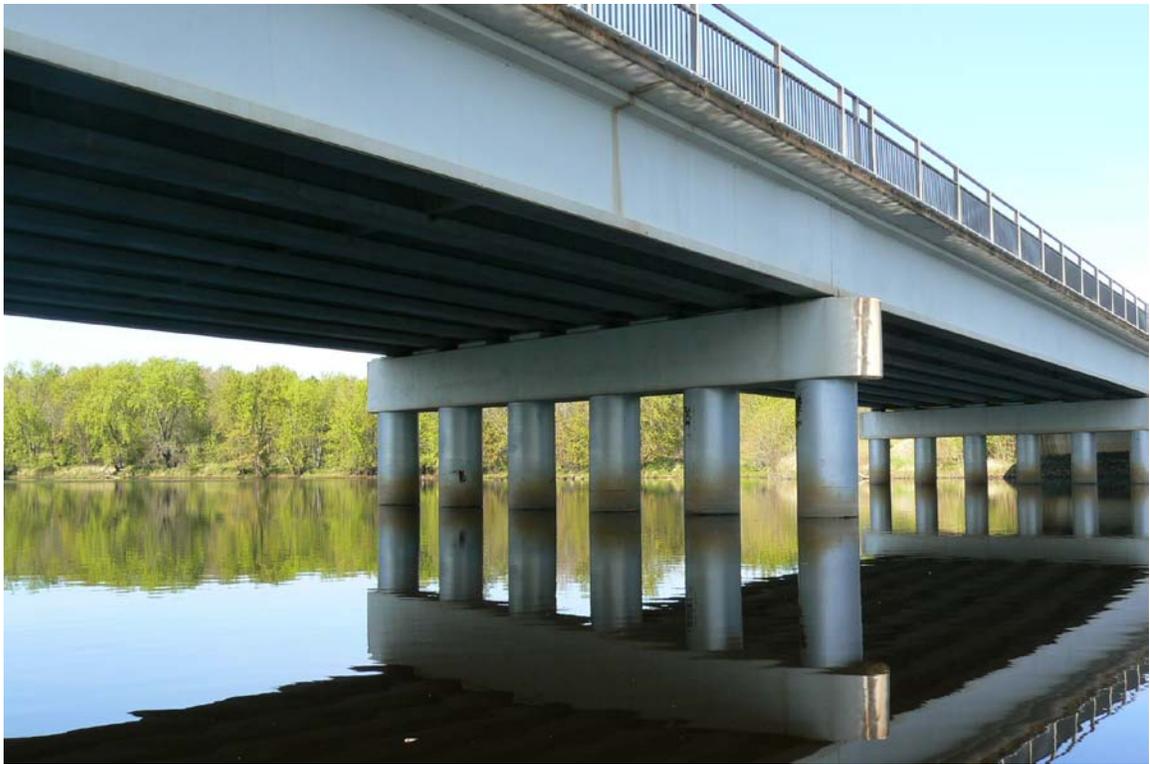
Photograph 2. View of Pier 2, Looking Northeast.

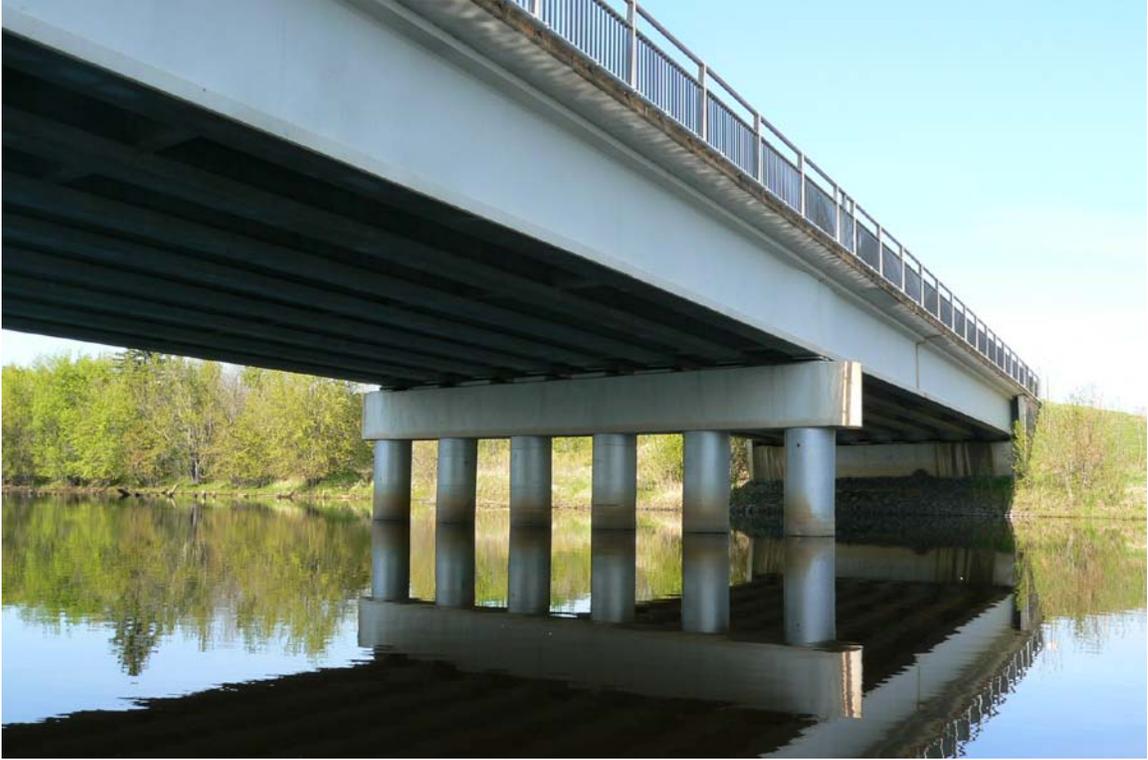
Photograph 3. View of Pier 3, Looking Northeast.

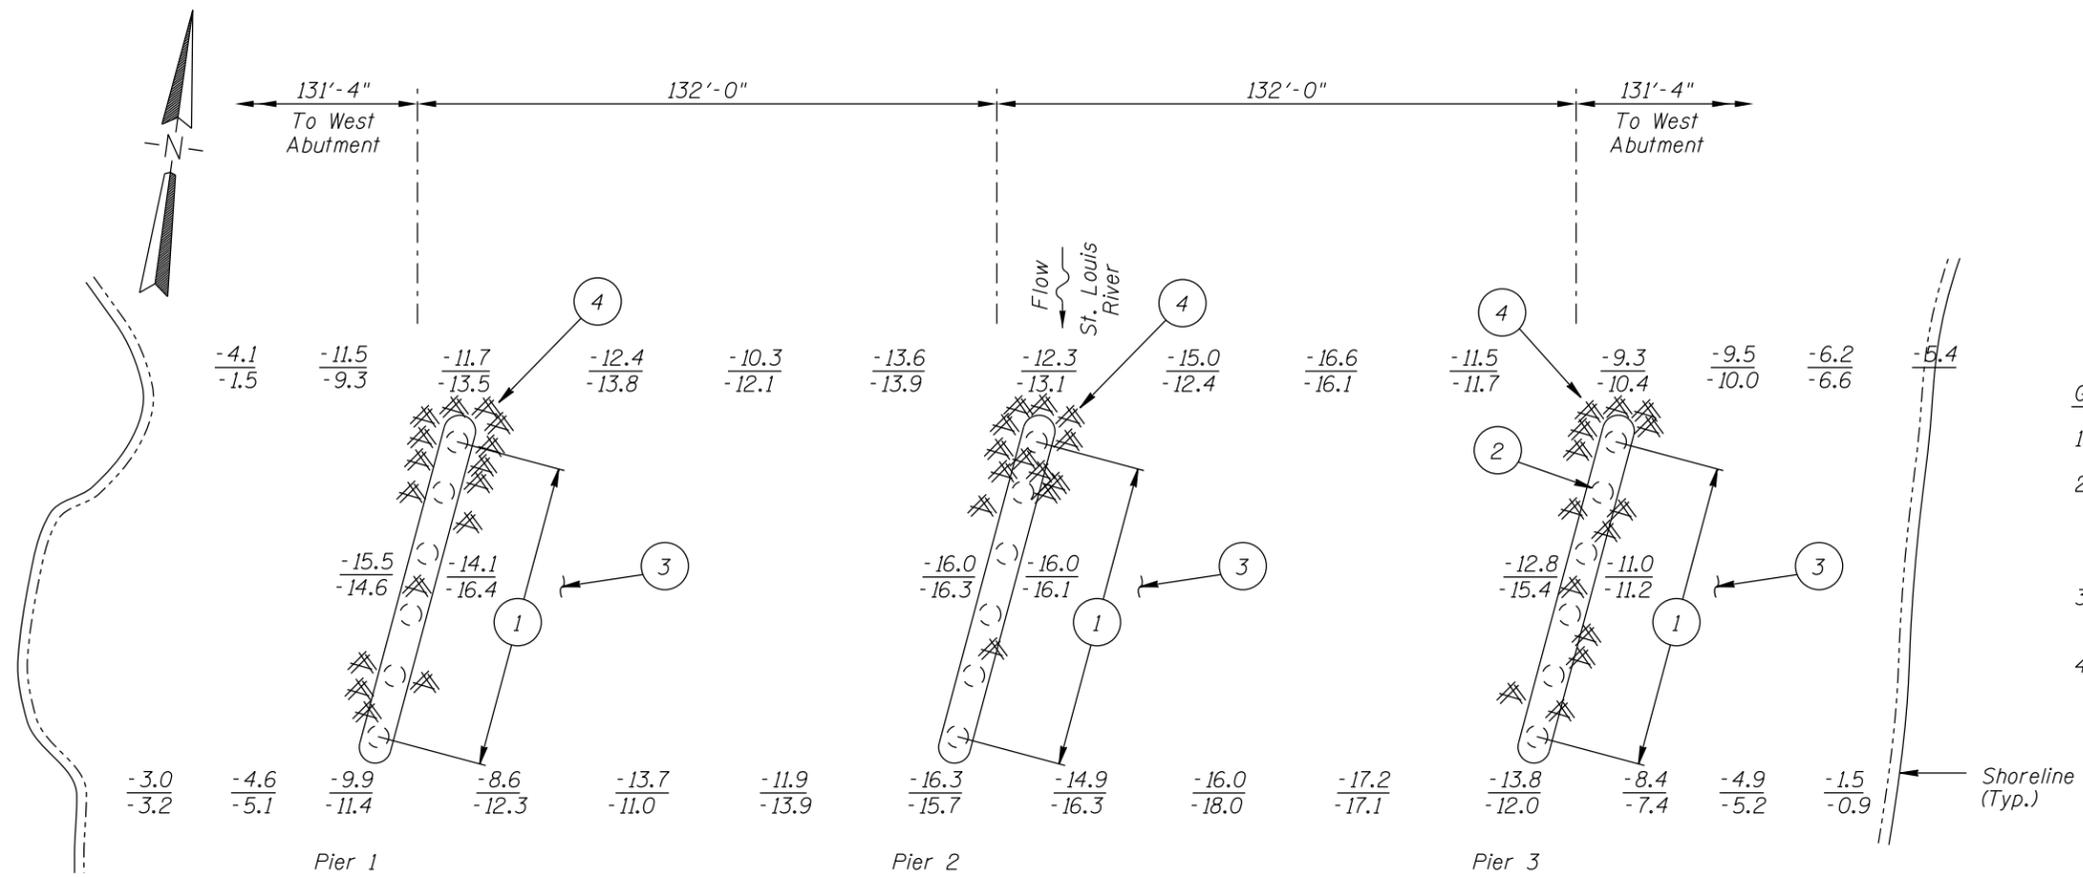
SOUNDING PLAN

1. The steel pipe piles exhibited coating loss with up to 1/2-inch-diameter nodular corrosion and up to 1/32-inch-deep section loss (pitting) over 10 to 25 percent of the surface area from the waterline to 4 feet below and on 100 percent of the surface area from 4 feet below the waterline to the channel bottom.
2. An outer steel casing was observed around the second upstream pile at Pier 3. The outer casing extended from the channel bottom to 8 feet below the waterline.
3. The channel bottom consisted of sand and gravel with 8 inches of probe rod penetration and occasional cobbles and riprap.
4. A moderate accumulation of 1-foot-diameter and smaller timber debris, ranging from 3 feet high off the channel bottom at the upstream end of the piers to 1 foot high throughout the pier, was observed on the channel bottom.
