UNDERWATER BRIDGE INSPECTION REPORT

STRUCTURE NO. 31510

MISSISSIPPI RIVER

OCTOBER 1, 2012

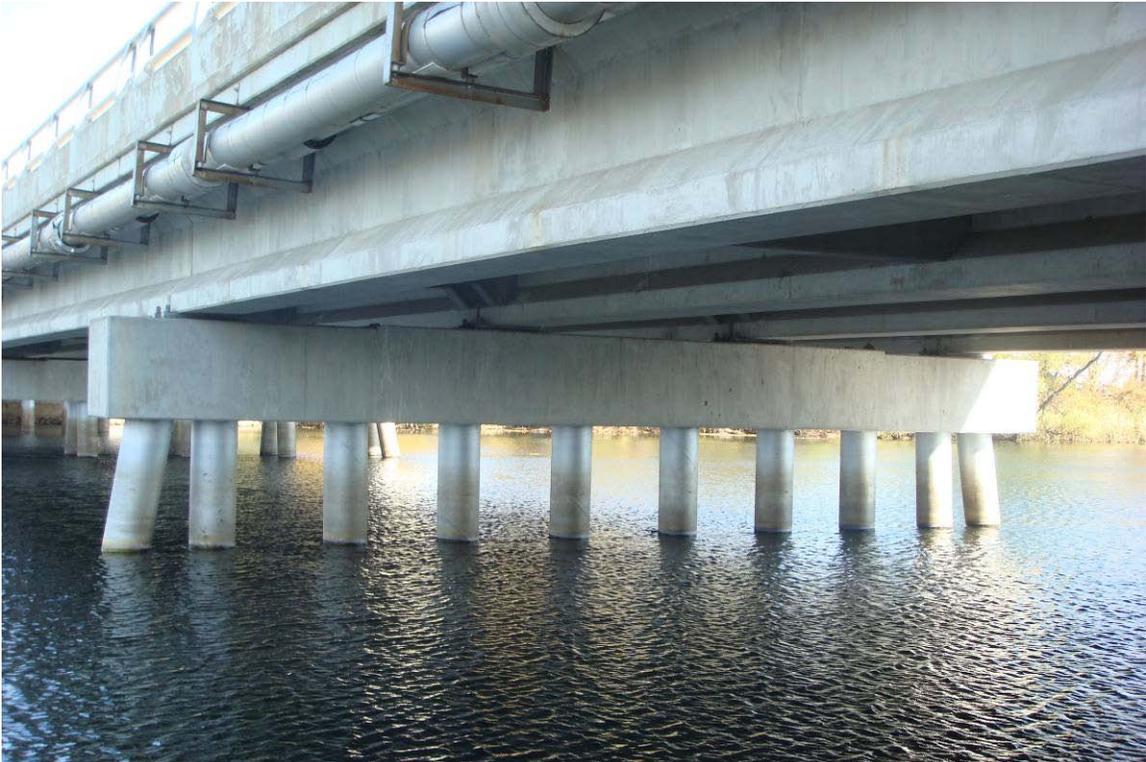
Photograph 2. View of Pier 1, Looking Northeast.

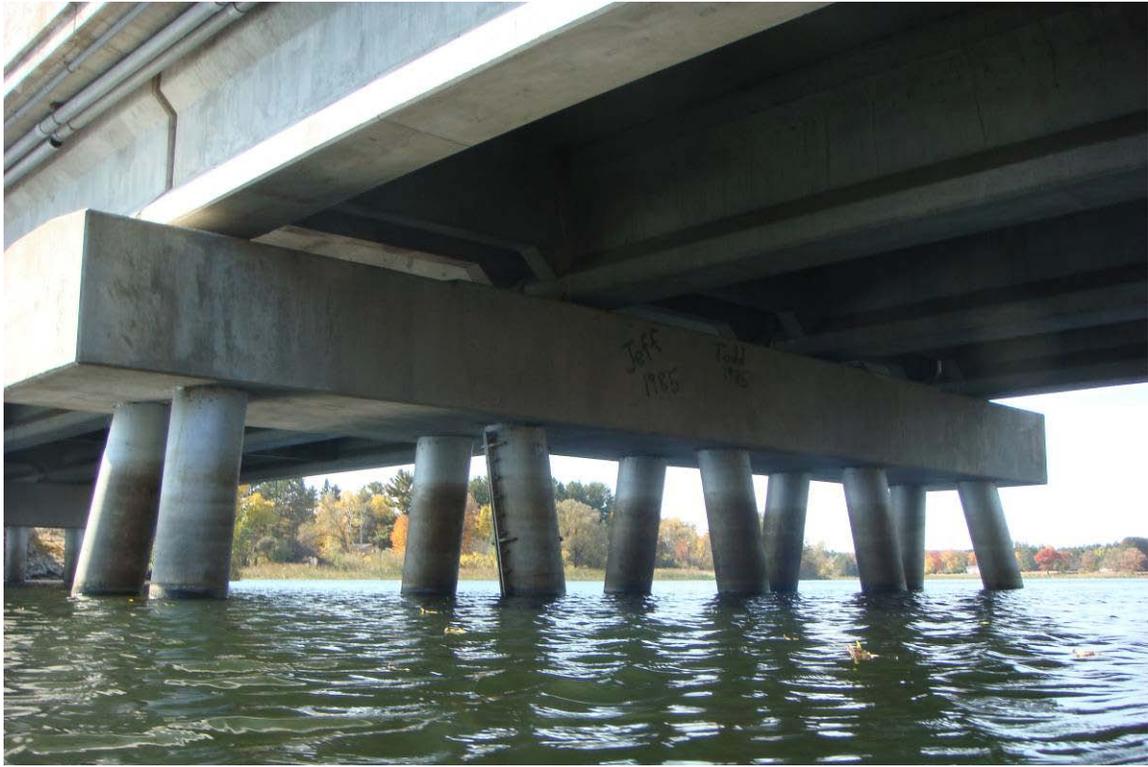
Photograph 3. View of Pier 2, Looking Southwest.

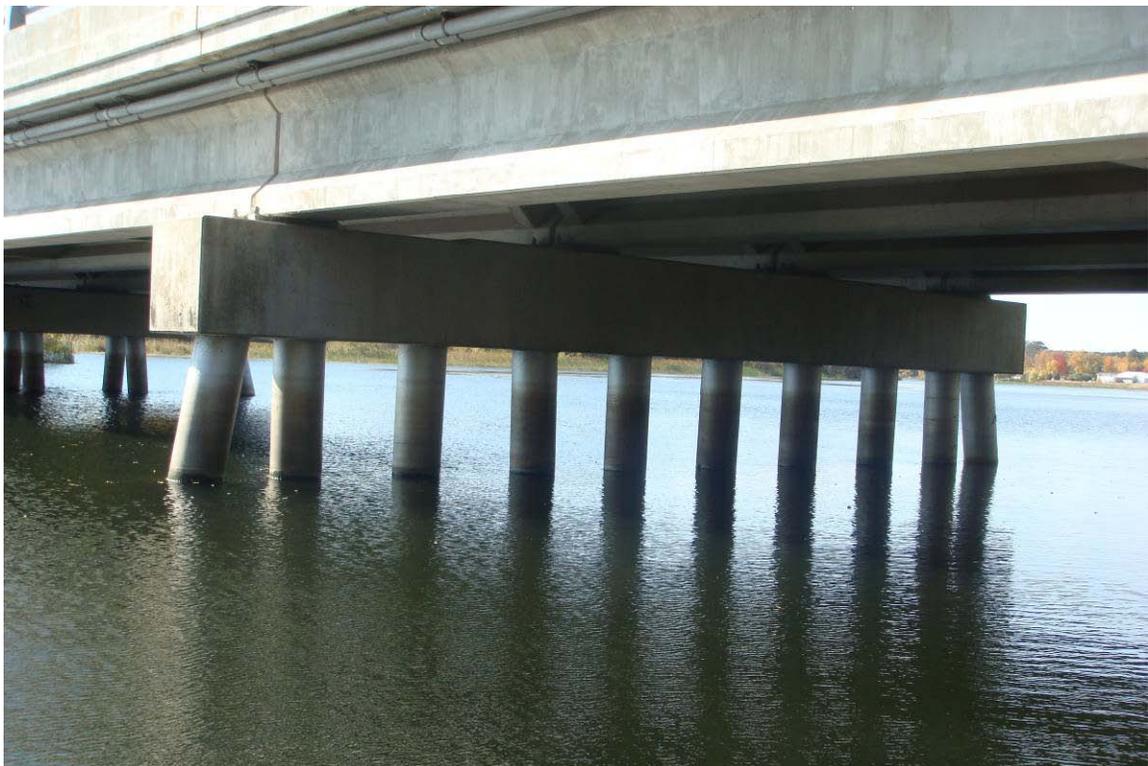
- (E) The downstream battered pile at Pier 3 exhibited a 15 degree bend 5 feet below the waterline where the pile then extends vertically into the channel bottom. (appears to be related to driving the pile during original bridge construction) The pile continues to be stable and not compromising the overall stability of the pier.

Photograph 4. View of Pier 3, Looking Southwest.

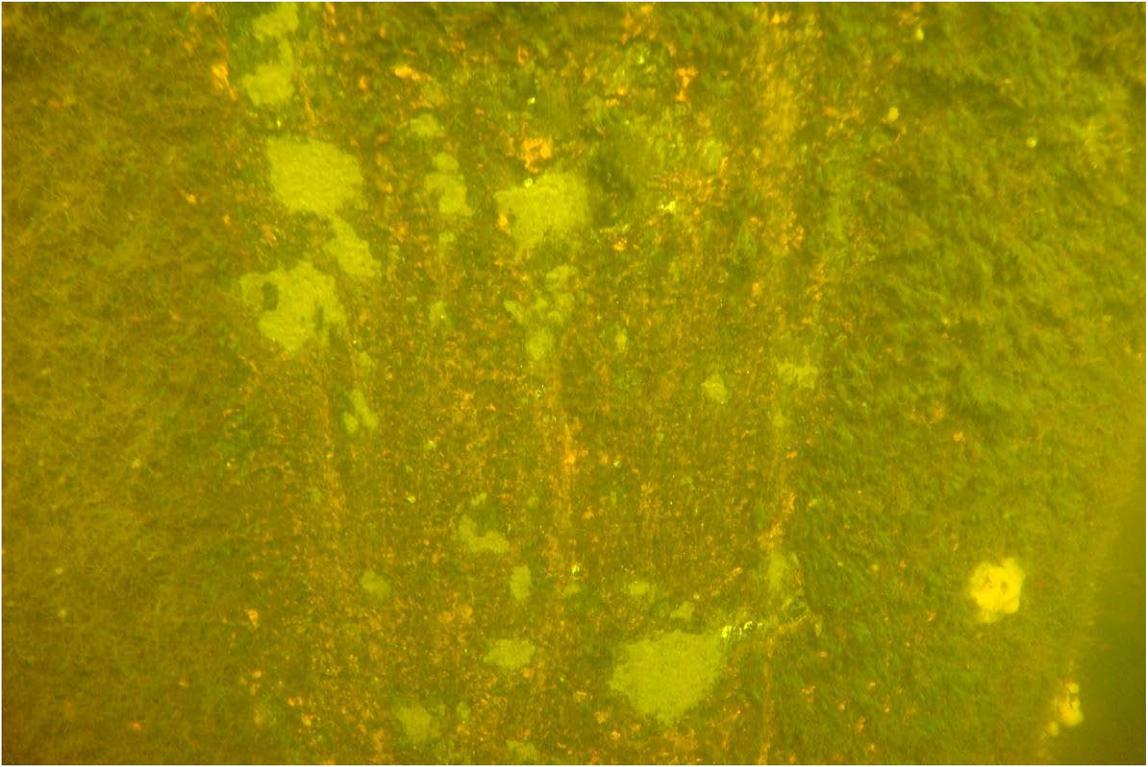
- (A) Moderate corrosion was observed on the steel pipe piles from the waterline to the mudline. The piles exhibited minimal section loss with typical pitting penetrations of no more than 1/32 inch and up to a maximum of 1/16 inch in random instances.
- (B) The vertical crack noted in a prior inspection at a Pier 2 pile has been adequately repaired with a bolted steel collar extending from the top of the pile to 3 feet below the waterline. The repair was in good and sound condition.
- (C) Minor scour depressions, up to 2 feet deep with up to a 2 feet radius, were observed around the two upstream piles of Pier 2.
- (D) A moderate accumulation of organics/vegetation with occasional timber debris was observed at the upstream nose and along the entire bank side of Pier 3 extending from

Photograph 5. View of the Typical Pile Condition Underwater, Looking North.

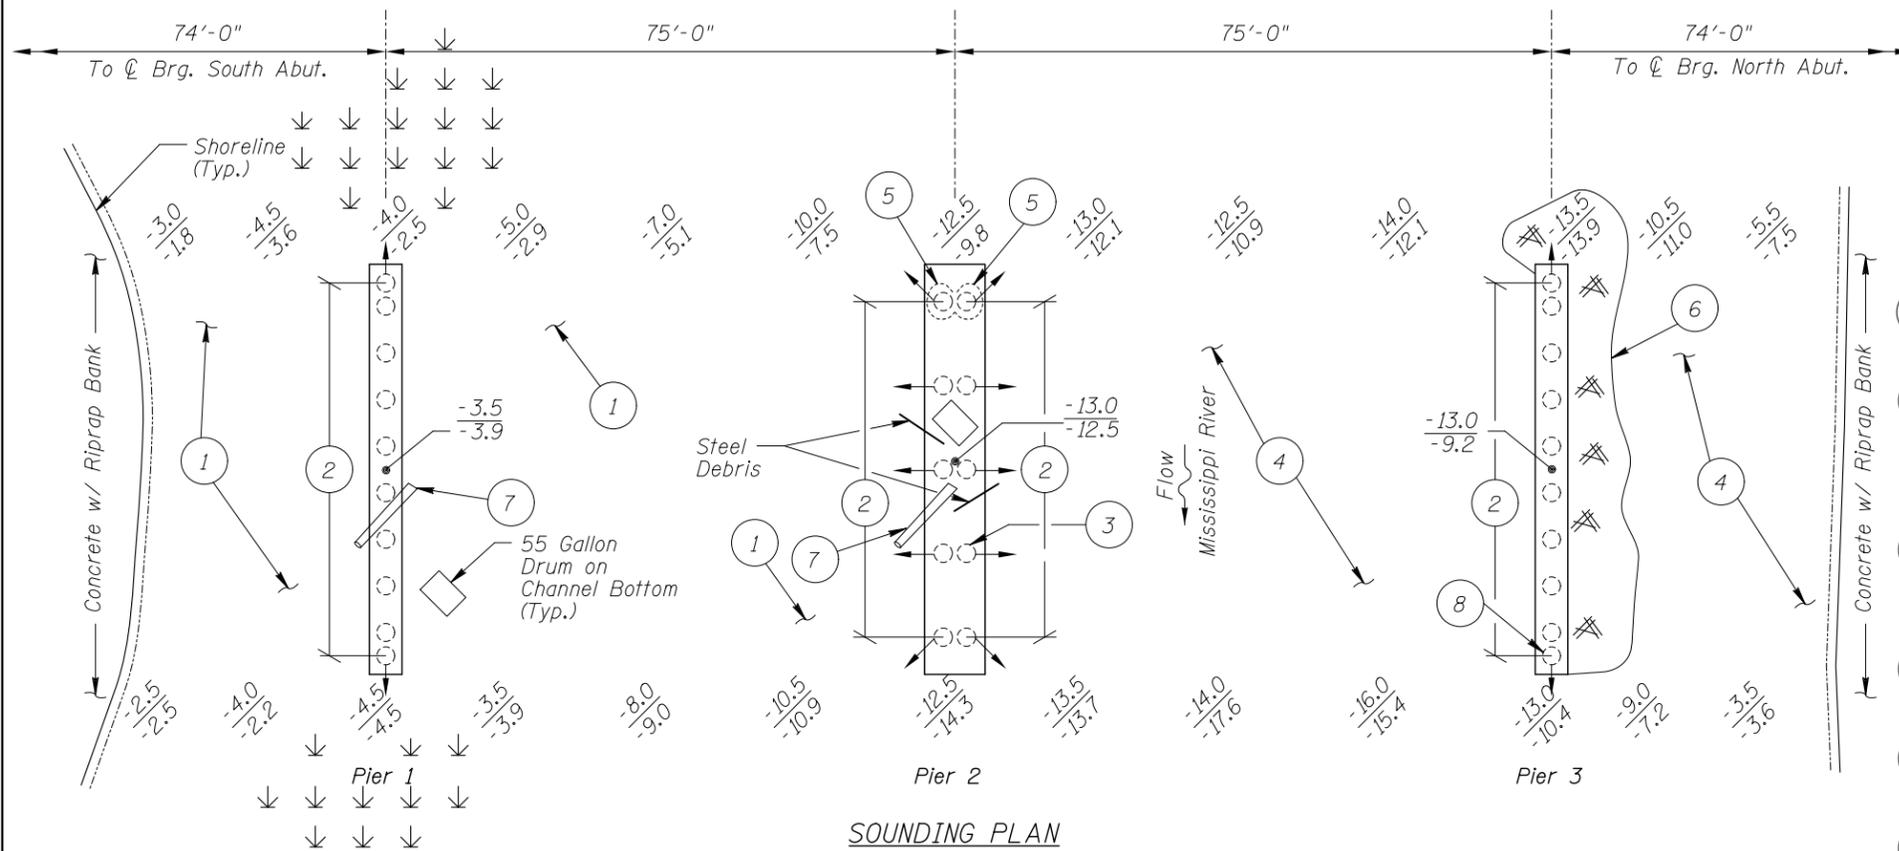
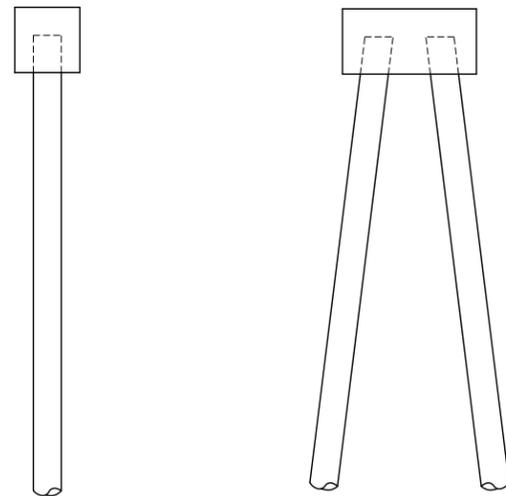
INSPECTION AND SOUNDING PLAN

- 1 The channel bottom material consisted of soft silty sand allowing maximum probe rod penetrations of 1 to 1.5 feet.
- 2 Moderate corrosion covered 75 to 100 percent of the pile surfaces from the waterline to the channel bottom. Minimal section loss was observed with typical pitting up to 1/32 inches deep and maximum pitting in random instances up to 1/16 inches deep near the waterline.

- 3 Vertical crack along welded joint noted in previous inspection, August 27, 1997, has been repaired with a bolted steel collar extending from the underside of the pile cap to 3 feet below the waterline. The repair was in good and sound condition.

- 4 The channel bottom material consisted of firm sandy gravel with 6 inch to 2 foot diameter rocks and probe rod penetrations of 2 to 4 inches.
- 5 Minor scour depressions, up to 2 feet deep with up to 2 feet radius, were observed around the upstream piles of Pier 2.

- 6 Moderate accumulation of organics/vegetation was observed at the upstream nose and along the entire bank side of Pier 3 with occasional 1 foot diameter timber debris extending from the mudline to 2 feet above the channel bottom.

- 7 One approximately 8 inch diameter piece of timber debris was observed on the channel bottom along the midpoint of the pier.
- 8 The downstream battered pile at Pier 3 exhibited a 15 degree bend 5 feet below the waterline where the pile then extends vertically into the channel bottom. (appears to be related to driving the pile during original bridge construction)
